EMPIRE STATION COMPLEX

Neighborhood Conditions Study

February 2021

FOR
Empire State Development

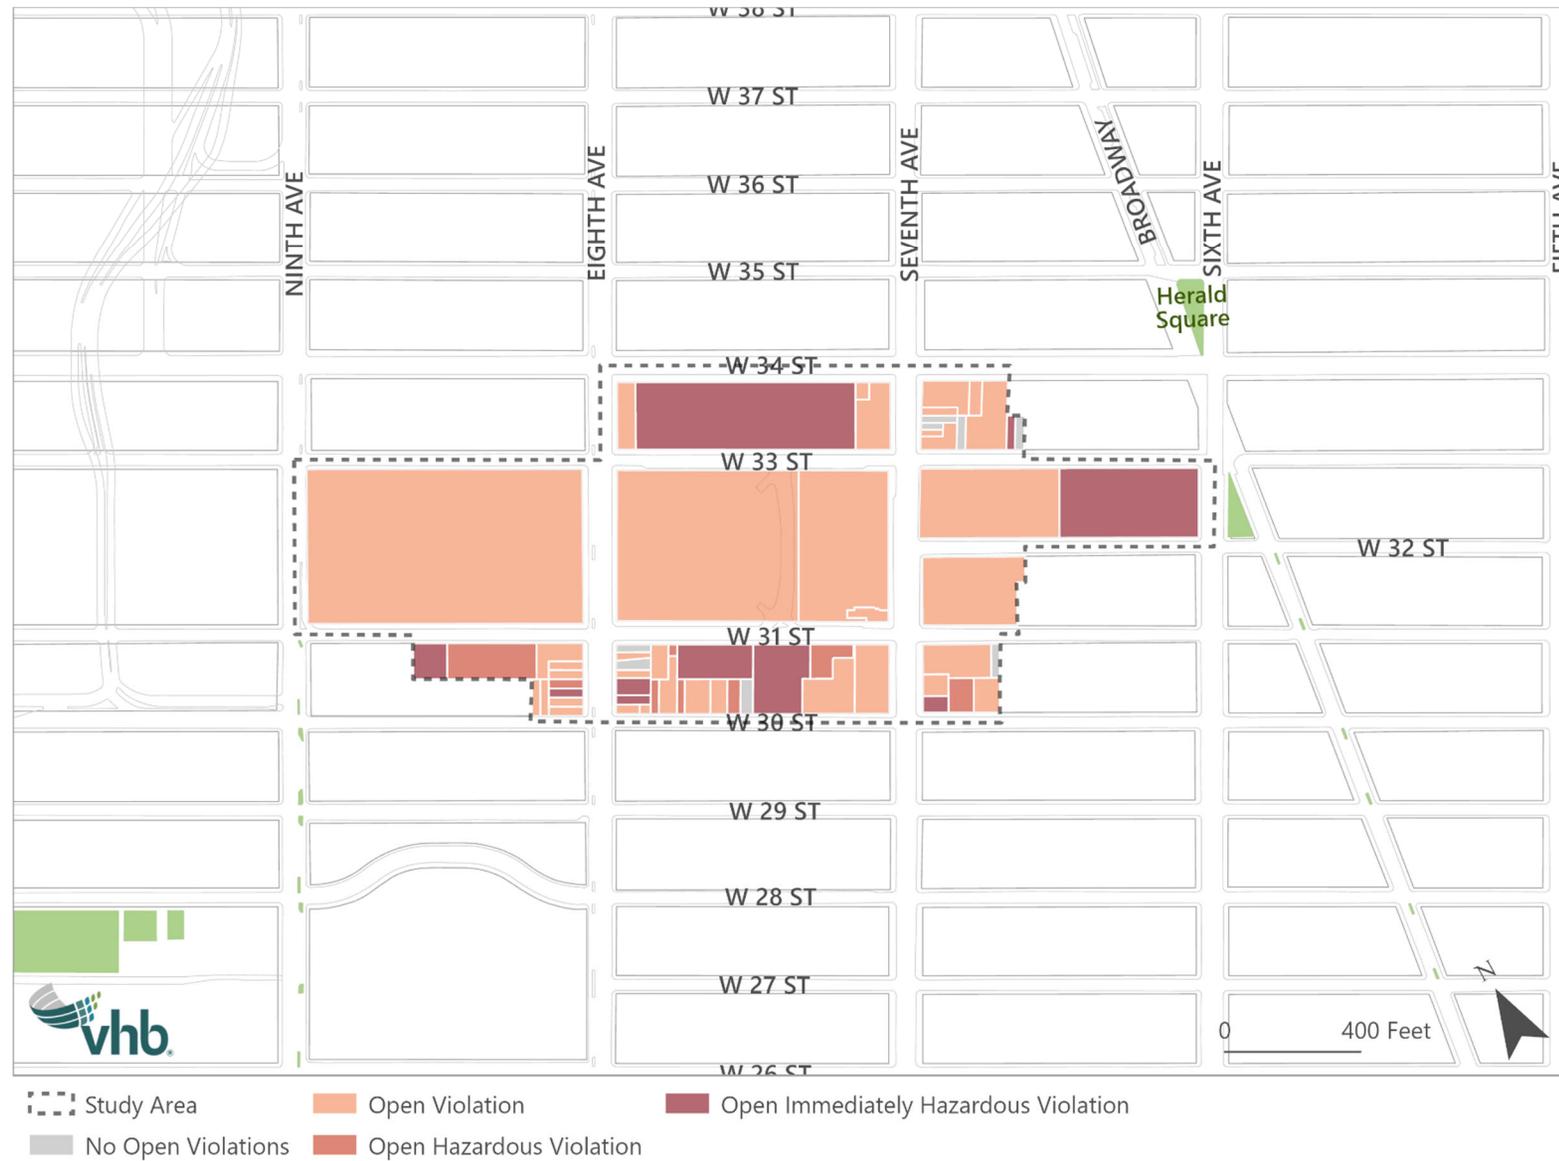
Figure E-5 Building Code Violations in the Study Area

- › *Block 754, Lot 38*: "Failure to maintain exterior building wall. Defect is section of the building façade from second story to roof level has collapsed on to the sidewalk...leaving loose and exposed bricks."
- › *Block 780, Lot 2*: "Openings – holes are not covered at the first floor and at the shaft at the second through fifth floors."
- › *Block 808, Lot 40*: "Failure to maintain elevator or conveying system. Decking unsecured by lower left handrail."
- › *Block 809, Lot 53*: "Failure to take required measures to provide safety measures to protect public from documented unsafe façade."

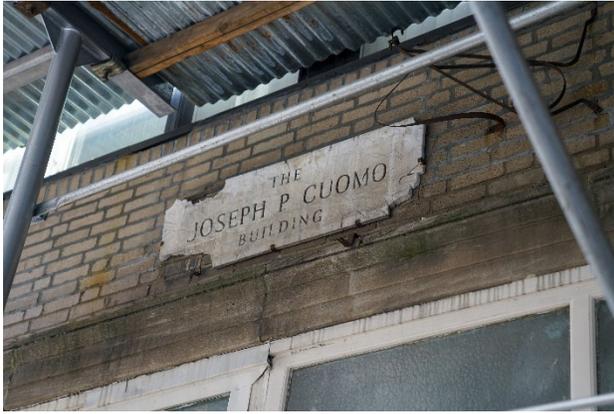
View of façade

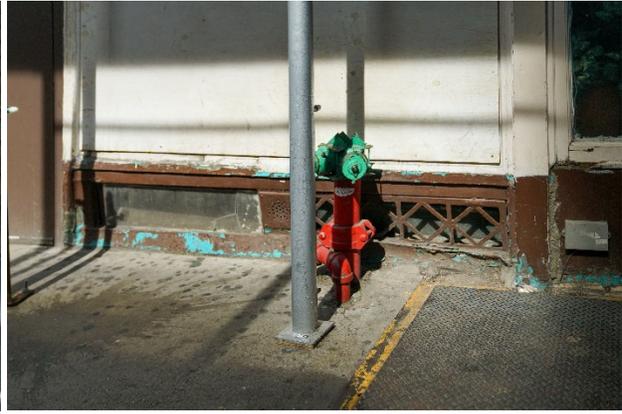
View of foundation
