CITY OF BUFFALO
BROADWAY MARKET
BUILDING CONDITIONS SURVEY REPORT

May 29, 2018
Compiled & Issued By:

A | Executive Summary

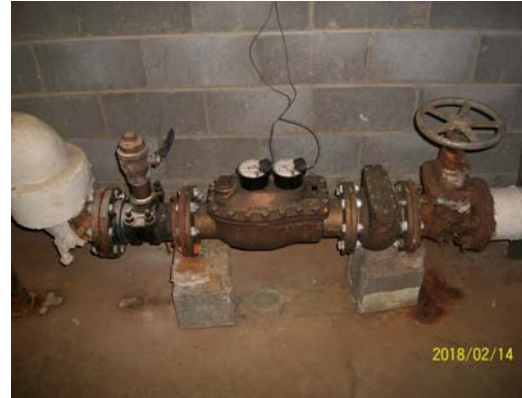
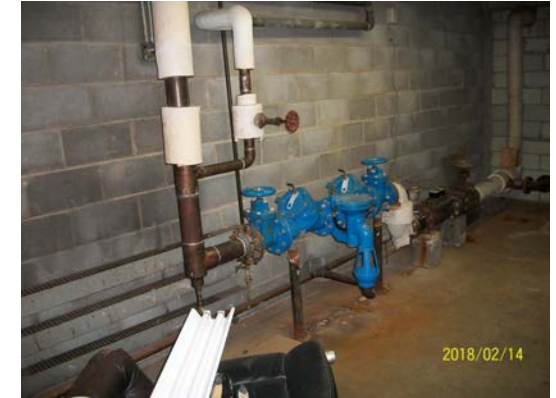
4" ductile iron domestic water service enters within the basement. Piping is insulated.
 4" gate type shut-off valve on water service is showing signs of rust.
 Water Meter: Neptune "TruFlo" model #E-B4.
 Backflow Prevention Device: Watt's model #909RP, serial #192626. 2" drain from device terminates indirectly above floor drain.
 Piping and devices were observed to be in good operating condition.
 No issues reported.

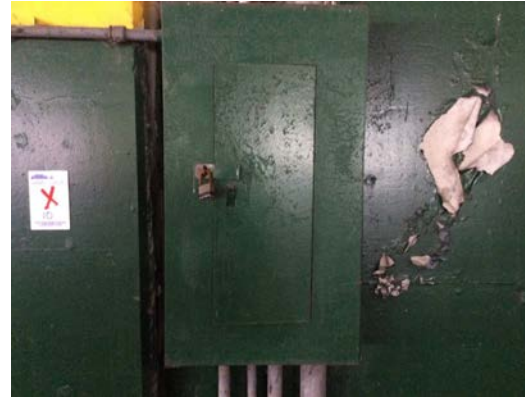
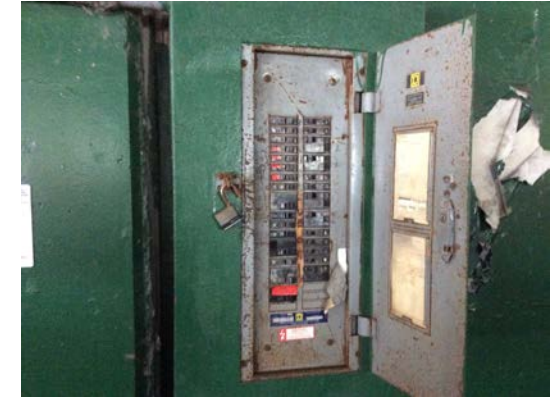
Square D panel board not locked rusted and corroded, 120/208 volt, 3 phase 4 wire.

Recommend replacing with panel boards suitable for outdoor environment and conditions.
