E-Comm Square Building Assessment

Structural, Electrical & HVAC

CHA Project Number: 16433

April, 2010

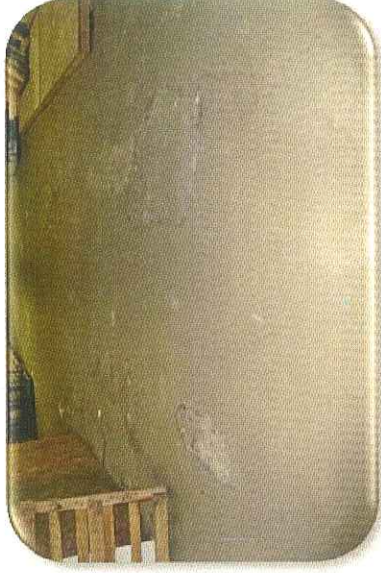
Photo 1

- ✦ The cast-in-place concrete exterior bearing walls and multi-wythe brick center bearing wall are in good condition with no structural deficiencies observed.
- ✦ The concrete slab-on-grade has some minor cracking, spalling and delamination. It appears that a concrete overlay was applied to the original concrete slab. The overlay is delaminating in some spots (Photo 1).
- ✦ Overall the basement is in good structural condition.

It is recommended that the areas where the slab is delaminating be repaired with a cementitious patching mortar.

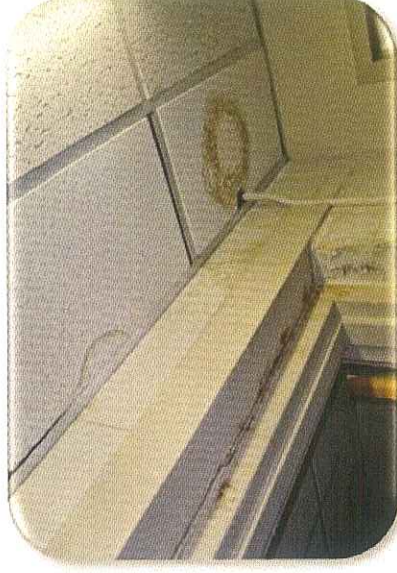
Photo 2

- + Water staining was observed in an electrical room and in the kitchen area adjacent to a skylight (Photos 2 & 3). These stains are likely from roof leaks.

It is recommended that repairs be made to fix roof the leaks.

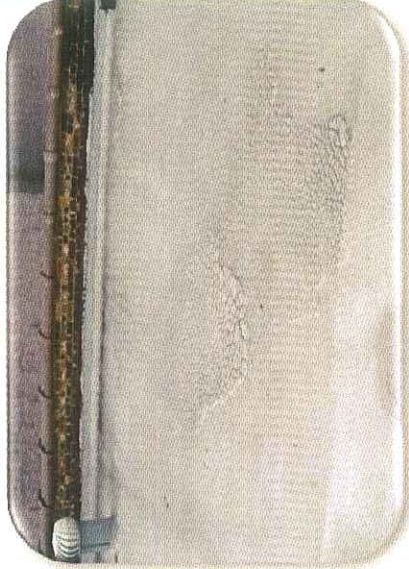
Photo 4

- + The roof consists of a built-up roofing material with a spray applied aluminum coating. The roofing is in overall poor condition (Photo 4).
- + The sheet metal coping on the north and east parapets is rusting and has loose and missing fasteners (Photo 5). A section of coping on the east parapet has come almost completely off (Photo 6).
- + The clay tile coping on the south and west parapets is in generally good condition but some deteriorated mortar joints and broken tiles were observed (Photo 7).

The existing roofing appears to be beyond its useful life. It is recommended that the existing roofing system be replaced.

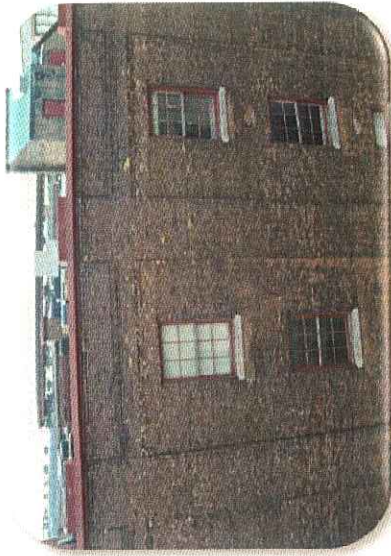
Photo 8

- + The facade is in fair condition. Some deteriorating mortar joints were observed and wood window frames have peeling and flaking paint (Photo 8).

It is recommended that all deteriorating mortar joints be repointed and all window frames should be stripped of existing paint, primed and repainted.

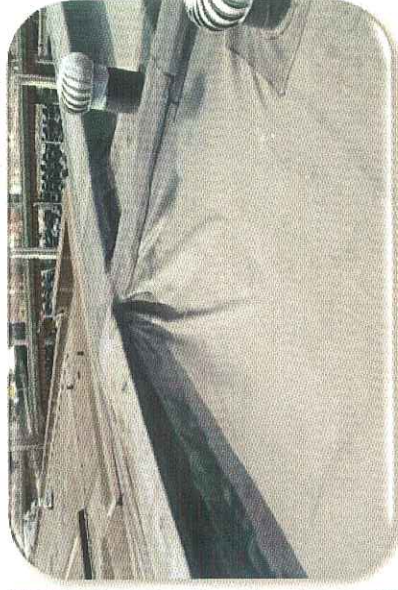
Photo 9

- ✦ The roofing consists of an adhered EPDM membrane roofing system. Many areas are not adhered and are pulling away from the parapets and mechanical equipment roof curbs (Photo 9). One failing seam was observed (Photo 10).
- ✦ Mortar joints in the brick façade of the penthouse are deteriorating (Photo 11).

It is recommended that all failing roof seams be repaired and areas of the EPDM membrane that have lost adhesion be re-adhered.

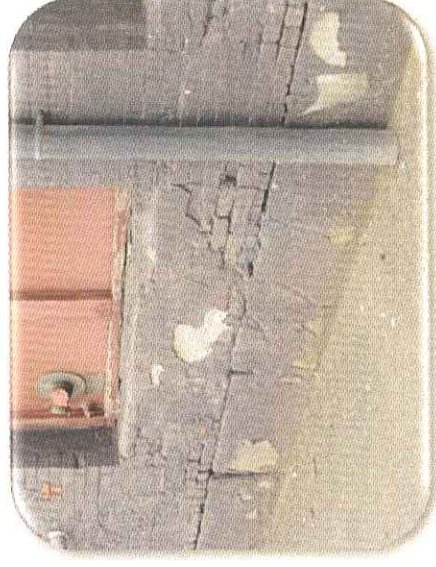
Photo 12

- ✦ In general mortar joints are deteriorating on all facades (Photo 12).
- ✦ In general all of the wood window sills show some signs of deterioration and many are severely rotted. All of the wood window frames have peeling and flaking paint (Photo 13). A few of the stone/concrete sills below the wood windows are cracked and spalling (Photo 14).
- ✦ A piece of stone veneer at the bottom of the south facade is coming off of the building (Photo 15).

It is recommended that all deteriorated mortar joints be repointed and the stone veneer on the south facade be reattached to the building.

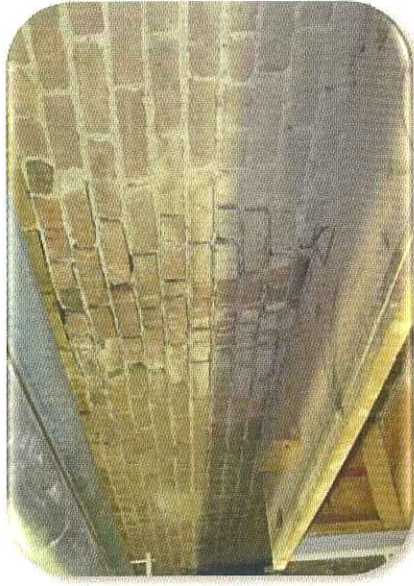
Photo 16

- The fieldstone foundation and brick bearing walls are in overall good condition with some minor deterioration of the mortar joints (Photo 16). No major cracking or deterioration was observed.
- The concrete floor slab-on-grade is in overall good condition with some minor random cracking.
- The timber floor framing (first floor) is in good condition. No deficiencies were observed.

It is recommended that all deteriorated mortar joints be repointed. The cracks in the slab-on-grade should be routed and sealed with a flexible sealant.

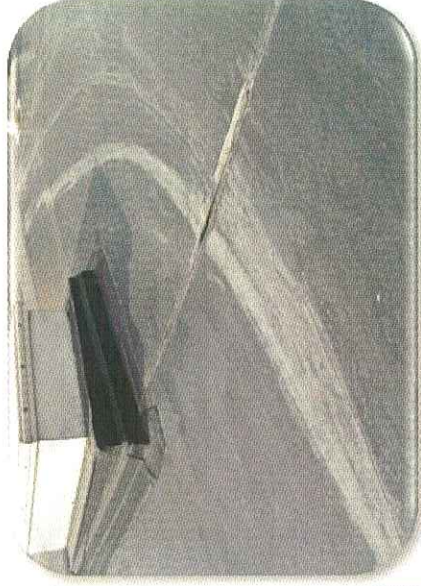
Photo 18

- + The roofing consists of an adhered EPDM membrane roofing system. There is a failure in the roof seam near the skylight where the water damage was observed on the fourth floor (Photo 18).
- + The EPDM roofing is coming up and pulling away from the parapet where the roof meets the parapet at several locations (Photo 19).
- + Two roof drains on the roof appear to be undersized and not properly flashed. The drains consist only of a pipe that comes up to the surface of the roof with no actual recessed drain grate cover assembly. The EPDM roofing is folded into and glued to the inside of the pipe (Photo 20).
- + The brick facade of the machine room, stairwell penthouse and the parapet at the roof step has minor mortar joint deterioration (Photo 21).

It is recommended that all failing roof seams be repaired and areas of the EPDM membrane that have lost adhesion be re-adhered. The roof drain size should be checked for adequacy and proper recessed roof drains and grate covers should be installed. All deteriorated mortar joints should be repointed.

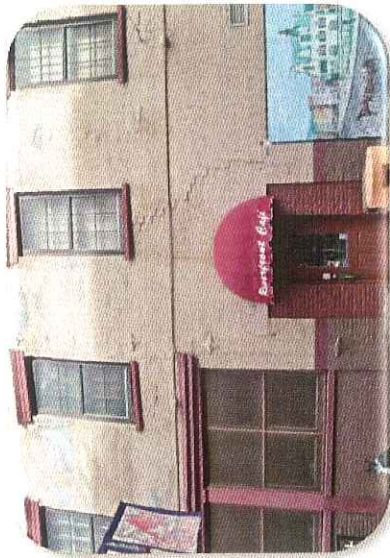
Photo 22

- + Step cracking and outward displacement of the brick facade was observed over the door on the south facade of the building (Photo 22).
- + The window heads and sills on the first row and third row of windows from the southeast corner of the building slope down towards the second row (Photo 23). It appears the building has settled at this location sometime in the past. It was observed that the head of one of the windows bears on a different course of brick than the other. This indicates that the settlement could have possibly occurred during construction of the building.

It appears that the possible settlement observed on the south facade occurred a significant time in the past and has not moved recently. It is recommended that the facade at this location be monitored for any additional movement and if the settlement is determined to be active, a thorough investigation should be performed to determine the cause and a method to stabilize the building.

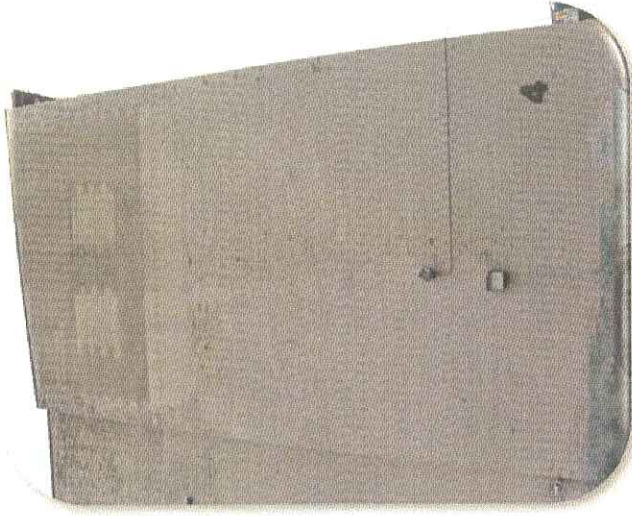
Photo 24

- + A vertical crack in the facade extends from the first to the third floors on the west facade (Photo 24).
- + A vertical crack extends from the first floor to the roof on the north face of the northwest corner of the building (Photo 25).

The vertical cracks in the west and north facades should be routed out and filled with a flexible sealant.

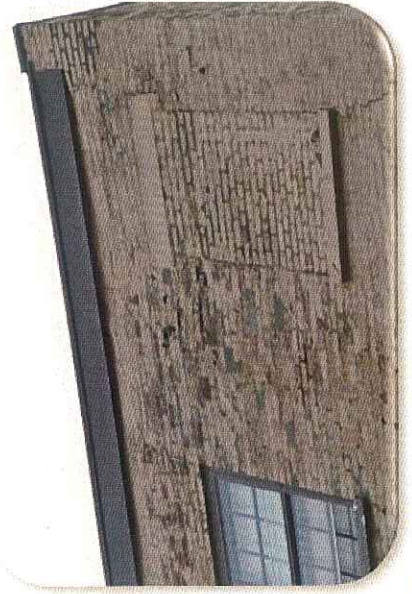
Photo 26

- + The facade bulges out slightly at the top of the wall on the north facade near the northwest corner of the building. A brick has come out of the wall at this location and a bird was observed flying out of the hole (Photo 26).

Further investigation of the bulging facade at the top of the north facade near the northwest should be performed to determine the cause. A bulging facade indicates that the brick wythes could be delaminating inside the wall or the lateral connection of the wall to the floor or roof framing could be failing. This could potentially lead to a failure or collapse of the facade. At a minimum the mortar joints at this location should be repointed and the missing brick replaced to minimize further deterioration until the investigation can be performed and a permanent repair made.

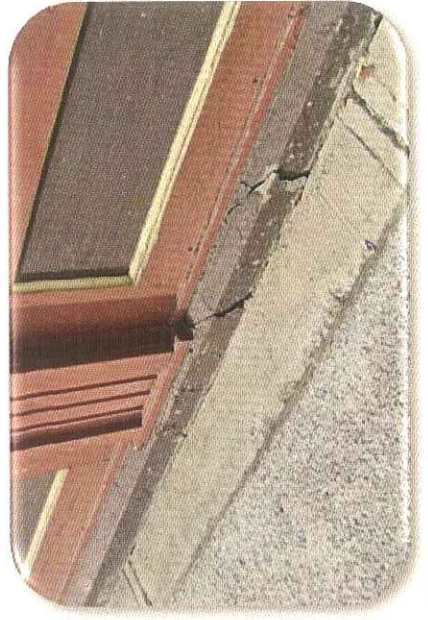
Photo 27

- + Concrete curbing at the bottom of the east facade is cracking and spalling (Photo 27).
- + In general mortar joints are deteriorating and brick faces are spalling off randomly on all facades of the building. The spalling brick faces indicates the brick is porous and is absorbing water. When the water freezes it causes the face of the brick to spall off.

The concrete curbing at the bottom of the east facade should have all unsound concrete sawcut and chipped out and repaired with a cementitious patching mortar.

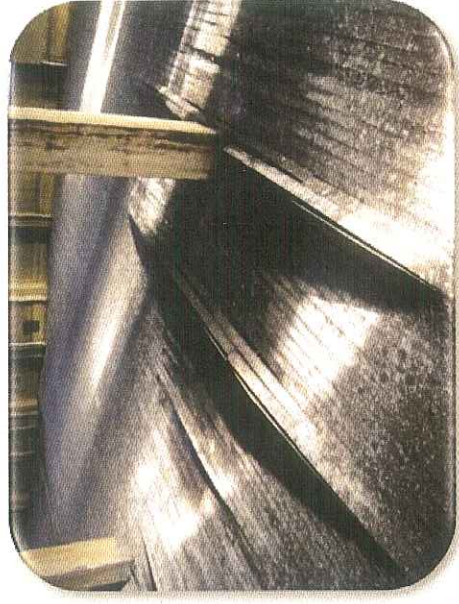
Photo 31

- ✦ Extensive water damage was observed. Floor boards are buckling and extensive water staining was observed on the underside of the third floor framing (Photos 31 & 32). Based on the conditions observed on the floors above, the water infiltration appears to be occurring at the roof and working its way down through the building.
- ✦ There are two holes, approximately three feet in diameter, in the roof over a room on the south side of the building (Photos 33 & 34).

It is recommended to repair the roof to halt the infiltration of water into the building. The wood flooring should be removed in its entirety to expose the structural wood planking underneath. The wood planking should be inspected and tested to determine its structural integrity. The wood framing supporting the third floor should be tested to determine if its structural integrity has been compromised by the water infiltration.

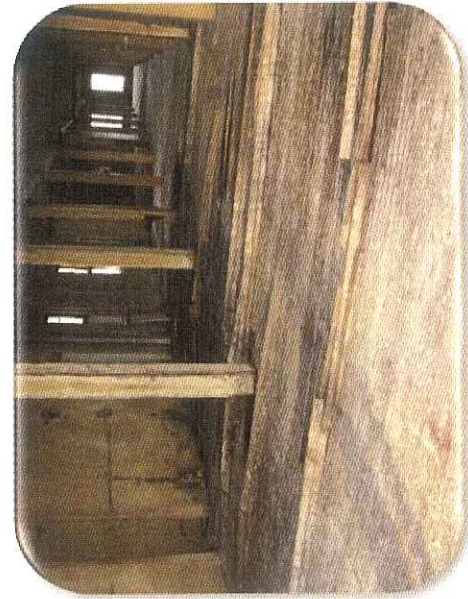
Photo 35

- ✦ Extensive water damage was observed. Floor boards are buckling and extensive water staining was observed on the underside of the fourth floor framing (Photos 35 & 36). Based on the conditions observed on the floors above, the water infiltration appears to be occurring at the roof and working its way down through the building.

It is recommended to repair the roof to halt the infiltration of water into the building. The wood flooring should be removed in its entirety to expose the structural wood planking underneath. The wood planking should be inspected and tested to determine its structural integrity. The wood framing supporting the fourth floor should be tested to determine if its structural integrity has been compromised by the water infiltration.

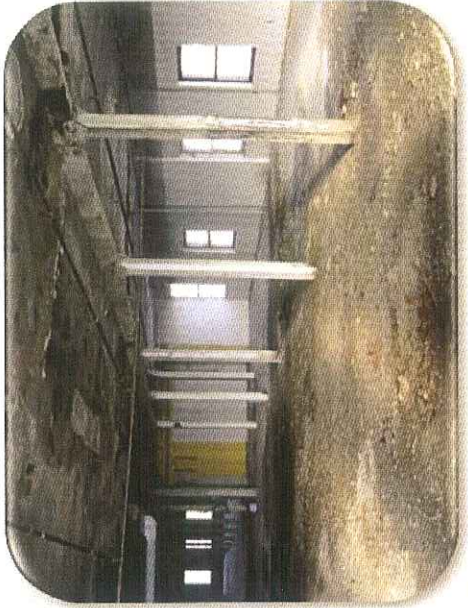
Photo 37

- ✦ Extensive water damage was observed (Photo 37). The floor is constructed of a concrete slab supported by timber framing. It was difficult to assess the presence of cracks due to a heavy layer of fallen ceiling material and pigeon droppings, however the severe water damage on the floors below and the staining observed on the fourth floor framing from below would indicate that there are cracks in the slab.
- ✦ The ceilings are heavily water damaged and large areas are falling down. The exposed timber roof framing and decking is heavily stained and is likely beginning to rot (Photo 38).

It is recommended to repair the roof to halt the infiltration of water into the building. The wood planking should be inspected and tested to determine its structural integrity. All of the ceiling finishes should be removed to inhibit the growth of mold and expose the structure for a thorough structural inspection. The wood framing supporting the roof should be tested to determine if its structural integrity has been compromised by the water infiltration.

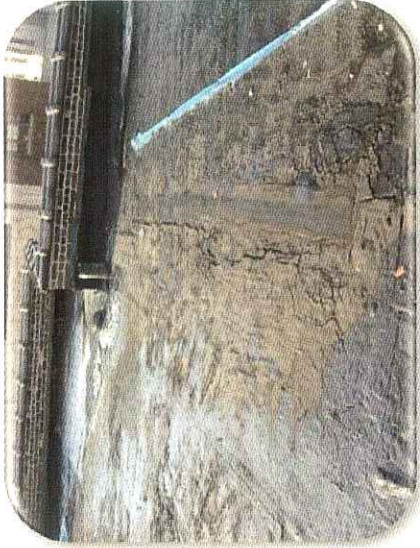
Photo 39

- + The roof consists of built-up roofing. It is in very poor condition and has completely failed (Photo 39).
- + A roof drain on the south side of the roof is plugged preventing water to drain from the roof. At the time of the inspection there was standing water and ice at the drain (Photo 40).
- + Mortar is missing in many of the clay tile parapet coping joints (Photo 41).

The existing roof should be removed and replaced with a new roofing system and the plugged roof drain should be repaired immediately to prevent further deterioration of the building.

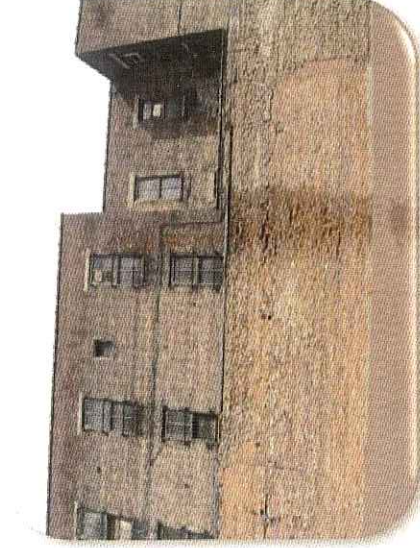
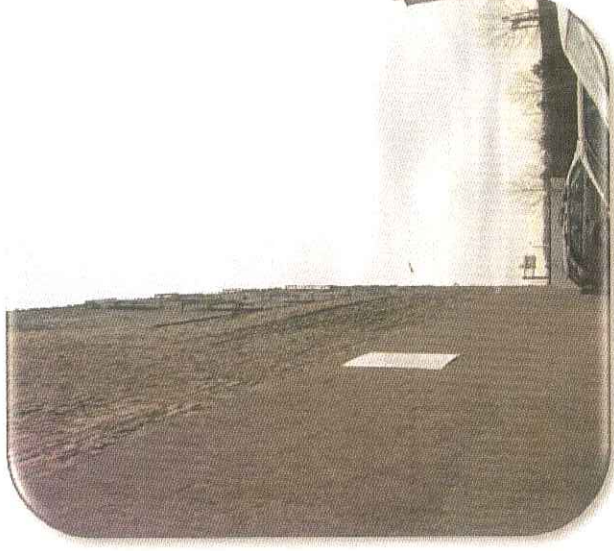
- + Serious water damage was observed on the south façade of the building extending from the roof to the first floor. This damage coincides with the location of the plugged roof drain. It appears that water is running down the face as well as inside the wall. The façade also bows out at this location (Photos 42 & 43).

Further investigation of the bowing façade on the south side of the building should be performed to determine the extent and cause of the deficiency and to design a means to stabilize it. A bowing façade indicates that the brick wythes could be delaminating inside the wall or the lateral connection of the wall to the floor or roof framing could be failing. This could potentially lead to a failure or collapse of the façade.

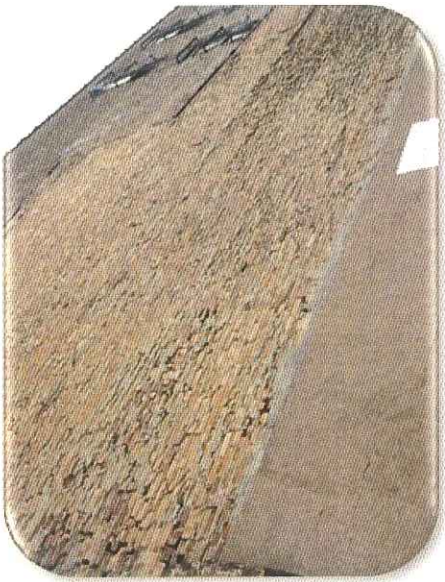
Photo 44

- + The mortar joints on the south façade are irregular where a building abutted Building No. 6 in the past (Photo 44).
- + Concrete curbing at the bottom of the façade on the west side of the building is spalling and cracking.

The irregular mortar joints on the south façade should be struck off and repointed. The spalled bricks and deteriorated mortar joints on the north façade should be repaired and repointed.

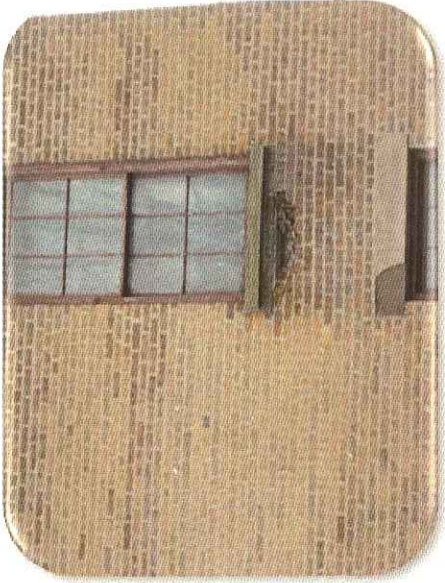
Photo 45

- + Water staining was observed near the top of the façade on the north side of the building. This staining is likely due to a roofing failure.
- + Some minor brick spalling and deteriorating mortar joints were observed on the north façade (Photo 45).

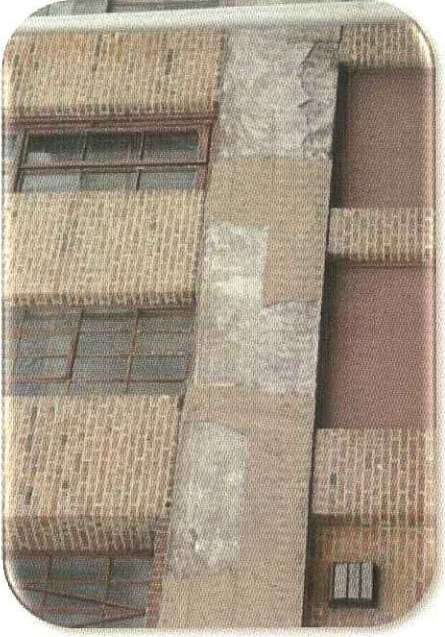
Photo 46

- + Parge coating below the second floor windows is failing on the north façade (Photo 46).
- + Numerous broken windows were observed on all facades and many of the window casings appear to be severely rotted.

The failing parge coating on the north façade should be removed and re-parged.

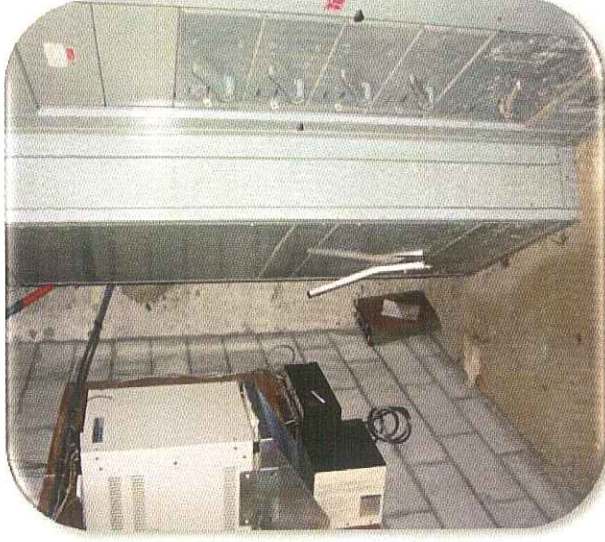
The electrical service to the building is underground. The building is equipped with a 1200 amp, 120/208 volt, three-phase, four-wire Westinghouse, switch/fuse type service rated switchboard in the basement of the building (See Photograph 1). The capacity was determined by the rating of the main disconnect switch of the switchboard. The main service switchboard in the basement, though somewhat dated (1985) it appears to be in good working condition. The interior of the switchboard was not observed due to exposure to potentially dangerous arc flash hazards. The existing electrical power infrastructure appears adequate to meet the building's existing power needs. We recommend when replacement parts become scarce, the older distribution components be replaced with modern equipment for ease of repair or modification. Due to the installation of a control system panel, the main service disconnect switch of the switchboard does not have the code required working clearance.

Photo 1 Access to Switchboard's Main Disconnect Switch, in violation of N.E.C. code, is blocked by a control cabinet.

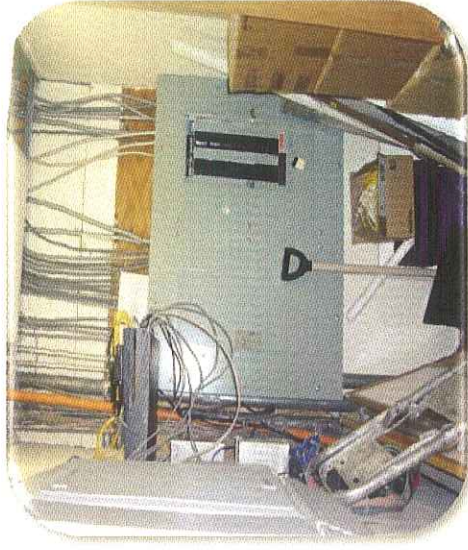
Photo 3. Mostly two panelboards were observed in each tenant closet. Closets are, however being used as a storage in violation of National Electrical Code.

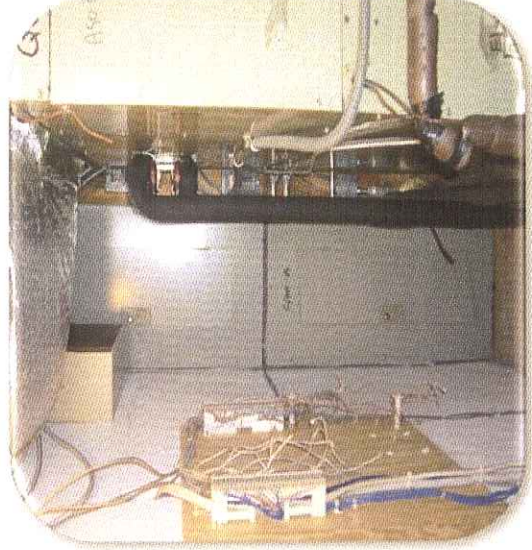
Photo 4. Electrical/Mechanical Equipment on 4th Floor -- HVAC equipment, in code violation, is blocking access to the panelboard.

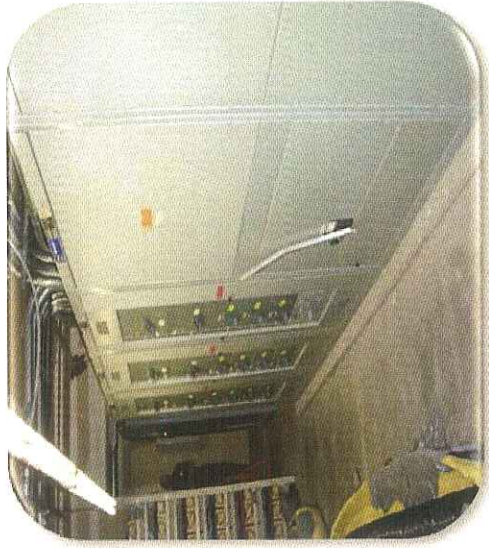
Lack of panic hardware in the basement on the doors to the room with the service switchboard was observed.

Photo 1 Main 1600A, 208/120V Switchboard Distributes Load to 16 Tenants. Electrical Room Have no panic hardware

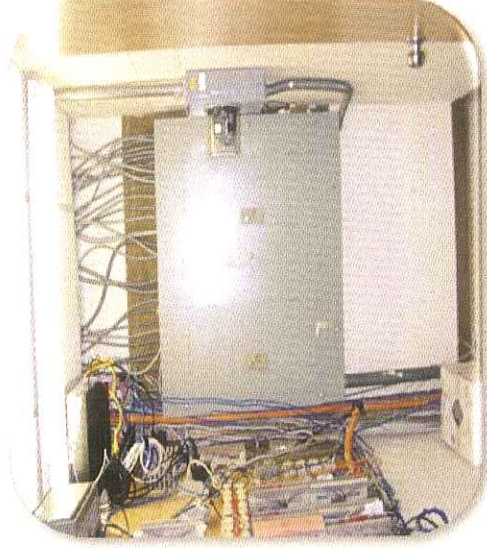
Photo 2 Double Tub Electric Panelboards Provided in the Electrical Closet in Each Tenant Space. However, in Violation N.E.C code, Closets are Also Being Used as Storage Space.
