MEP/FP SYSTEM INVENTORY AND ASSESSMENT – FINAL REPORT

Project Title:	Buffalo Outer Harbor Access & Activation Civic Improvements
----------------	--

REP-17055-001, REV. 2

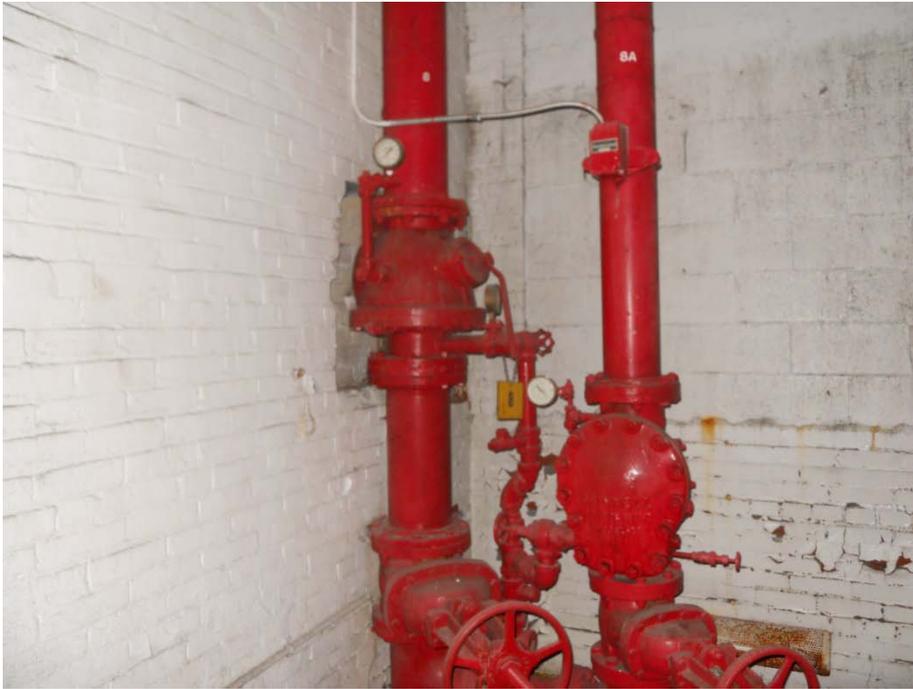
Figure F-005

The Sprinkler risers shown in Figure 2 have been converted to wet pipe systems. Both of these systems are obsolete and parts non-virtually existent for repairs.

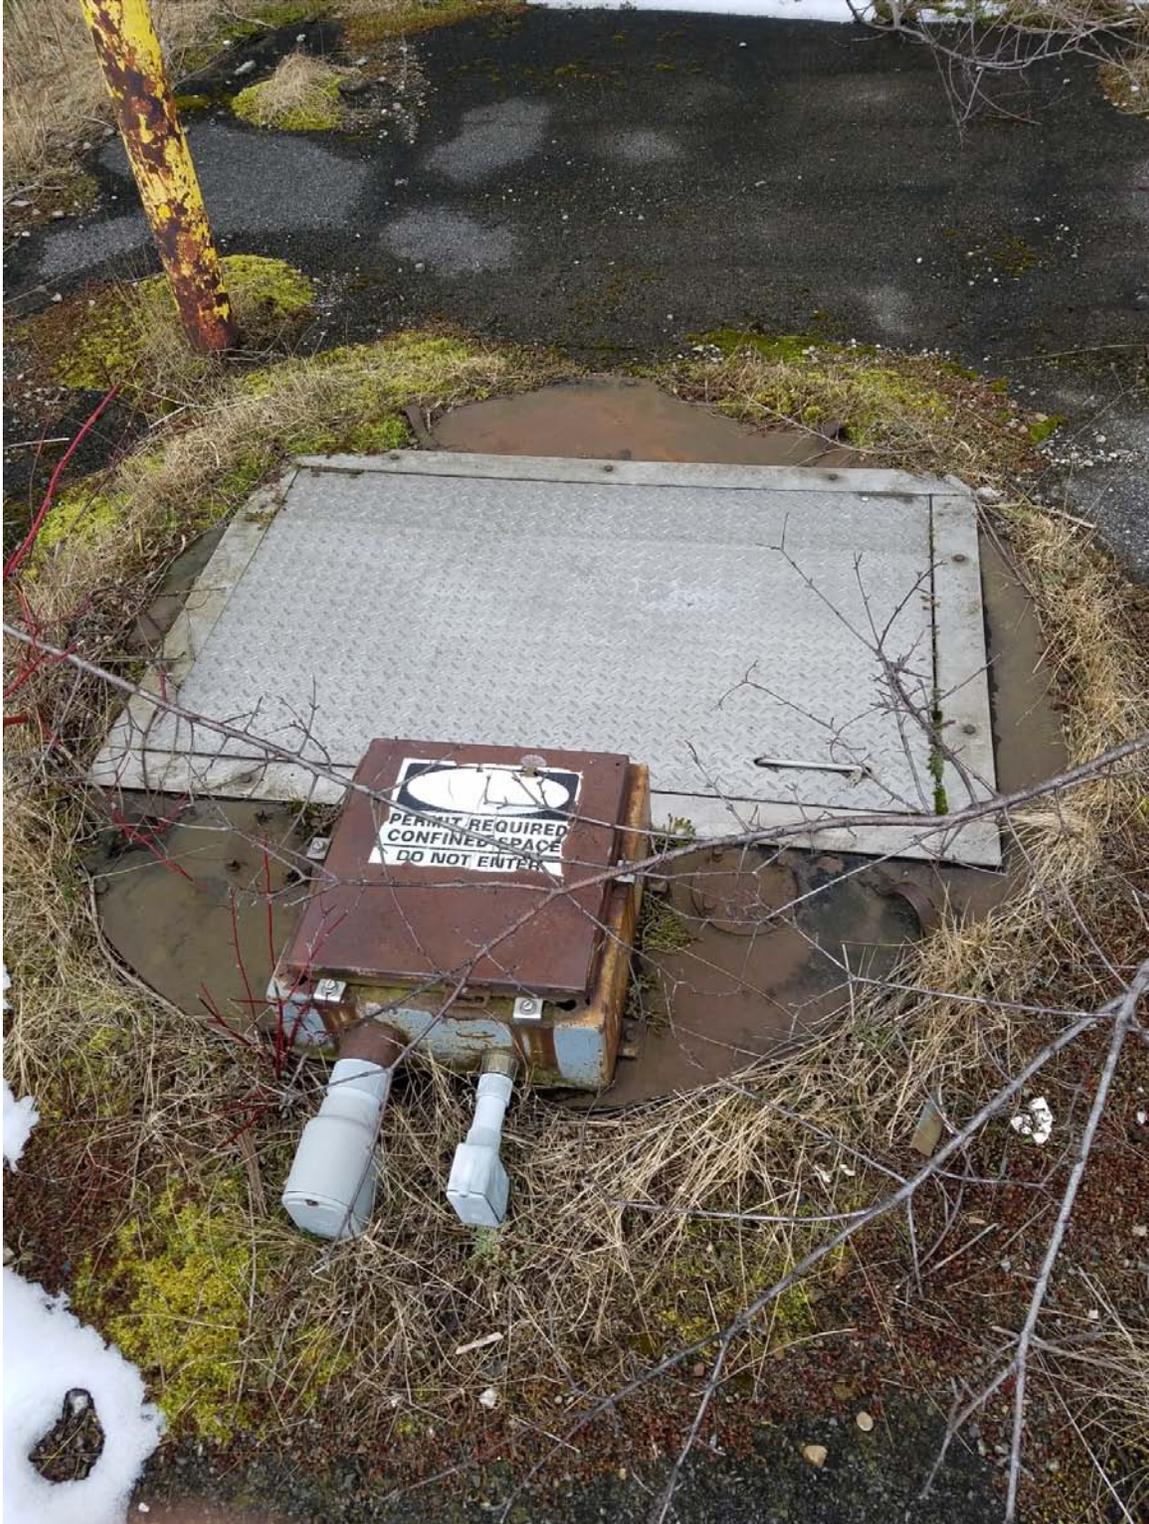
Figure P-002

Sewerage at the site consists of a combination of forced and gravity fed lines. Terminals A and B gravity feed all sewage to a pump station located at the north-west corner of the Terminal A building, as seen in figure P-002, from which a pair of force mains are discharged to a manhole at the edge of the site along Fuhrmann Boulevard and into the Buffalo Sewerage system beyond at the manhole shown in Figure P-003. Condition of the Terminal A and B pump station is unknown as the control panel is de-energized and the wet well is inaccessible. It is reasonable to assume that all mechanicals will require replacement due to the length of time since last use and the corrosive nature of the conditions within a typical sewerage wet-well. Sewage from the Blue building is routed to a pump station directly adjacent to the building at its south-

- Reactivation/replacement of the Terminal A sewage pump station equipment will be required for continued use of any restroom facilities on the site, as all waste is routed to that point.

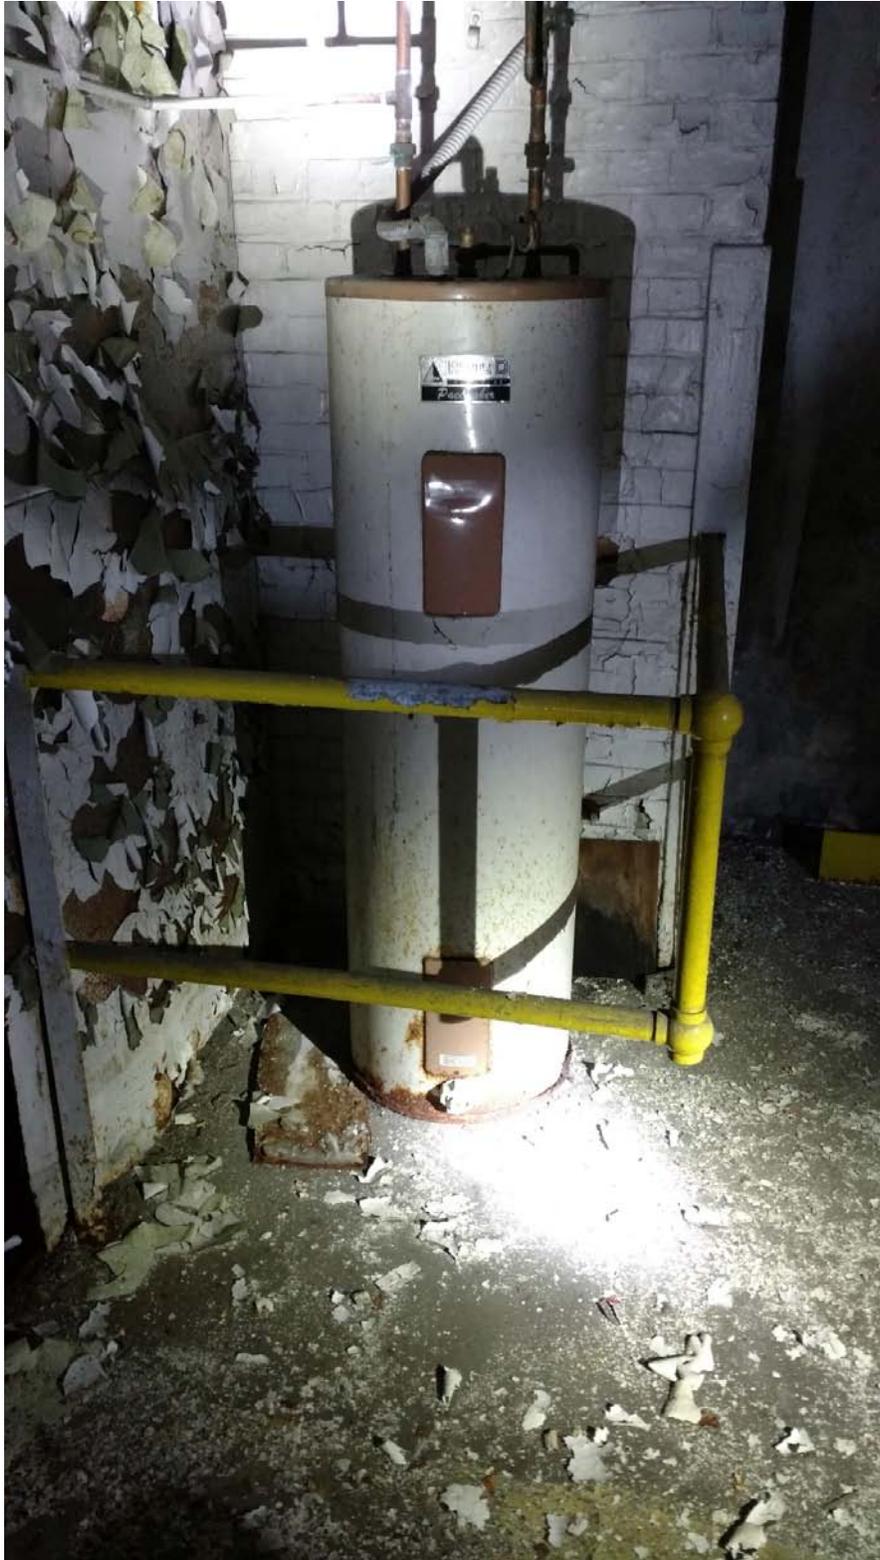
Figure P-005

As discussed in the site utilities section of this report, water service to Terminal A is currently deactivated. Plumbing throughout the building looked to be in fair condition, where accessible. The majority of fixtures observed, including multiple water heaters, are in poor condition and are in need of replacement prior to use. Examples are shown in figures P-005 through P-008

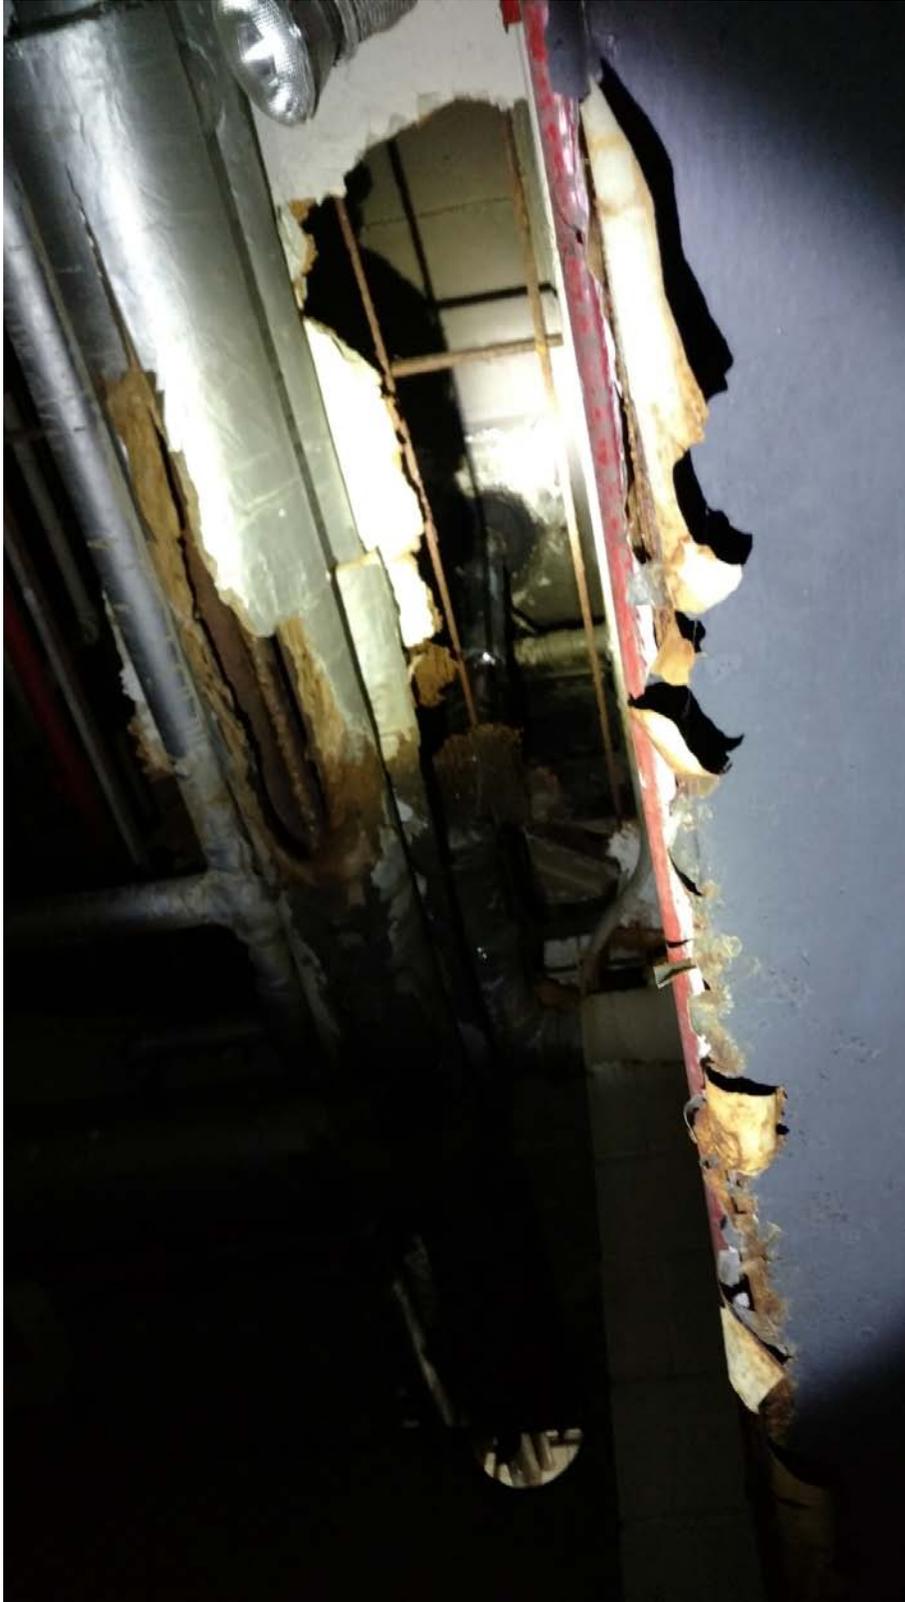
Figure P-009

The building roof drain system is in poor repair with many broken down pipes, as seen in figure P-009, as well as locations at which the roof is leaking adjacent to a roof drain – an indication of clogging as seen in figure P-010. Repair/replacement of all damaged roof drains is of paramount importance to prevent further water damage to all systems within the structure.

- Repair of clogged and broken roof drains and associated piping to prevent further deterioration of conditions within the building.
- Plug floor drains

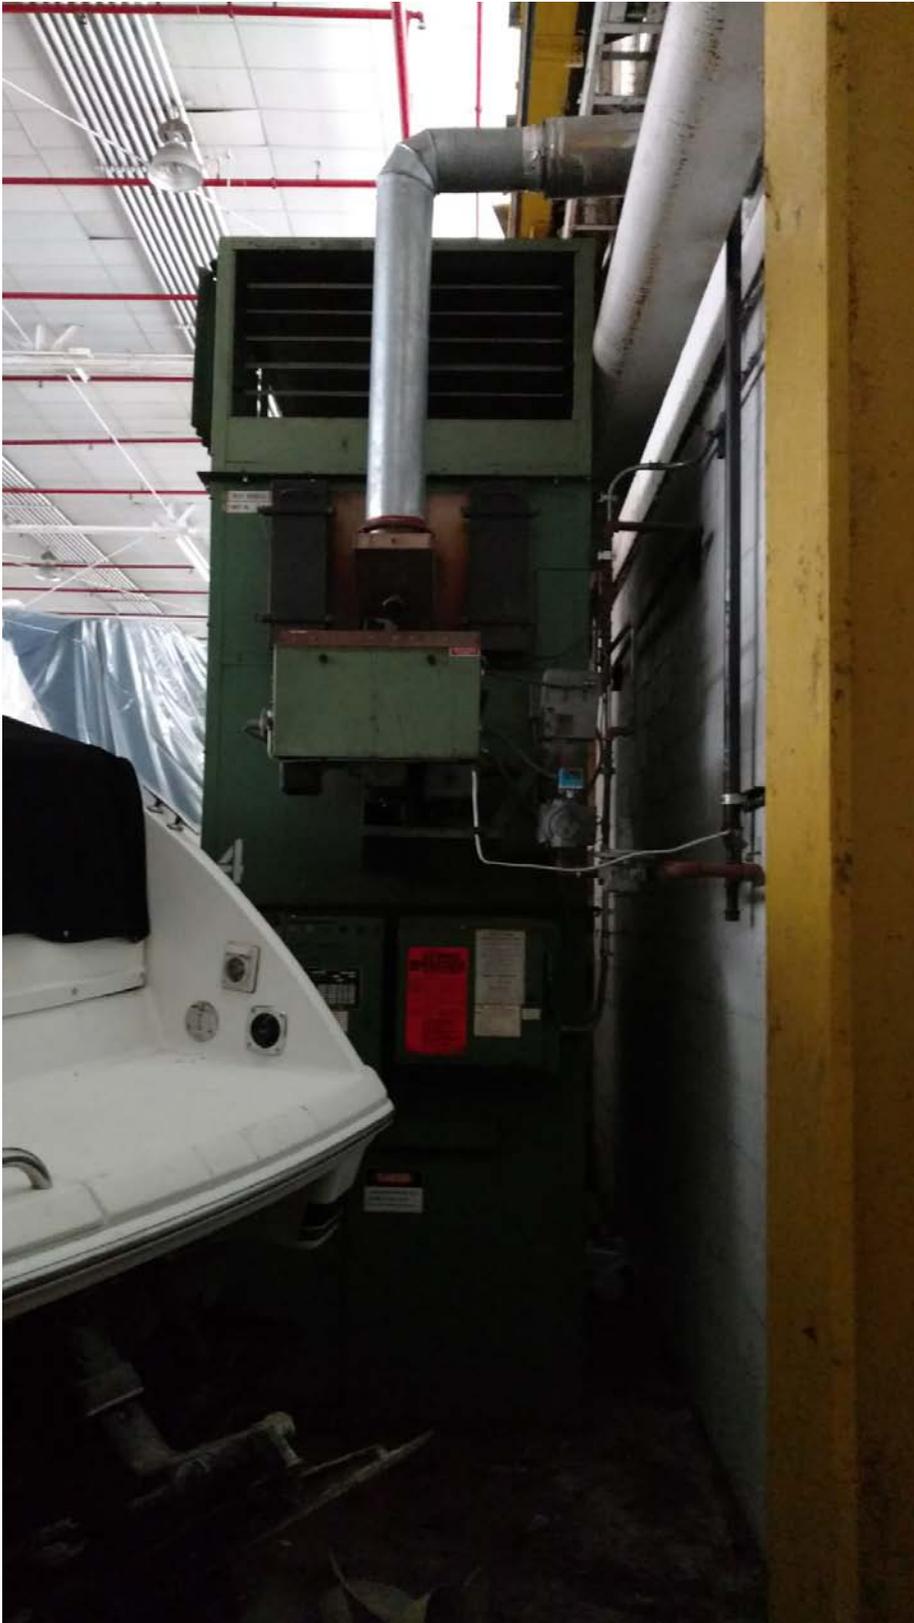
Figure M-004

Thirteen industrial air rotation systems are located throughout the first and second floors of the building. These units are shown in figures M-004 through M-015. The air rotation systems units contain gas fired heaters and circulation fans. Due to the size of the building, it appears that these units are intended for supplemental heat only as they are of insufficient capacity to prevent freezing temperatures during winter months on their own. All units appear to have been in operational condition when the building was decommissioned and drawings indicate that unit H-3 was replaced in 2009 or 2010. It is recommended that each unit be inspected prior to startup due to the moisture issues within the

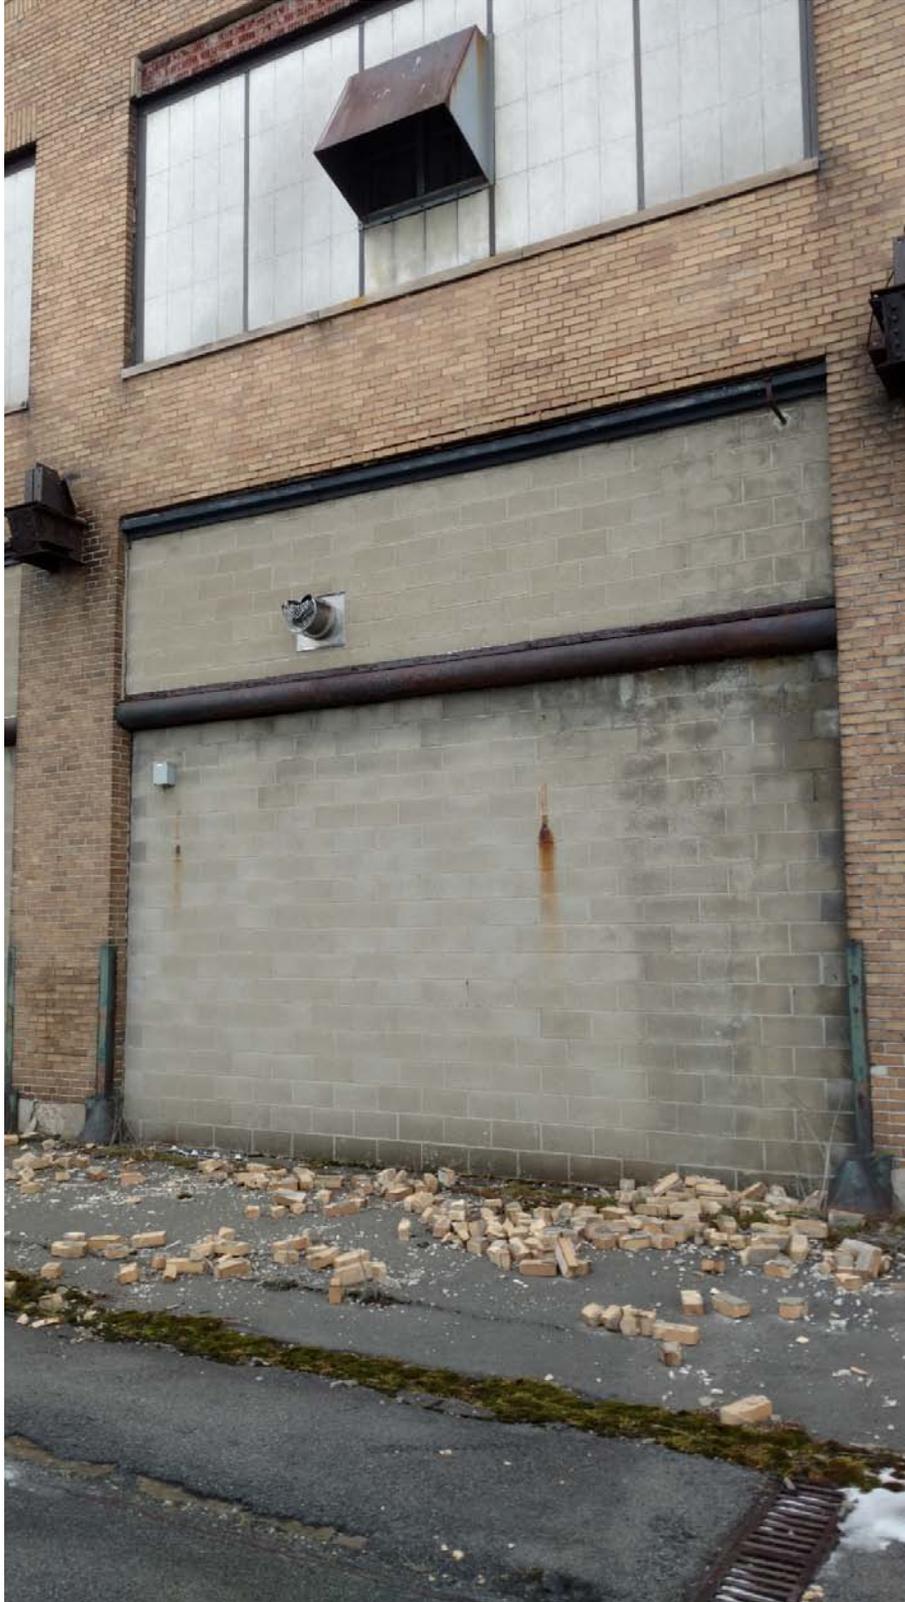
Figure M-016

building, observed damage to exhaust outlets as shown in figure M-016, and the noticeable odor of natural gas surrounding unit H-7.

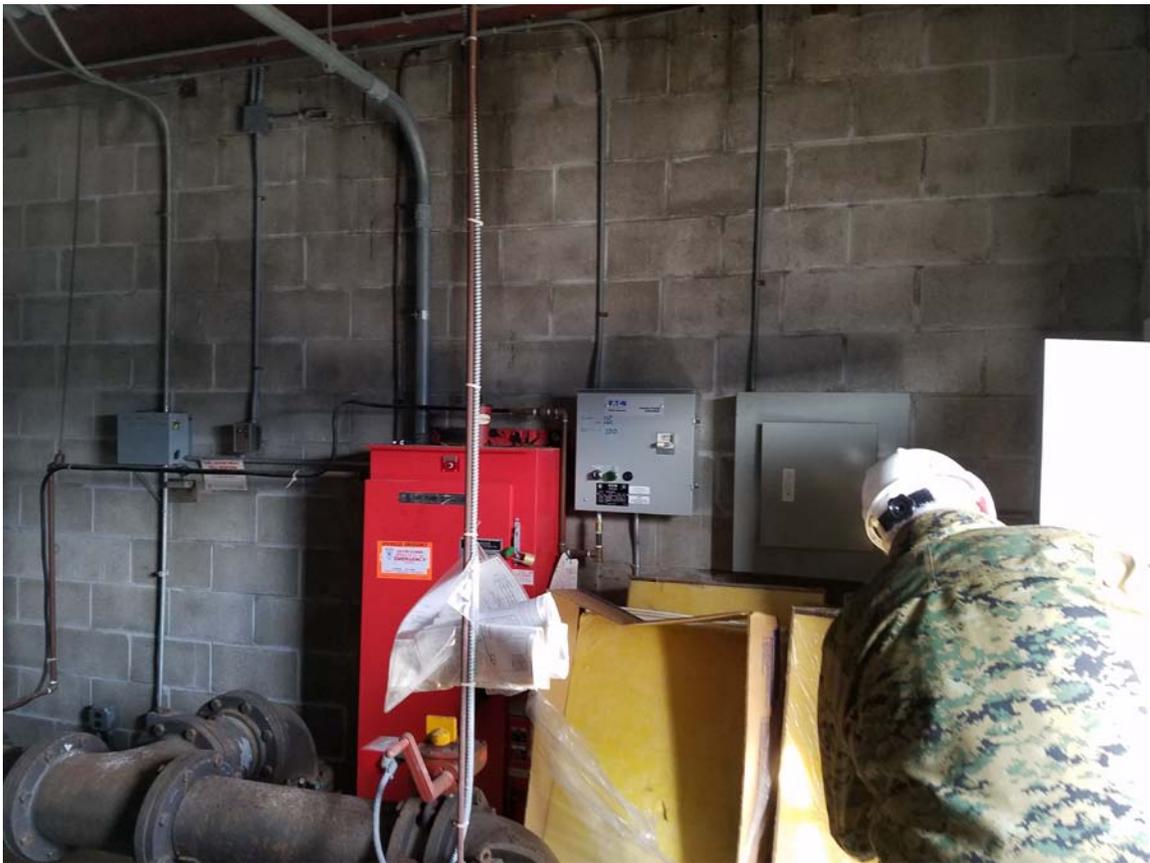
The site fire pump building has its own electrical service that appears to be active. However, the electric fire pump itself has been taken out of service. Additionally, building lighting was not functioning. An electrician should be called out to ensure everything is functioning correctly within the building and replace components as needed. Electrical panelboards and transformer appear to be in good condition, and absent any hidden damage should be reusable (Figure E-016 through E-019).

Figure E-018. Fire Pump House Fire Pump Controller and other Electrical Equipment

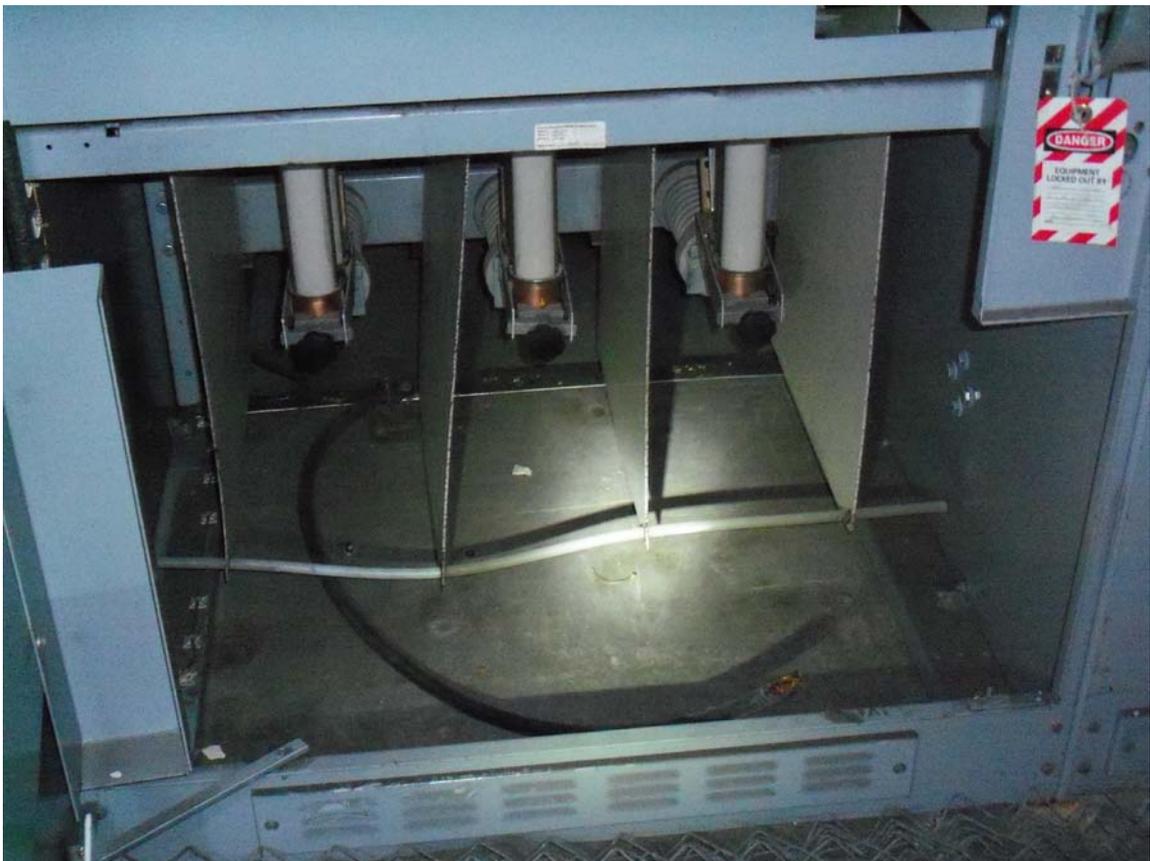
Figure E-032. Substation 3 Medium Voltage Switch Damaged Phase Barriers and Cut Wiring

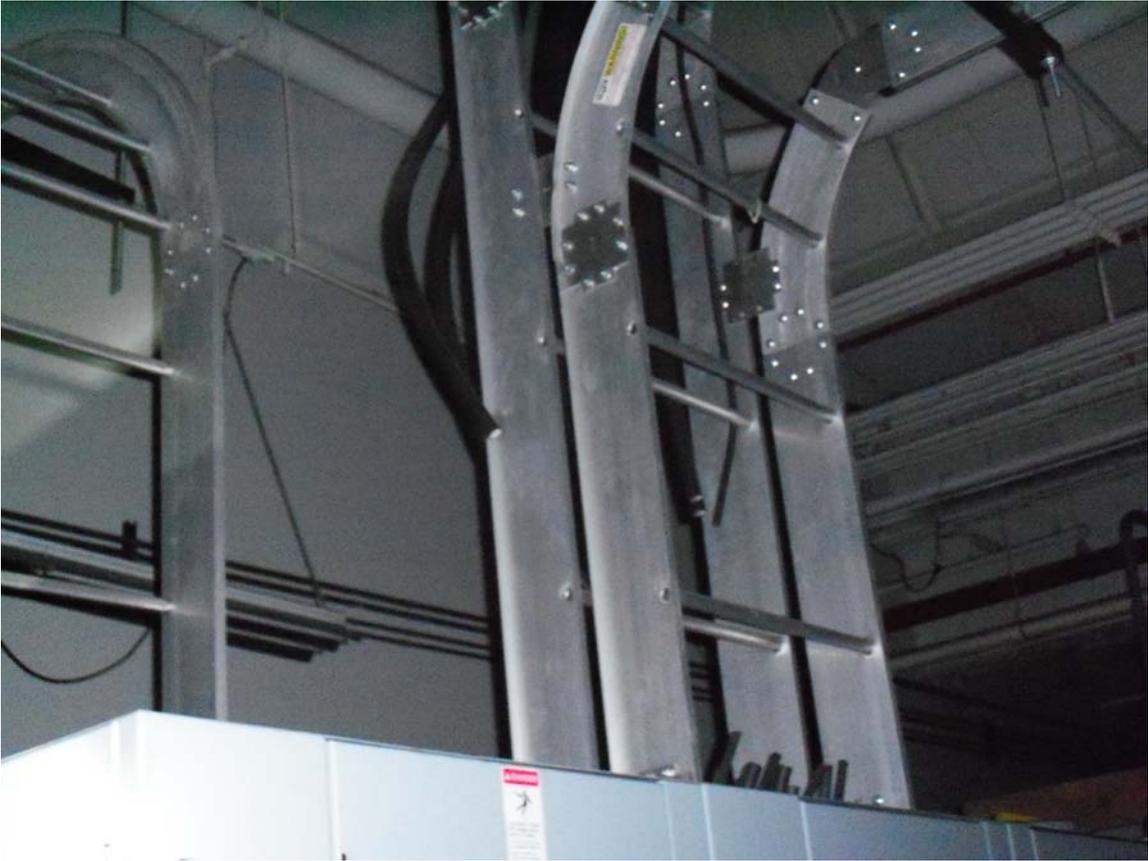
Figure E-033. Cut Wiring at Substation 3

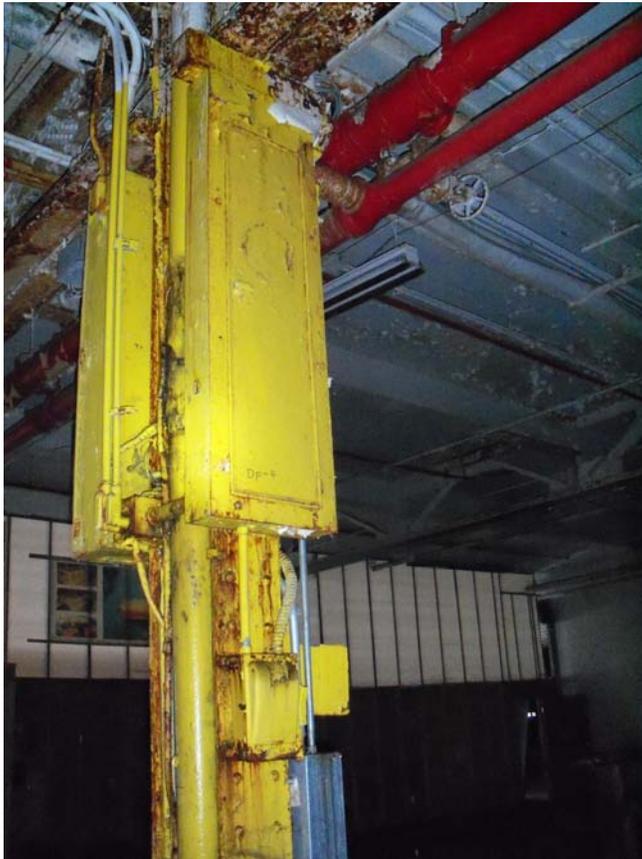
Figure E-044. Water Damaged Panelboards, 1st Floor

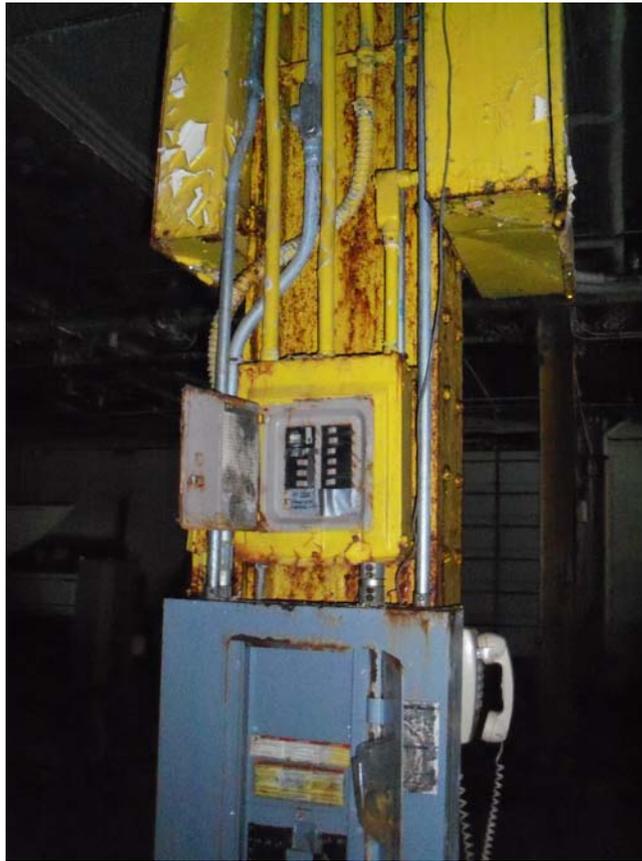
Figure E-045. Water Damaged Panelboards, 1st Floor

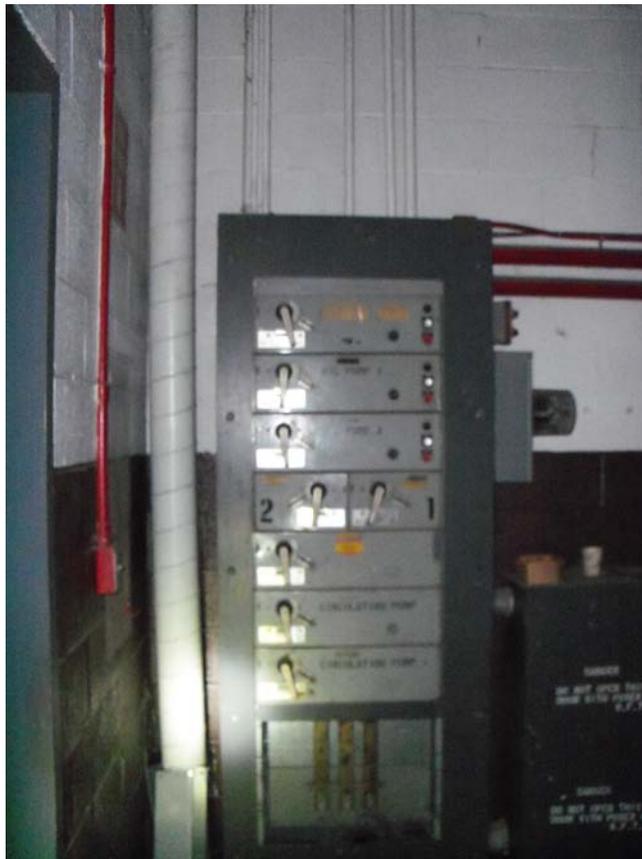
Figure E-046. Damaged Panelboard, 1st Floor Boiler Room

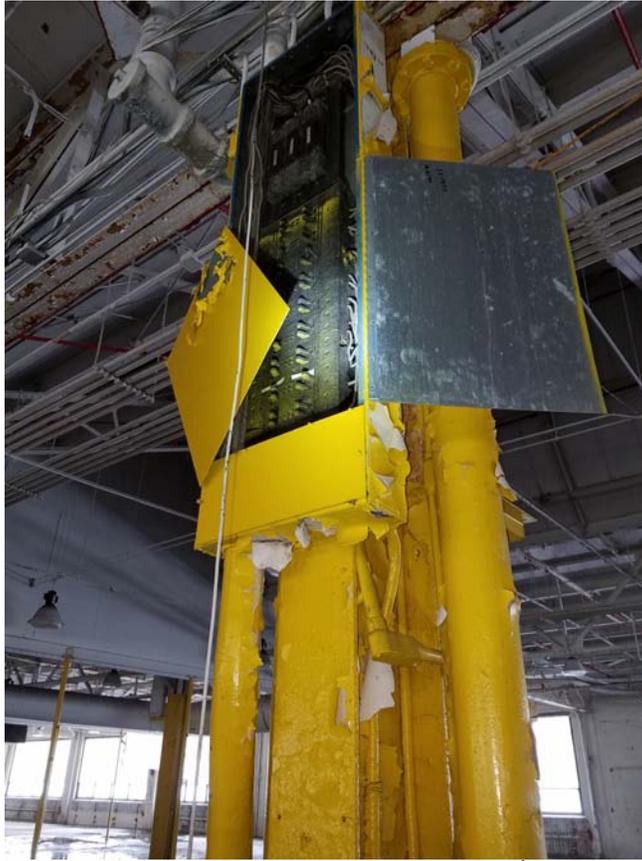
Figure E-047. Damaged Panelboard, 2nd Floor

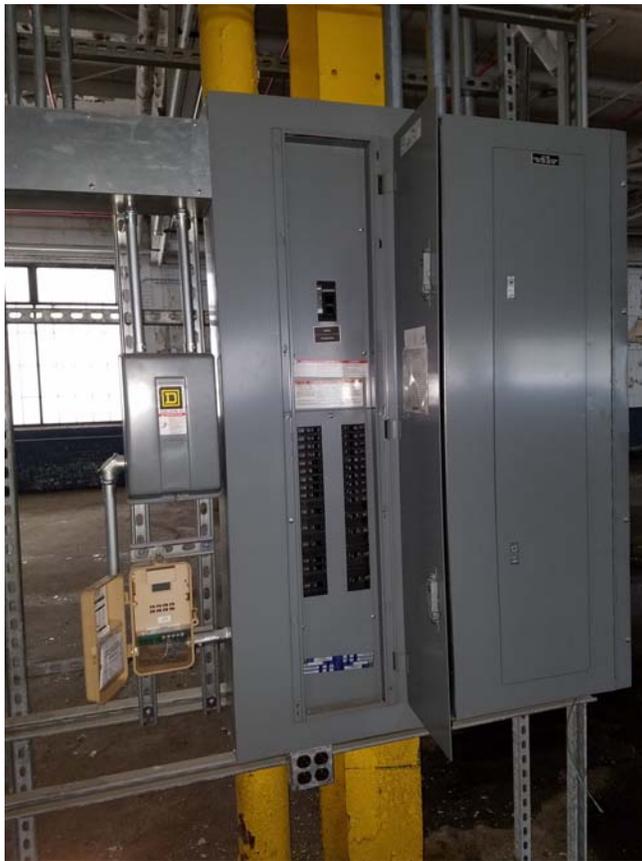
Figure E-048. Potentially Salvageable Panelboard, 2nd Floor

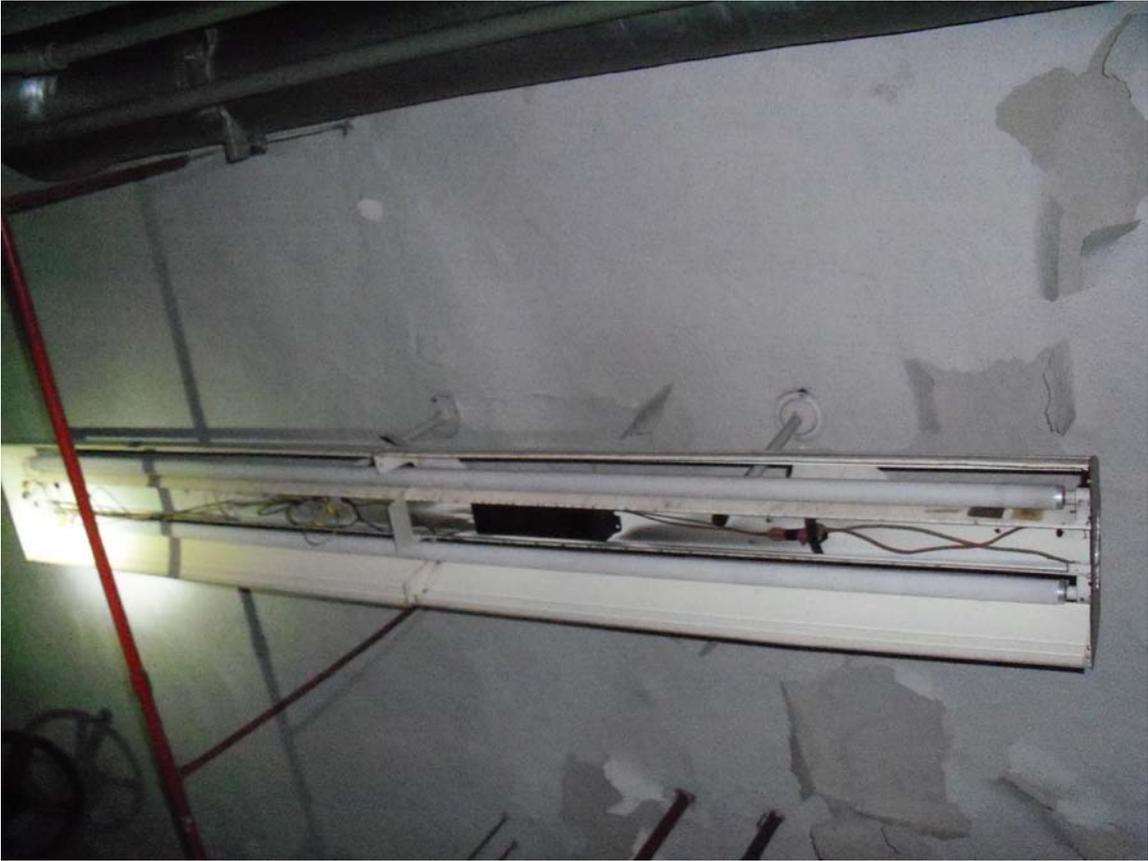
Figure E-051. Damaged Lighting, 1st Floor

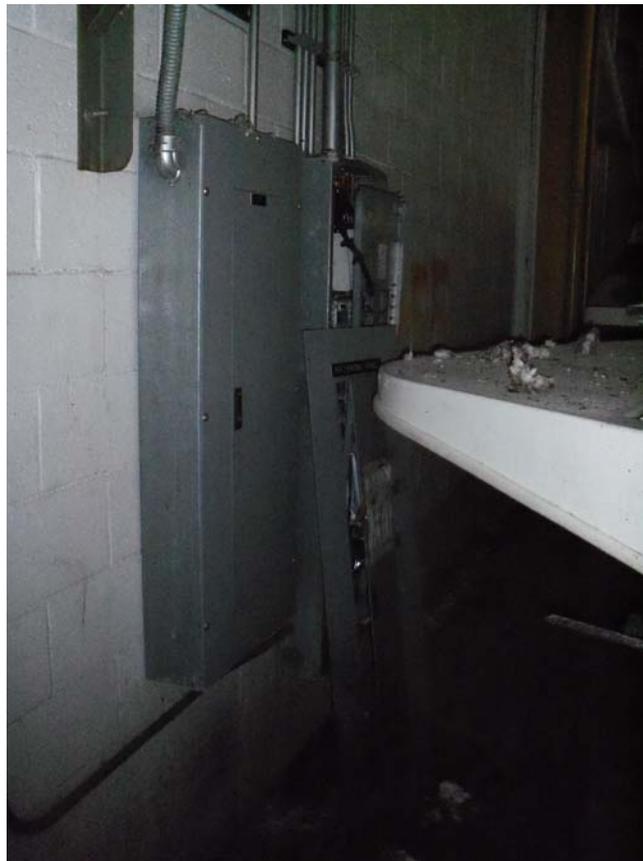
Figure E-056. Panel Showing Damage due to Cable Theft

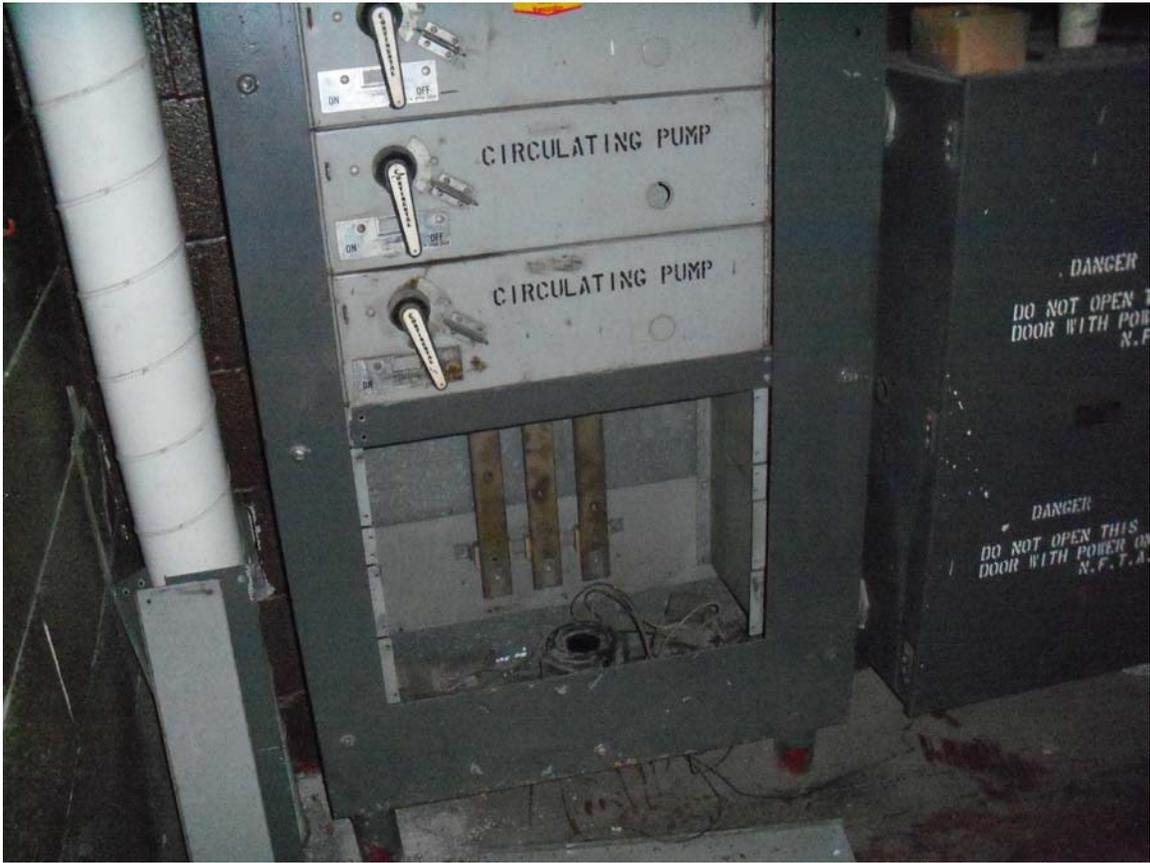
Figure E-057. Panel Showing Damage due to Cable Theft

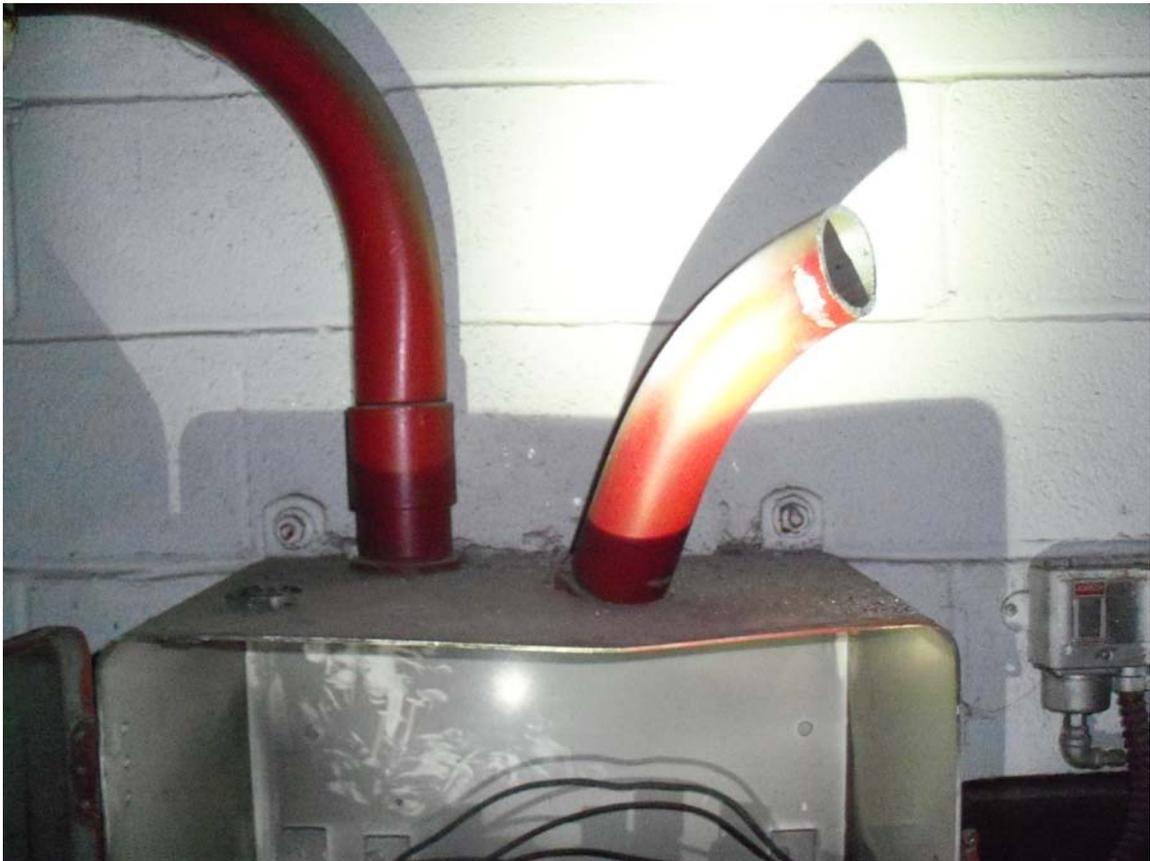
Figure E-058. Conduits Showing Damage due to Cable Theft

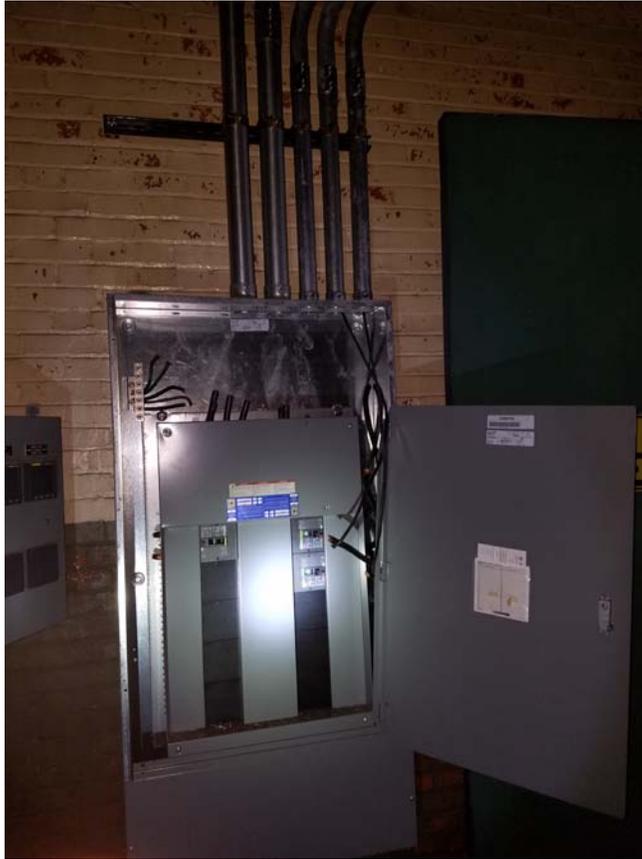
Figure E-059. Panel Showing Damage due to Cable Theft

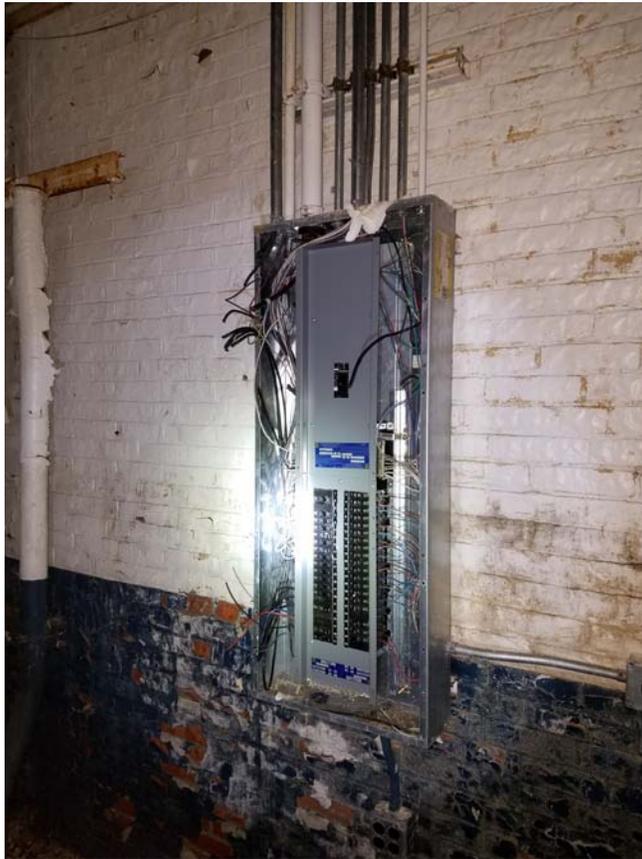
Figure E-060. Panel Showing Damage due to Cable Theft

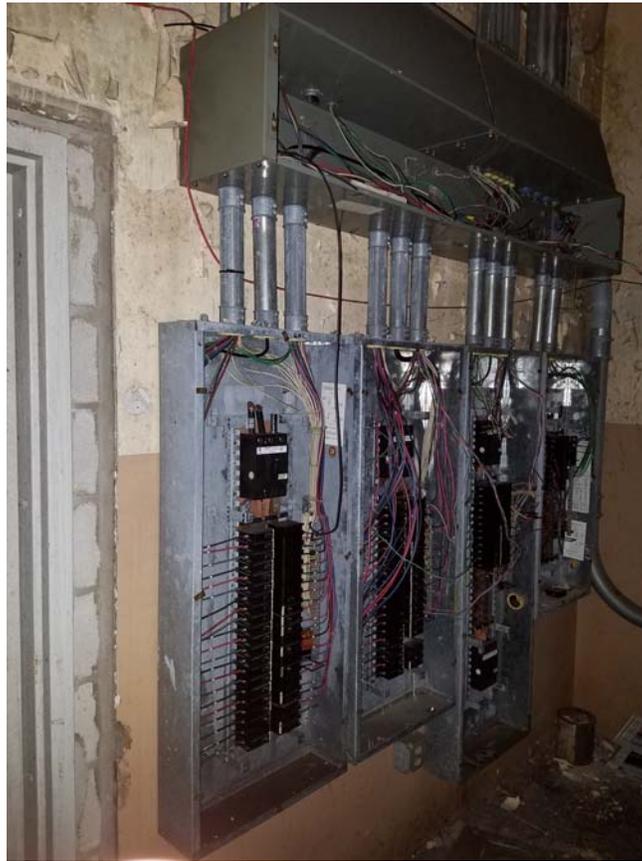
Figure E-061. Panels Showing Damage due to Cable Theft
