2017 PROPERTY CONDITION ASSESSMENT REPORT – VOLUME II – Pavement -FINAL

**Buffalo Outer Harbor Access and Activation Civic
Improvement Project**

901 FUHRMANN BLVD., BUFFALO, NEW YORK

August, 2017

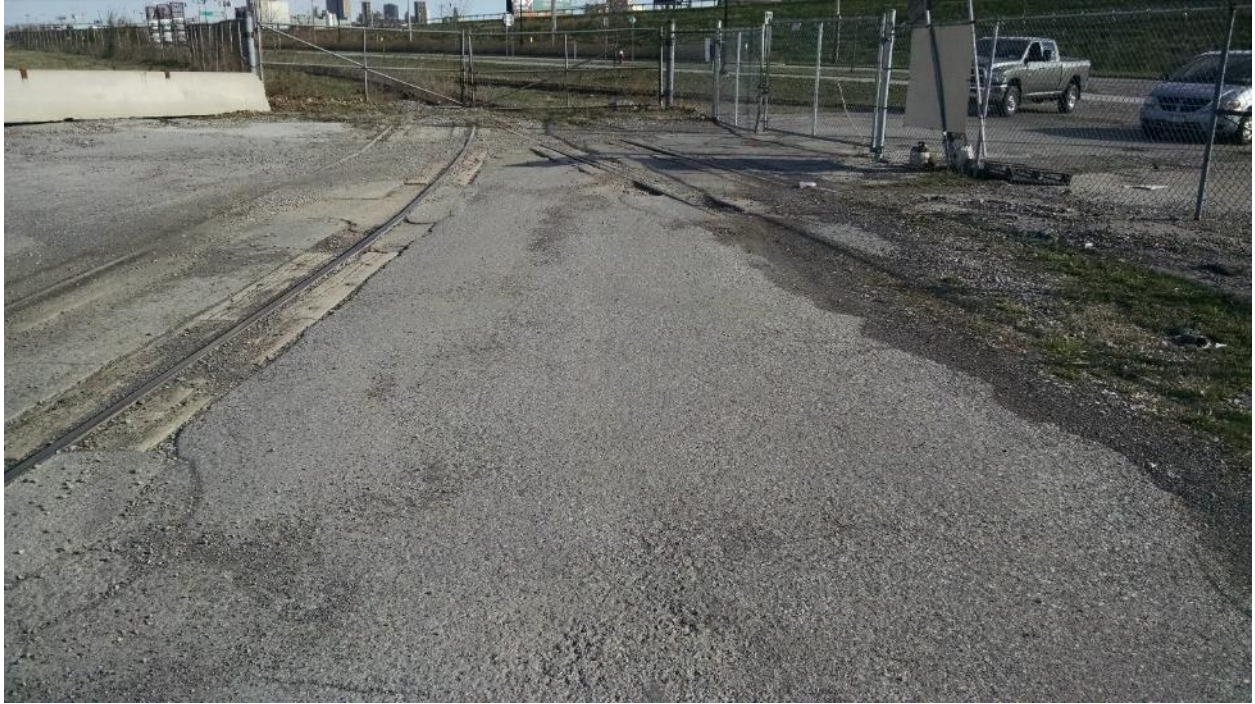
Photo A-1: Terminal A main entrance

Access is provided to the Terminal A parking lots by two driveways that split from a common entrance at Fuhrmann Blvd. The south driveway is 600 feet long by between 20 and 80 feet wide. This driveway provides primary access to Terminal A as well as the Blue Building. The surface consists of asphalt top course and generally displays minor cracking such as longitudinal, edge and minor alligator cracking. Localized damage includes pavement grooves and potholes. At the driveway entrance from Fuhrmann Blvd., alligator cracking and potholes are present throughout.

- Mill and Overlay the existing south driveway apron
- Remove localized areas of loose asphalt, fill potholes with crushed stone and re-pave with chip/seal.
- Full depth asphalt surface replacement in area surrounding proposed fuel tank removal east of Blue Building

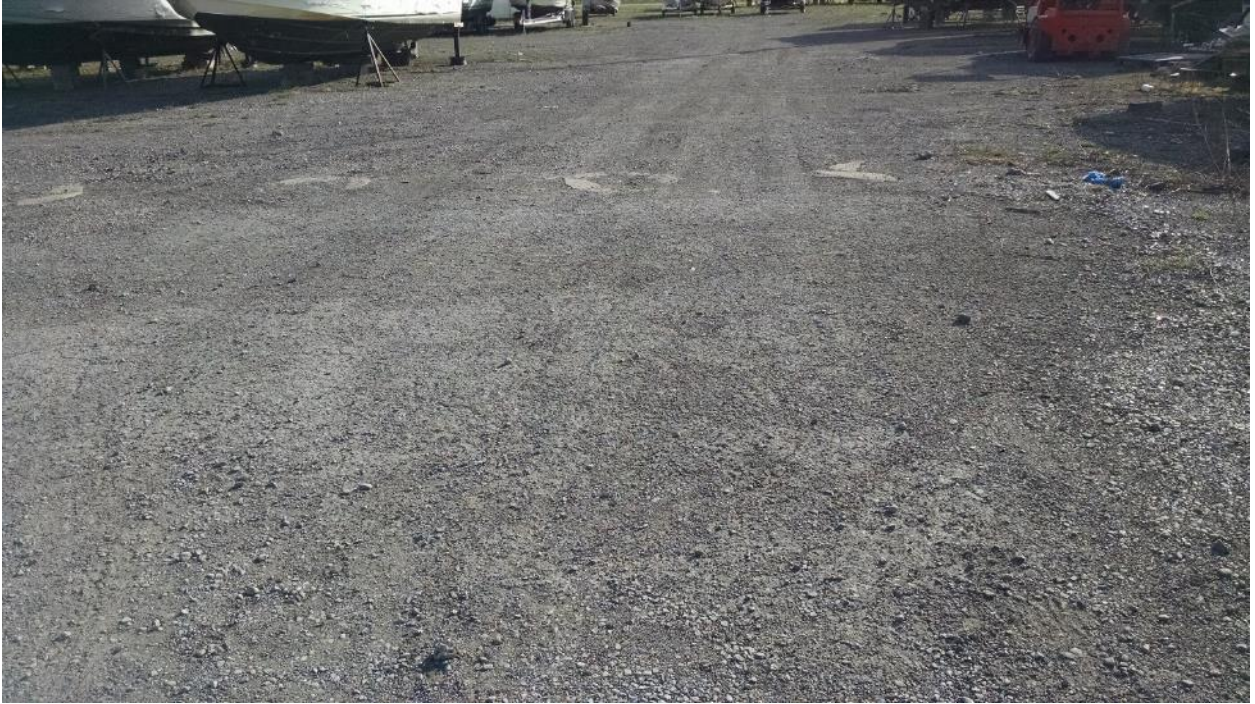
Photo A-3: Boat storage lot

The lot at the southeast corner of the property, between Fuhrmann Blvd. and the Blue Building, is approximately 2.5 acres and is used for recreational boat storage by the adjacent business. The surface consists of disintegrating asphalt pavement. While adequate as a gravel lot for boat storage, the pavement has completely unraveled, allowing vegetation to grow in along pavement seams. The asphalt bond of the aggregate has nearly completely failed.

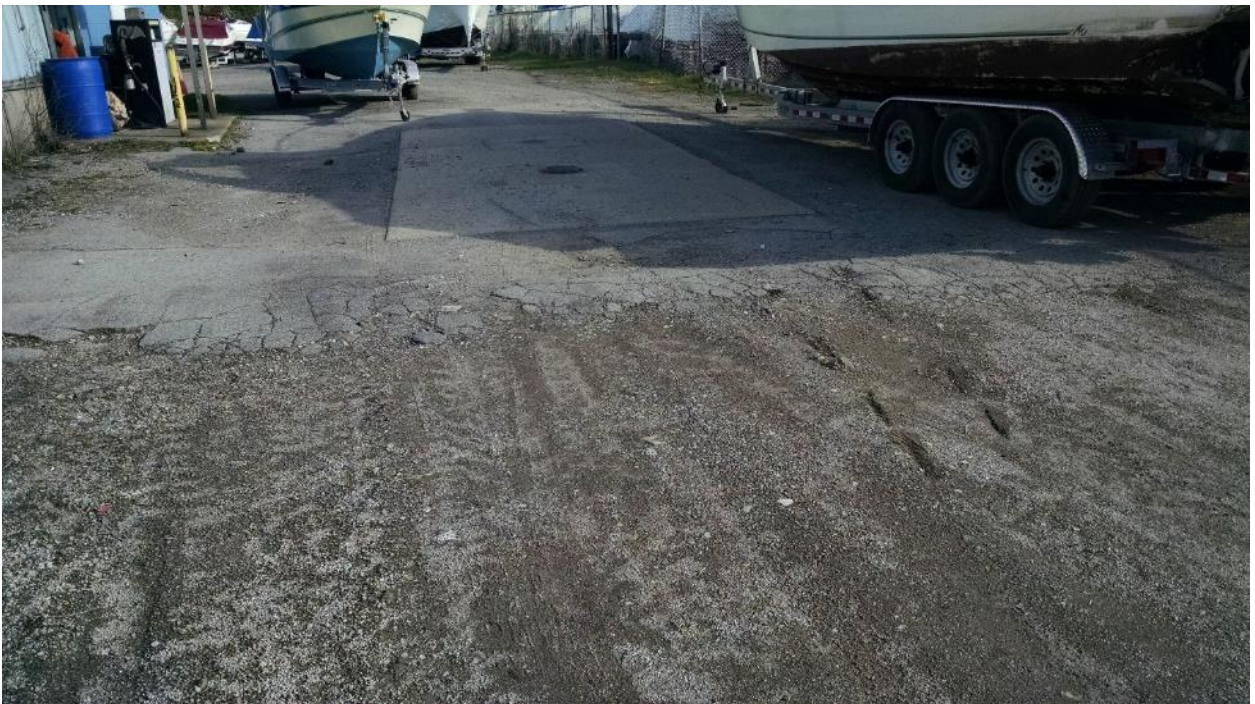
Photo A-4: Blue Building east side

The driveways and parking lots leading to and surrounding the Blue Building vary in condition and material. The main driveway to the business as well as the adjacent driveways that surround the building are made up of a mix of gravel and asphalt pavement. The asphalt exhibits widespread cracking throughout and the gravel surface is uneven and potholed. Failed sections of asphalt pavement have been topped with crushed gravel to level the surface.

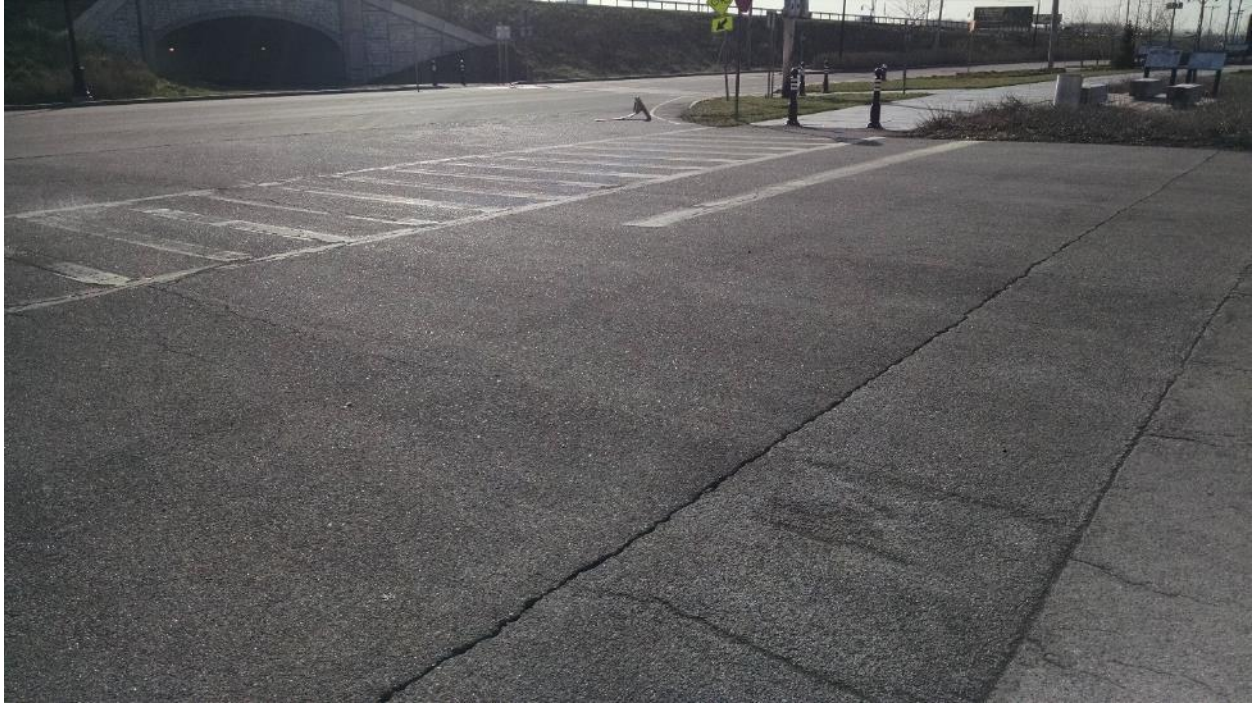
Photo A-7: Terminal A secondary entrance

The 240-foot auxiliary driveway to the Terminals A and B area was more recently constructed new in 1988. The driveway displays deficiencies

including longitudinal and alligator cracking, and minor unraveling of the top course along the edge of pavement. The secondary driveway ends at a fence and gate restricting access to the Terminal A lots.

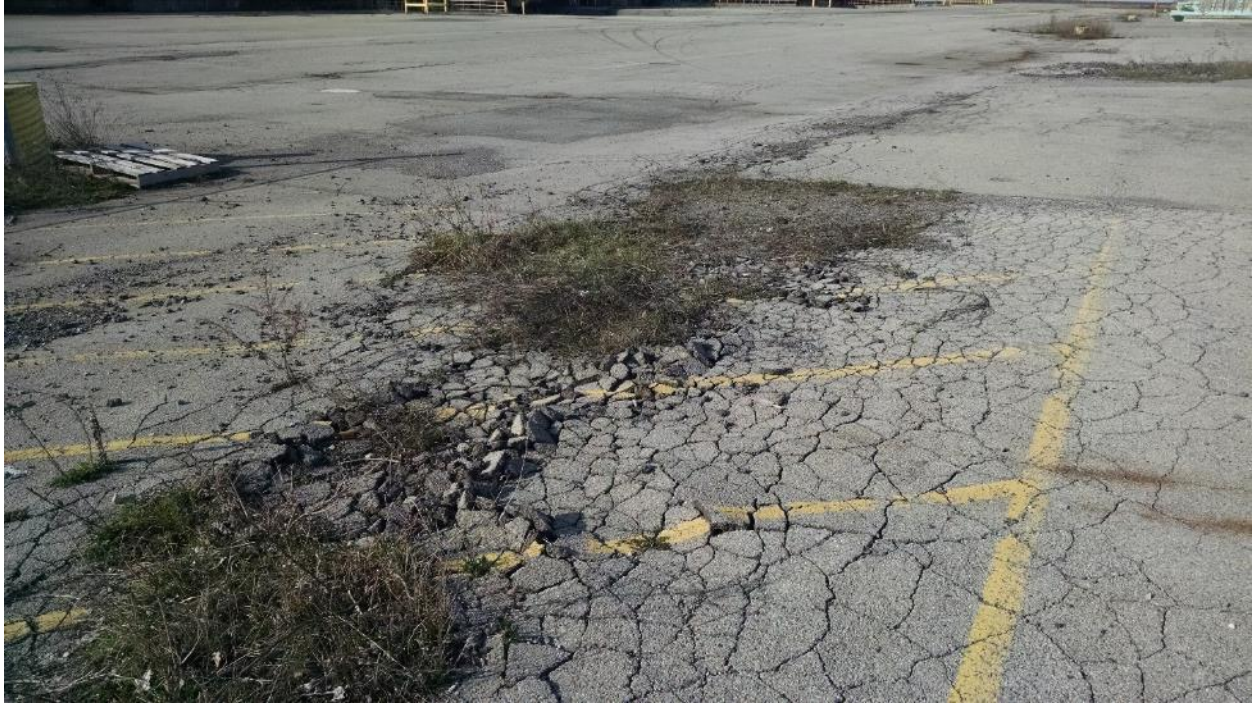
The Auxiliary Parking Lots consist of over 5 acres of asphalt pavement located along the northern edge of the Terminal A site and were built in 1988 with the Secondary Access Driveway. While newer than the adjacent lots, the asphalt pavement displays deficiencies such as longitudinal, transverse and alligator cracking at pavement seams. The parking lot nearest to Fuhrmann Blvd. is currently utilized by the City of Buffalo as storage for a large rock salt pile. The portions of the pavement not covered by the salt pile exhibit longitudinal, transverse and edge cracking. Significant ponding at the south end of the driveway occurs following a rain event due to a clogged catch basin. The presence of rock salt on the pavement has likely degraded the asphalt.

Photo A-13: Terminal A auxiliary parking lot asphalt degradation

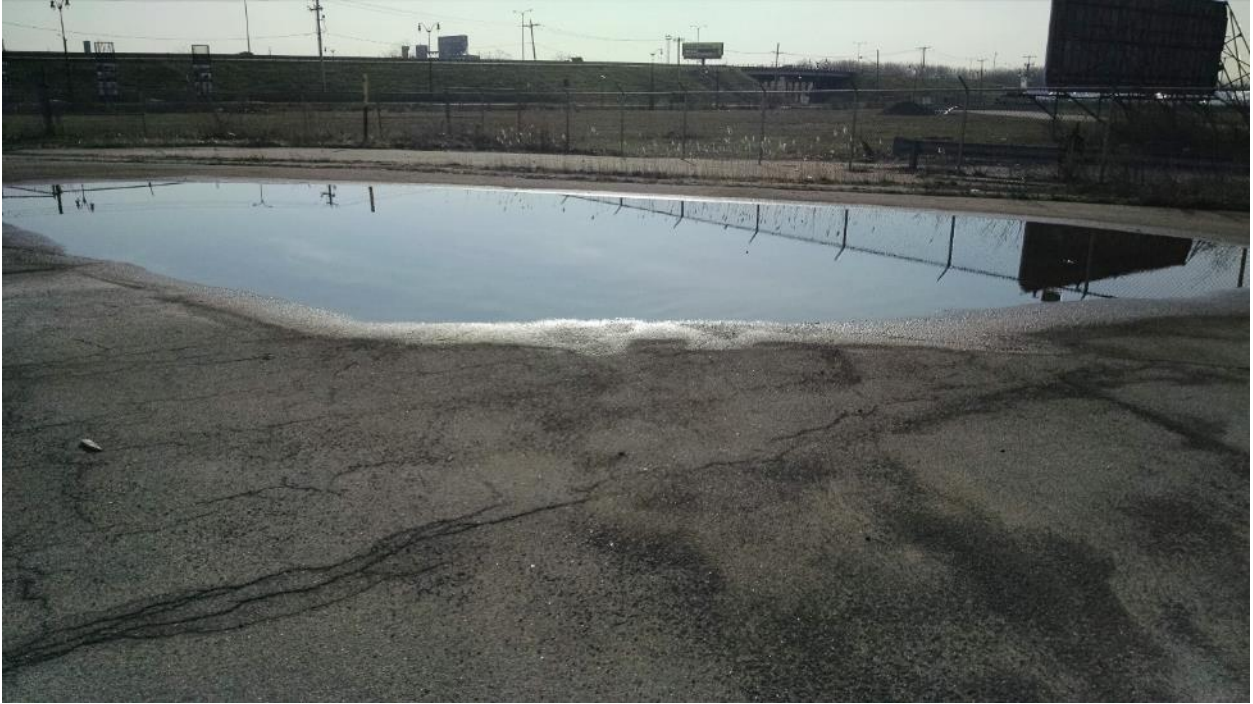
Photo A-17: Terminal A salt storage lot ponding

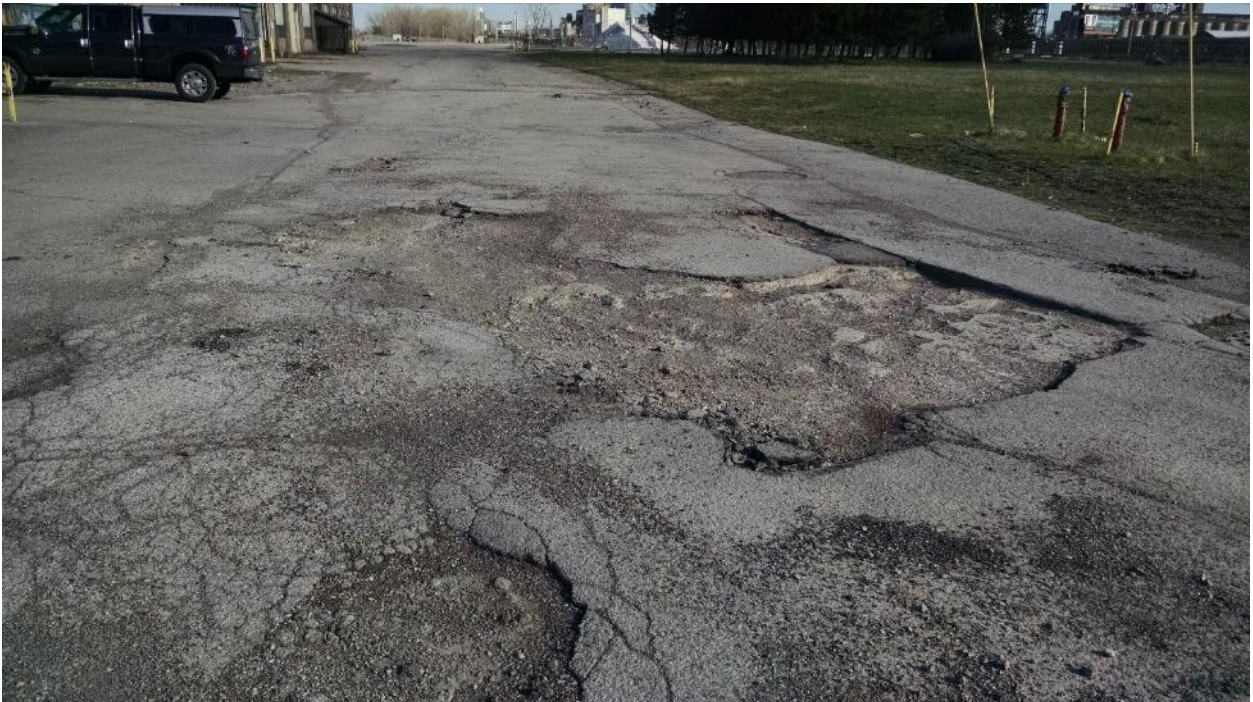
Photo A-18: Terminal A east driveway

Last, the east face of the building is lined with a driveway that has perhaps seen the heaviest traffic volumes over the years. This section connects the southern main entrance driveway to the Terminal A driveways and Terminal B. This section exhibits widespread cracking, potholes, uneven surface and poor drainage.

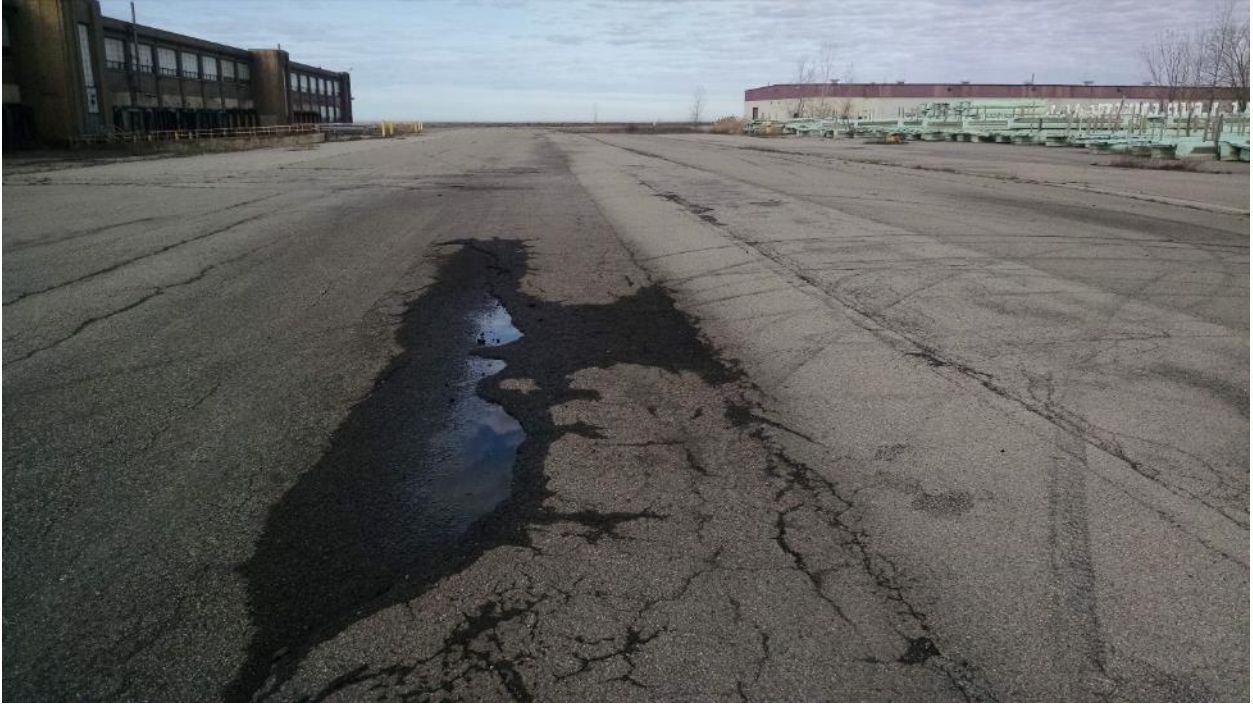
Photo A-19: Terminal A north driveway

The driveway along the north face of the building exhibits longitudinal, transverse and alligator cracking along with potholes, overgrowth with weeds at the seams and at the rails, and ponding due to poor grading.

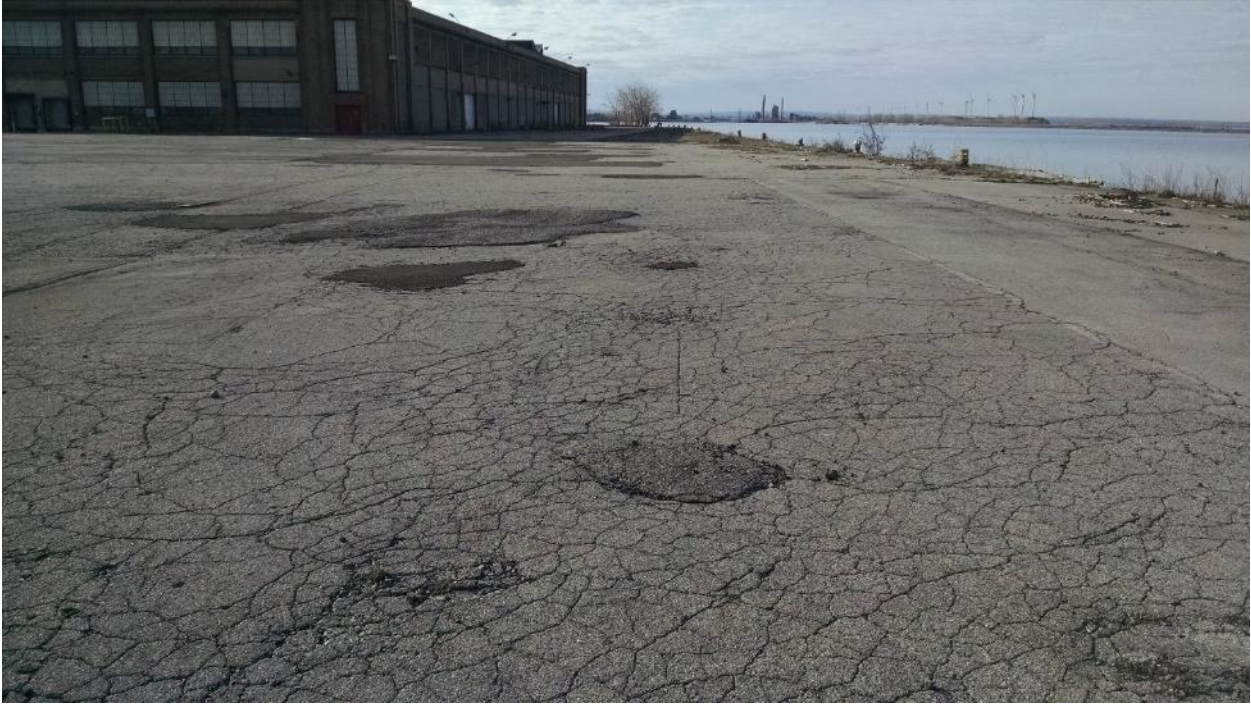
Photo A-21: Terminal A west driveway

The driveway between the western face of the building and sea wall exhibits similar cracking to the north face driveway, with the addition of reflection cracks that have formed along the joints of the concrete base below. The asphalt along the seawall and areas surrounding the mooring posts has unraveled and become overgrown with weeds at the seams.

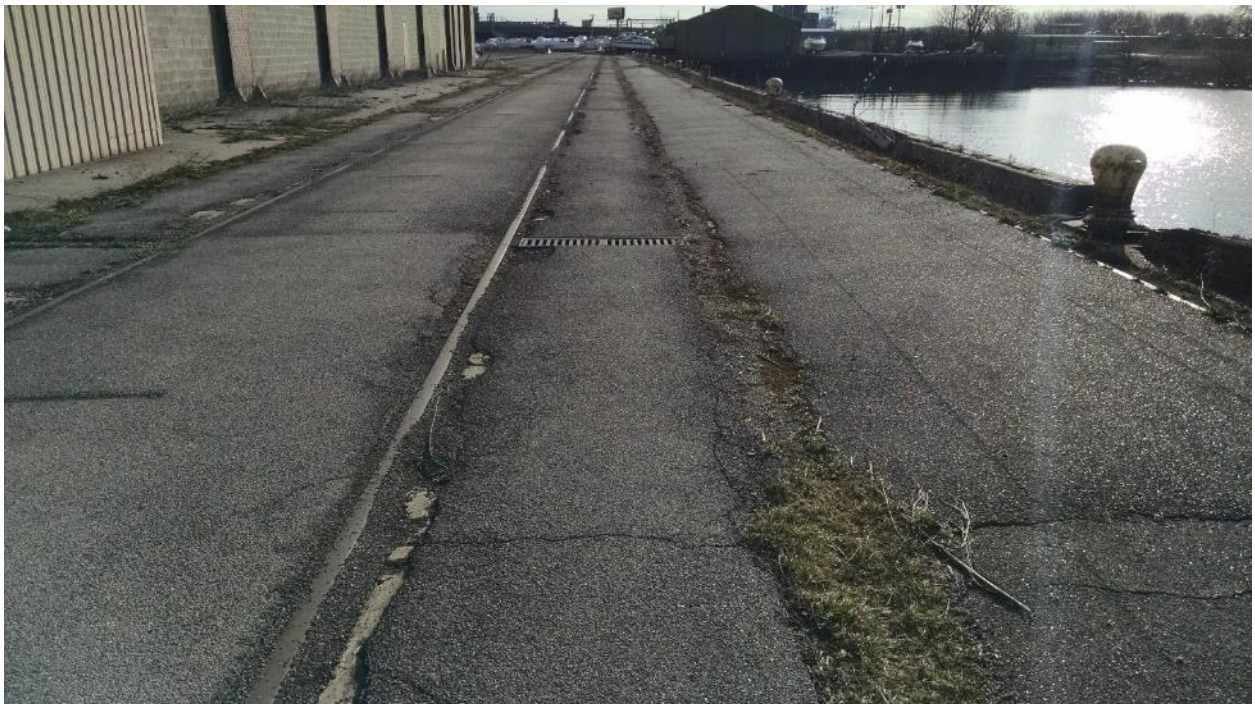
Photo A-24: Terminal A south driveway

The driveway between the deep water slip and south face of the building is shared with a paved-over pair of railroad tracks. The driveway consists of asphalt pavement over a concrete base and rail bed. In many locations, the asphalt is unraveling at the edges, especially along the rails.

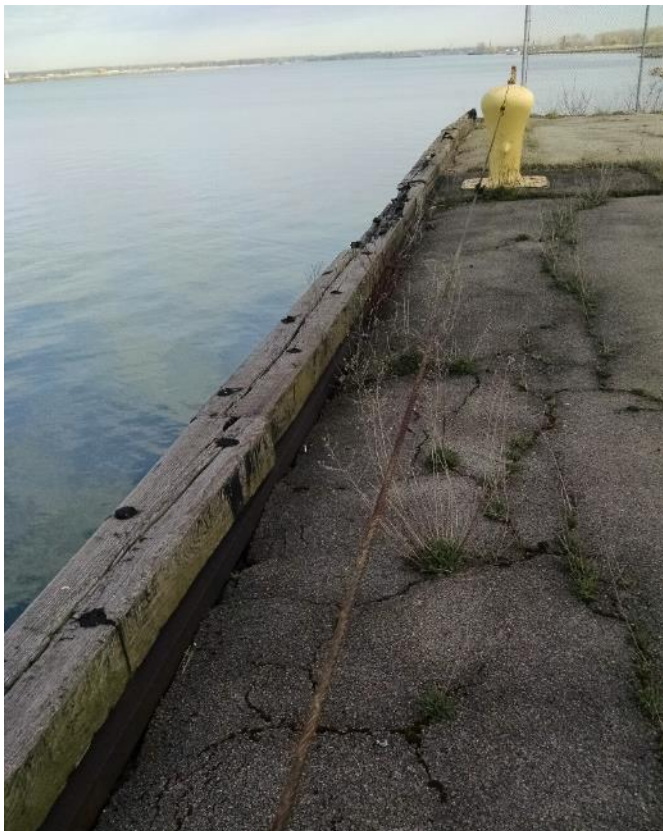
Photo A-32: Terminal B bulkhead

The edge of the seawall is lined with large mooring posts for docking vessels. The pavement between the posts is severely cracked, with the edge of pavement along the sheet pile wall having settled between 6 and 12 inches, likely due to a loss of material below.

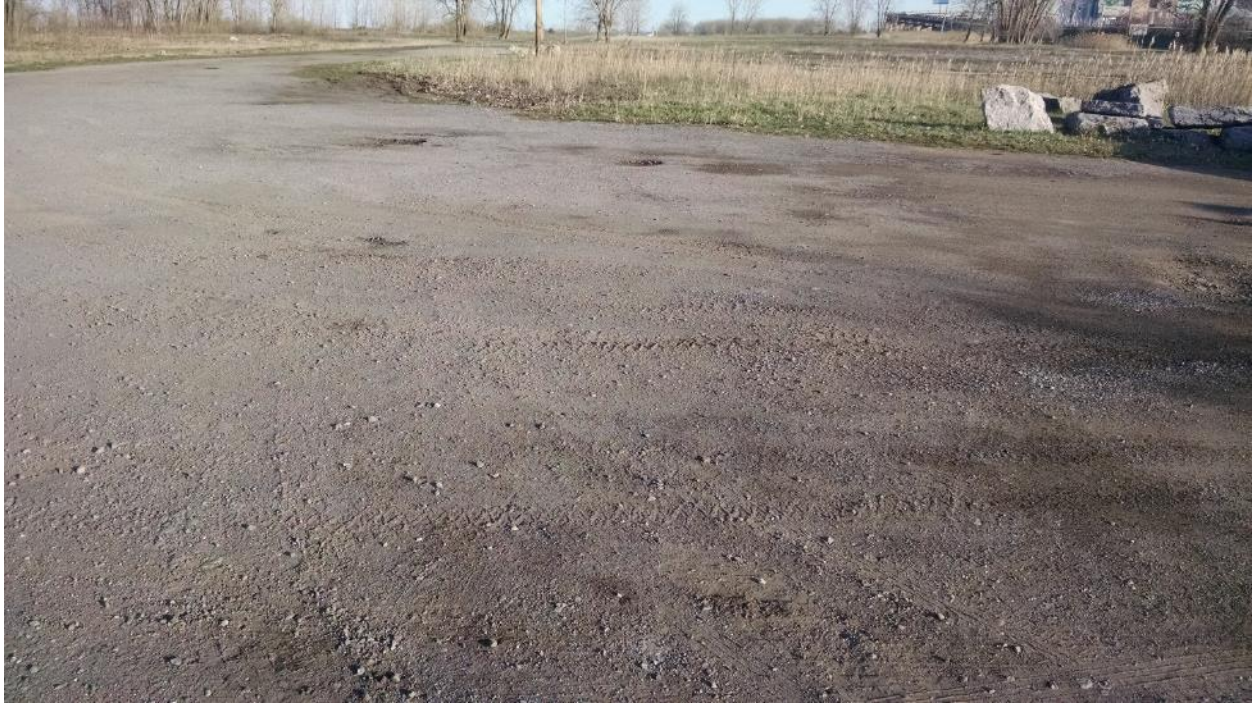
Photo C-1: Outer Harbor Drive south end

The original asphalt surface of Outer Harbor Drive extends from the Fuhrmann Blvd. roundabout, north to the Event Space parking lots. This roadway does not appear to have been maintained in several decades. There are widespread potholes and alligator cracking throughout the surface.

WSP recommends either full depth reconstruction of Outer Harbor Drive, or application of a chip and seal surface.

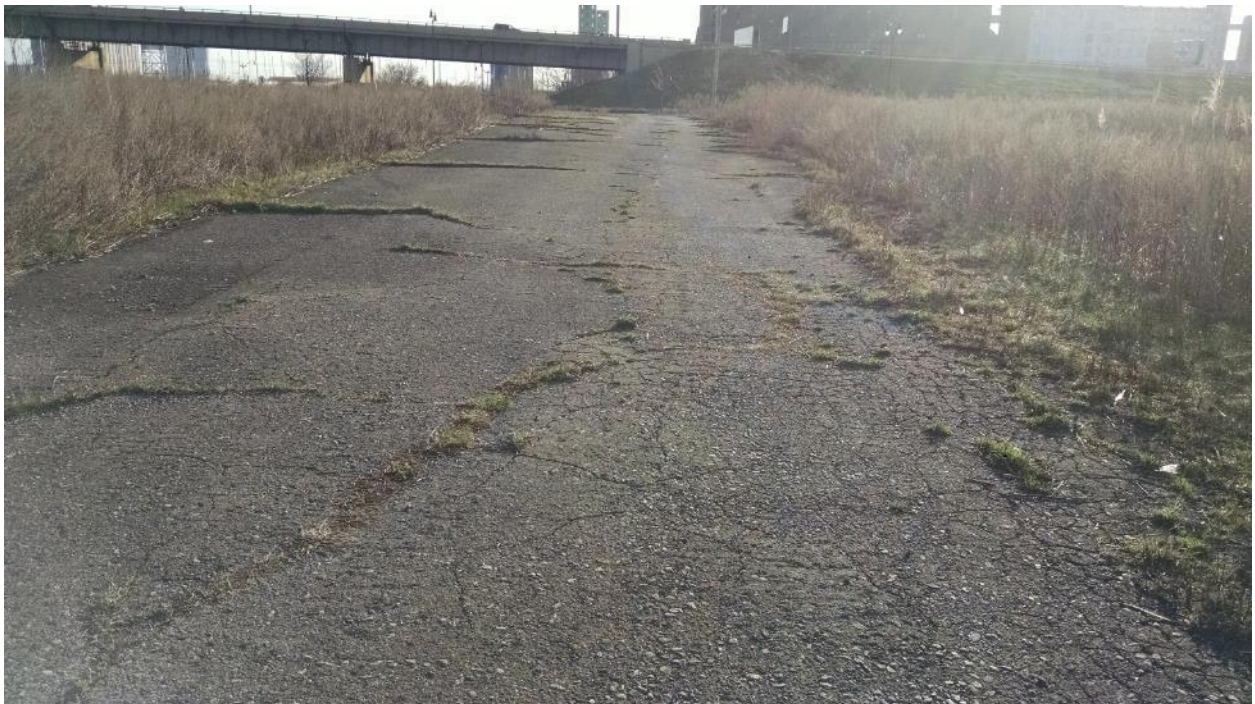
Photo C-4: Abandoned driveway adjacent to Outer Harbor Drive

One former driveway is still reasonably intact, connecting Outer Harbor Drive with Fuhrmann Blvd. Reflection cracking is widespread along the joints of the concrete base below. The surface course of the asphalt section has completely weathered away. The grade of the driveway is very uneven, with exaggerated high and low points likely caused by heaving and settlement.

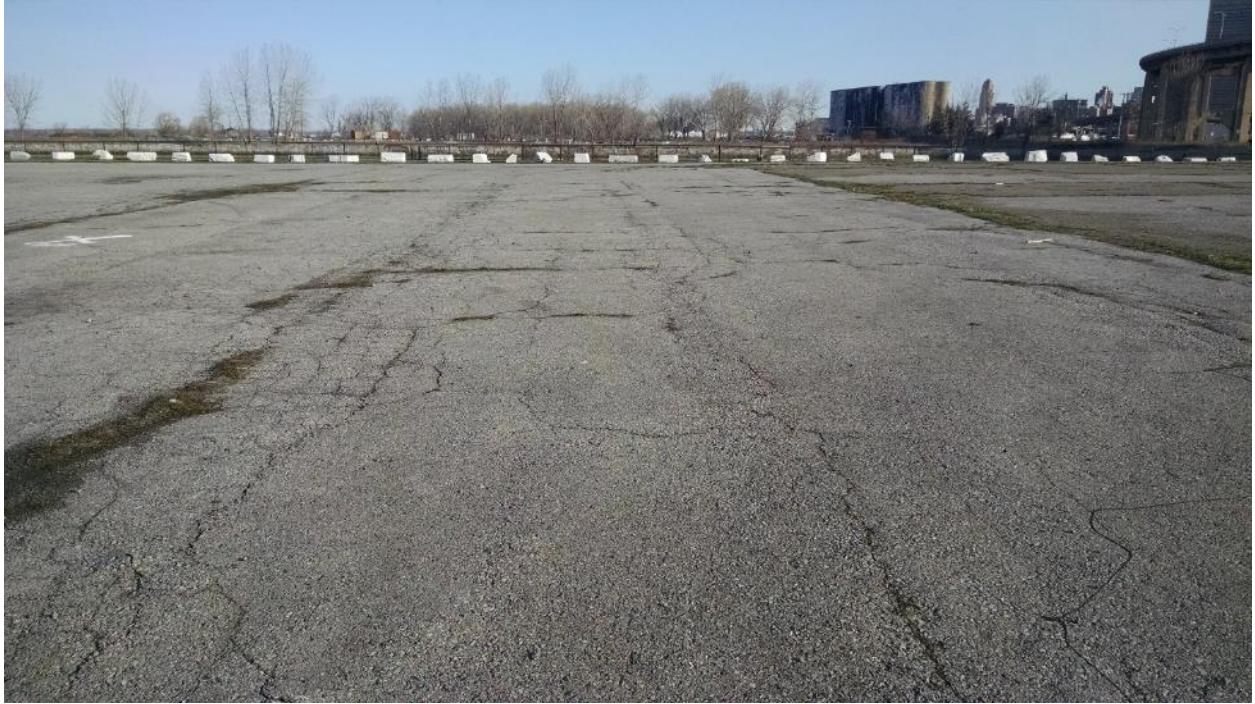
Photo D-1: North Events Space (looking north)

There is widespread longitudinal and alligator cracking as well as potholes throughout the surface. It is evident that certain sections have been repaved

more recently than others. Throughout the older eastern portion, vegetation has established along the seams of the asphalt pavement.

- Removal of weeds growing in cracks in asphalt pavement
- Apply a truing and leveling course of asphalt pavement where needed to reduce ponding at low areas
- Crack seal and skim coat existing asphalt pavement surface

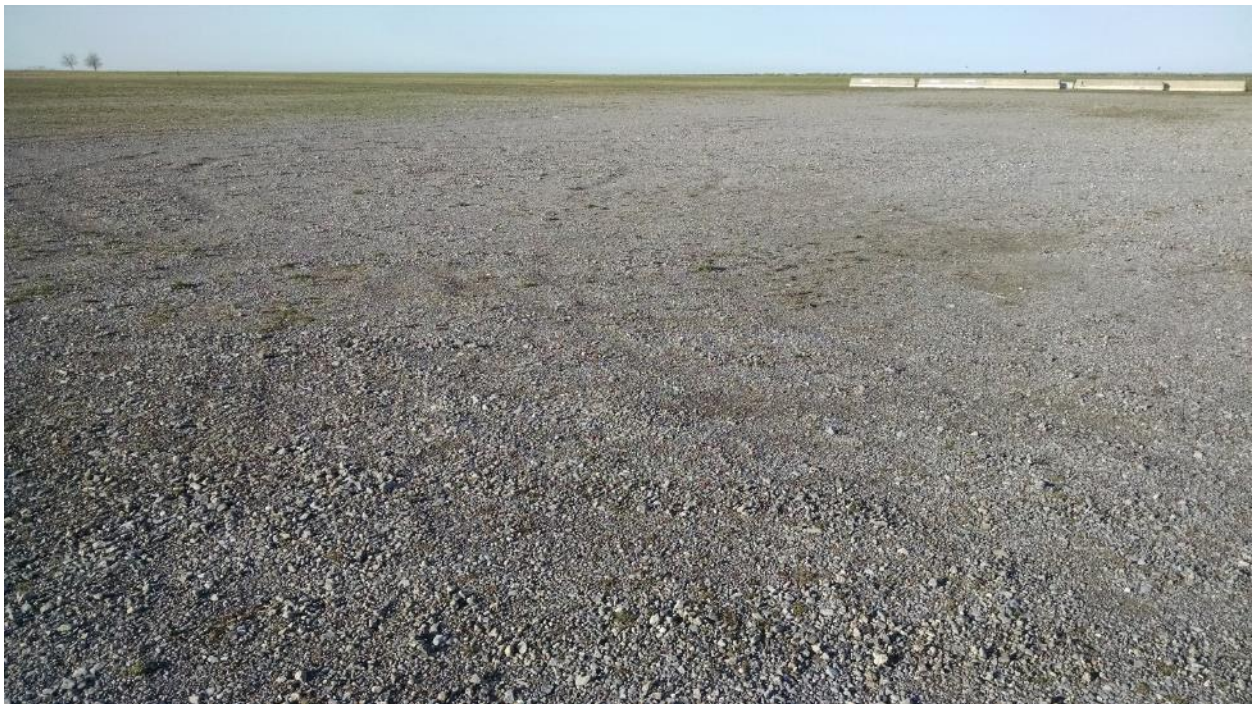
Photo D-4: North Events Space gravel lot (looking southwest)

South of the asphalt parking lots is an area of gravel lots that is becoming overgrown with vegetation. The lots become completely overgrown toward their southern edge.
