2017 PROPERTY CONDITION ASSESSMENT REPORT – VOLUME III – Utilities -FINAL

**Buffalo Outer Harbor Access and Activation Civic
Improvement Project**

901 Fuhrmann Blvd, Buffalo, NY 14203

August, 2017

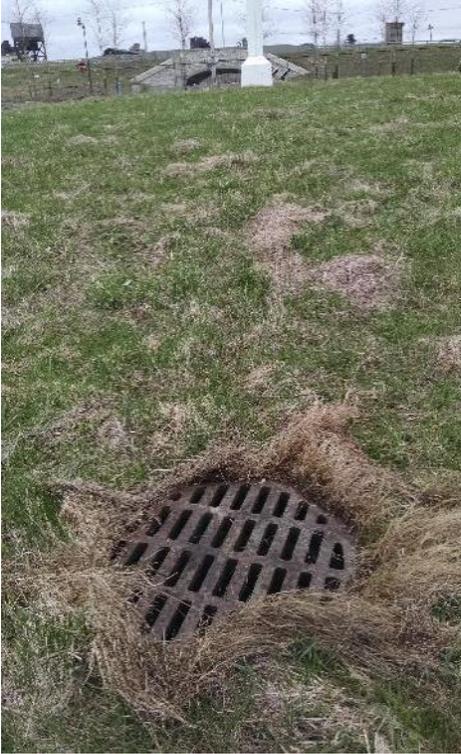
Several catch basins along the barricaded Terminal A driveway connect to form a separate network that drains to Fuhrmann Blvd. Heavy sedimentation has caused most of these inlets to become completely filled with debris.

Photo A-1: Storm drain inlet along Terminal A northern entrance driveway

To restore function to all drainage systems in the vicinity of Terminals A and B, WSP recommends a thorough cleaning of the existing storm drain systems. This effort involves removing sediment from catch basins and manholes and cleaning the connecting storm drain pipe by water jetting. Use of a video inspection system will also help determine the cause of encountered blockages and locate damaged section of pipe.

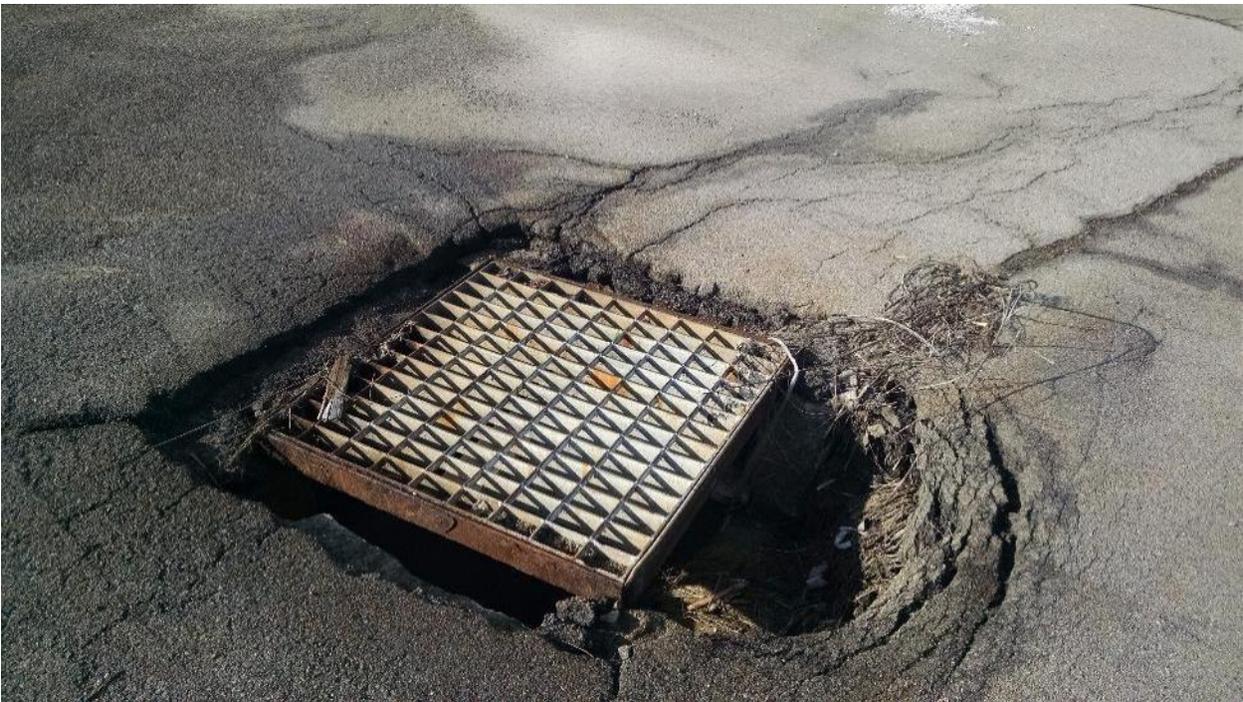
Three of the catch basins located within the 1988 expansion portion of the Terminal A parking lot exhibit structure damage. The top portion of the catch basin structure has failed and caused collapse of the surrounding pavement. Two of the catch basins have steel plates placed over them eliminate the safety risk. WSP recommends removing the steel plates and existing grates and frames, repairing the damaged concrete structure top, and replacing the frame, grate and surrounding pavement.

Photo A-2: Collapsing pavement surrounding Terminal A auxiliary parking lot catch basin

Replacement of the section built in the late 1980s is not necessary since the piping and most of the basins are operating properly, with no major deficiencies aside from those anticipated to be fixed as part of the first year repairs. While the entire system wouldn't need replacing, WSP recommends that the catch basins that currently exhibit structural damage be replaced during long-term improvement work.

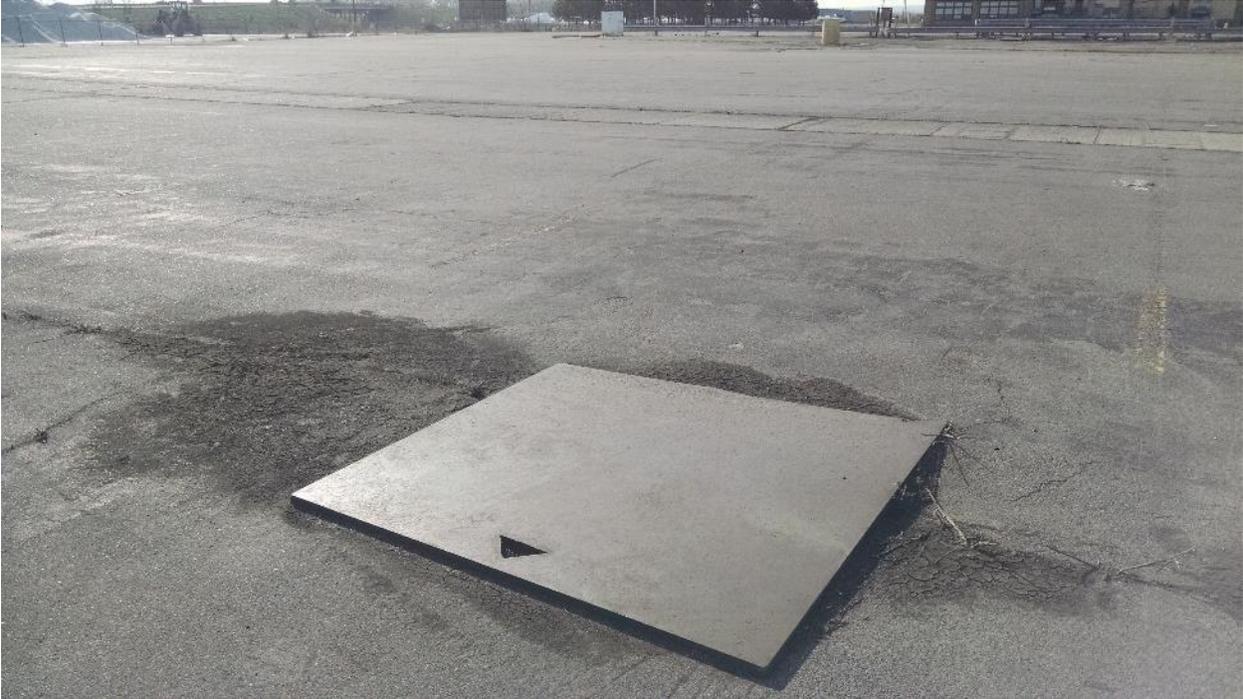
Photo A-3: Collapsed catch basin covered by steel plate in Terminal A auxiliary parking lot

| | Quantity | Unit | Unit Cost | Total Cost | UNIT COST BACKUP | | |
|---|---|---|---|---|---|---|---|
| Remove Steel Plates Covering Catch Basins | 2 | EA | \$ 200.00 | \$ 400.00 | | | |

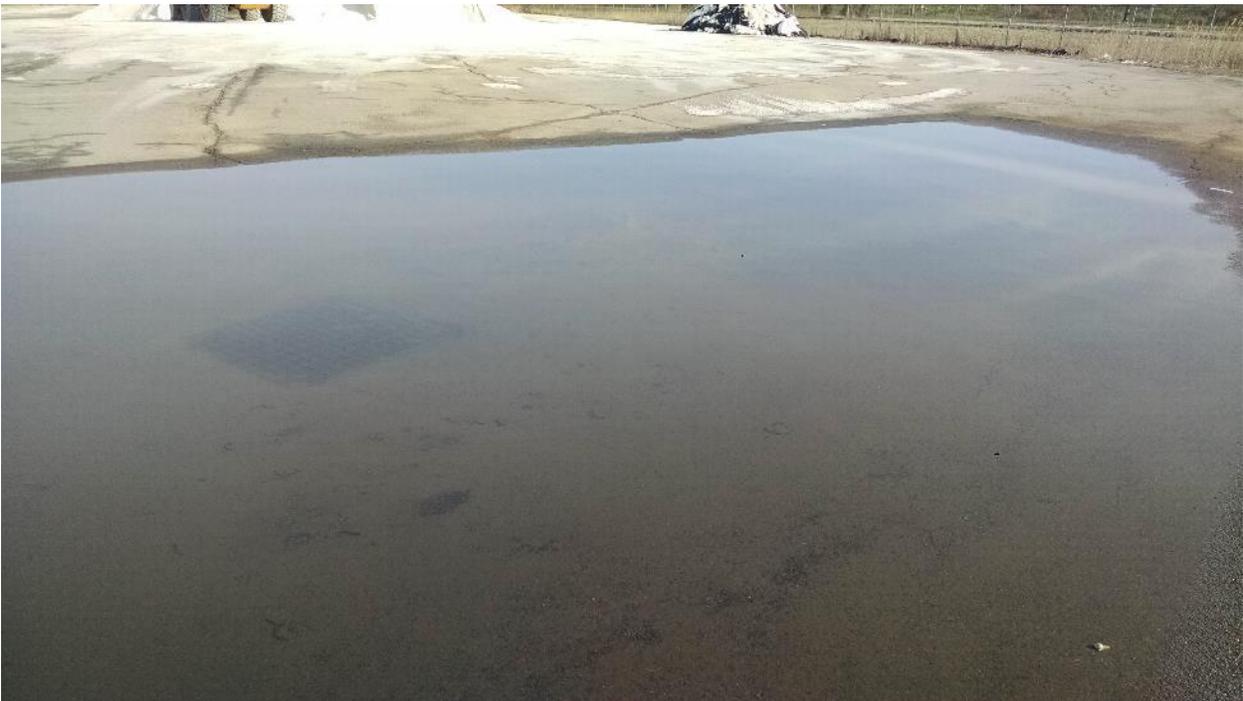
Photo A-4: Blocked and flooded catch basin in Terminal A salt storage lot

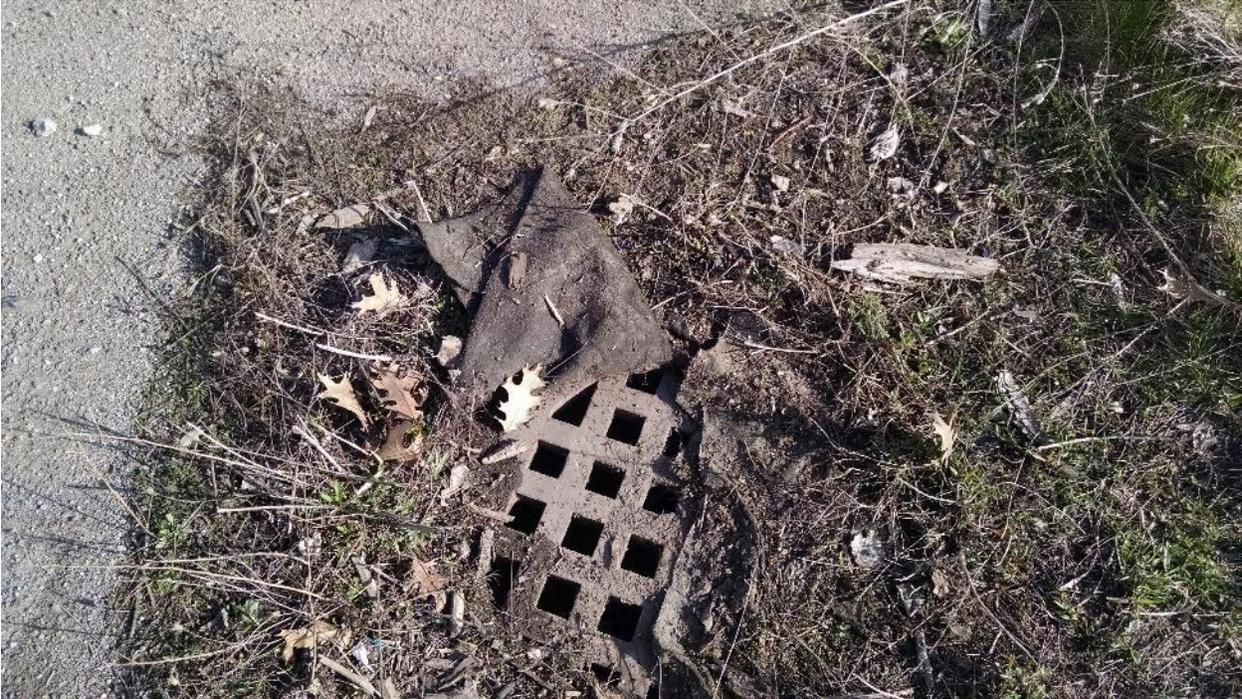
Photo A-5: Terminal A east driveway catch basin plugged with sediment

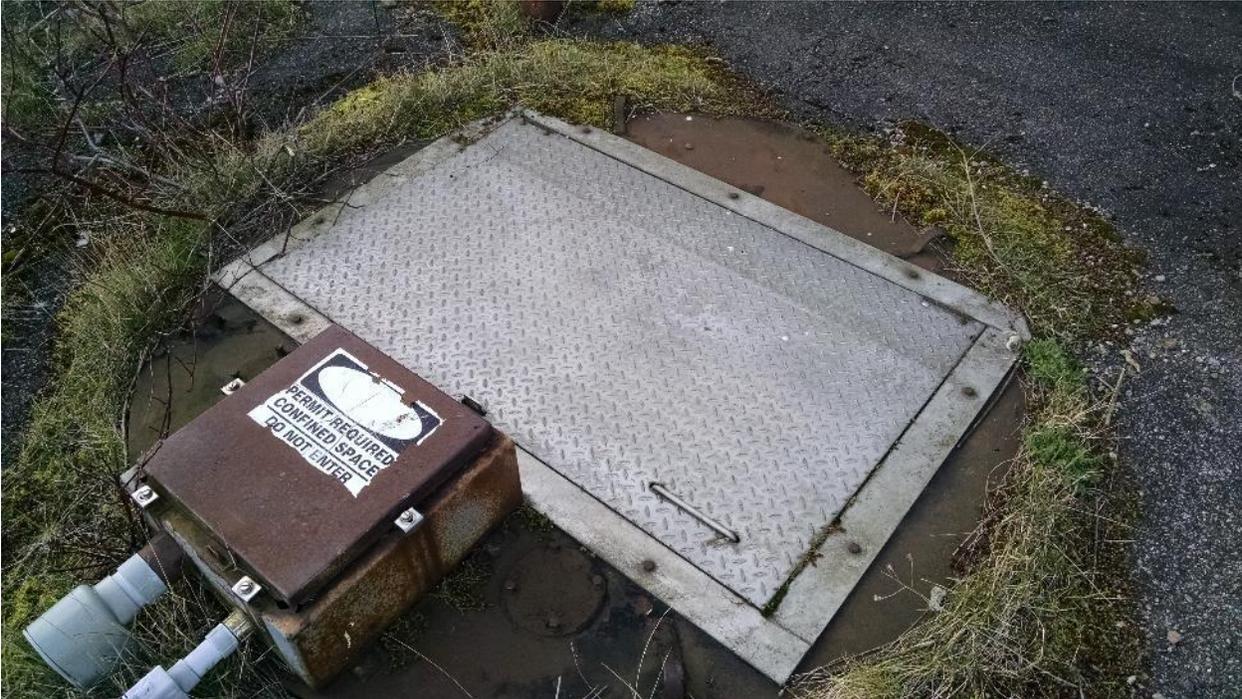
All of the buildings with water service also have sanitary sewer connections. Terminal A is served by twin 6" force mains that run from a pump station at the northwest corner of the building to the 8" line on Fuhrmann. Blvd.

Photo A-6: Terminal A sanitary pump station (northwest corner)

The three sanitary ejector pump stations that comprise part of the sanitary sewer system should be cleaned, inspected and rehabilitated if not performing properly. During the field investigation, water mixed with oil was observed discharging from the fresh air pipe located on the gravity main that exists Terminal B. The discharge flows over the pavement until reaching the nearest storm drain inlet. If the source of the discharge is the

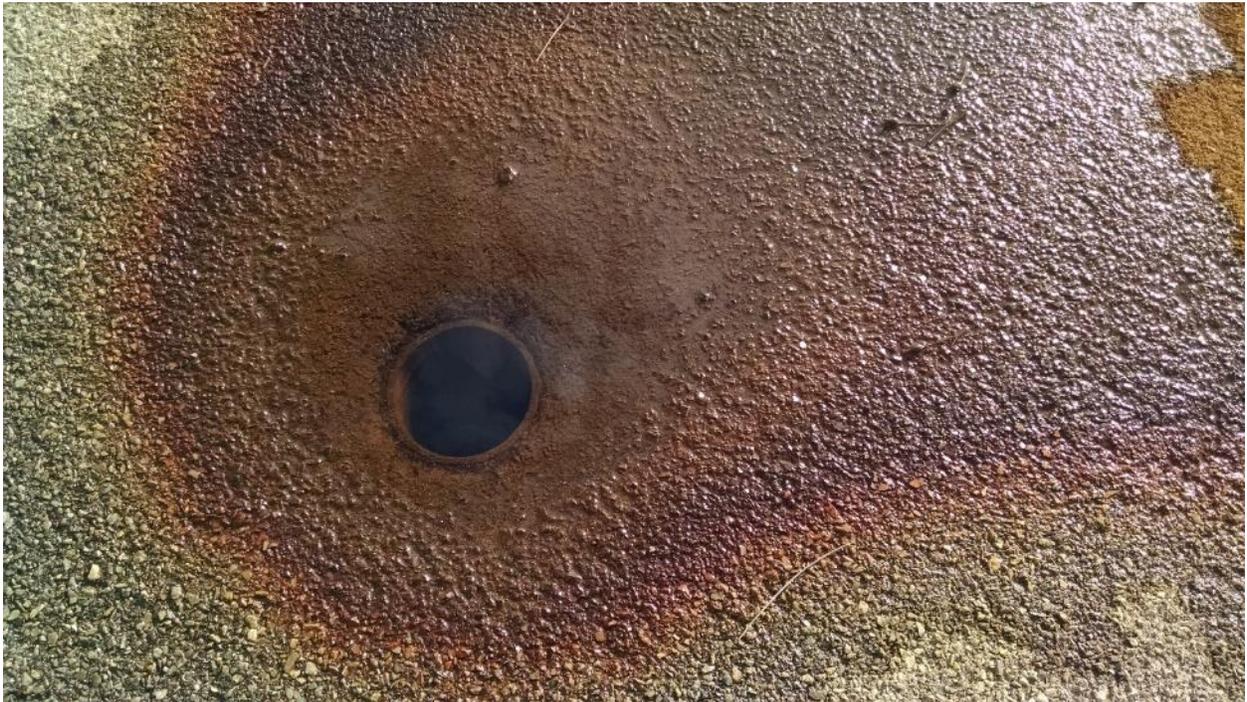
building's sanitary sewer, the water observed would contain raw sewage. WSP recommends that the sanitary main that serves Terminal B be cleaned and inspected to locate the source of the discharge.

Photo A-9: Terminal B sanitary fresh air vent discharging backed-up sanitary waste

| | Quantity | Unit | Unit Cost | Total Cost | UNIT COST BACKUP | | |
|---|---|---|---|---|---|---|---|
| Investigate and Mitigate Overflowing Terminal B Air Vent | 1 | EA | \$ 5,000.00 | \$ 5,000.00 | | | |

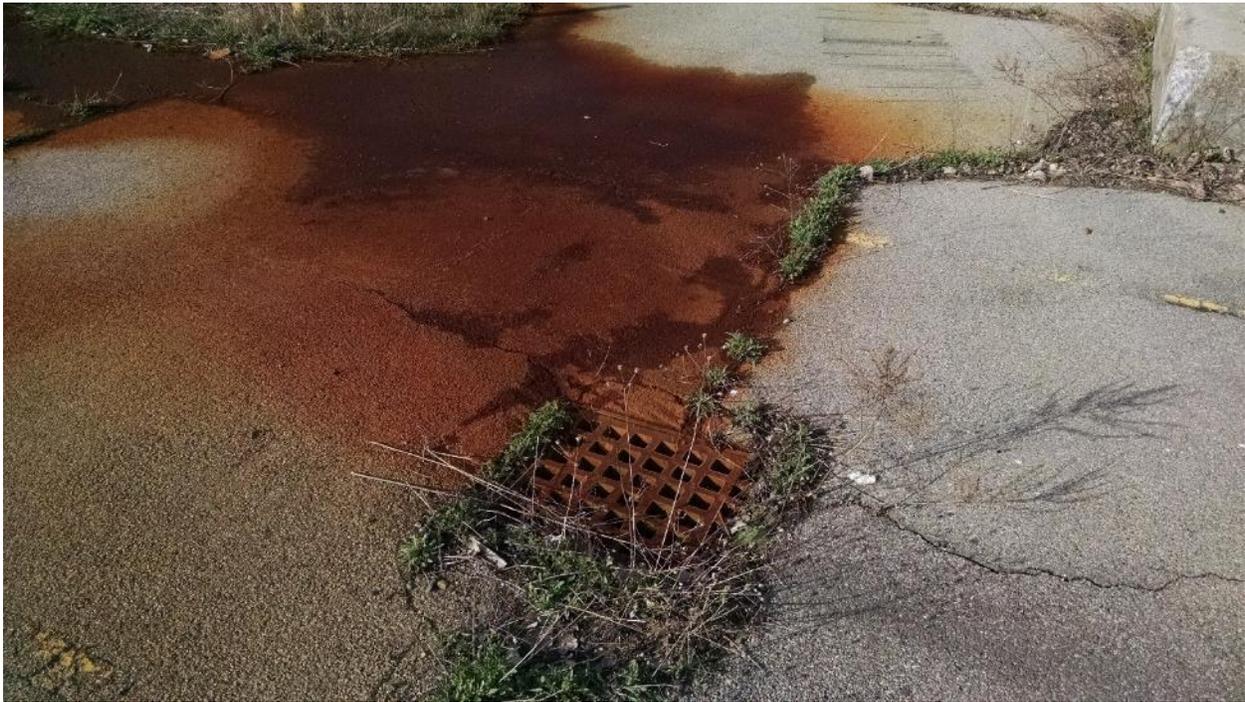
Photo A-11: Waste discharging from Terminal B sanitary fresh air vent reaching drainage inlet

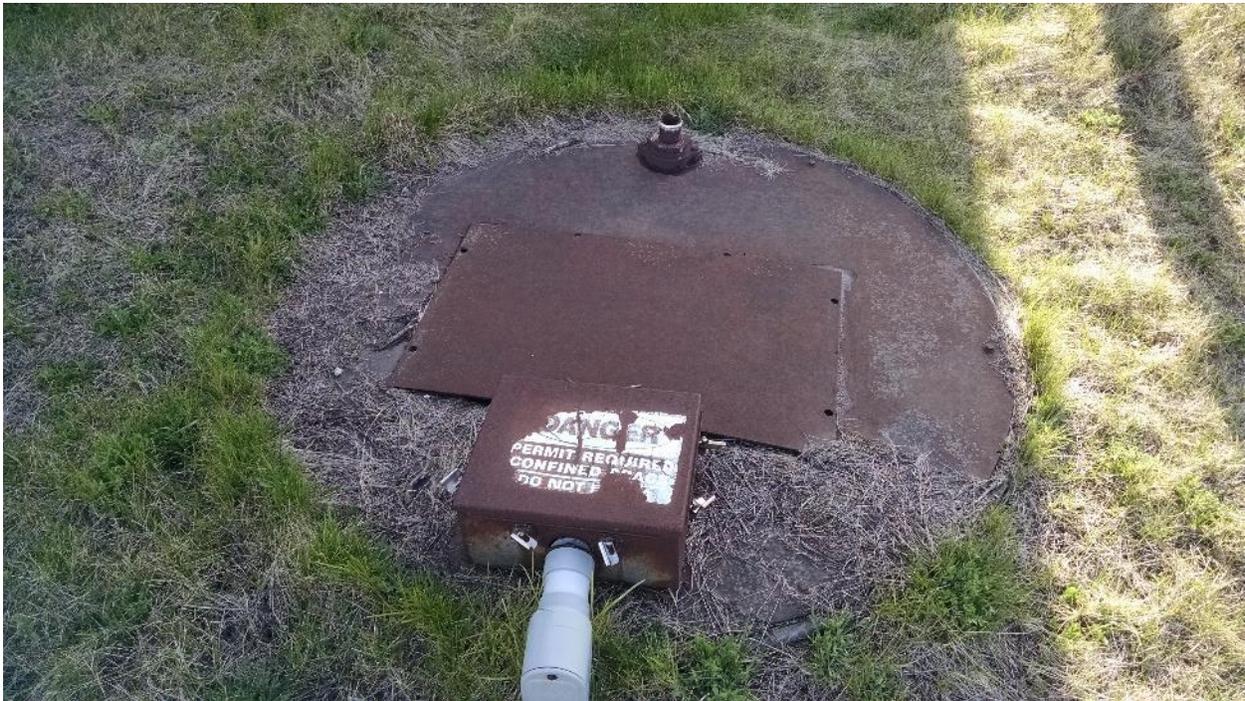
The Blue Building is also served by a force main. Sanitary sewage collects into a pump station located on the southwest corner of the building and is conveyed to a pump station located in the Administration Building. From the Administration Building, the sewage is pumped into the upstream end

Photo A-12: Blue Building sanitary pump station (west side)

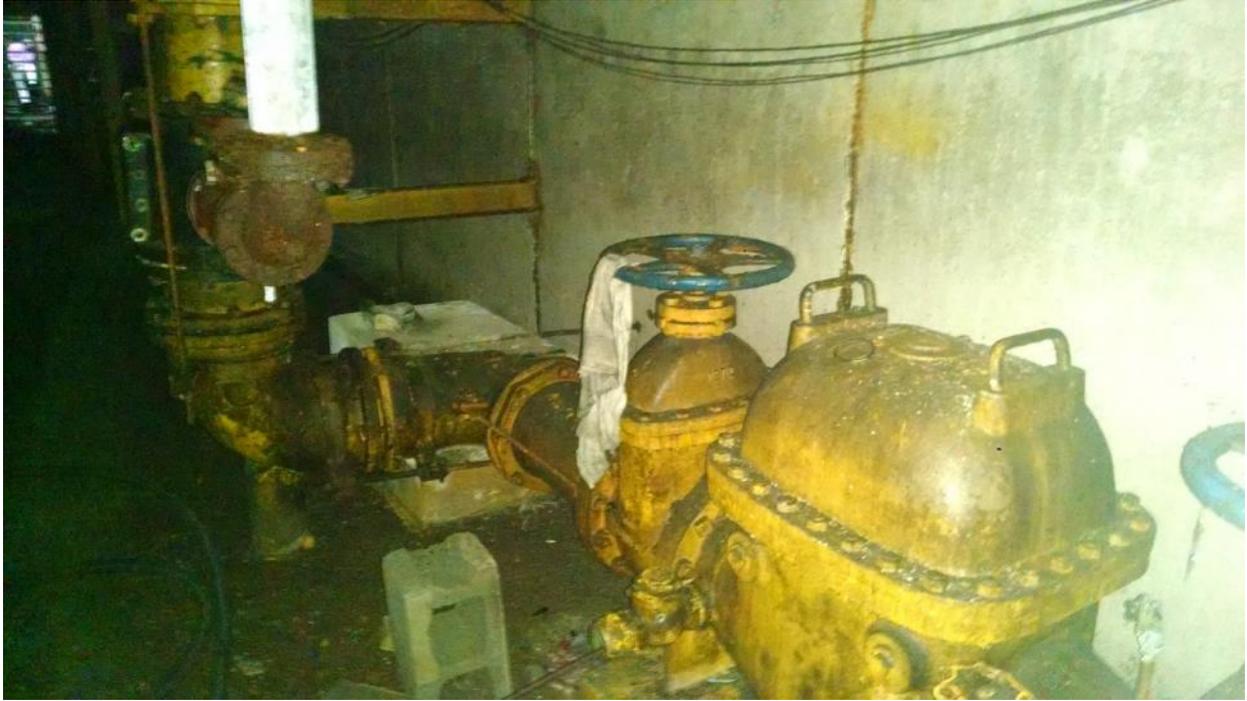
Photo A-15: Dismantled water meter on Terminal A water supply main in utility tunnel

Water service is provided to each building at the south end of the Outer harbor site. WSP recommends that all backflow preventers and meters throughout the complex be inspected and tested by a water service contractor. Currently, water service is shut off to unused buildings. The first-year recommendations include test-operating each section of service.

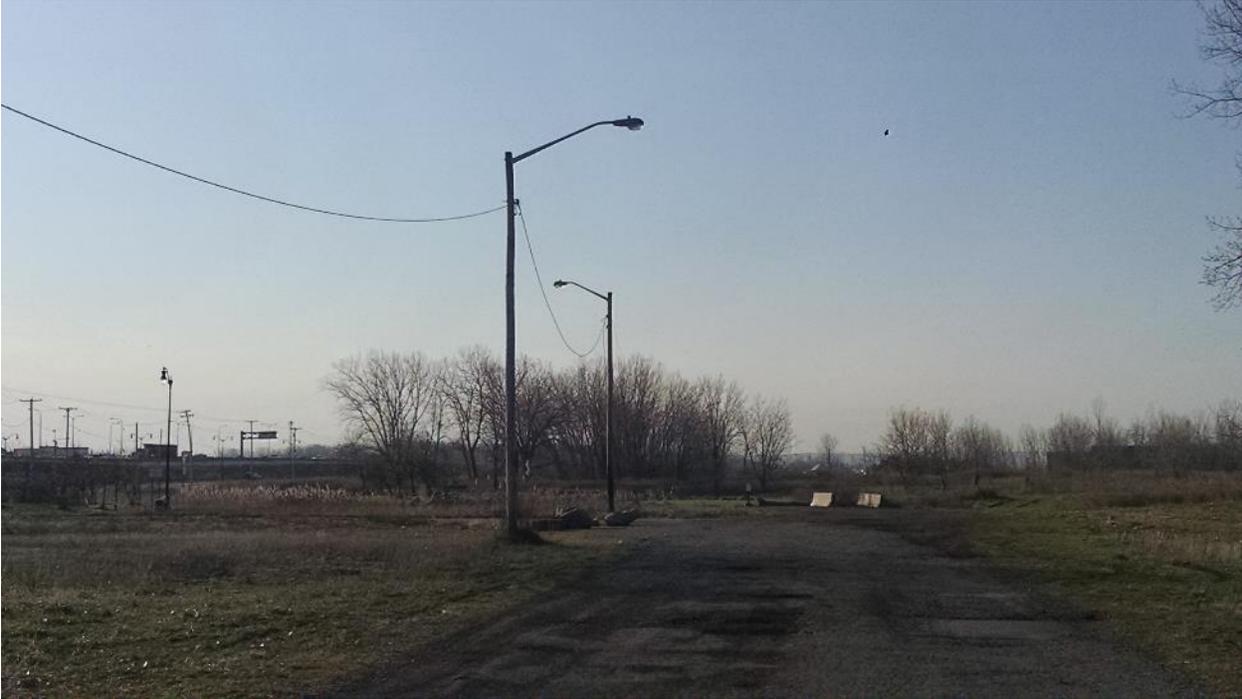
No functioning utilities or storm drainage systems currently serve this area. Wooden light poles line a portion of Outer Harbor Drive and a former building driveway. While the luminaires are still affixed to these poles, the electric lines have been disconnected and dangle against the wooden poles.

Photo B-1: Disconnected street lighting along Outer Harbor Drive

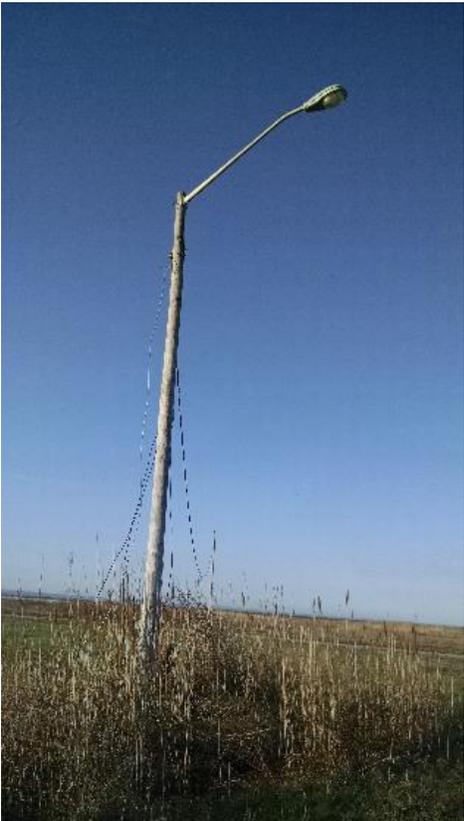
Photo B-2: Disconnected street light near Outer Harbor Drive

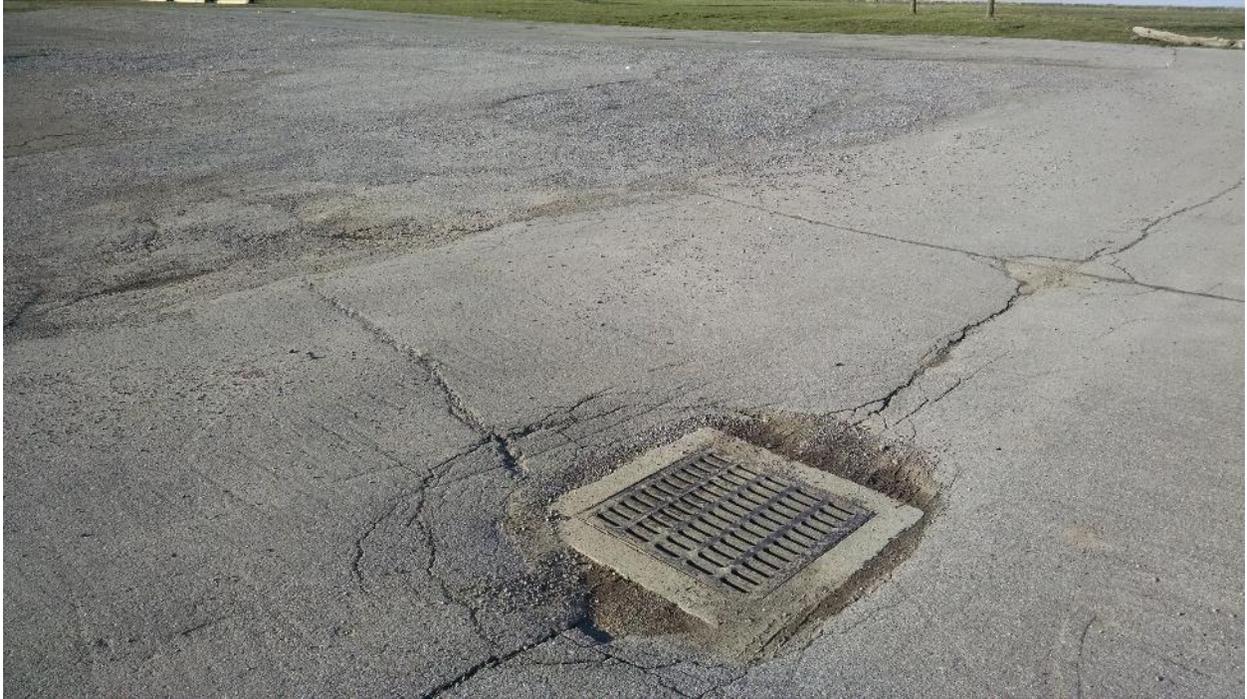
The catch basins throughout the North Event Space are partially filled with sediment. The grate of the large catch basin at the corner of the lot is severely damaged.

Sediment was found blocking flow in two of the catch basins. Also, the steel grate over the large catch basin in the southwest corner of the lot is damaged and falling into the structure.

Photo C-1: North Events Space catch basin

WSP recommends that the closed drainage system in the north end parking lot be cleaned and sediment removed. The frame and grate of the

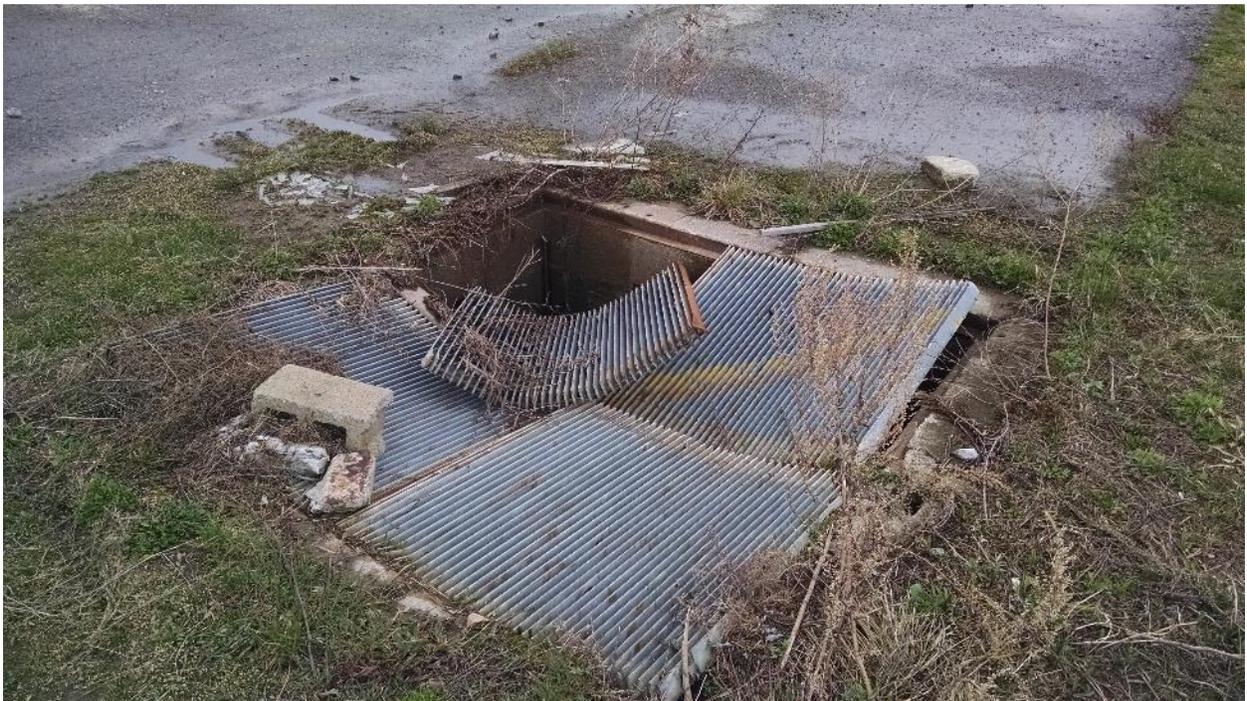
Photo C-2: North Events Space collapsed catch basin grate

large catch basin should be replaced to eliminate a safety risk to the public. A contractor should also be hired to inspect the outlet pipe section to locate the discharge point and, if necessary, clean or replace the end to provide an outlet for runoff collected by the system.
