2017 PROPERTY CONDITION ASSESSMENT REPORT – Volume I – Structure Assessment

**Buffalo Outer Harbor Access and Activation Civic
Improvement Project**

801 FUHRMANN BLVD., BUFFALO, NEW YORK

May 19, 2017

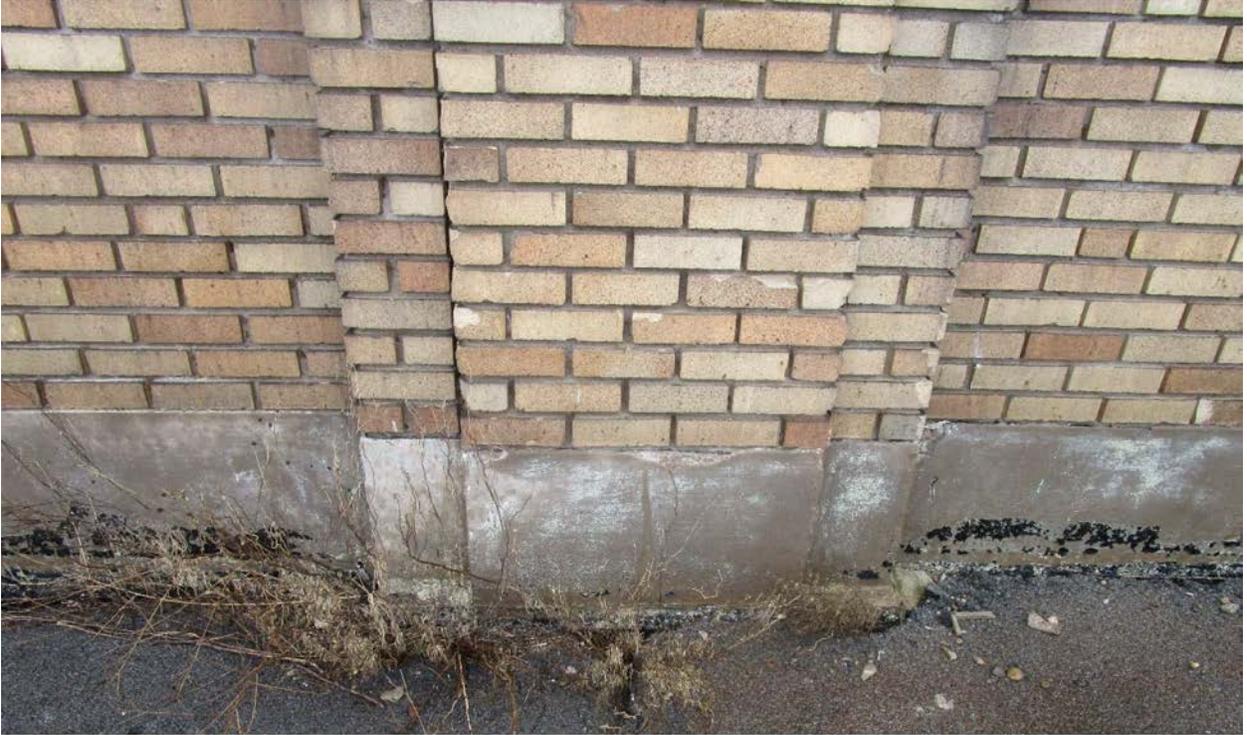
A_001

The foundation of Terminal A is rated as Good Condition, as the floor is generally flat with typical settlement cracks as would be expected. There are some areas where there is standing water, typically in sections of the building which match damage to the roof structure or failed drain piping. The foundation and floor slab do not appear to be negatively affected by this water infiltration from ground level. As the structure is metal-framed with a CMU and brick infill, there is typical hairline cracking at each of the

column piers consistent with expected column movement (Photo A_001). This cracking is evident in columns along the exterior walls, but does not appear to be an immediate structural concern. The foundation is generally sound and level, but there is an isolated location near the southwest corner of the structure where the foundation wall appears to have shifted approximately ½" at an expansion joint (Photo A_002). There does not appear to be significant damage to the wall proliferating from this location, but additional subsurface investigation and monitoring may be necessary to determine what, if any, remediation may be required, and how much.

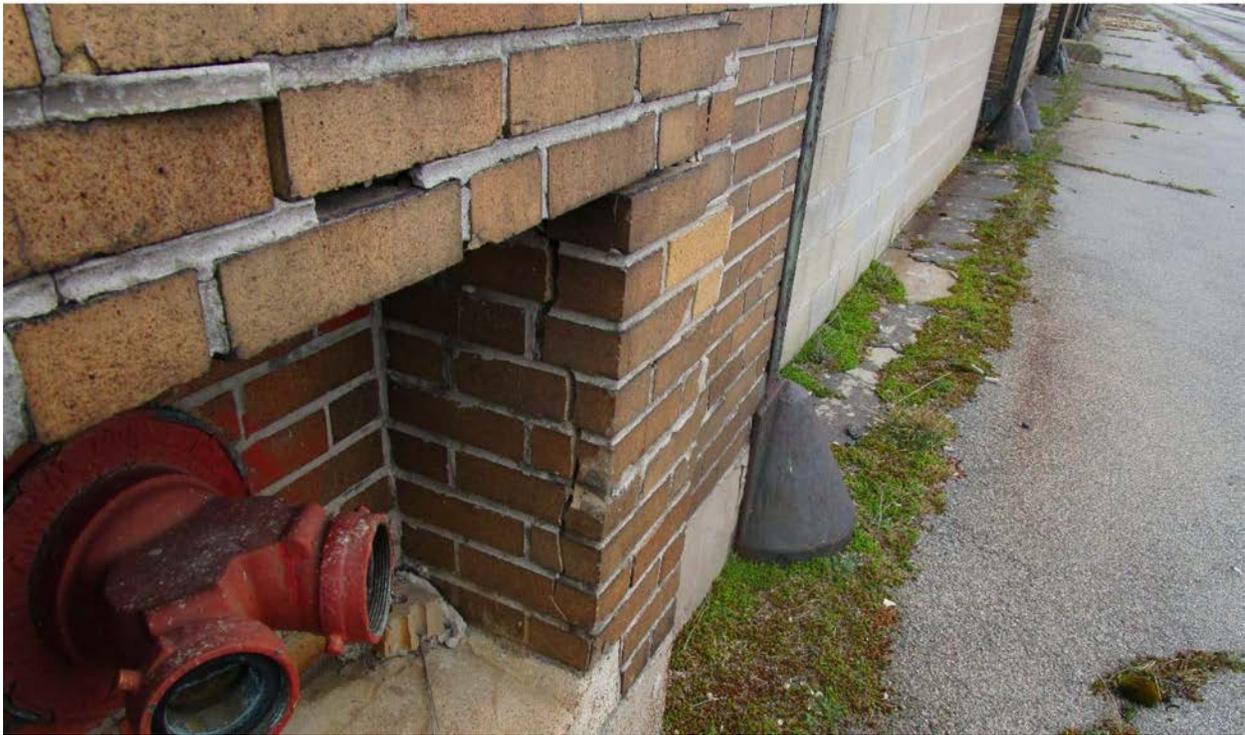
A_004

The walls appear to be in generally Satisfactory Condition, as there is mortar missing from many of the exterior joints, and there are some areas where the brick veneer has started to separate from the supporting wall (Photo A_004). There is some hairline settlement cracking visible, but no major cracking which poses a significant threat to the overall stability of the building. Several of the lintels appear to have been repaired, as there are areas along the exterior with newer brick. Some of the lintels show signs of significant weathering, and there are a couple along the south side of the building which have failed. The lintel failure appears to be contained on the veneer, so it does not pose a structural threat, but if not remediated, may lead to water infiltration and further interior damage in addition to the threat of falling bricks if failure does occur.

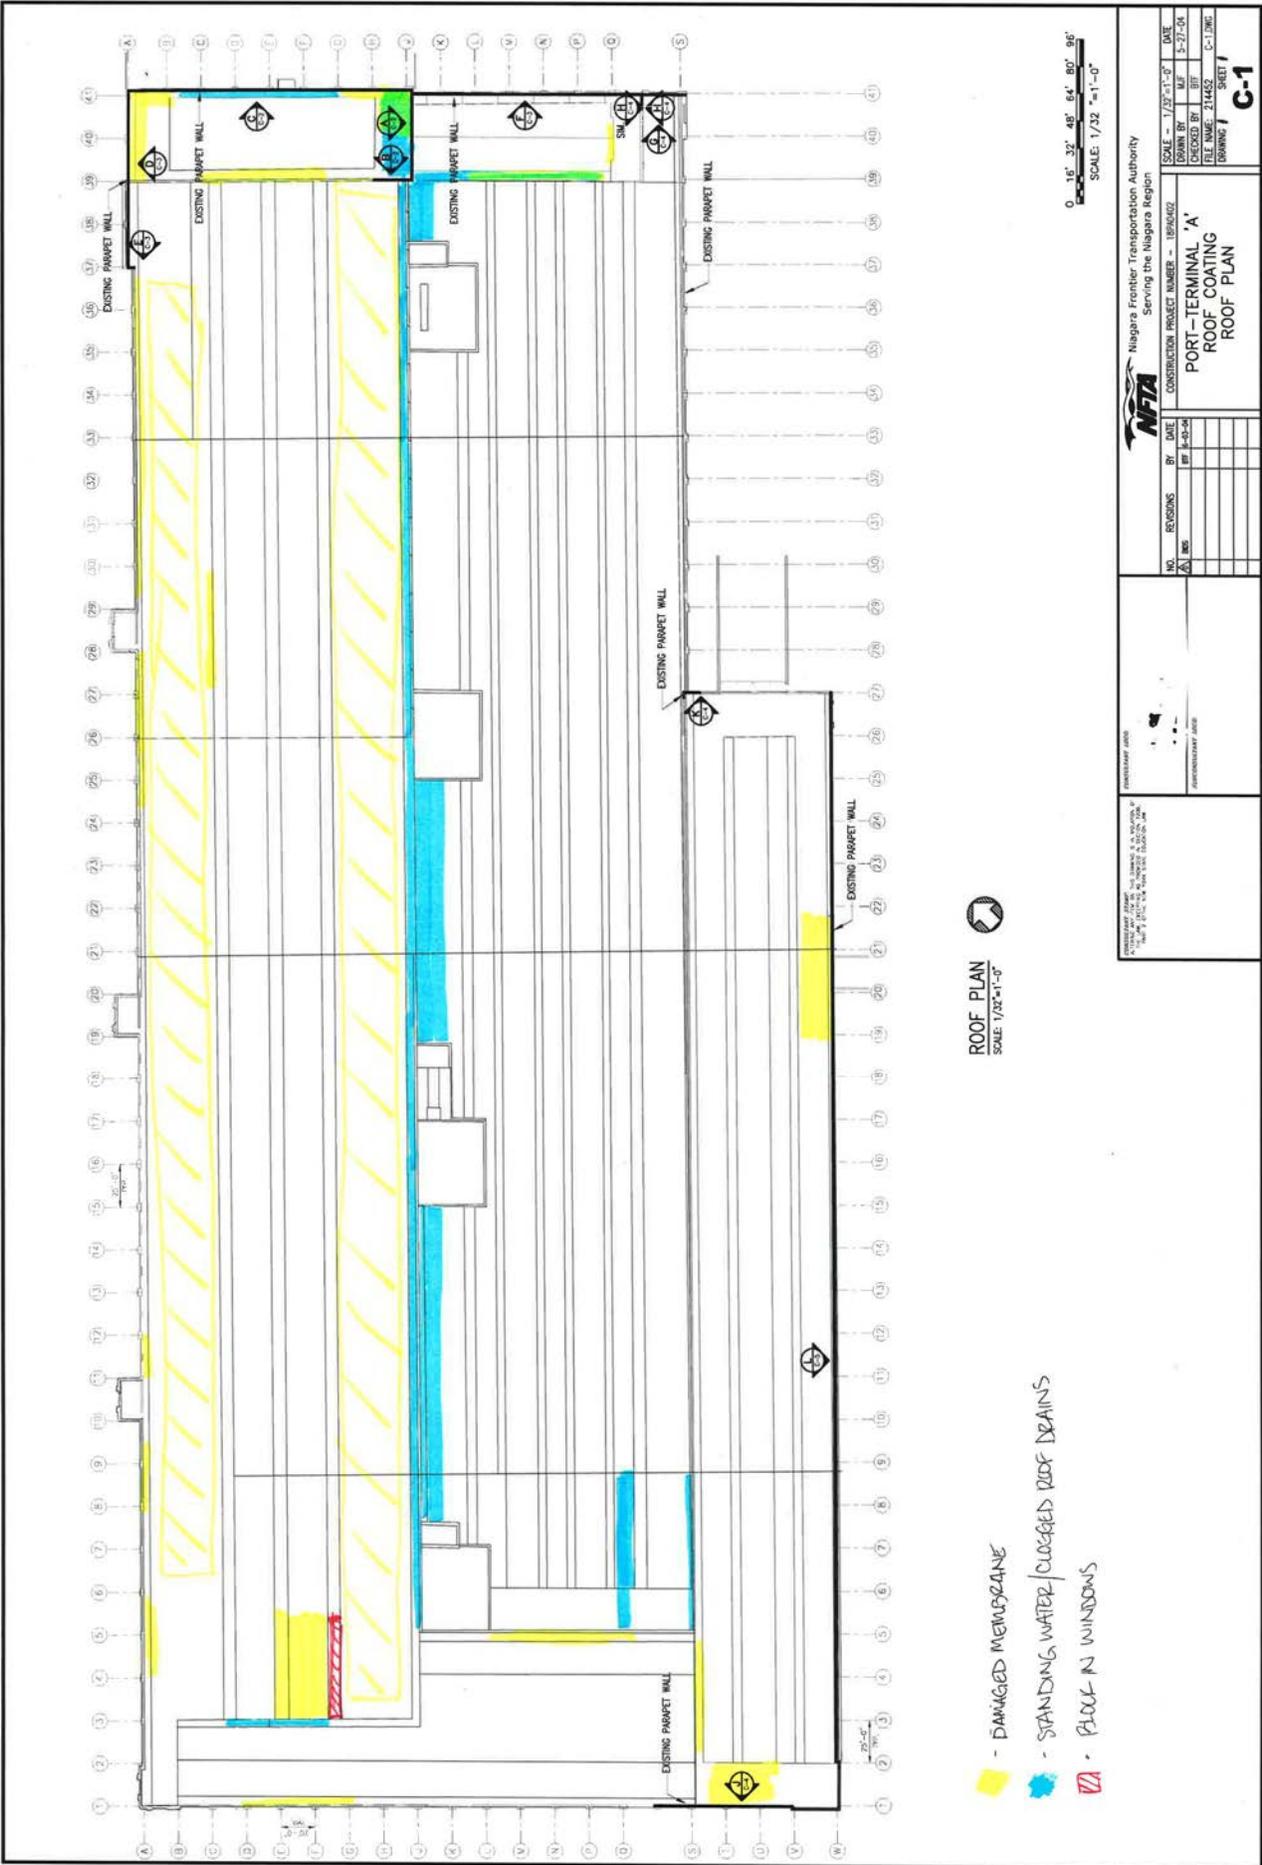
ROOF PLAN
SCALE: 1/32"=1'-0"

- - DAMAGED MEMBRANE
- - STANDING WATER / CLOGGED ROOF DRAINS
- - BLOCK-IN WINDOWS
