**PCB CAULK ENVIRONMENTAL SCREENING
and
XRF LEAD-BASED PAINT SURVEY**

**Access and Activation Civic Improvement Project
Buffalo Outer Harbor
Terminal B
Buffalo, New York 14203**

Volume 2 of 4

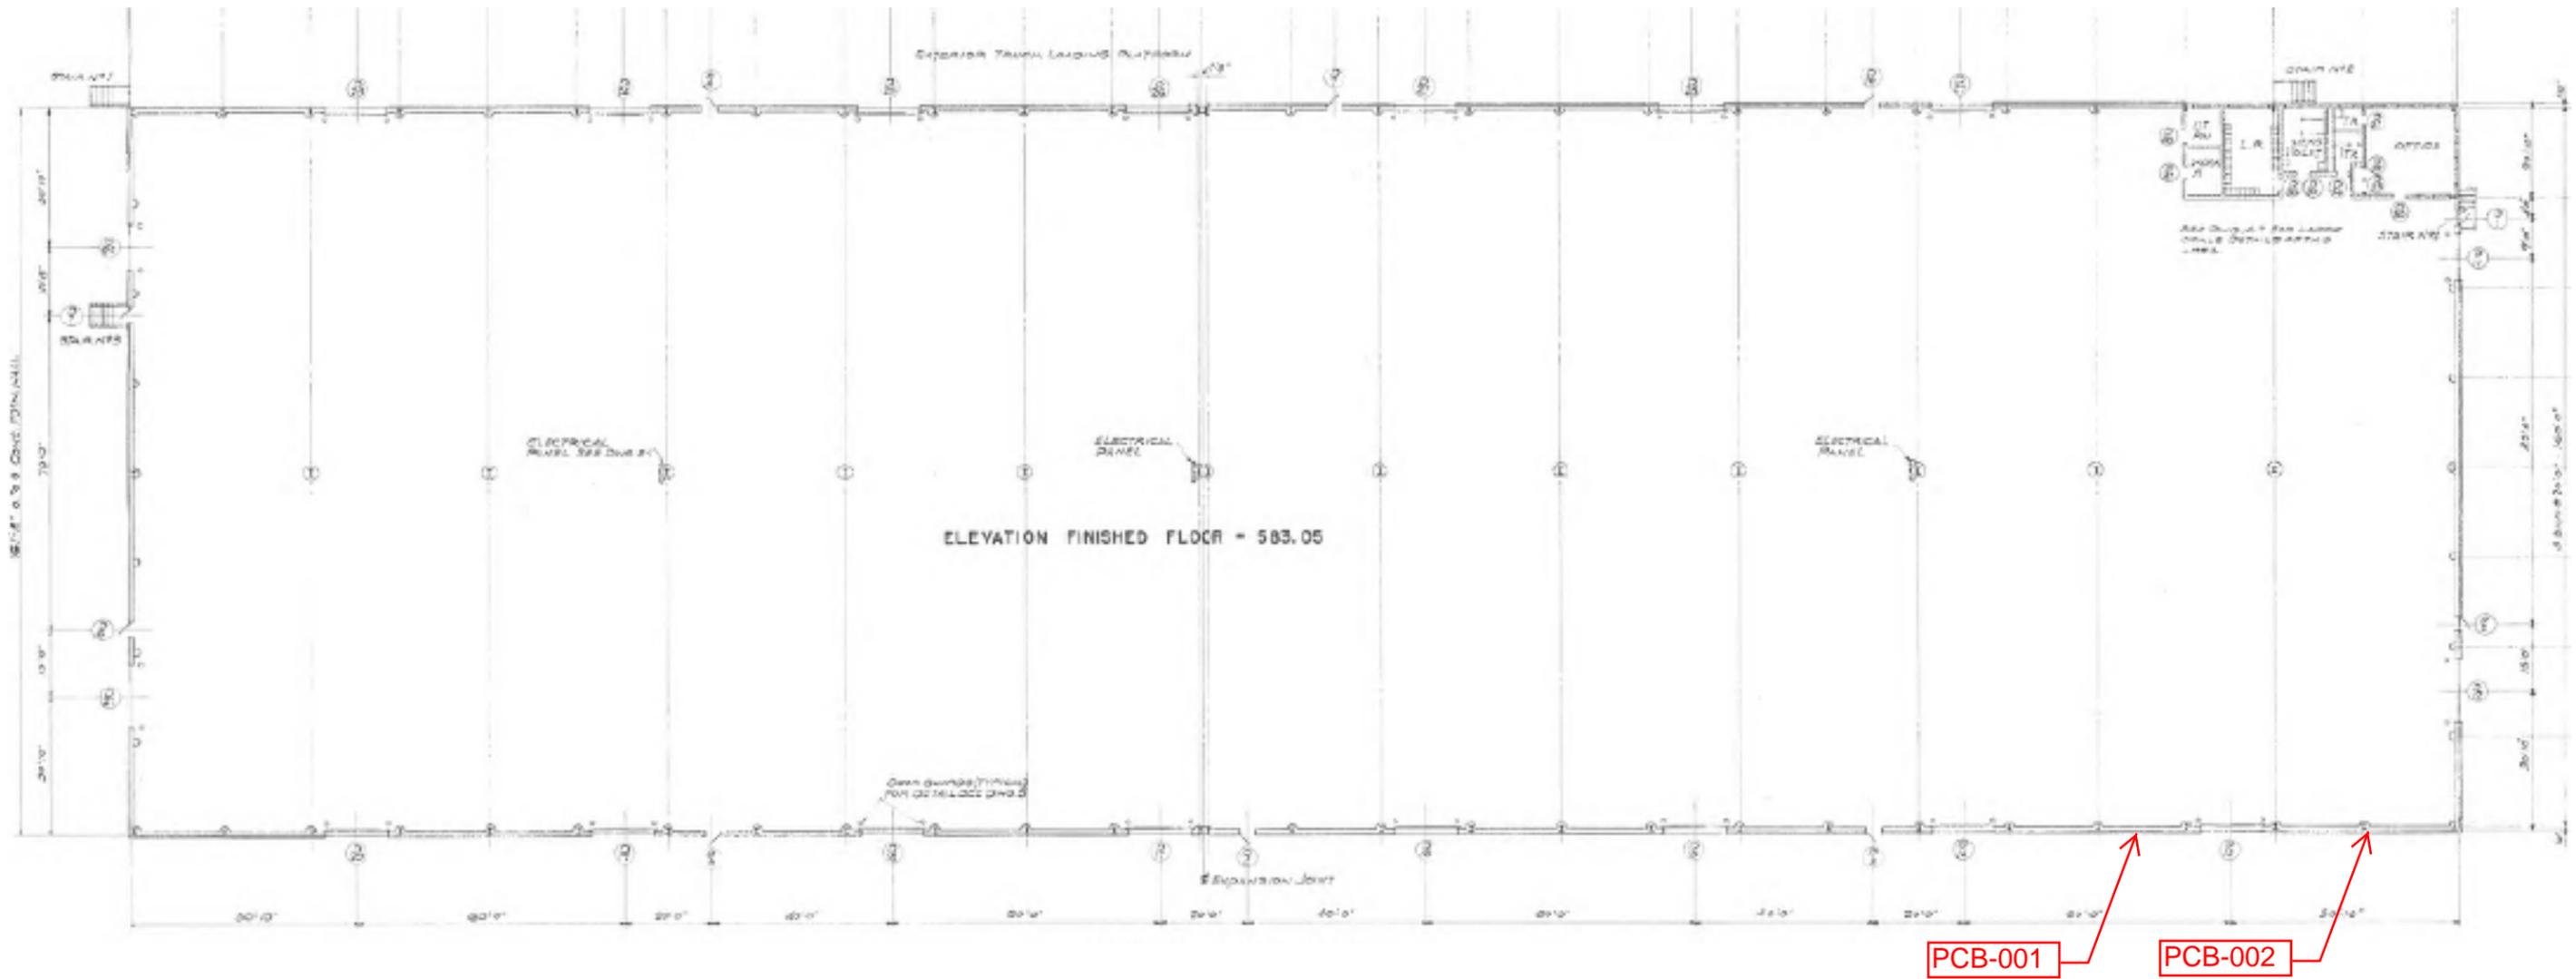
ATTACHMENT A: AREAS OF INSPECTION/BULK SAMPLE LOCATION PLANS

Two (2) caulk samples were collected and submitted to EHS for PCB content determination. A copy of EHS's certification is included in Attachment D. Bulk sample locations are found in Attachment A. The following table identifies caulks that were sampled and analyzed for PCBs.

Material Description	Sample Number	Result
Gray pliable exterior door caulk	PCB-001	<19 ppm
Gray pliable exterior seam caulk	PCB-002	<20 ppm

None of the samples analyzed were found to be above the regulatory threshold for PCB waste (≥ 50 ppm).

Any sealant or caulk materials encountered during future renovation that were not identified in this Screening should be assumed to be PCB containing until laboratory results prove otherwise.
