MOLD ASSESSMENT

**Access and Activation Civic Improvement Project
Buffalo Outer Harbor
Terminal B
Fuhrman Boulevard
Buffalo, New York 14203**

April 2017

Project No. 20-16-204

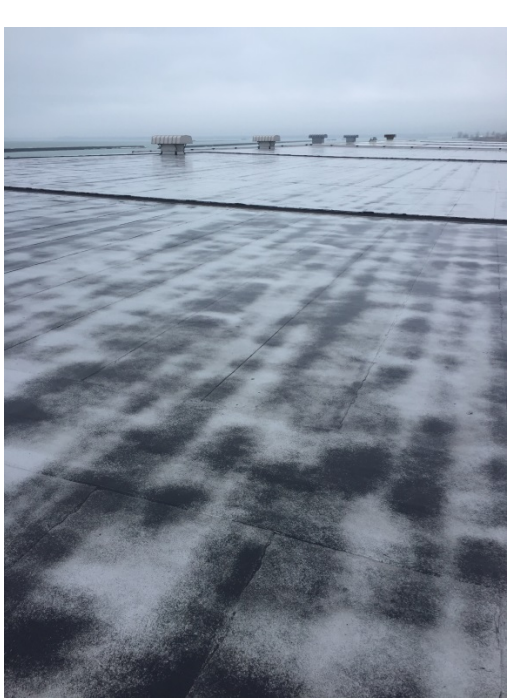
Intact Roof System

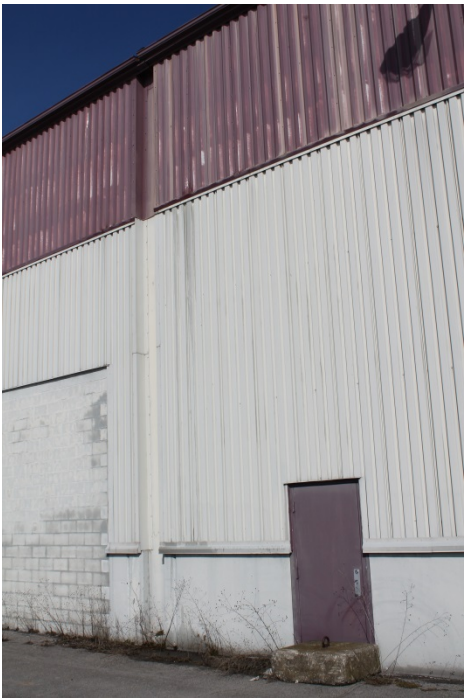
The cause of water infiltration to this portion of the building is from failing gutters and downspouts on the exterior of the building. Based on moisture mapping and thermal imagery, water is becoming trapped between the metal façade and the concrete masonry units, thus entering the building.

Missing Downspout and Wet Façade

ACMs and lead paint are present in Terminal B, but are not located where water damage and mold contaminated building materials are present. The west wall of Terminal B contains select locations of water damage and mold growth. The water damaged gypsum wall boards and plywood on the west wall are recommended for removal and disposal after water intrusion from the failing gutters and downspouts are resolved.

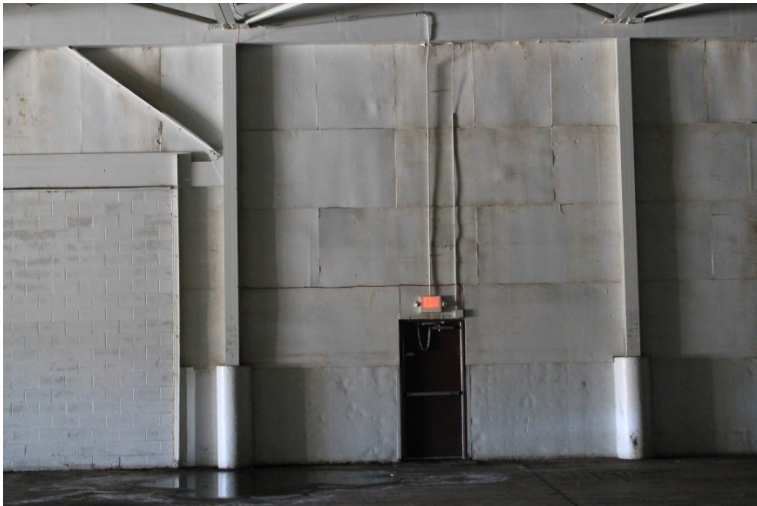
West Wall, Standing Water, Elevated Moisture Readings

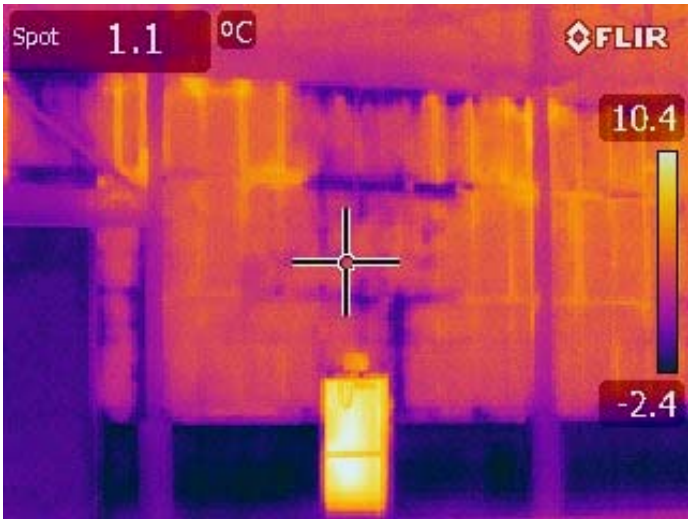
West Wall Thermal Imagery Matching Moisture Meter Readings

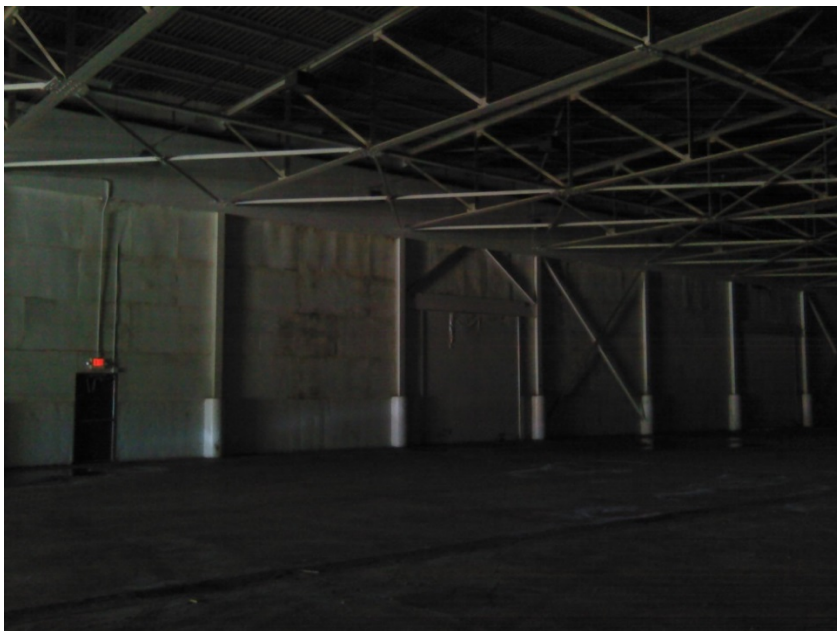
West Wall Overview

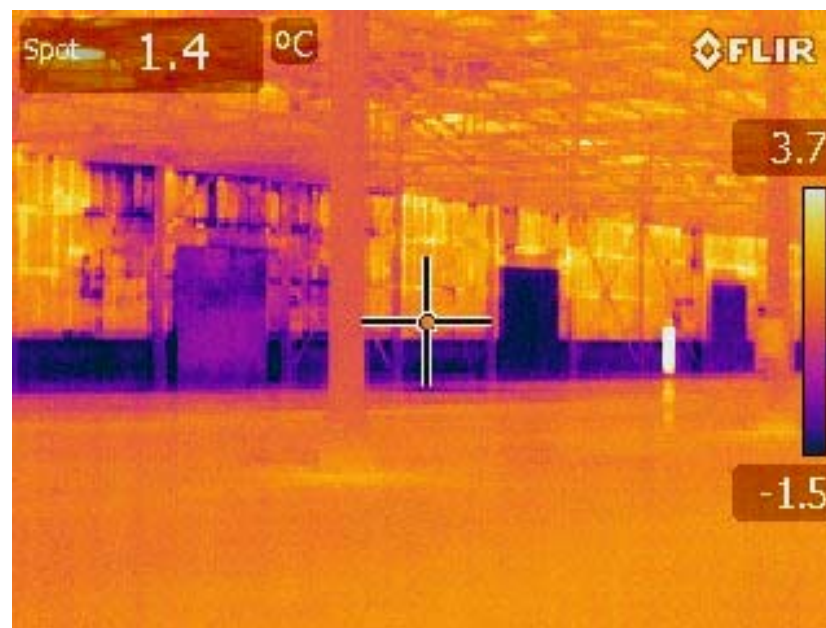
West Wall Thermal Imagery Readings, Evidence of Infiltration

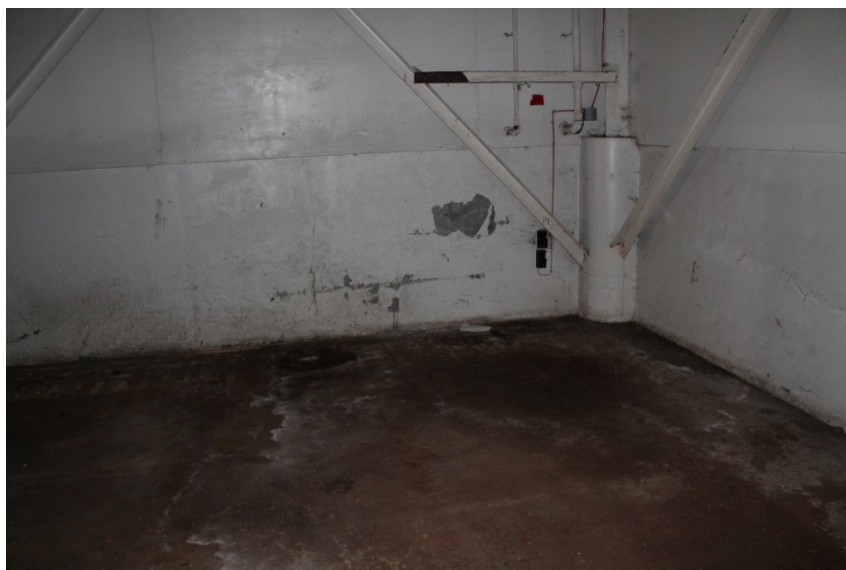
West Wall, North Corner, Past Standing Water

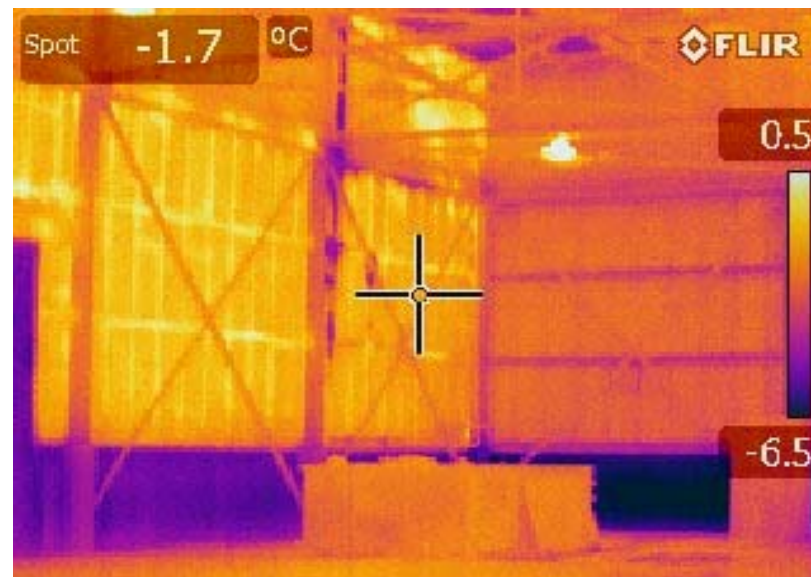
West Wall, North Corner, No Evidence of Infiltration

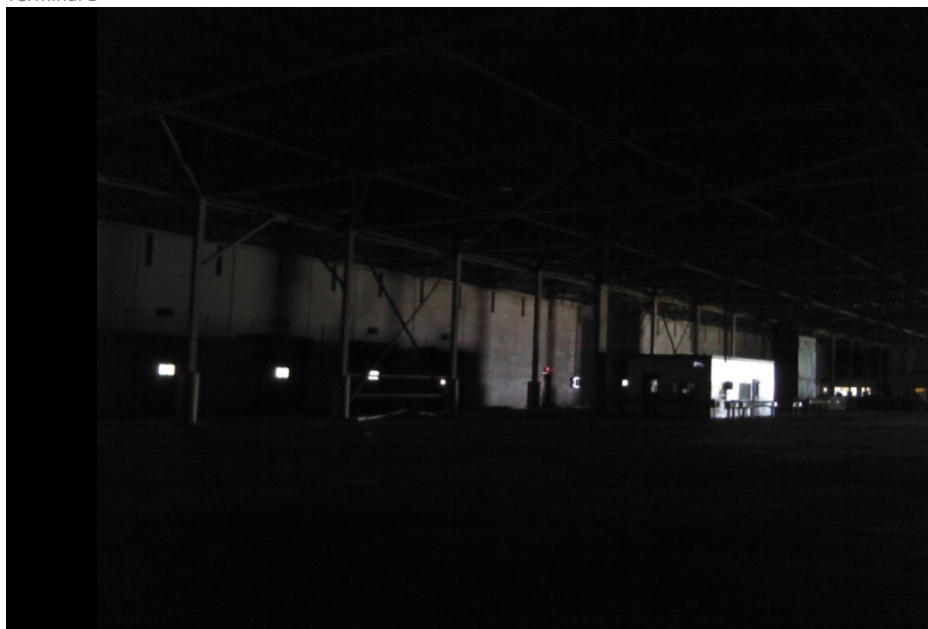
East Wall Overview

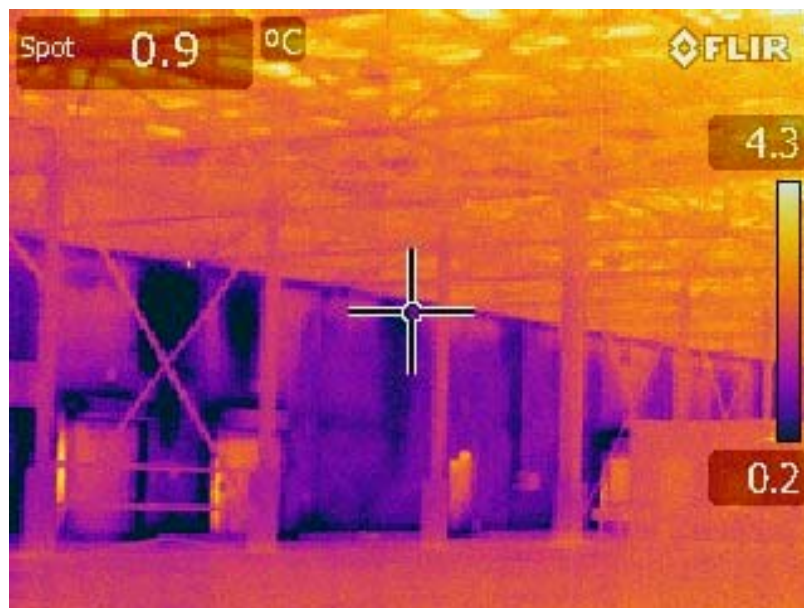
East Wall Thermal Imagery Readings, Evidence of Minor Infiltration

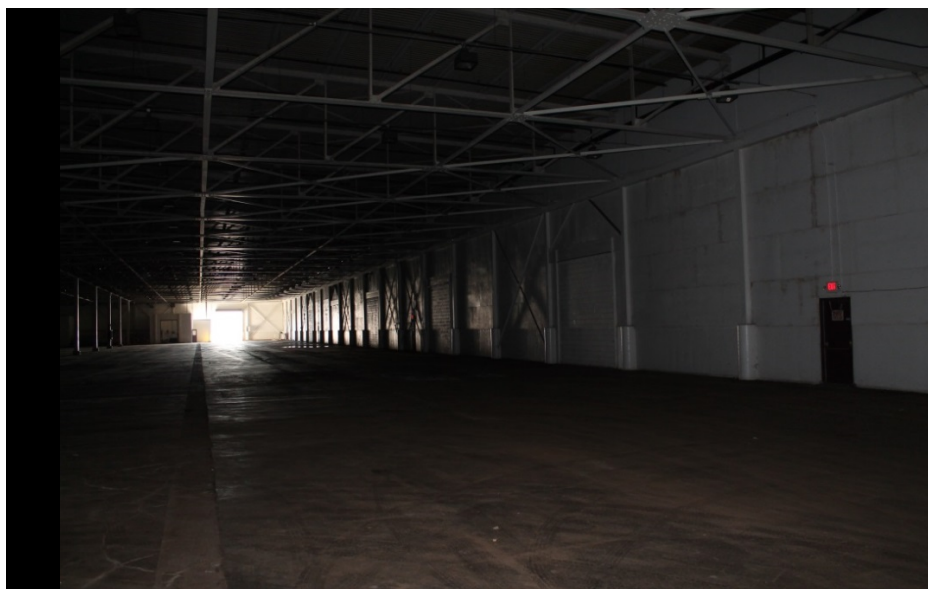
West Wall Overview Looking South

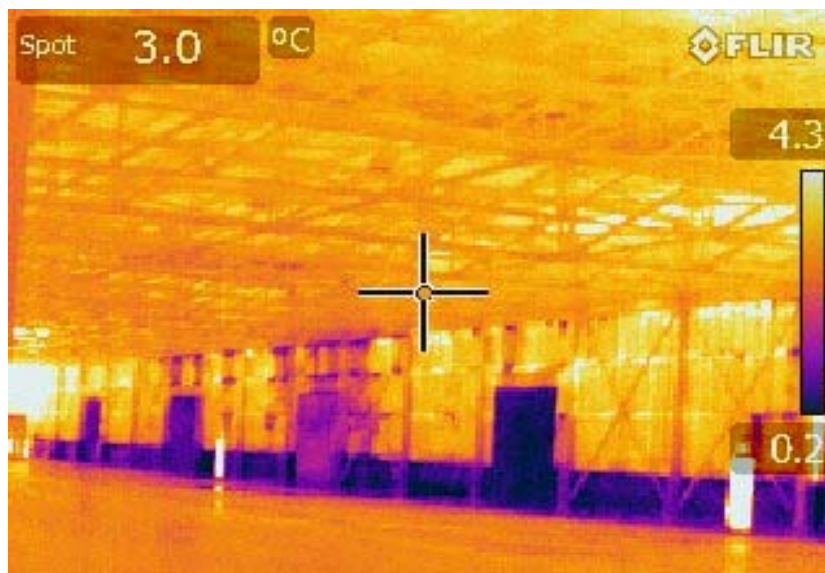
West Wall Thermal Imagery Readings, Evidence of Infiltration

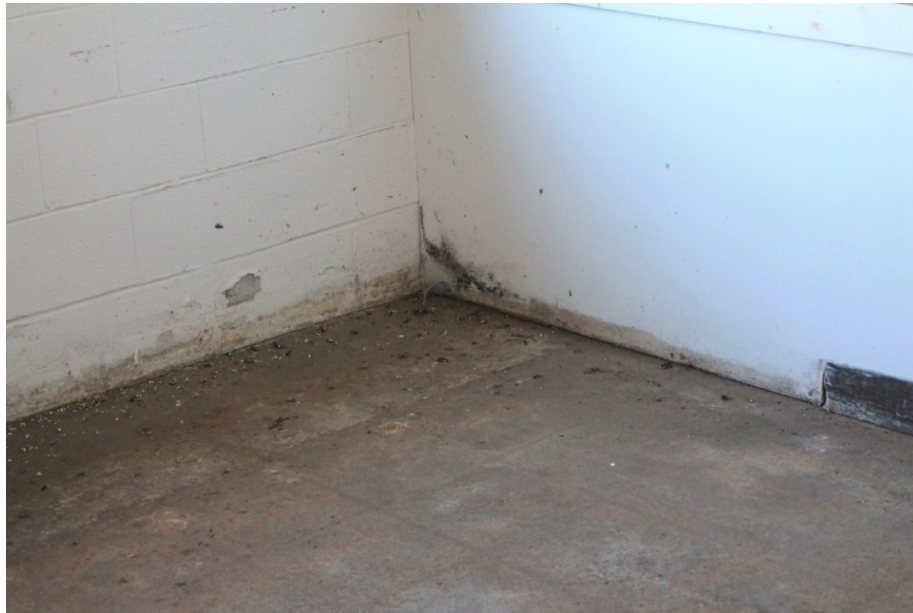
Break Room #1 Minor Mold Growth

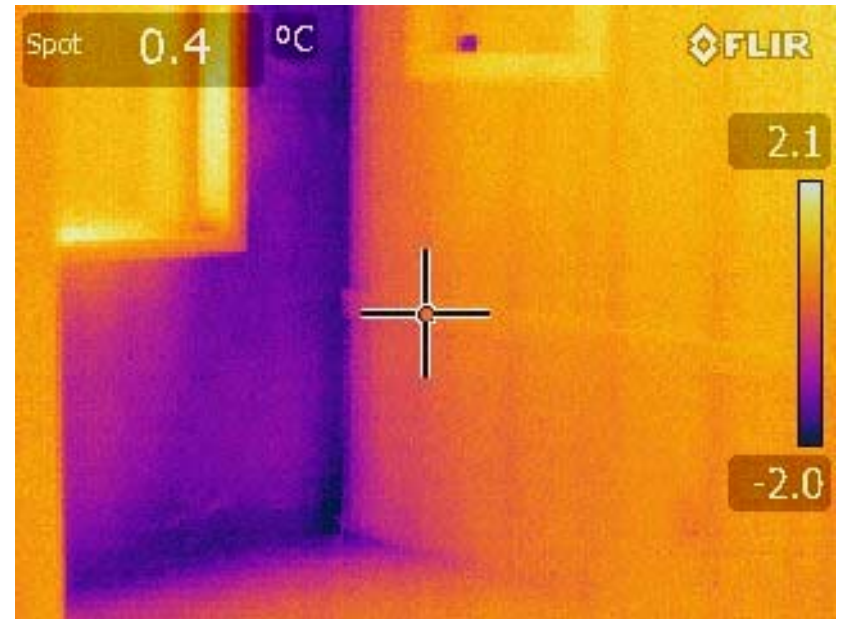
Thermal Imagery Showing Water Infiltration in Corner
