EMPIRE STATION COMPLEX

Neighborhood Conditions Study

February 2021

FOR
Empire State Development

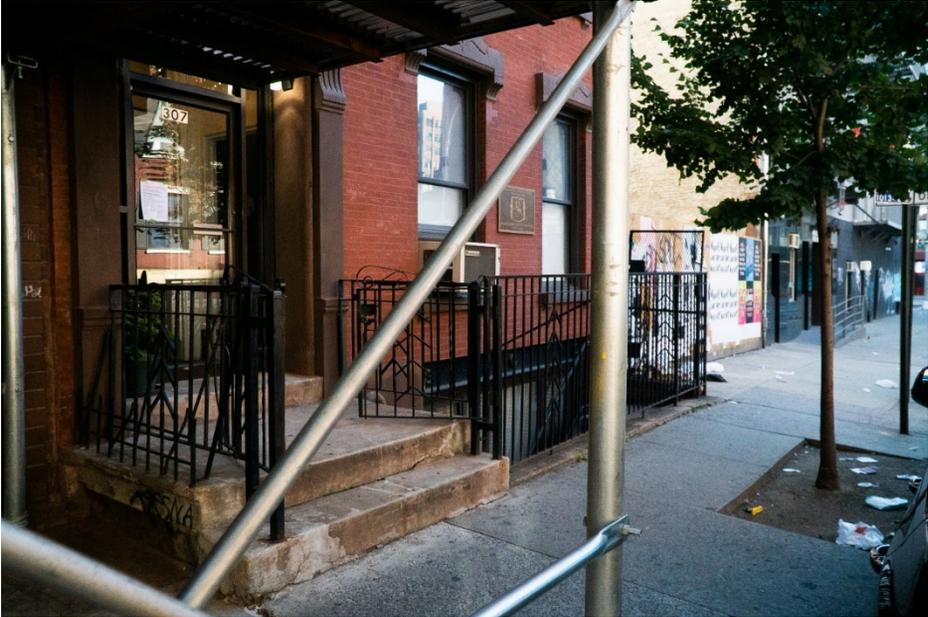
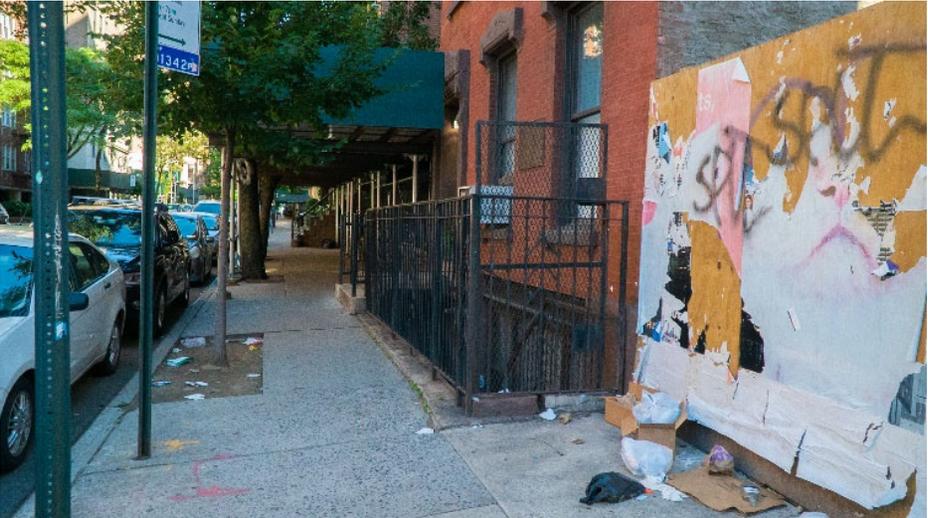
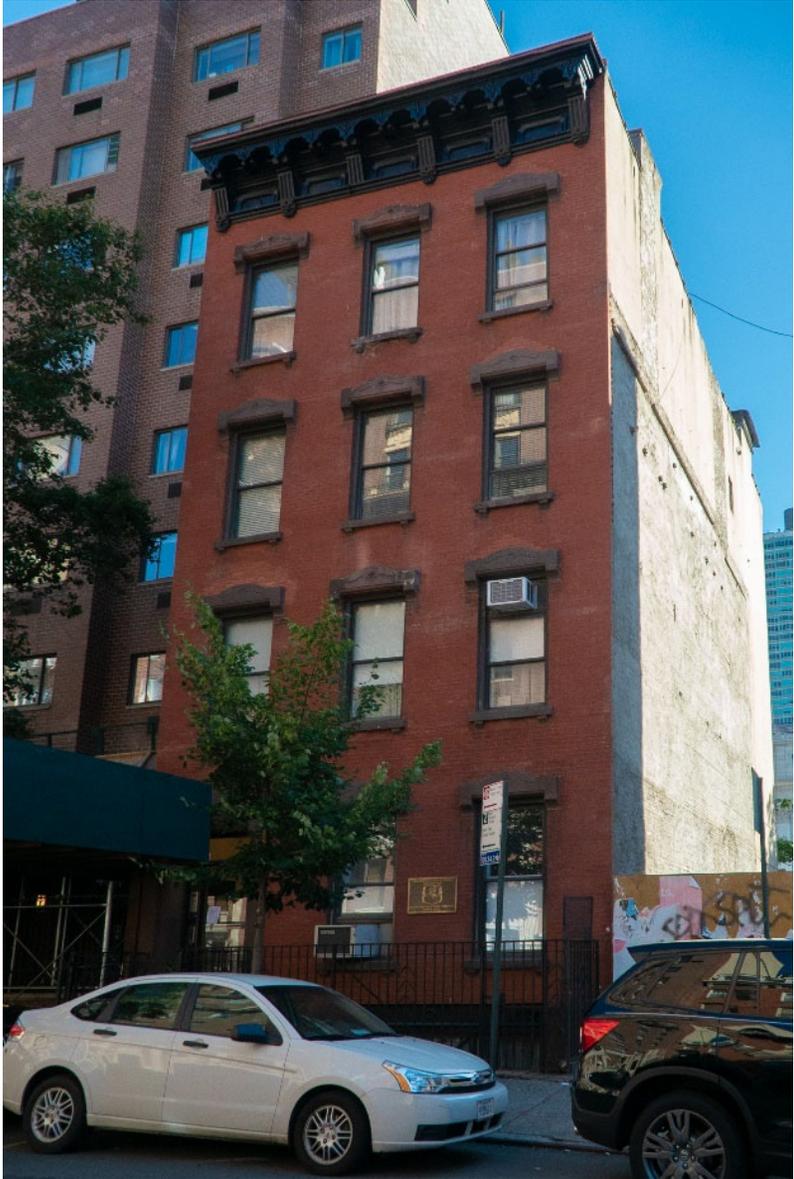
Figure 1-3 Block 754, Lot 34 Photographs

Based upon a review of the EDR database report, DOB records, and DOHMH records, there is no evidence to suggest that significant environmental concerns exist at this property. In addition, according to FDNY records, there are no tanks or violations associated with this property.

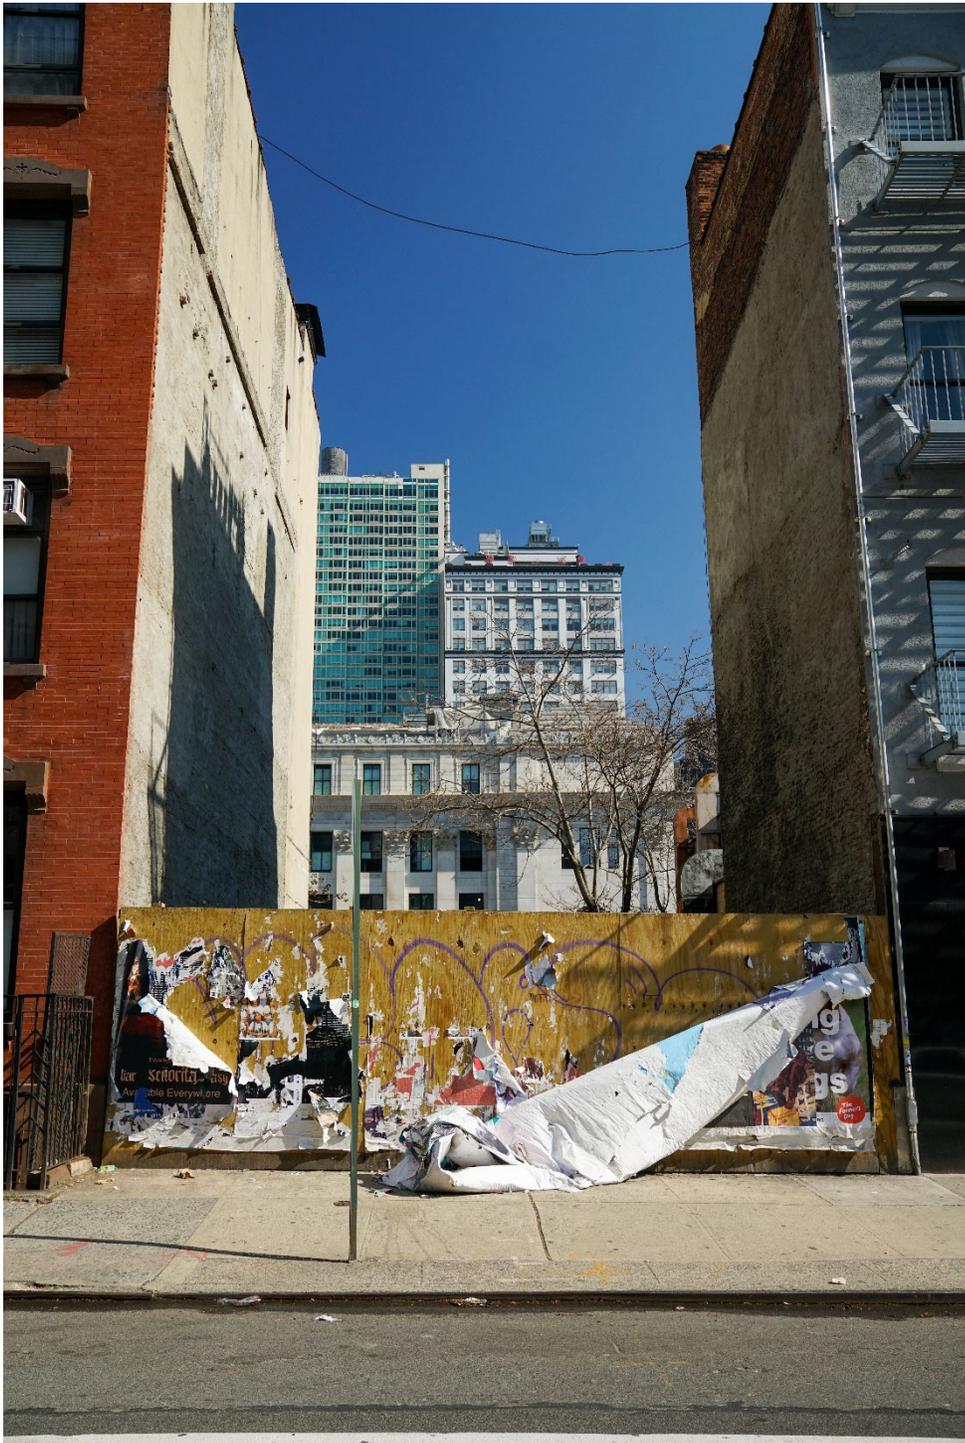
Figure 1-4 Block 754, Lot 35 Photographs

There is potential for subsurface contamination associated with the property's historic use as a gasoline service station in 2014, according to the EDR database report. In addition, no records were maintained by DOHMH, indicating that no reported insanitary conditions exist at this property. Further, according to FDNY records, there are no tanks associated with this property.

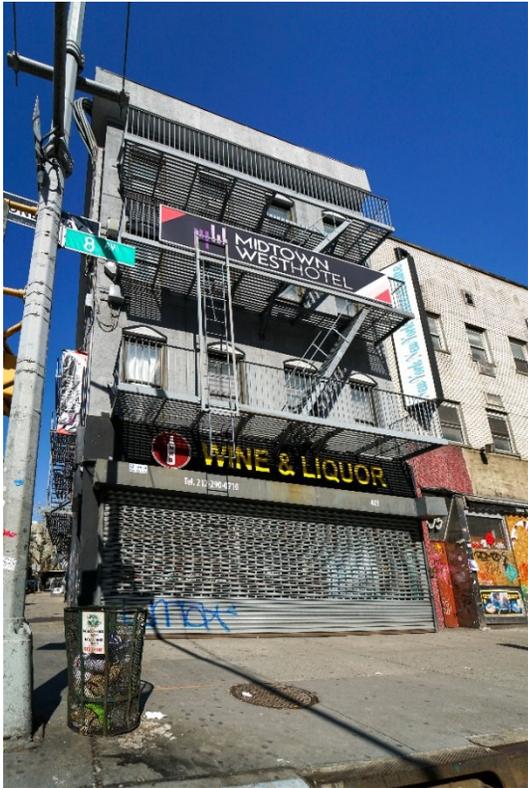
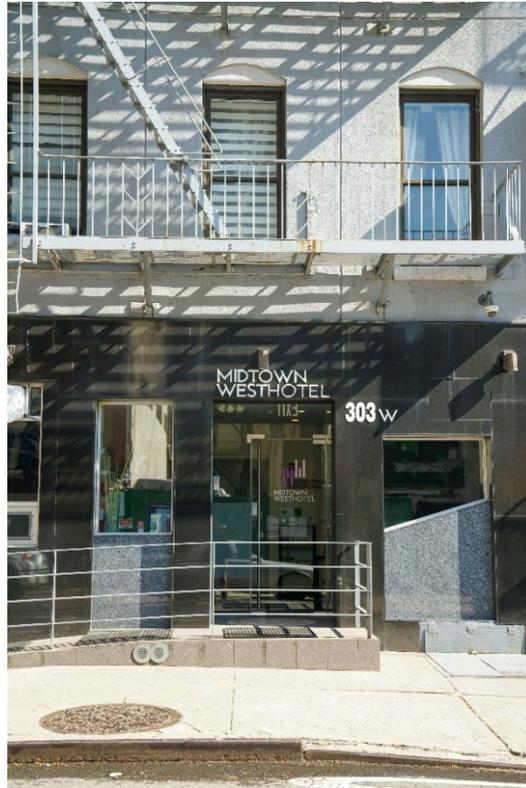
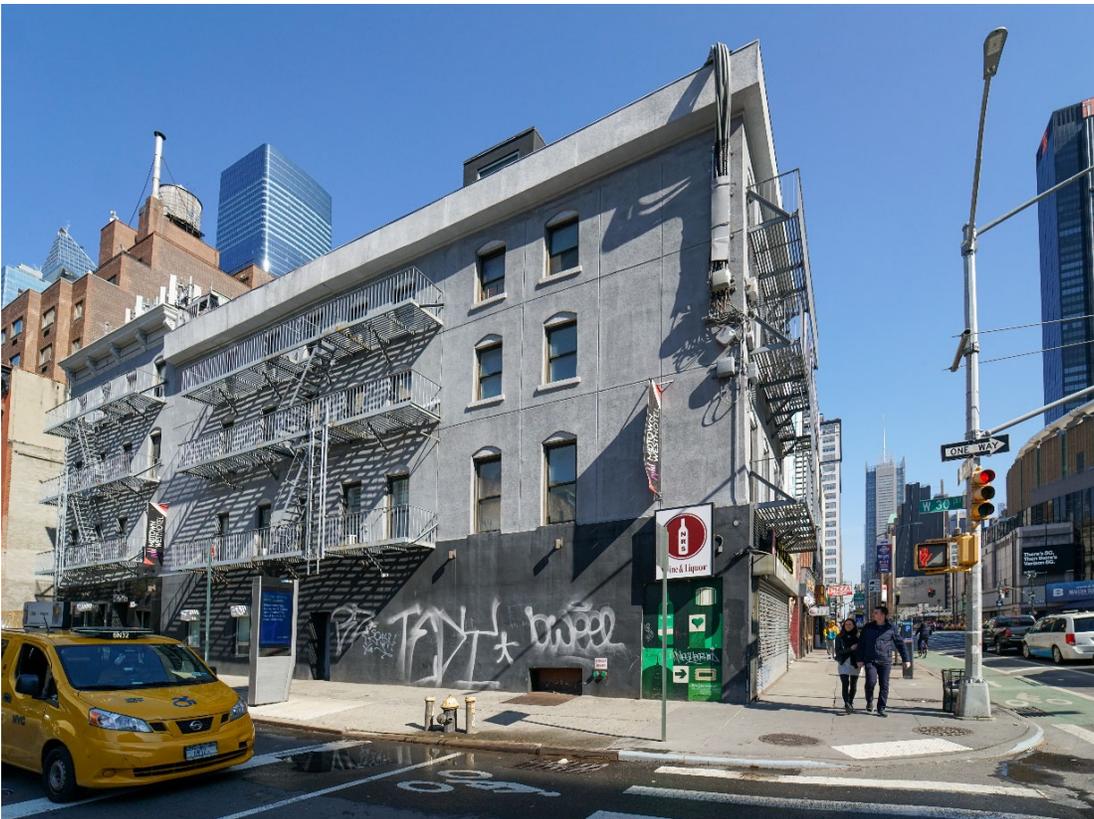
Figure 1-5 Block 754, Lot 36 Photographs

Based upon a review of the EDR database report, DOB and DOHMH records, there is no evidence to suggest that significant environmental concerns exist at this property. According to FDNY records, this property is registered with a 550-gallon fuel oil tank which was abandoned in 1994 when the property converted to natural gas.

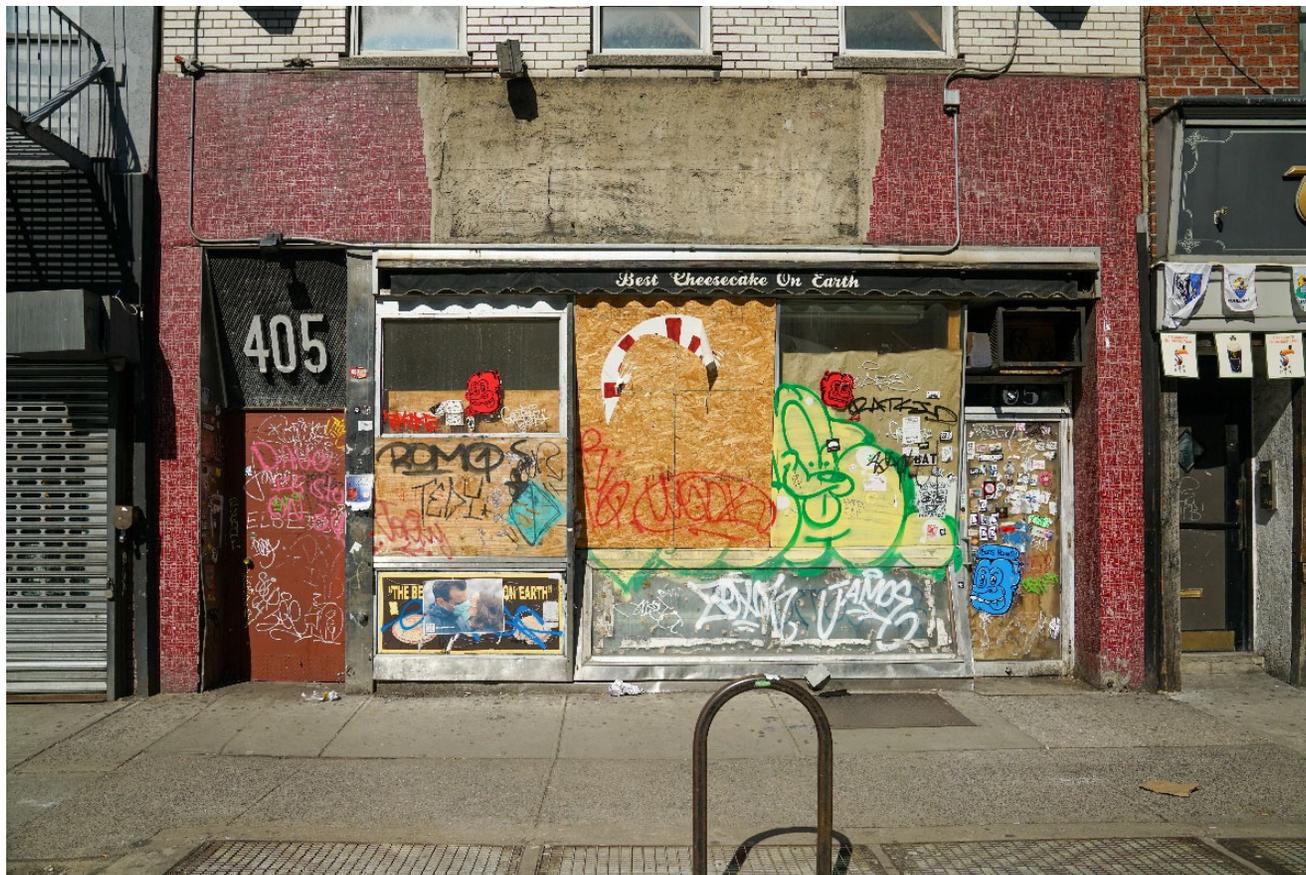
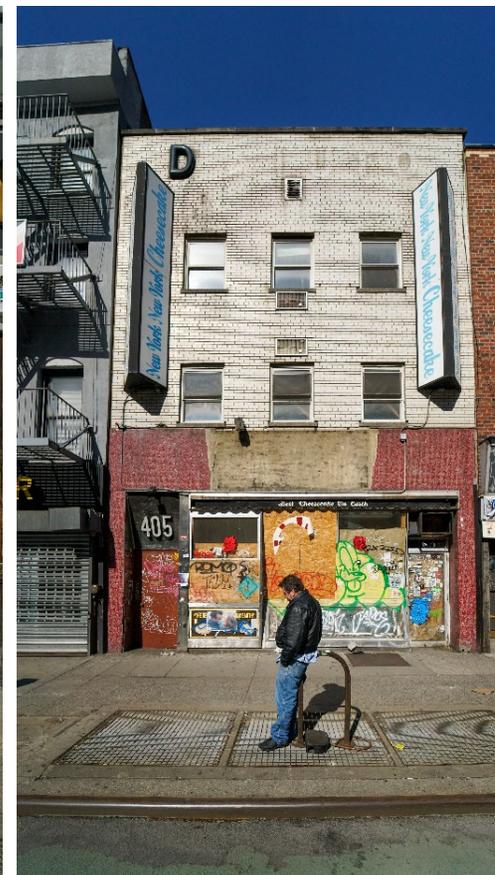
Figure 1-6 Block 754, Lot 37 Photographs

DOB records indicate suspected fuel oil storage tanks, however according to FDNY records, there are no tanks or violations associated with this property. In addition, no records were maintained by DOHMH.

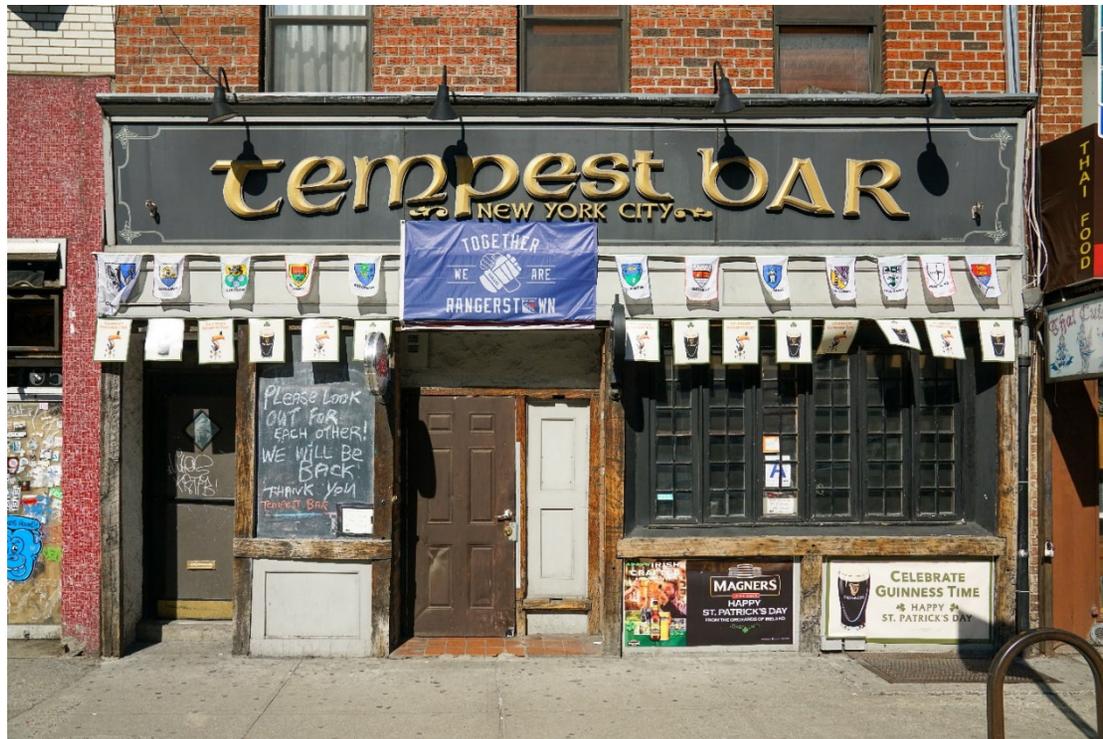
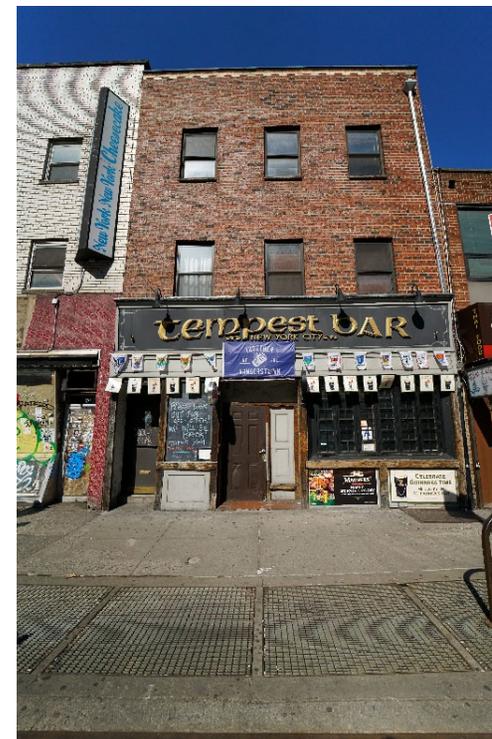
Figure 1-7 Block 754, Lot 38 Photographs

Based upon a review of the EDR database report, DOB and DOHMH records, there is no evidence to suggest that significant environmental concerns exist at this property. In addition, according to FDNY records, there are no tanks or violations associated with this property.

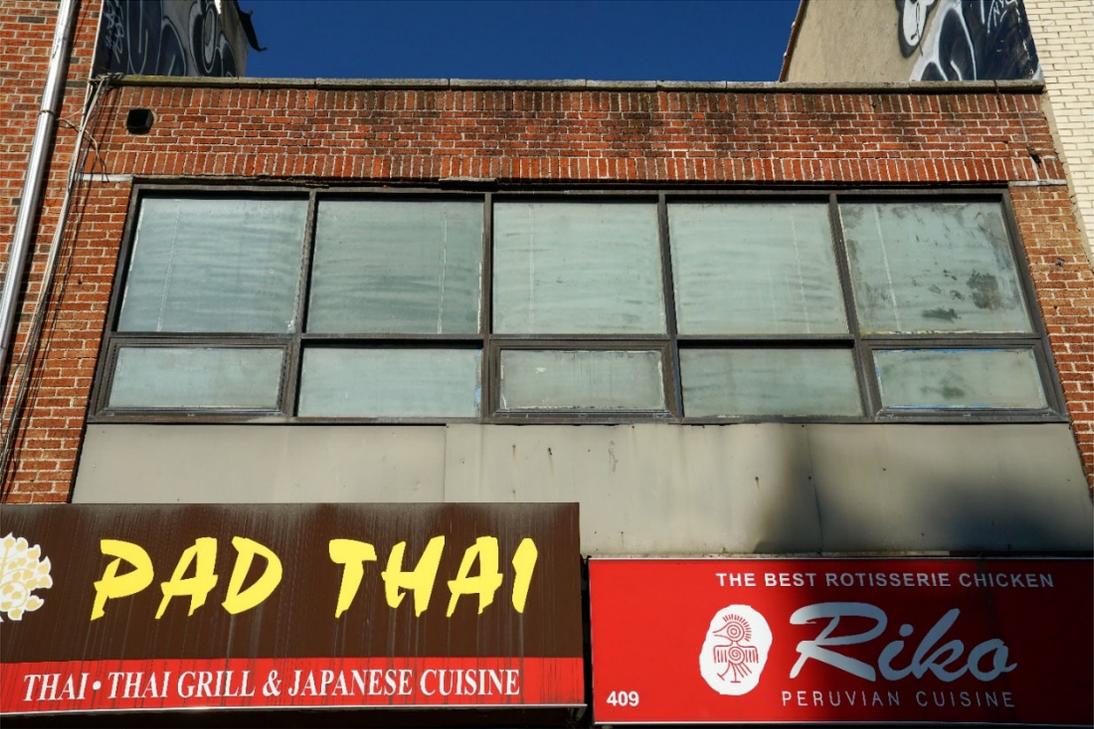
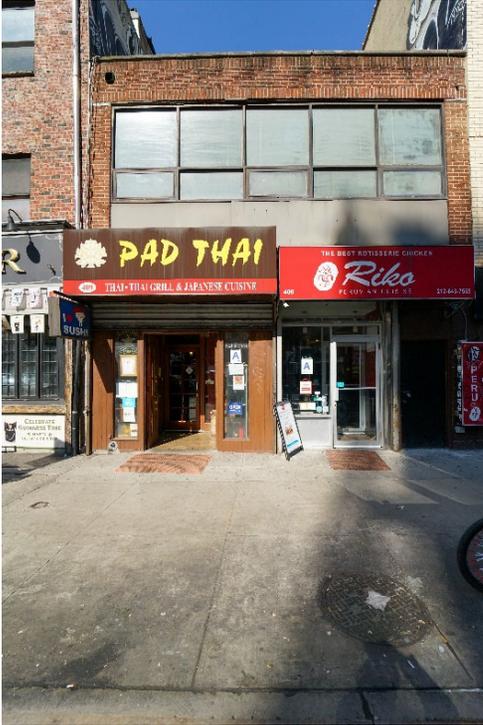
Figure 1-8 Block 754, Lot 39 Photographs

Based upon a review of the EDR database report, DOB and DOHMH records, there is no evidence to suggest that significant environmental concerns exist at this property. In addition, according to FDNY records, there are no tanks or violations associated with this property.

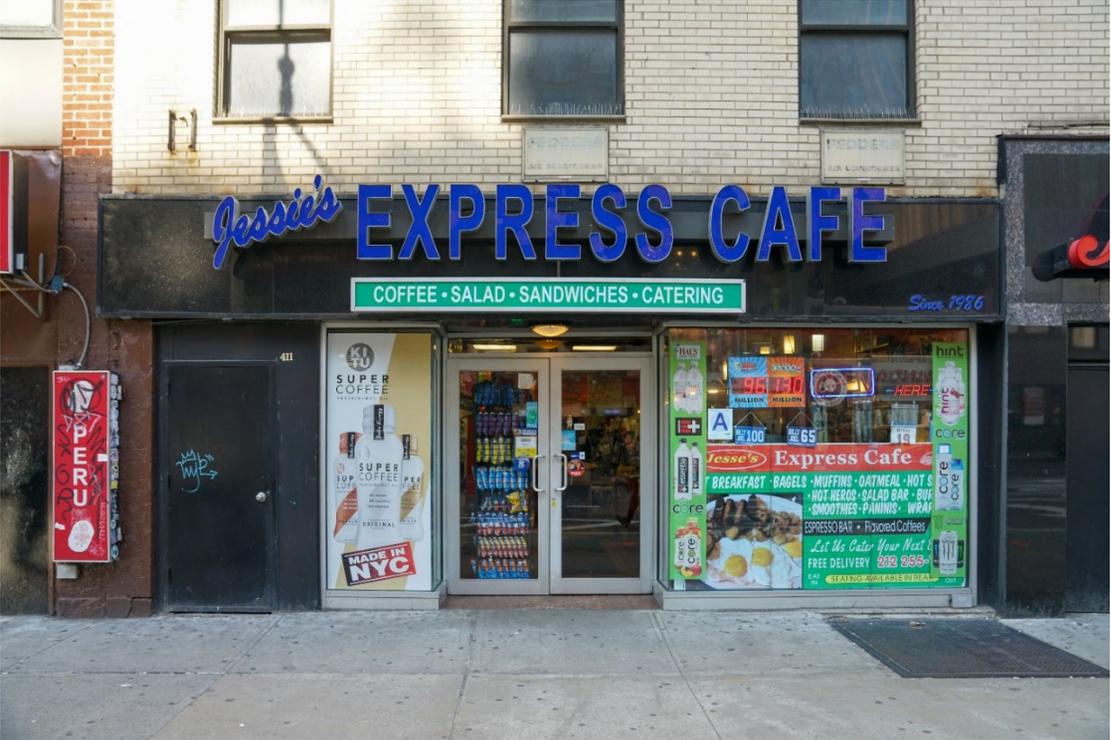
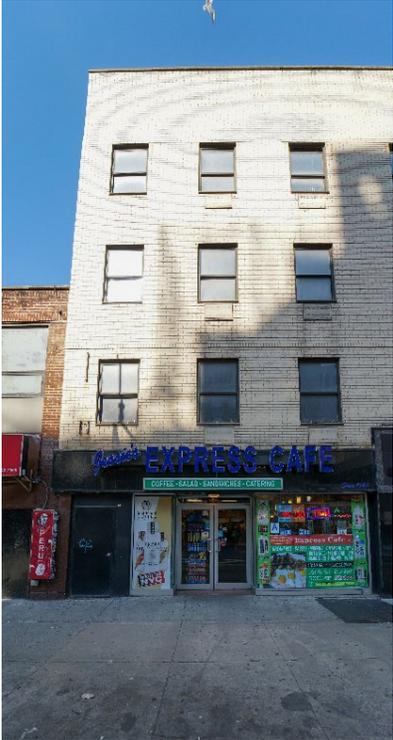
Figure 1-9 Block 754, Lot 40 Photographs

There is potential for fuel oil tanks located at this property, as indicated by DOB records. According to FDNY records, this property is registered with two (2) 275-gallon fuel oil tanks that were abandoned in 1996 when the property converted to natural gas. Further, Lot 40 was issued a violation notice in 2016 for failing to provide extinguishers within the building. In addition, no records were maintained by DOHMH.

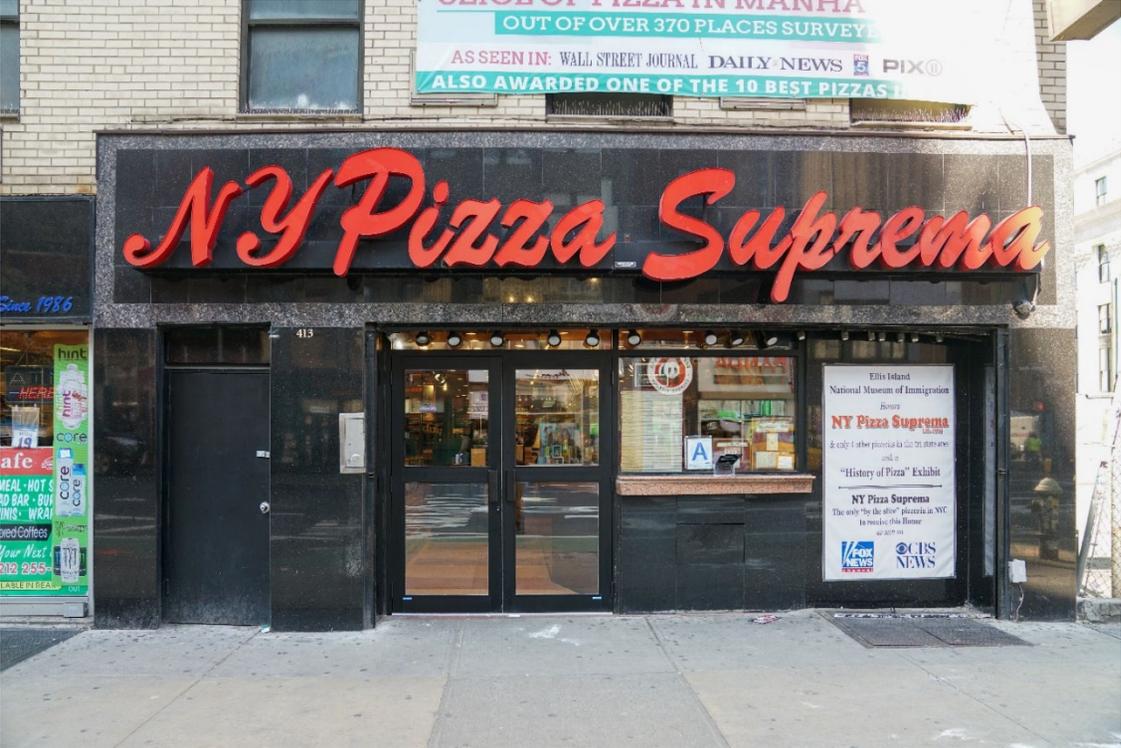
Figure 1-10 Block 754, Lot 41 Photographs

There is potential for fuel oil tanks located at this property, as indicated by DOB records however, according to FDNY records, there are no tanks or violations associated with this property. In addition, no records were maintained by DOHMH.

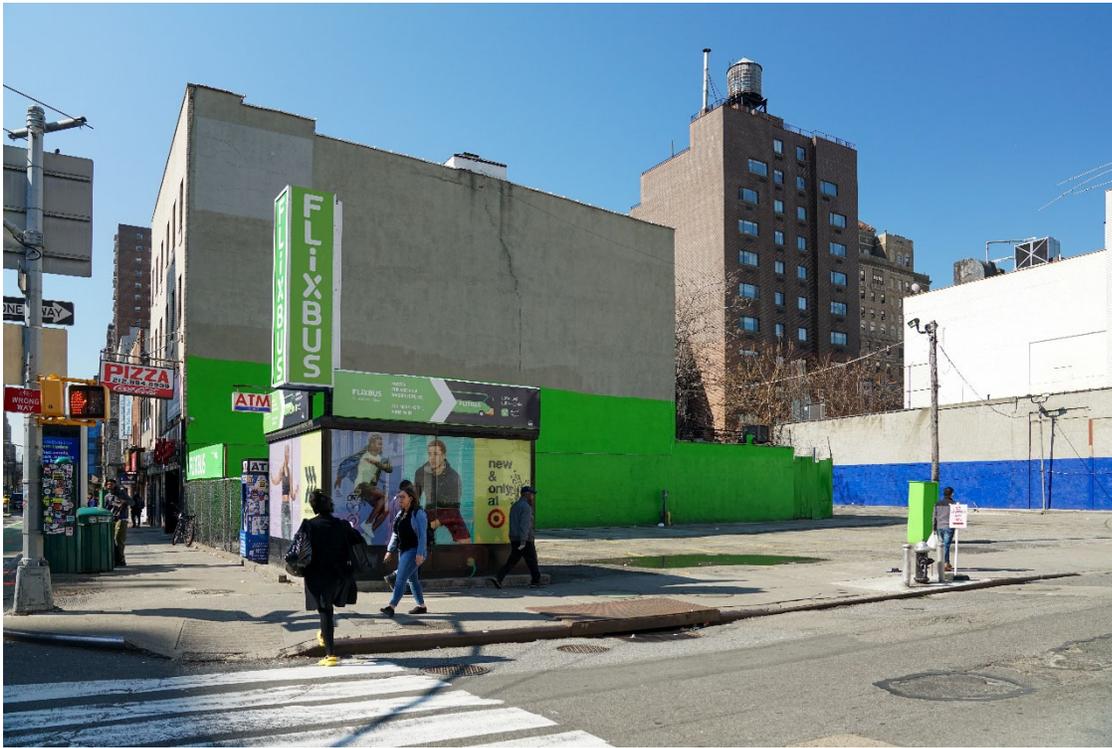
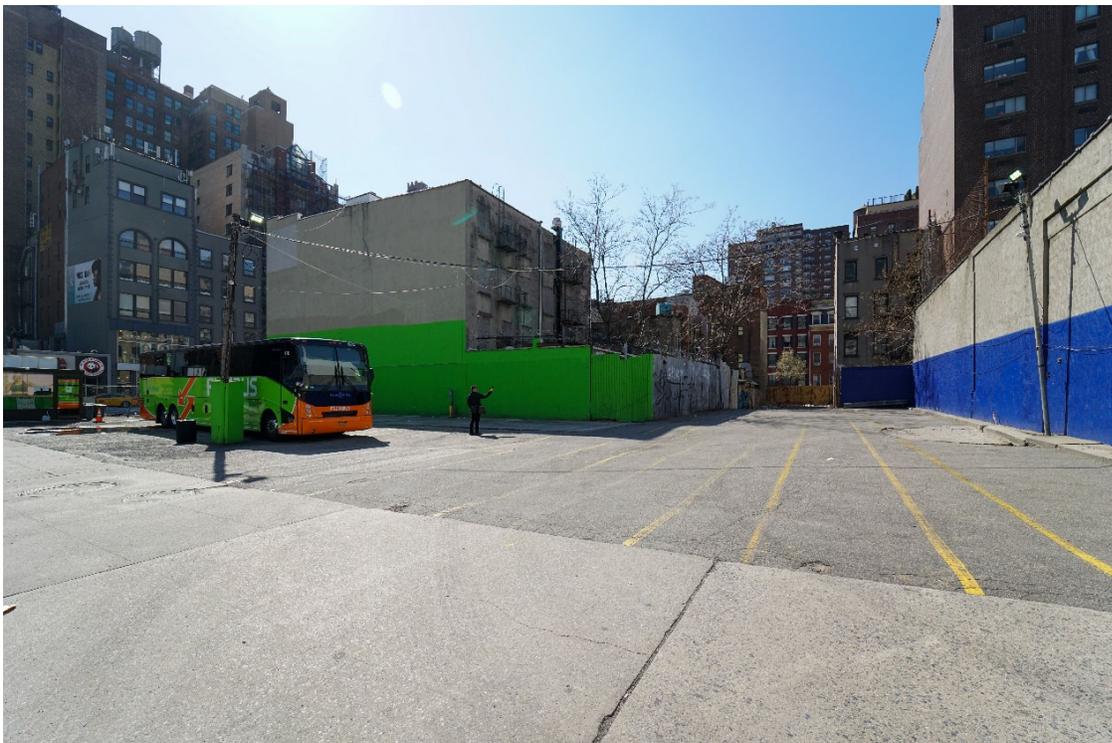
Figure 1-11 Block 754, Lot 44 Photographs

Lot 44 contains a paid parking lot with a small one-story ticket booth made of metal and glass. While there is some graffiti at the site, the structure—including its doors and windows—is in good condition. The security fence, yard surface, sidewalk, and lighting are in fair condition. The curb cuts are in poor condition with areas of cracking and crumbling. Overall, the building and site conditions were given a rating of fair condition.

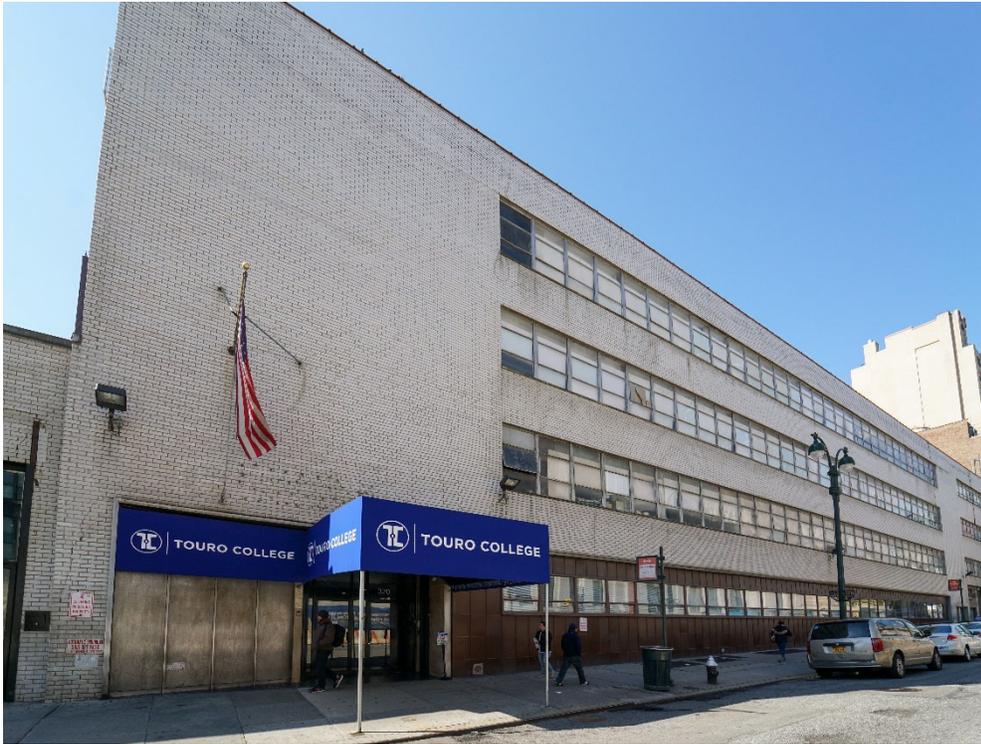
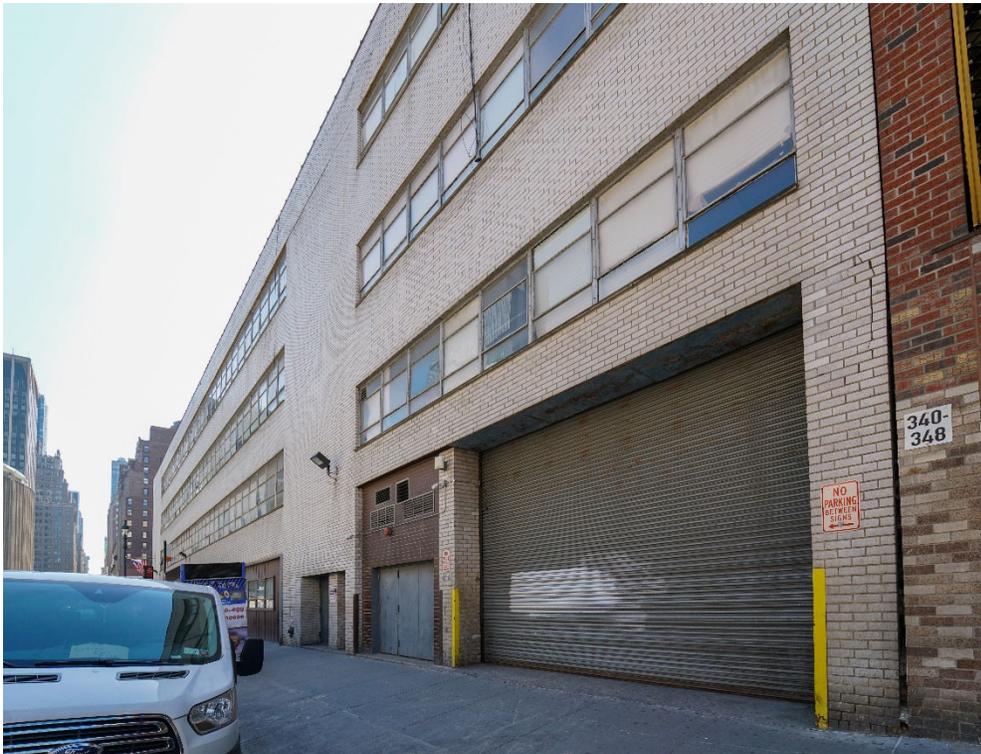
Figure 1-12 Block 754, Lot 51 Photographs

Lot 51 contains a four-story academic building. The façade is mostly exposed brick, with metal panels on the ground floor and an awning at the building entrance. The doors are in good condition. The windows show some damage and cracking but are in fair condition. The main entrance shows no barrier to accessibility. The sidewalk and curb cuts are in fair condition, with some cracking and corrosion. The building has an energy efficiency grade of B, as reported by the Mayor's Office of Sustainability. Overall, the building and site conditions were given a rating of good condition.

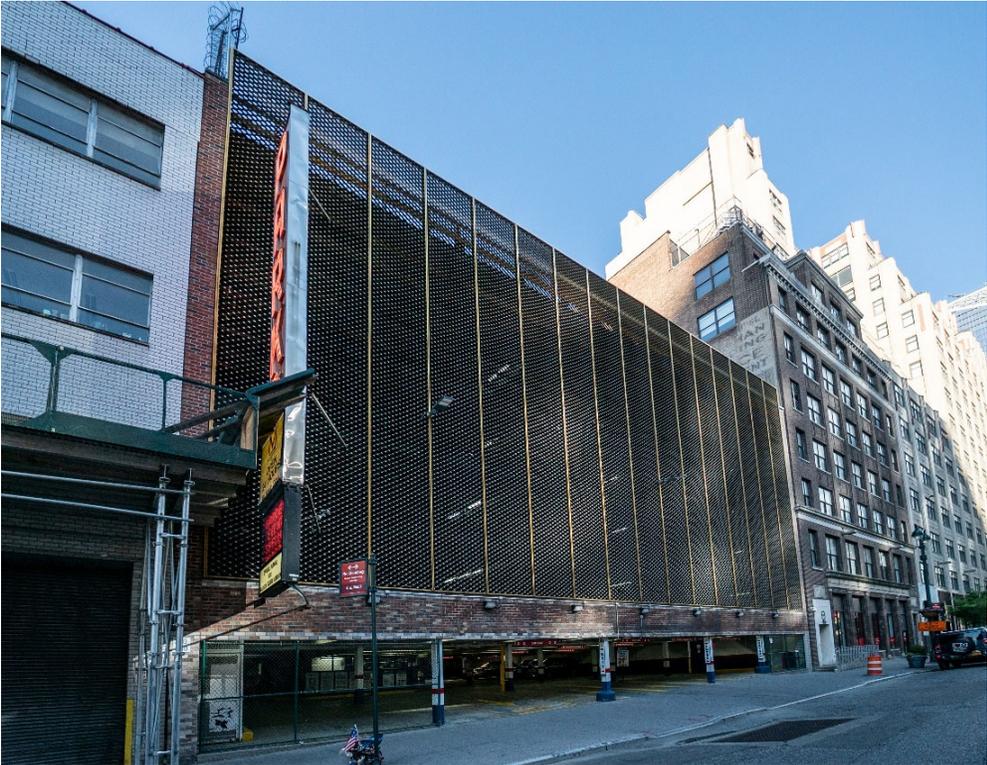
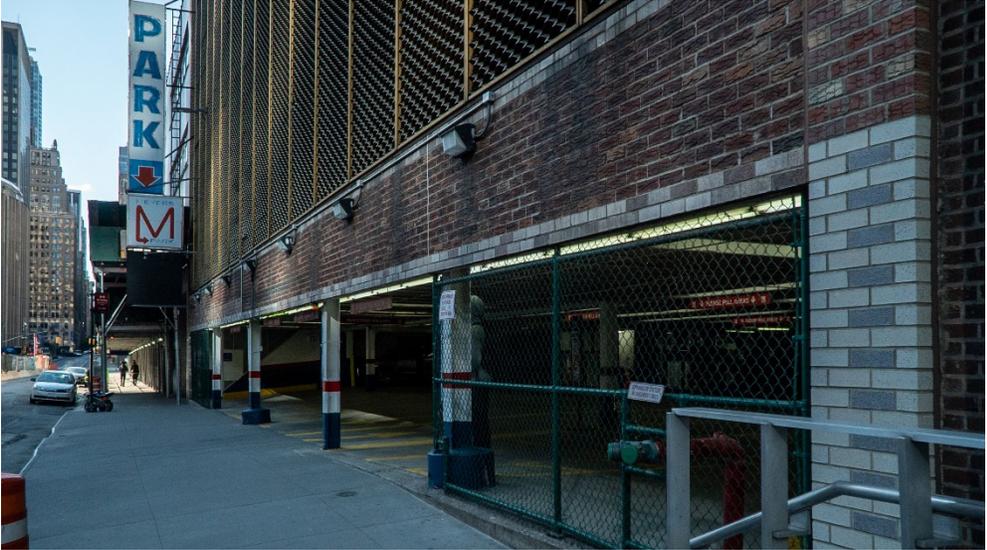
Figure 1-13 Block 754, Lot 63 Photographs

Lot 63 has an eight-story parking garage building. The building is ADA accessible at its entry. The façade consists of bricks and metal. The exterior walls and windows are in good condition, while the gate is in fair condition with moderate corrosion and staining. The sidewalk and curb cuts are in fair condition with minor cracks, stains and debris. Overall, the building and site conditions were given a rating of good condition.

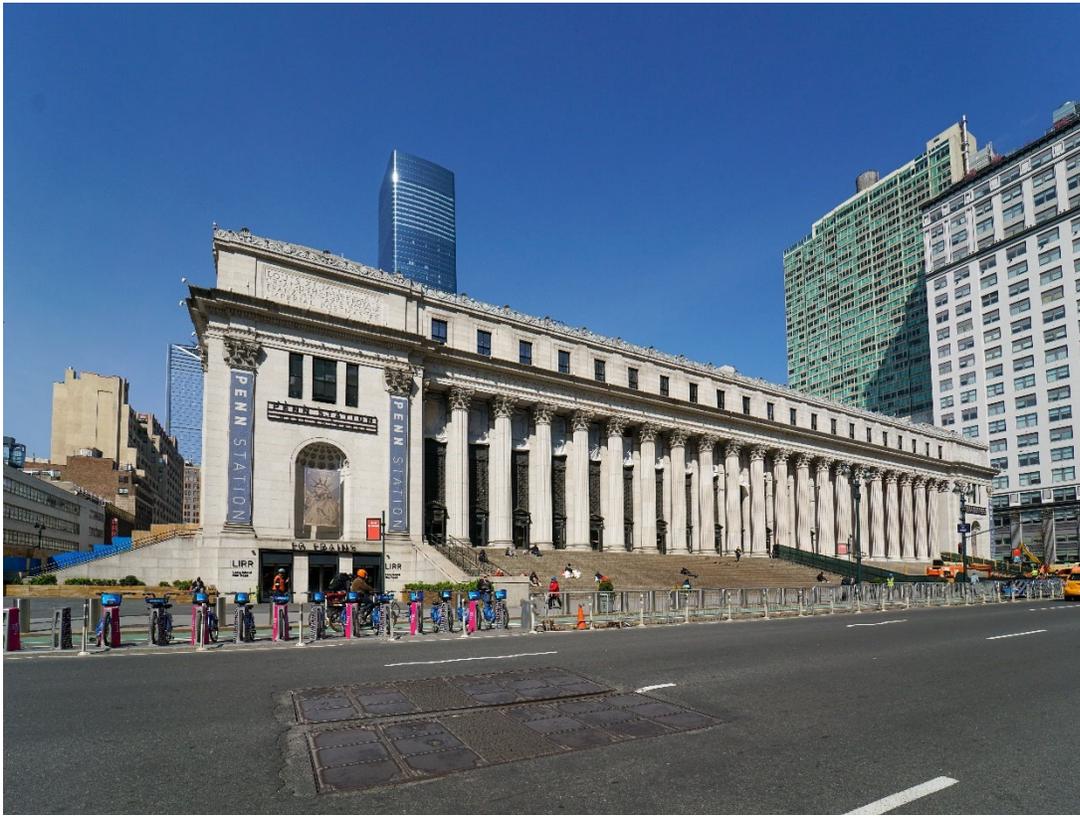
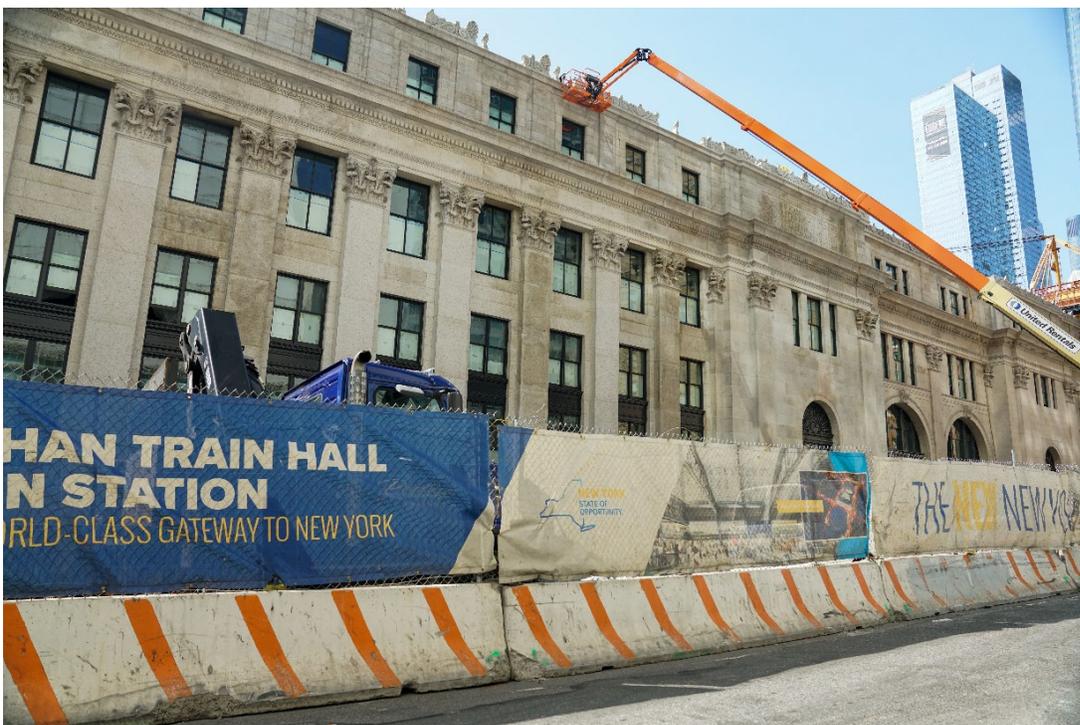
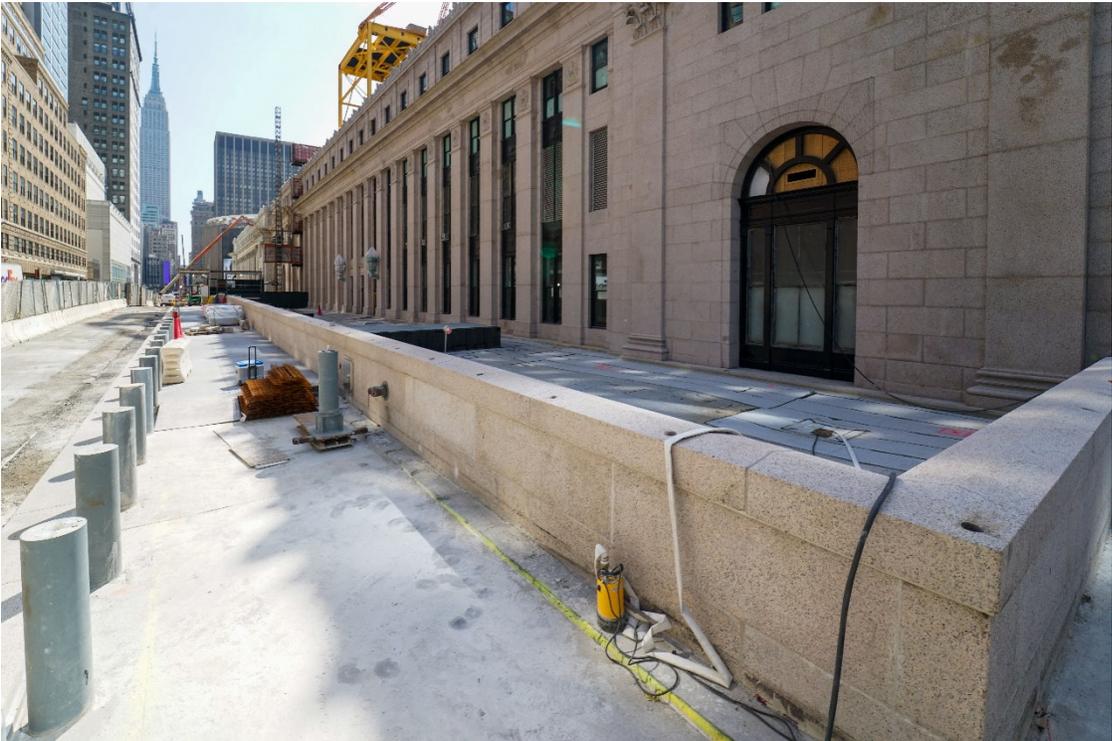
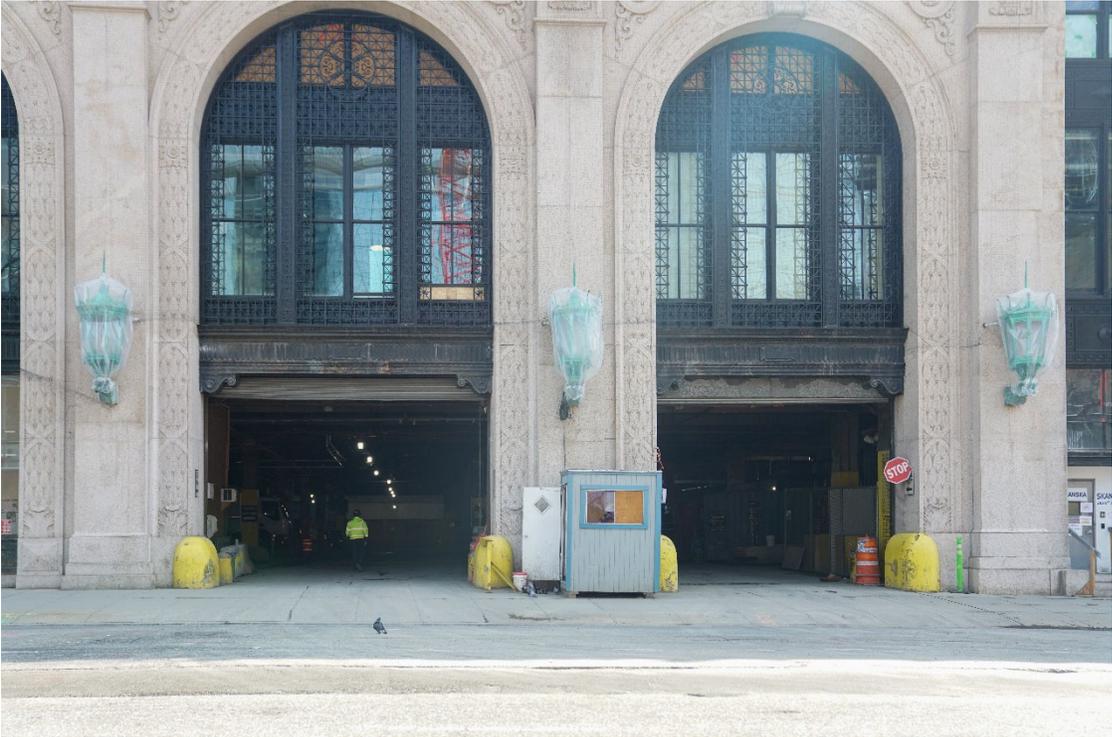
Figure 1-15 Block 755, Lot 40 Photographs

The building on Lot 40 occupies the entire block. It is five-stories and contains entrances to Pennsylvania Station at its southeast and northeast corners. It also functions as a post office. The building's façade, doors, and windows are all in good condition. The sidewalk and curb cuts are in good condition on the east side of the building. However, elsewhere they are in fair condition, with some cracking and crumbling. A portion of the sidewalk is under construction. Overall, the building and site conditions were given a rating of good condition.

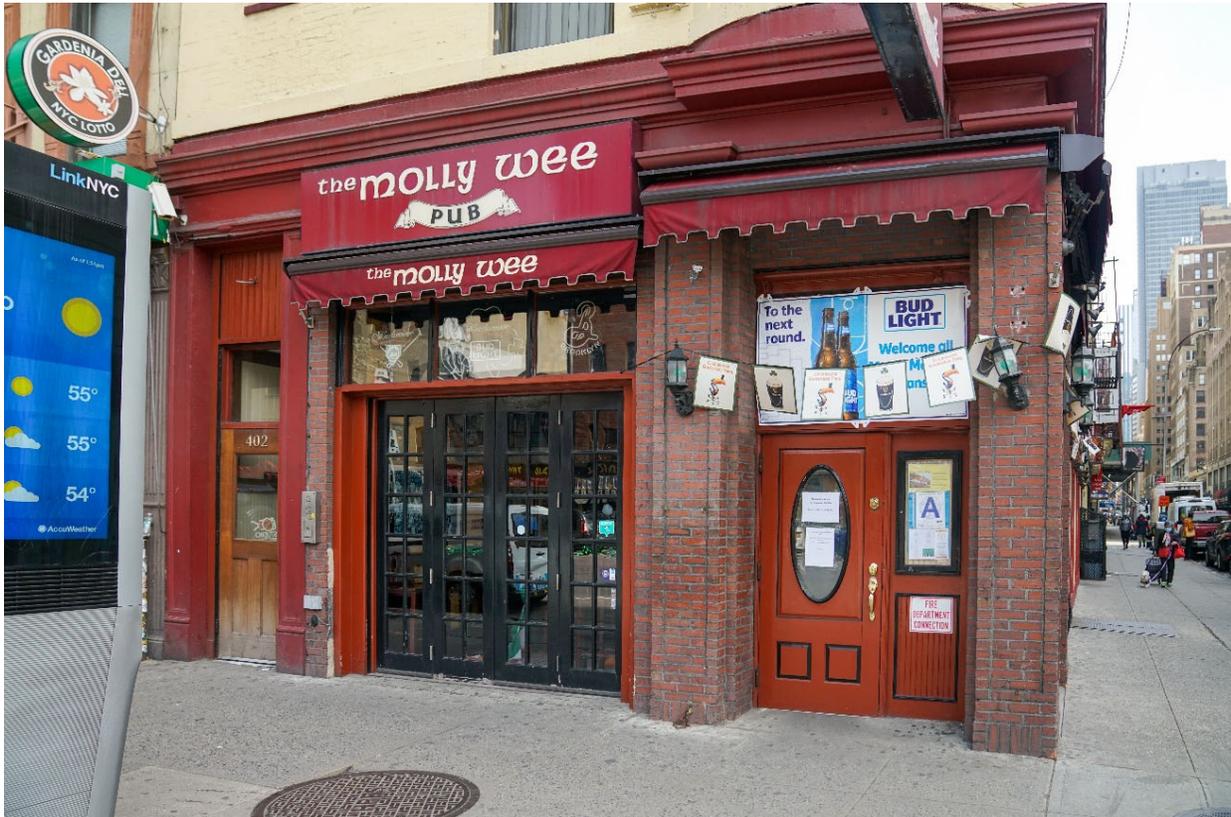
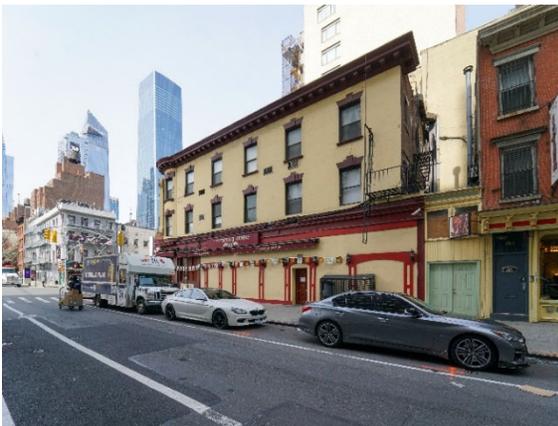
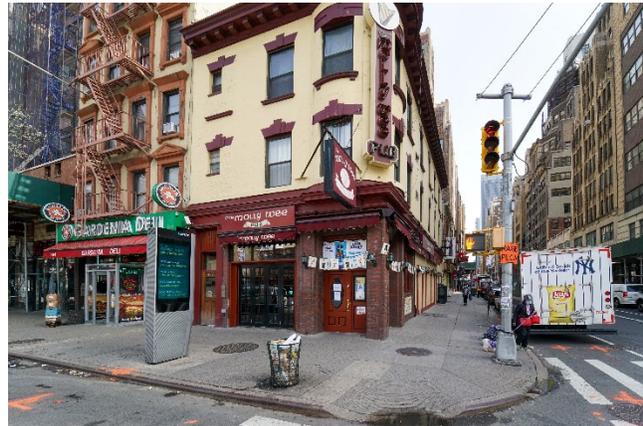
Figure 1-17 Block 780, Lot 1 Photographs

Lot 1 contains a three-story building with retail on the ground floor and residential units on the upper floors. The façade consists of brick, wood, and stucco on the ground floor and brick and wood on the upper floors. The exterior walls are in fair condition, showing minor peeling and cracking of the paint. Windows and doors are intact, with minor corrosion on one of the doors that leads to the upper apartments. Sidewalk and curb cuts are in fair condition, with minor cracking, staining, and debris. The building shows no barrier to accessibility at the entry level. Overall, the building and site conditions were given a rating of good condition.
