EMPIRE STATION COMPLEX

Neighborhood Conditions Study

February 2021

FOR
Empire State Development

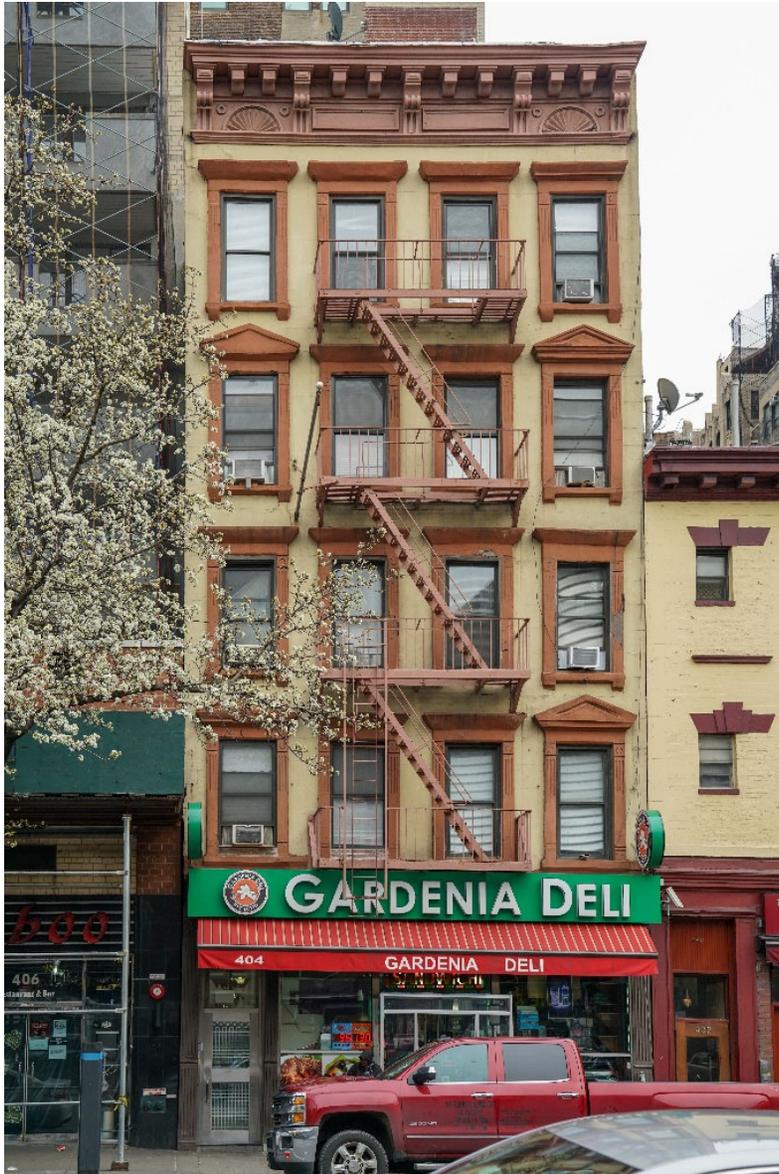
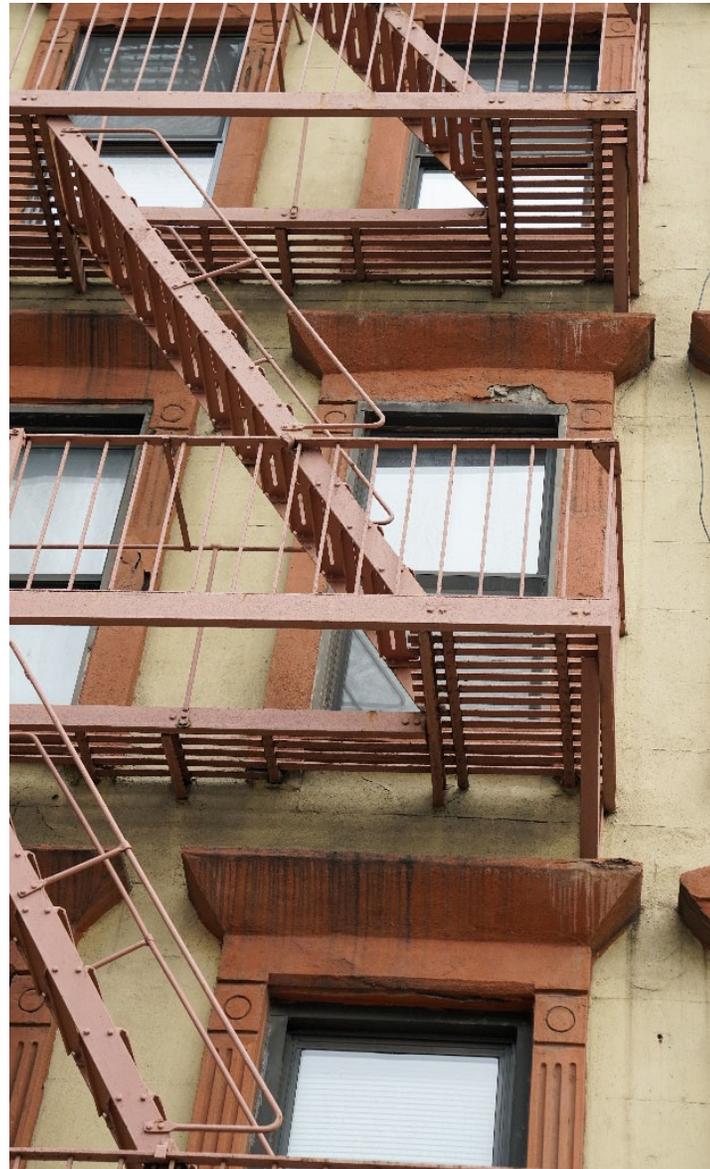
Figure 1-18 Block 780, Lot 2 Photographs

Lot 2 contains a five-story building, with retail on the ground floor and residential uses on the upper floors. The façade consists of wood and glass at the ground floor, and wood and stucco on the upper floors. The exterior wall is in fair condition, with minor cracks in the painted wall and window lintels. Windows and doors are in good condition. Sidewalk and curb cuts show minor cracking, staining, and debris. The building shows no barrier to ADA accessibility at the ground-floor entrance. Overall, the building and site conditions were given a rating of good condition.

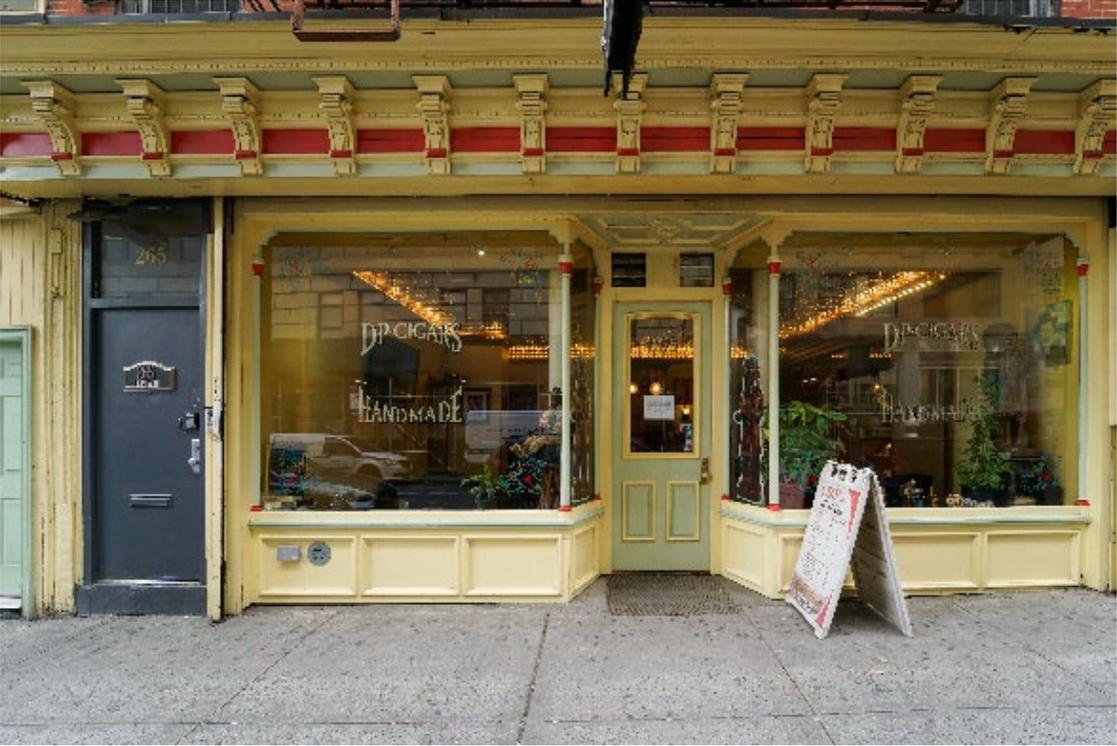
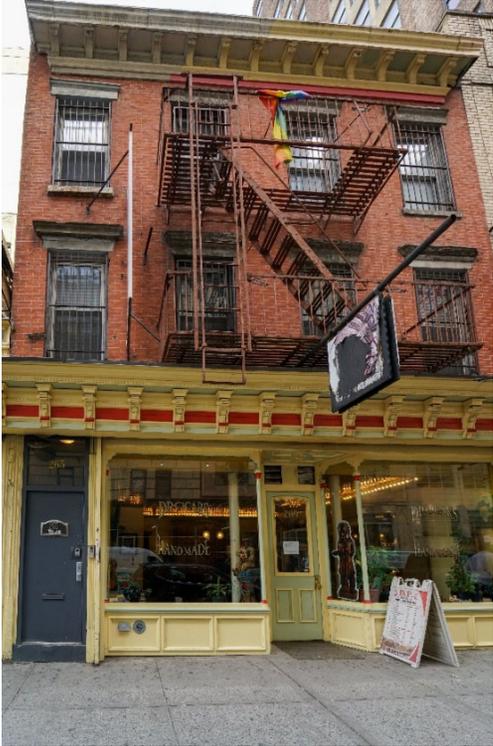
Figure 1-19 Block 780, Lot 5 Photographs

Lot 5 contains a three-story building, with retail at street level and residential uses on the upper floors. The façade consists of painted wood and glass on the ground floor and brick and wood on the upper floors. The exterior wall is in a fair condition, with minor corrosion and cracks in the paint on the window lintels. Windows and doors are intact and undamaged. The sidewalk is in fair condition, showing minor cracking, staining, and debris. The ground floor retail entrance shows no barrier to accessibility, but the door accessing the upper floors is not accessible due an existing step at its entry. Overall, the building and site conditions were given a rating of good condition.

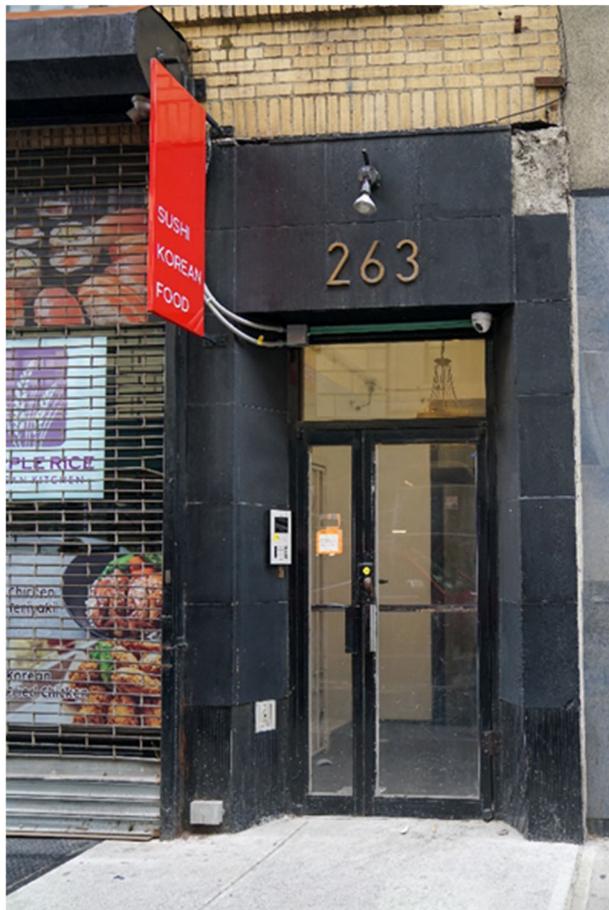
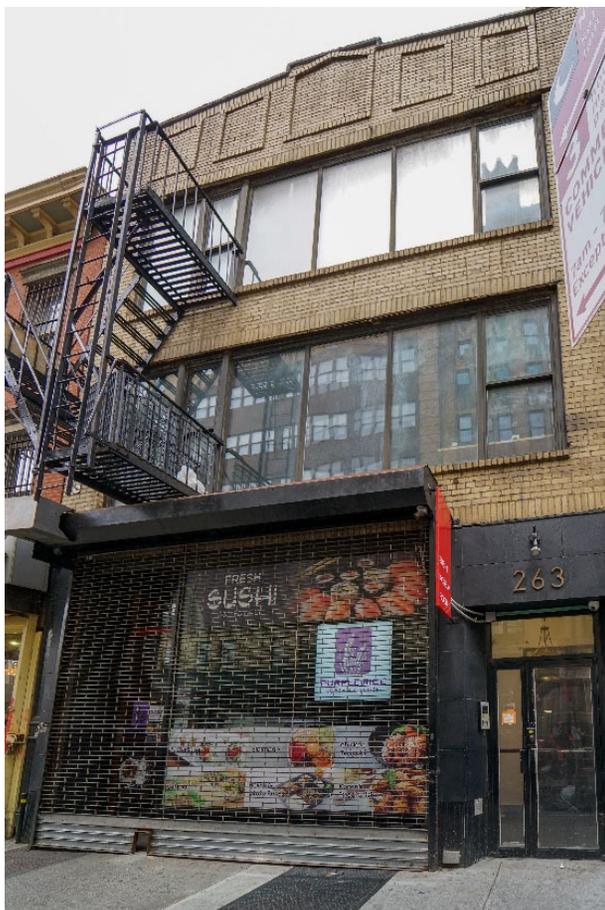
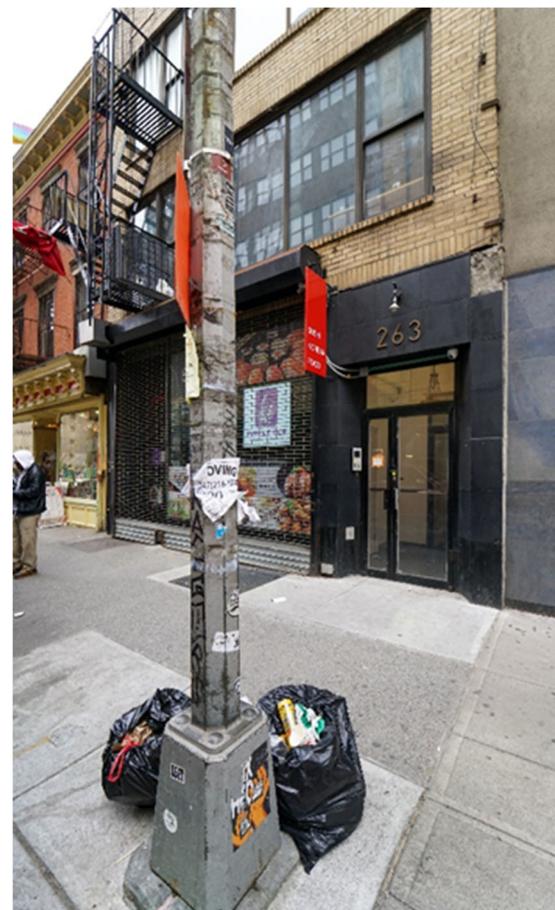
Figure 1-20 Block 780, Lot 6 Photographs

Lot 6 contains a three-story building, with retail at street level and residential uses on the upper floors. The façade consists of a stone-tile and glass storefront on the ground floor and brick, metal, and glass on the upper floors. The exterior wall is in poor condition, with a missing stone tile, moderate corrosion, and stains. Windows are also in poor condition, with heavy corrosion showing on their frames. The doors are in fair condition with moderate stain. Currently, the first-floor façade has a rolled down security gate that is in fair condition. The sidewalk is in fair condition, showing minor cracking and staining. The building shows no barrier to accessibility at the street-level entry. Overall, the building and site conditions were given a rating of fair condition.

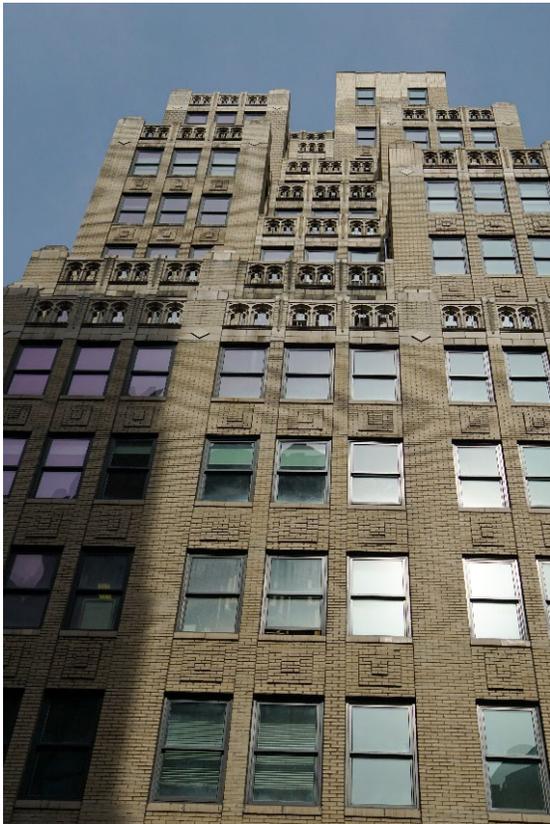
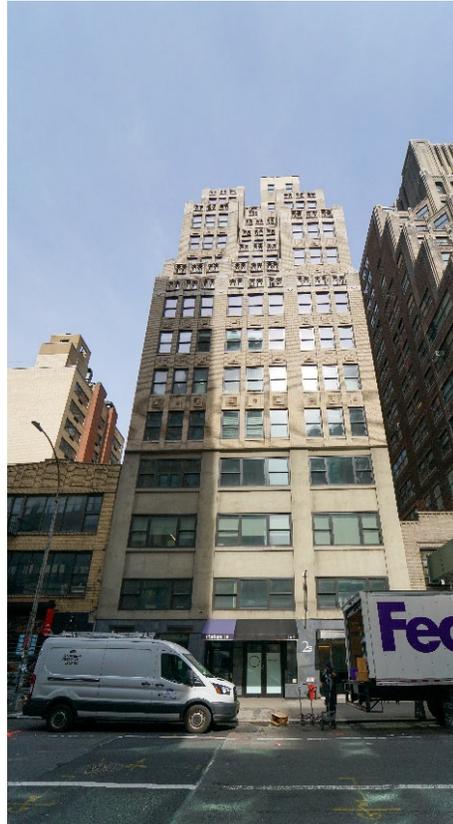
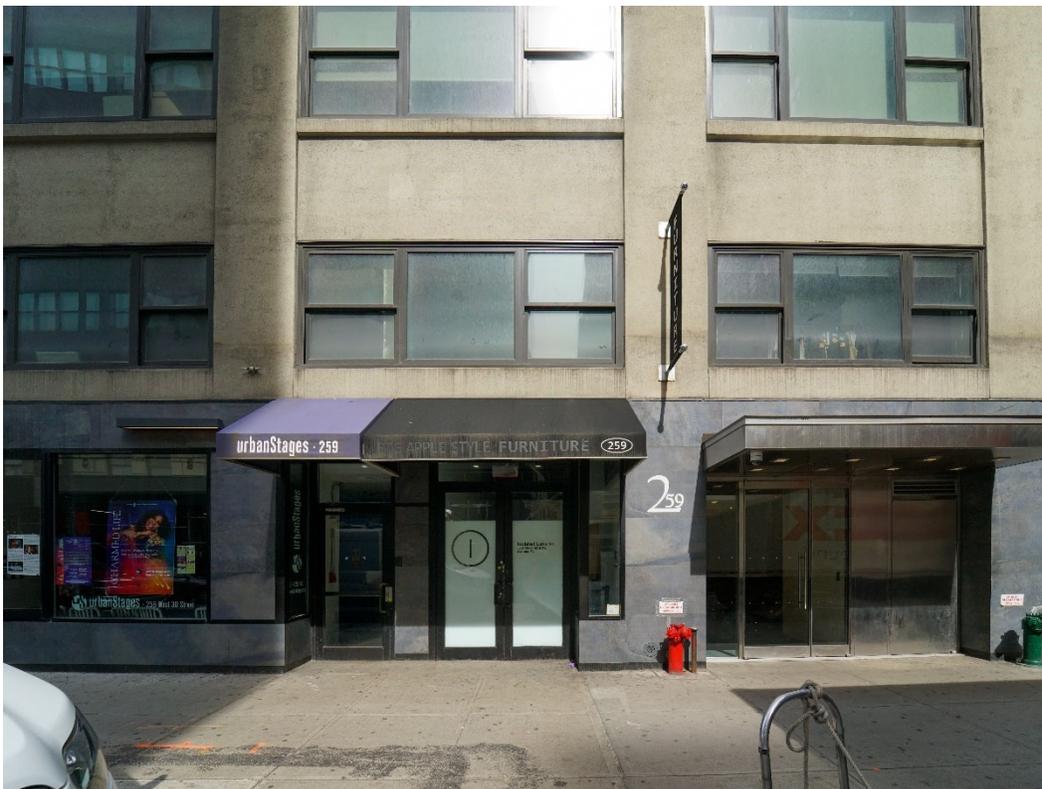
Figure 1-21 Block 780, Lot 7 Photographs

Lot 7 contains a 17-story building, with retail at the ground floor and office space on the upper floors. The façade consists of stone tiles on the ground floor and brick and stone on the upper floors. The exterior wall, windows, and doors are in fair condition, showing moderate staining. The sidewalk is in fair condition, with minor cracking, staining, and debris. The building has an energy efficiency grade of C, as reported by the Mayor's Office of Sustainability. The building shows no barrier to accessibility at the ground-floor entrance. Overall, the building and site conditions were given a rating of good condition.

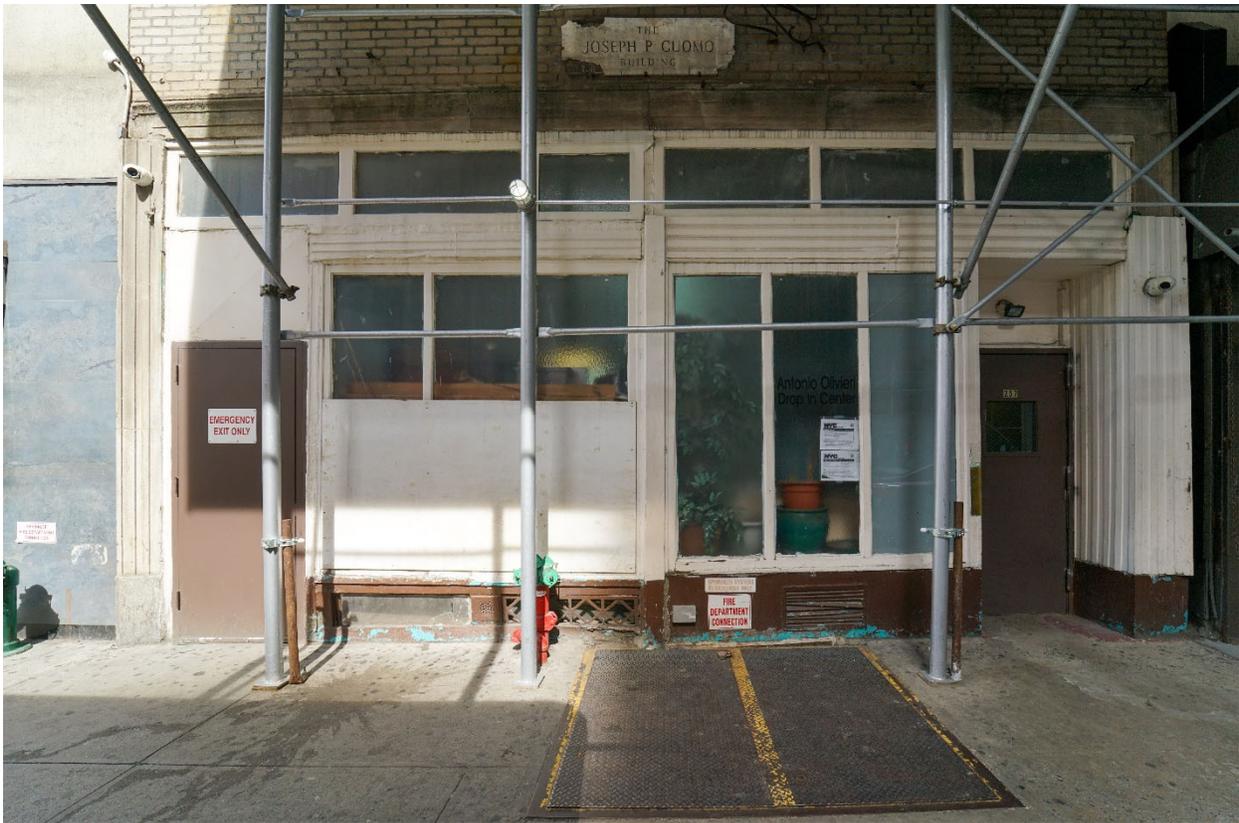
Lot 9 contains a two-story social-services building. The façade consists of wood and glass at street level and brick on the upper floor. The exterior wall appears to be in critical condition; showing noticeable damage, it's currently boarded up, and scaffolding canopies the sidewalk. The doors are in fair condition and the windows are in poor condition, showing heavy staining and corrosion. The sidewalk is in poor condition, showing cracking, staining, and debris. The building shows no barrier to ADA accessibility at the ground-floor entry. Overall, the building and site conditions were given a rating of poor condition.

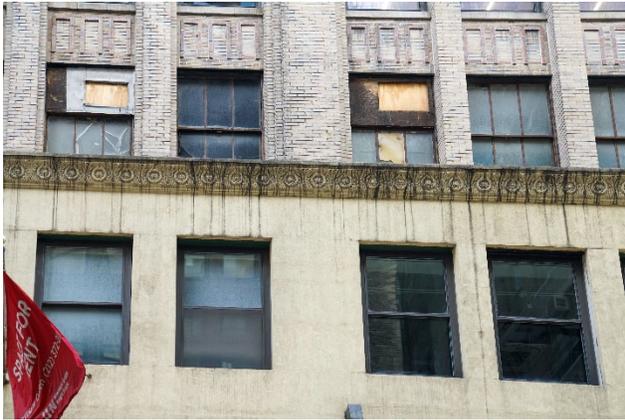
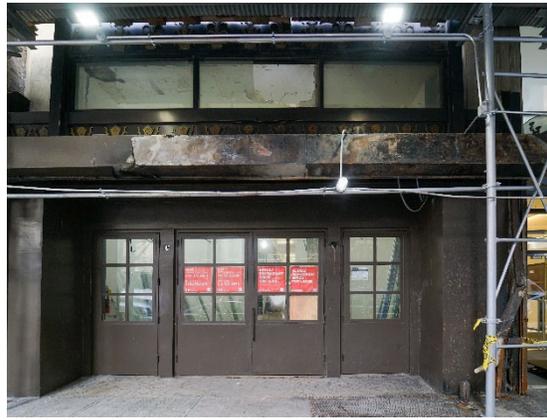
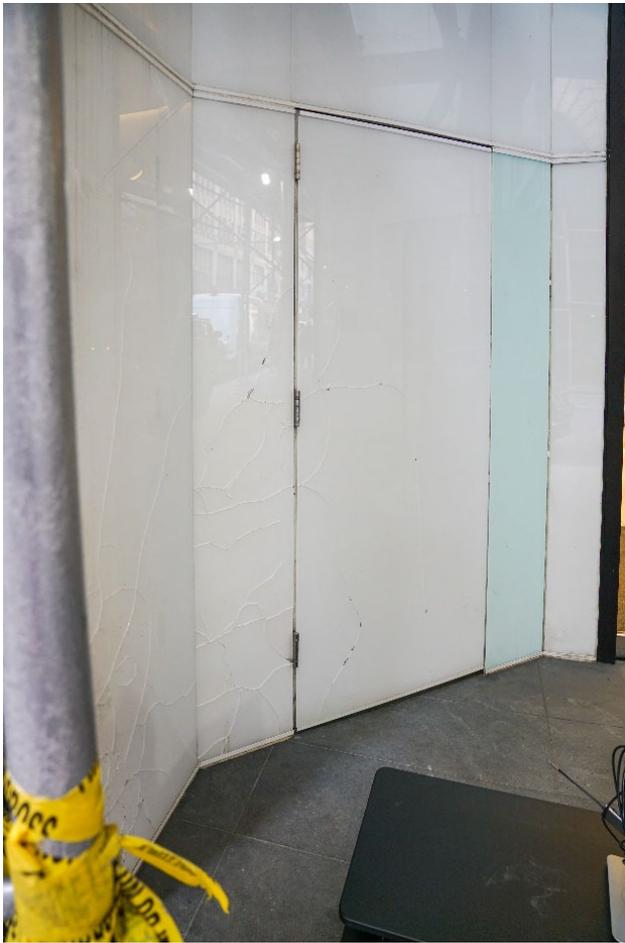
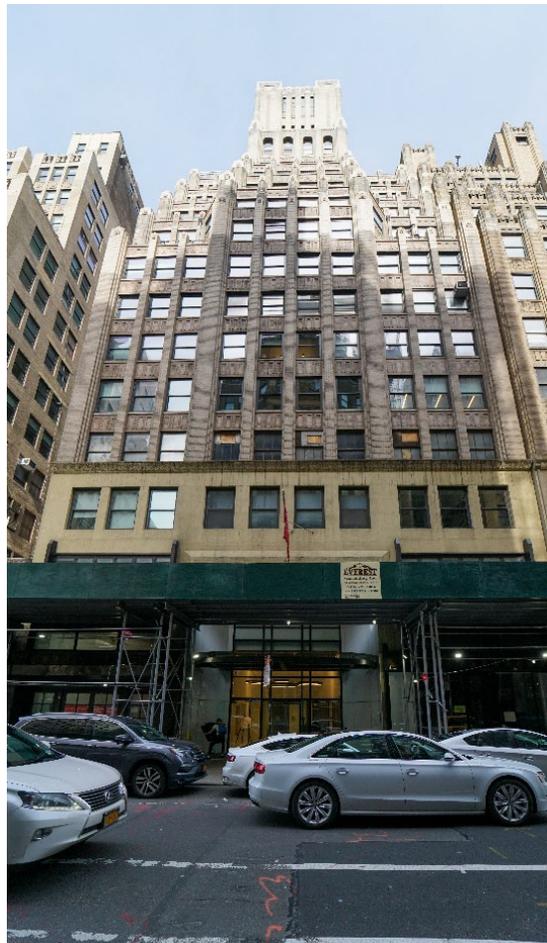
Figure 1-23 Block 780, Lot 10 Photographs

Lot 10 contains a 16-story building, with retail and an office lobby at the street level and office space on upper levels. One of the retail stores appears to be under construction. The façade consists of tile, metal, and glass storefronts on the ground floor and a combination of brick, stucco, and stone on the upper floors. The lower façade is covered with scaffolding. The exterior wall is in critical condition; glass tiles are severely cracked, and sections of the steel structure are both unprotected and heavily corroded on the lower levels. The upper levels show moderate staining. The metal doors are intact but corroded. Some windows are missing, cracked, and boarded with wood panels. The sidewalk is in fair condition, showing minor cracking, staining, and debris. The ground floor entrances to the lobby and retail stores show no barrier to accessibility. Overall, the building and site conditions were given a rating of poor condition.

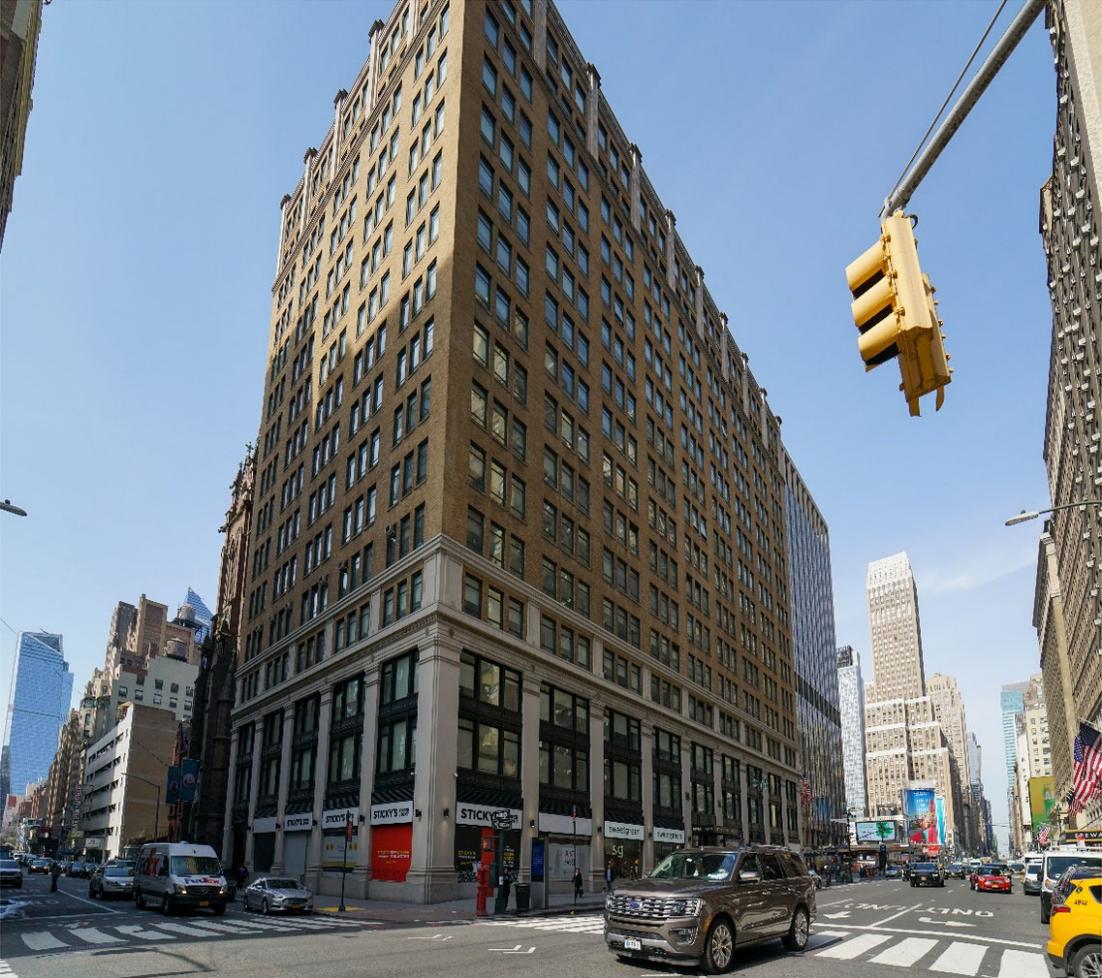
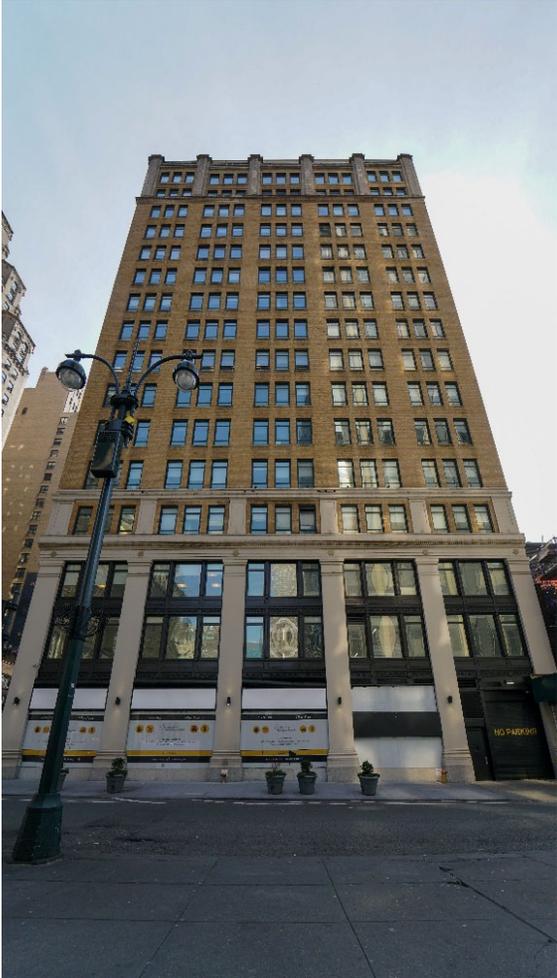
Figure 1-28 Block 780, Lot 36 Photographs

Lot 36 contains a 17-story building, known as Seven Penn Plaza, with retail spaces and a lobby on the ground floor and offices on the upper floors. The façade consists of stone, metal, and glass storefronts at the base and brick and stone on the upper floors. The exterior walls, windows, and doors are in good condition. The sidewalk and curb cuts are in good condition, with minor debris. The building has an energy efficiency grade of D, as reported by the Mayor's Office of Sustainability. The building shows no barrier to accessibility at the ground-floor entrances. Overall, the building and site conditions were given a rating of good condition.

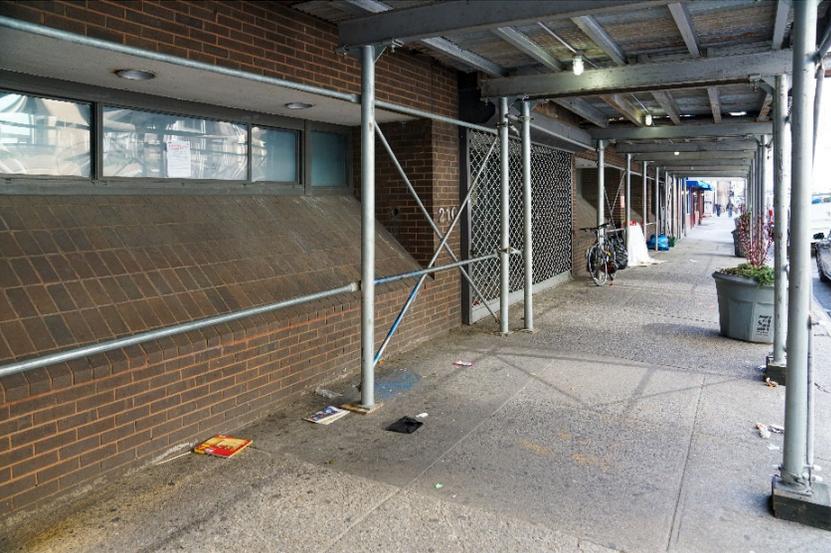
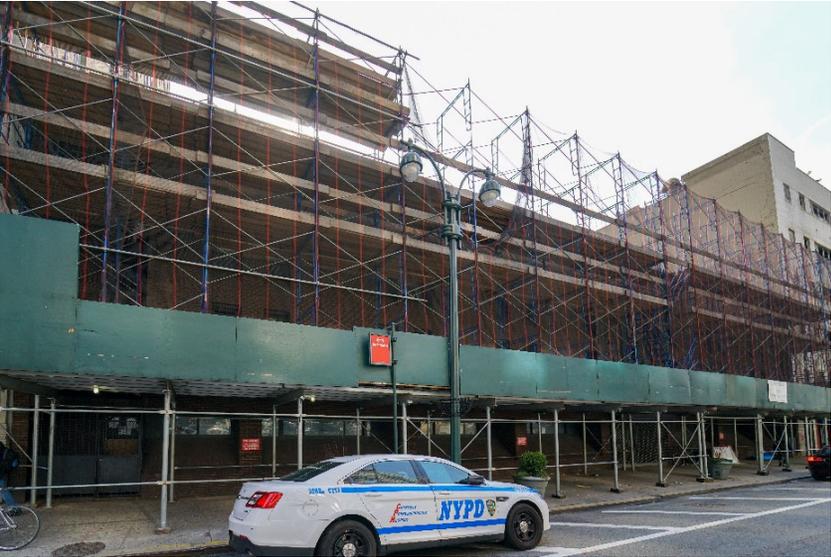
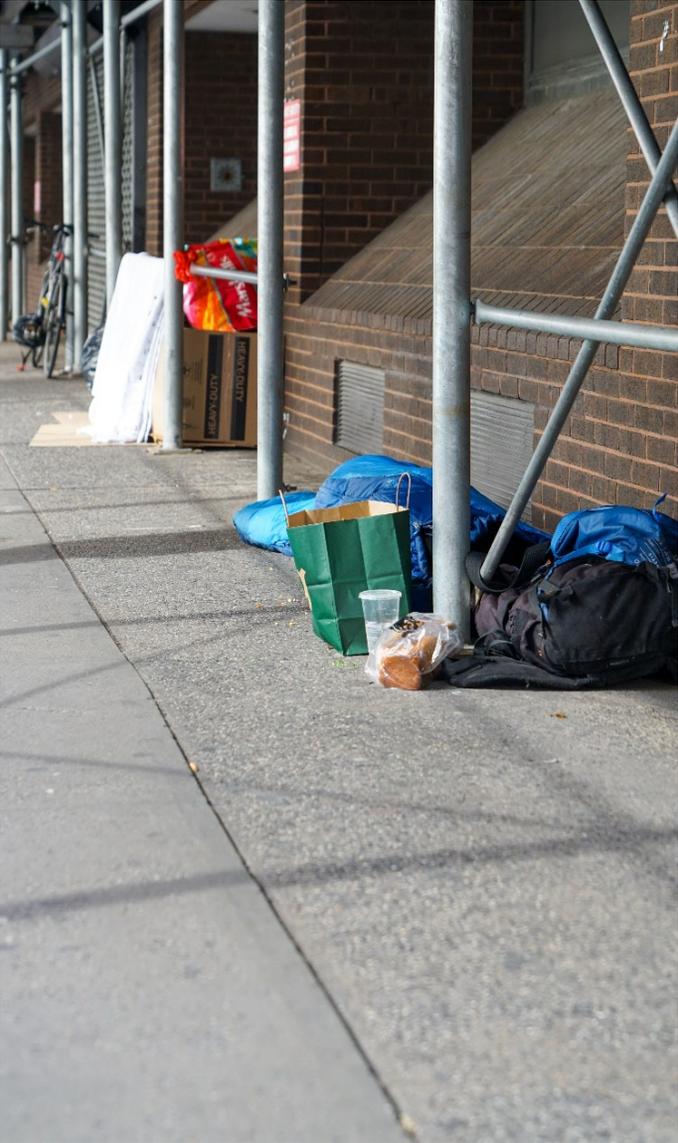
Figure 1-29 Block 780, Lot 45 Photographs

Lot 45 contains a three-story building that is currently under construction; it is surrounded by scaffolding. The façade consists of bricks that are in poor condition, showing large cracks and heavy stains. The doors and windows on the ground floor are in fair condition, though covered with dirt and staining. The upper windows are not visible and their condition is unknown. The sidewalk is in fair condition, showing minor cracking, staining, and debris. At the time of this assessment, there was an encampment in front of the building. Overall, the building and site conditions were given a rating of poor condition.

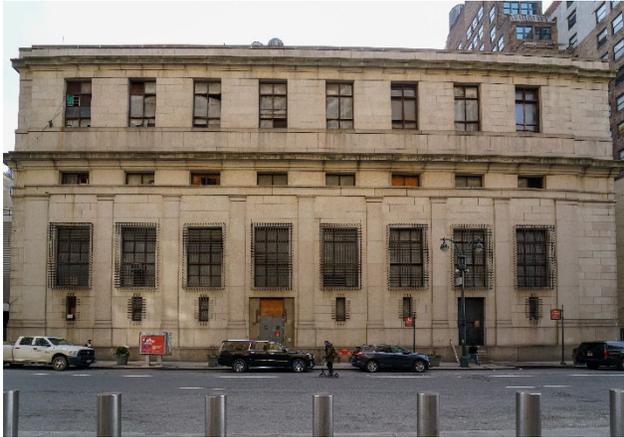
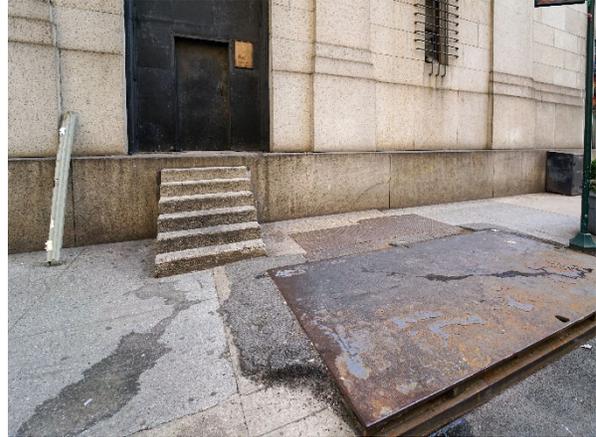
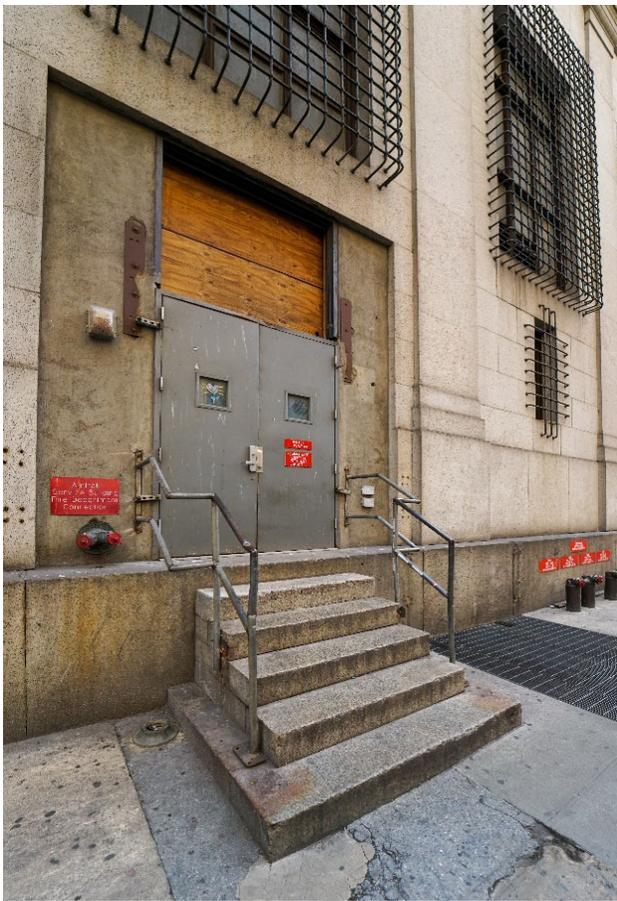
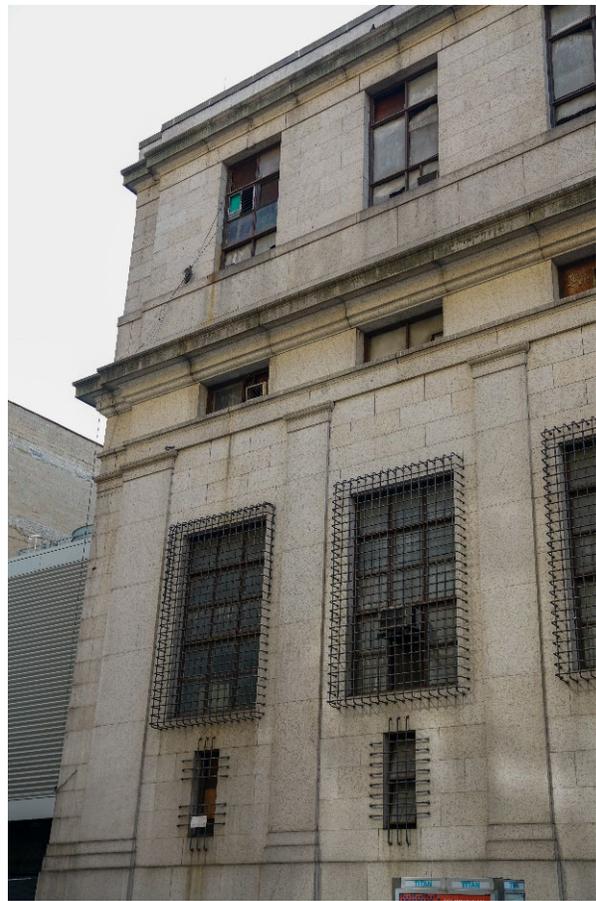
Figure 1-30 Block 780, Lot 60 Photographs

Lot 60 contains a four-story railroad service facility. Its façade consists of stone that is in fair condition, showing moderate cracking and heavy staining. The doors and windows are in critical condition; many are damaged, missing, or boarded up with wood panels. The sidewalk is in critical condition, showing large cracks and uneven patches, and curb cuts are in poor condition, with heavy cracking and damages. The security bars on the building are in generally poor condition, as the metal surfaces are heavily corroded. The building is not accessible, because its entrance is elevated from the street level and can only be accessed by stairs. Overall, the building and site conditions were given a rating of critical condition.

Lot 60 has eight open building code violations. One of the eight violations was issued by ECB and relates to the “failure to maintain exterior building wall,” which creates a hazardous condition. The parapet masonry was noted to be cracked and “bulging outward.” The remaining seven violations were issued by DOB and relate to the building’s elevator and construction. The construction violations and four of the elevator violations were issued prior to 2015. The remaining two elevator violations were issued in 2019.

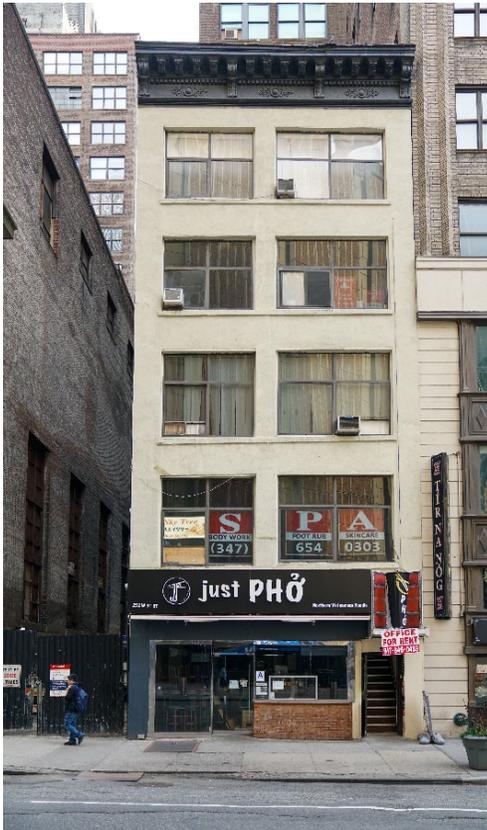
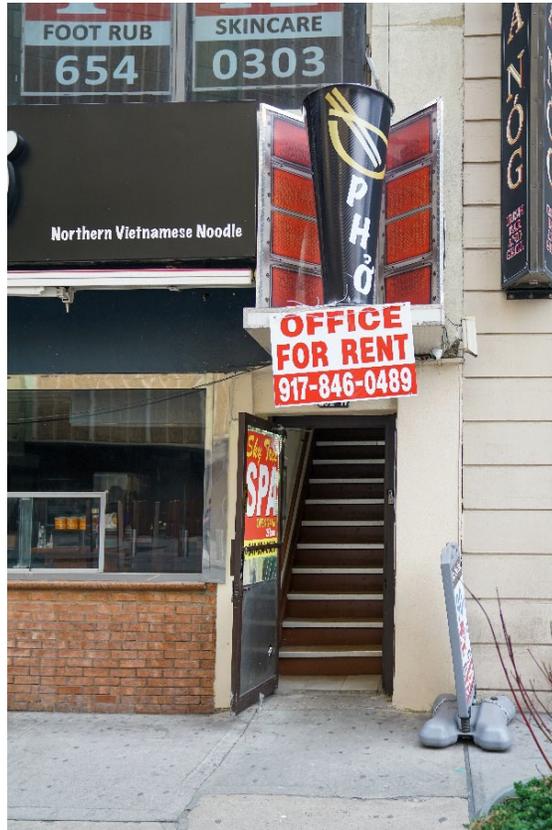
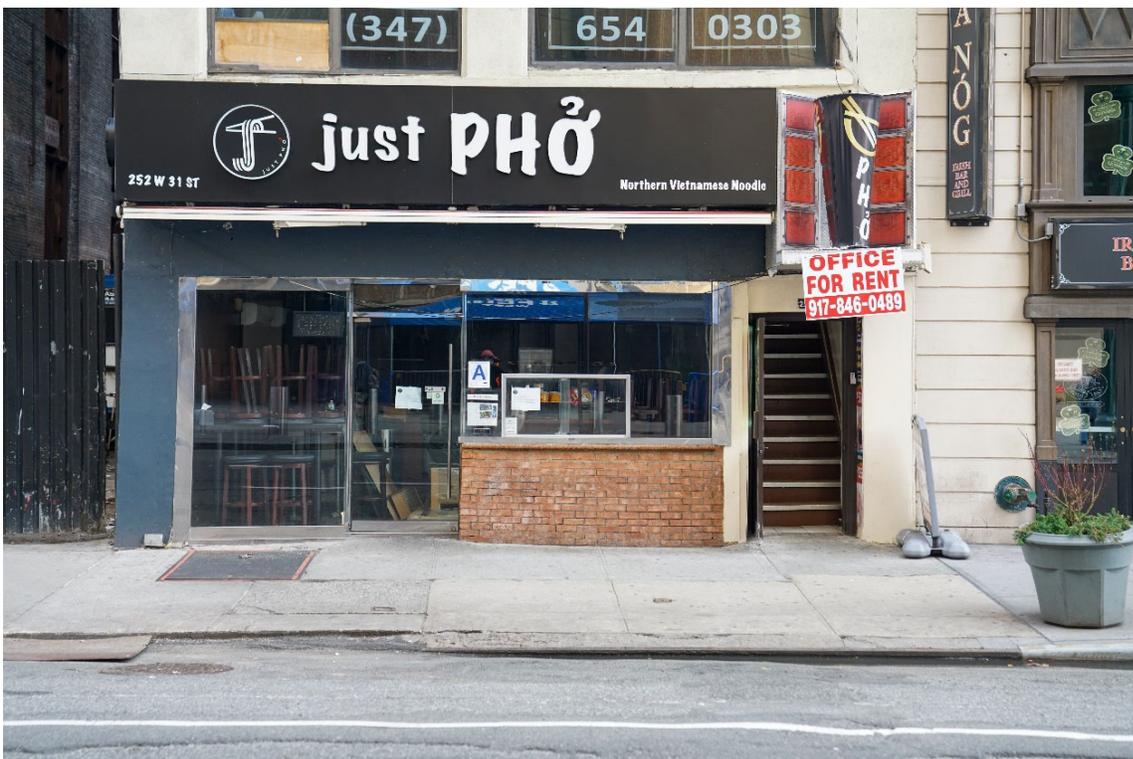
Figure 1-31 Block 780, Lot 70 Photographs

Lot 70 contains a five-story building, with retail on the ground floor and office on the upper floors. The façade consists of a glass storefront and stucco at the street and upper levels. The exterior wall and doors are in fair condition, with some cracks and stains. The windows are in poor condition, showing heavy corrosion on their frames. The sidewalk is in poor condition, with large cracking, moderate staining, and debris. The ground floor entrances show no barrier to accessibility. A sign over the upper-level entry advertises an office for lease. Overall, the building and site conditions were given a rating of poor condition.

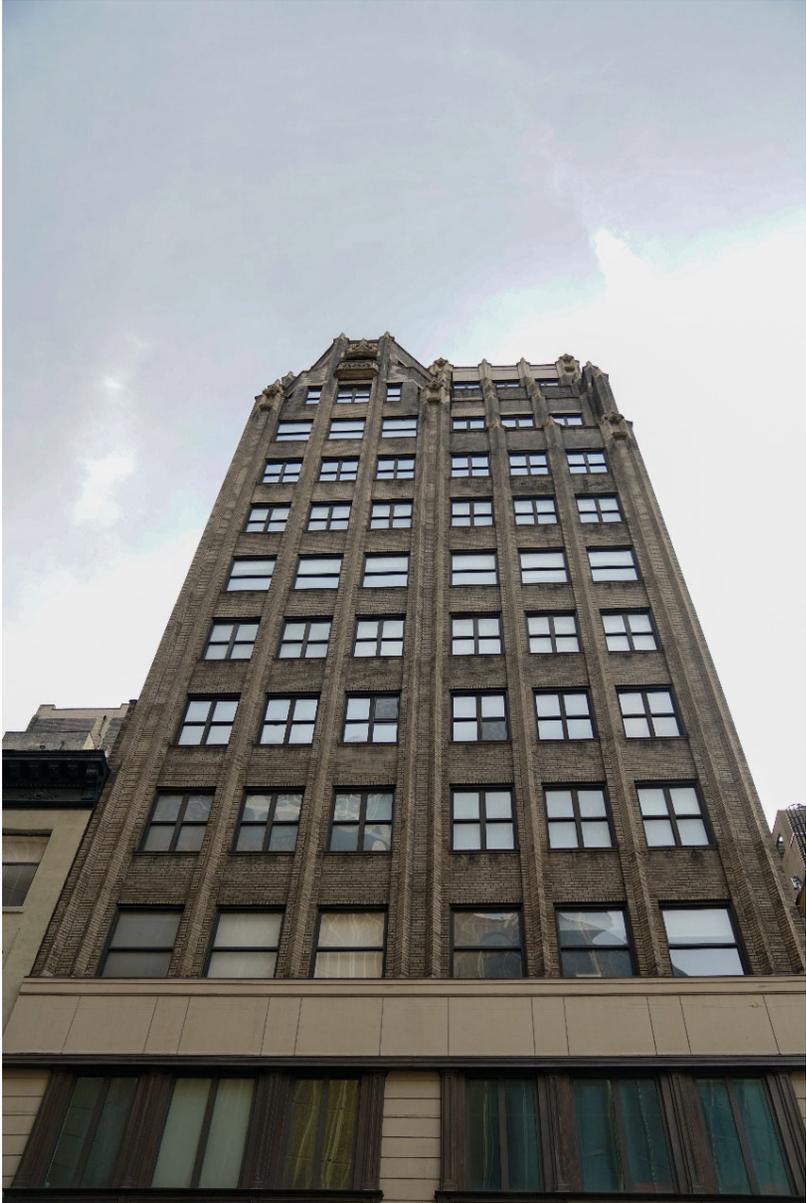
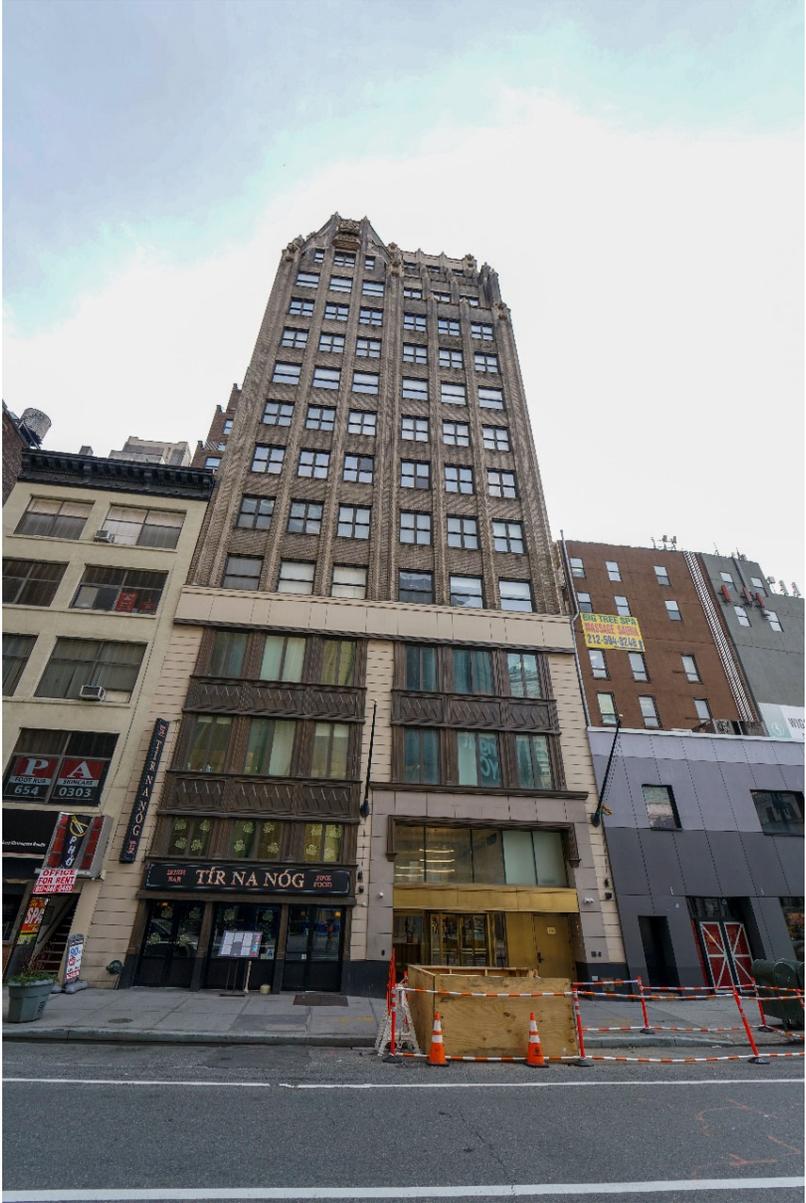
Block 780, Lot 71 Photographs

Lot 71 contains a 15-story building, with retail and an office lobby on the ground floor and office space on the upper floors. The façade consists of a stone, metal, and glass storefront at the base and brick on the upper floors. The exterior wall on the ground floor is in good condition, but the upper floors are in fair condition, as the brick wall has moderate corrosion and staining. The windows and doors are in good condition. The sidewalk is in fair condition, showing minor cracking, staining, and debris. The building has an energy efficiency grade of B, as reported by the Mayor's Office of Sustainability. The building shows no barrier to accessibility at the ground-floor entrances. Overall, the building and site conditions were given a rating of fair condition.

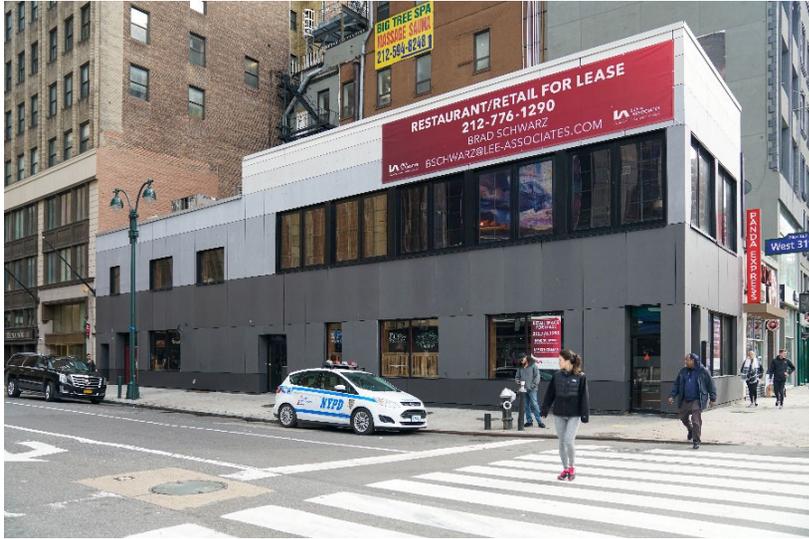
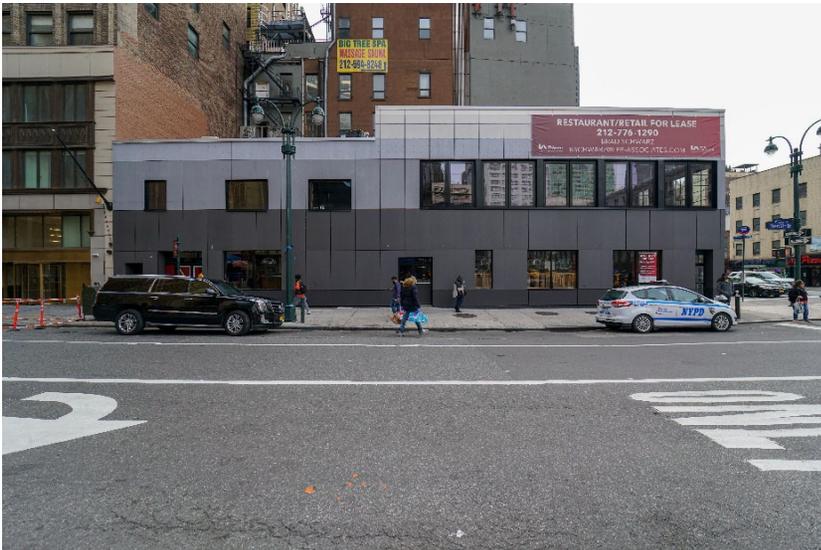
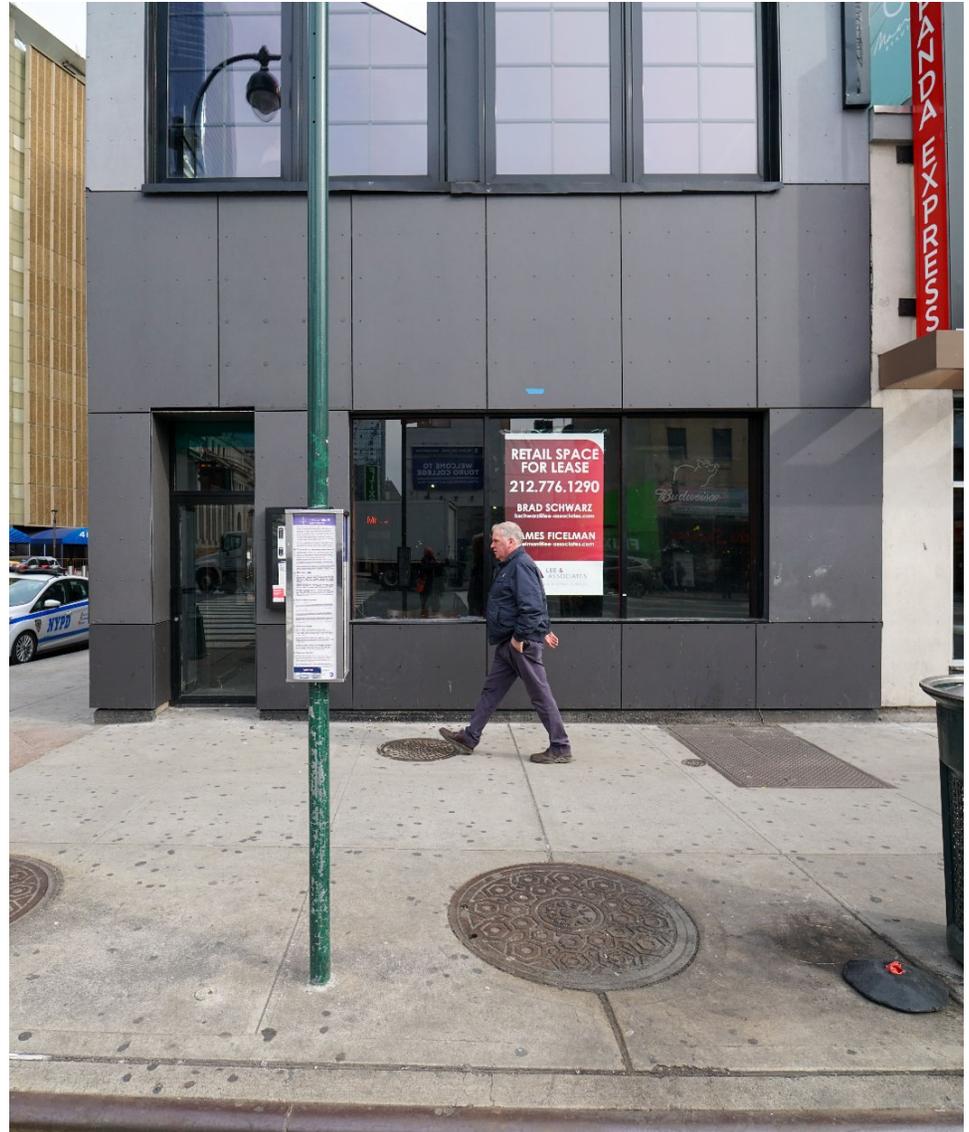
Figure 1-32 Block 780, Lot 73 Photographs

Lot 73 contains a two-story retail store that is currently unoccupied and advertised for lease. The façade consists of metal panels and glass and is in fair condition, showing one or two minor stains, while the windows and doors are in good condition. The sidewalk and curb cuts are in fair condition, showing minor cracking, staining, and debris. The building shows no barrier to accessibility at the ground floor entrance. Overall, the building and site conditions were given a rating of good condition.
