EMPIRE STATION COMPLEX

Neighborhood Conditions Study

February 2021

FOR
Empire State Development

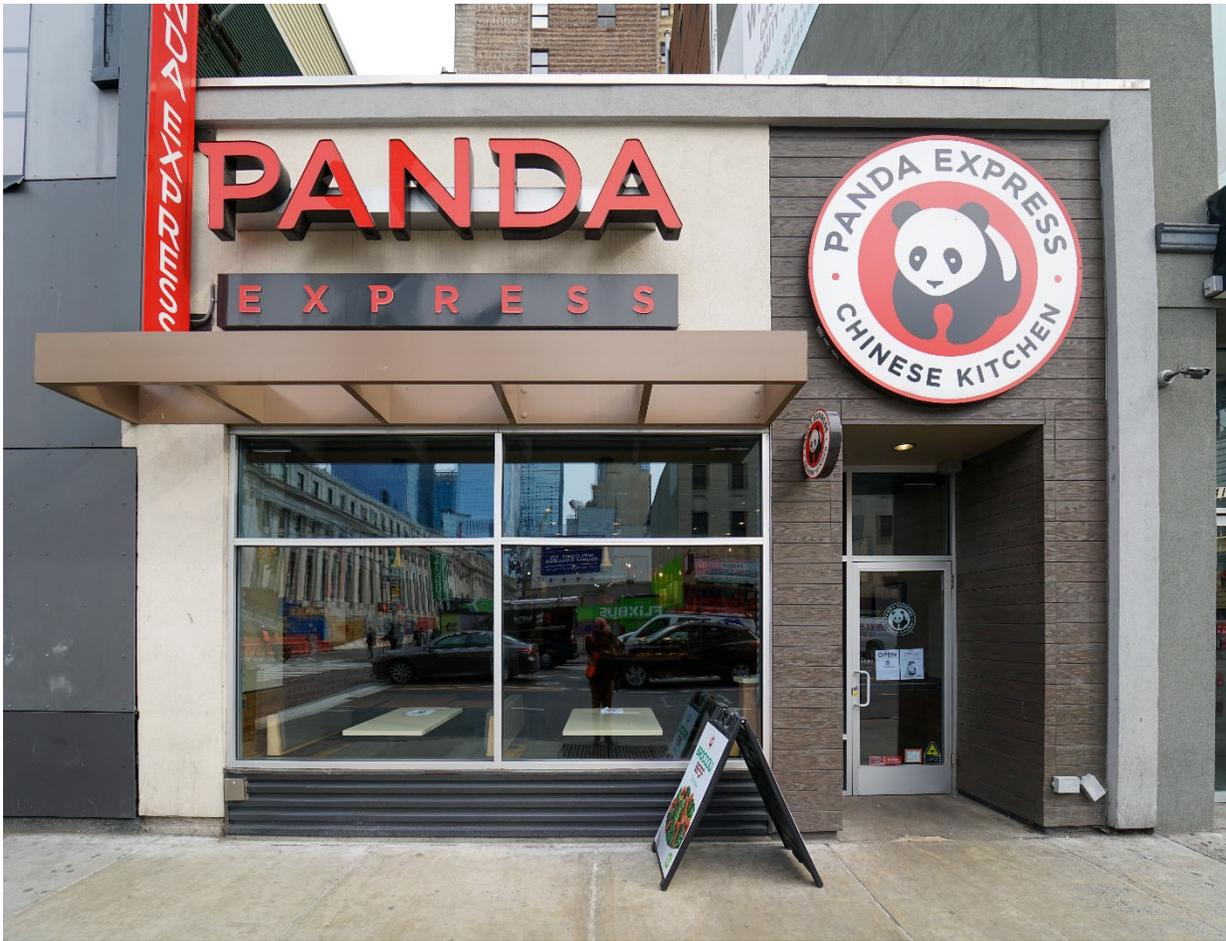
Figure 1-33 Block 780, Lot 74 Photographs

Lot 74 is occupied by a one-story retail store. The façade consists of a stucco, stone, metal, and glass storefront. The exterior wall, doors, and windows are in good condition. The sidewalk is in fair condition, showing minor cracking, staining, and debris. The building shows no barrier to accessibility at the entrance. Overall, the building and site conditions were given a rating of good condition.

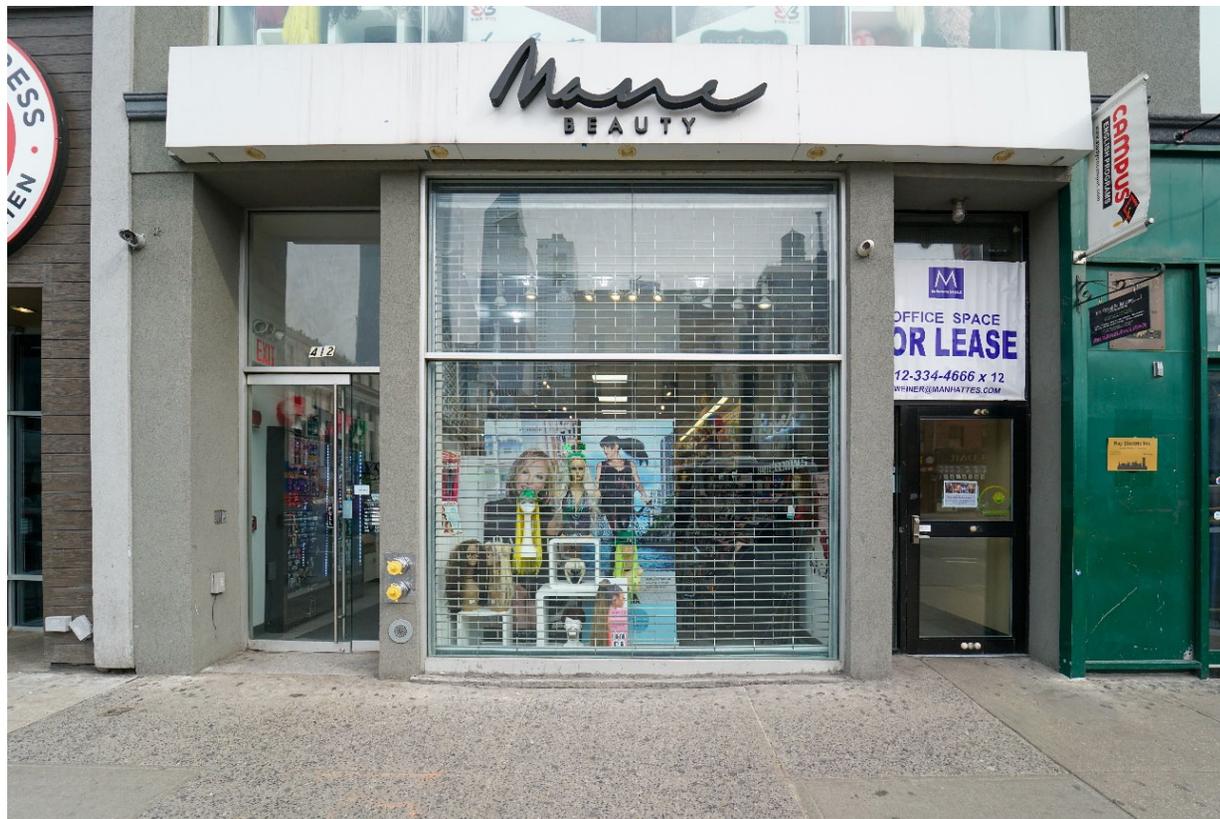
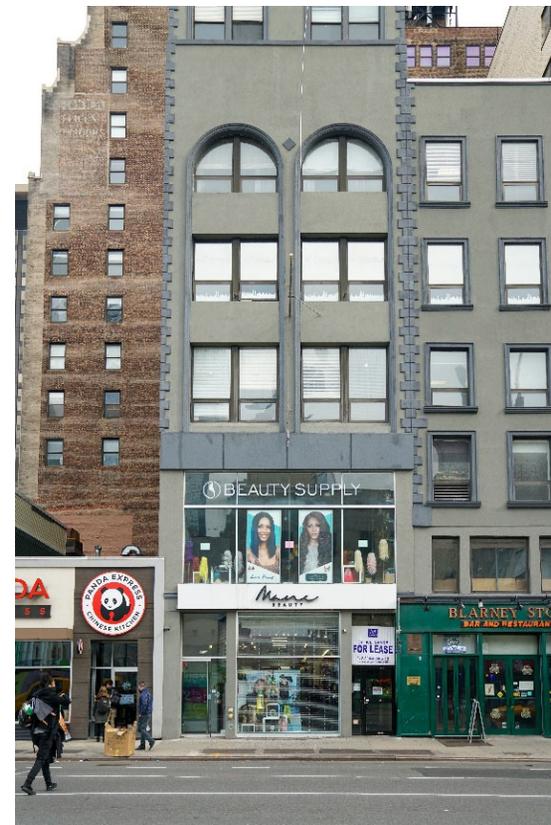
Figure 1-34 Block 780, Lot 75 Photographs

Lot 75 contains a seven-story building, with retail on the ground floor and second floor, and office space on the upper floors. The façade consists of a stucco, concrete, and glass storefront on the lower levels and stucco and concrete on the upper levels. The exterior wall, doors, and windows are in good condition. The sidewalk is in fair condition, showing minor cracking, staining, and debris. The building shows no barrier to accessibility at the ground-floor entrance. The upper office is for lease. Overall, the building and site conditions were given a rating of good condition.

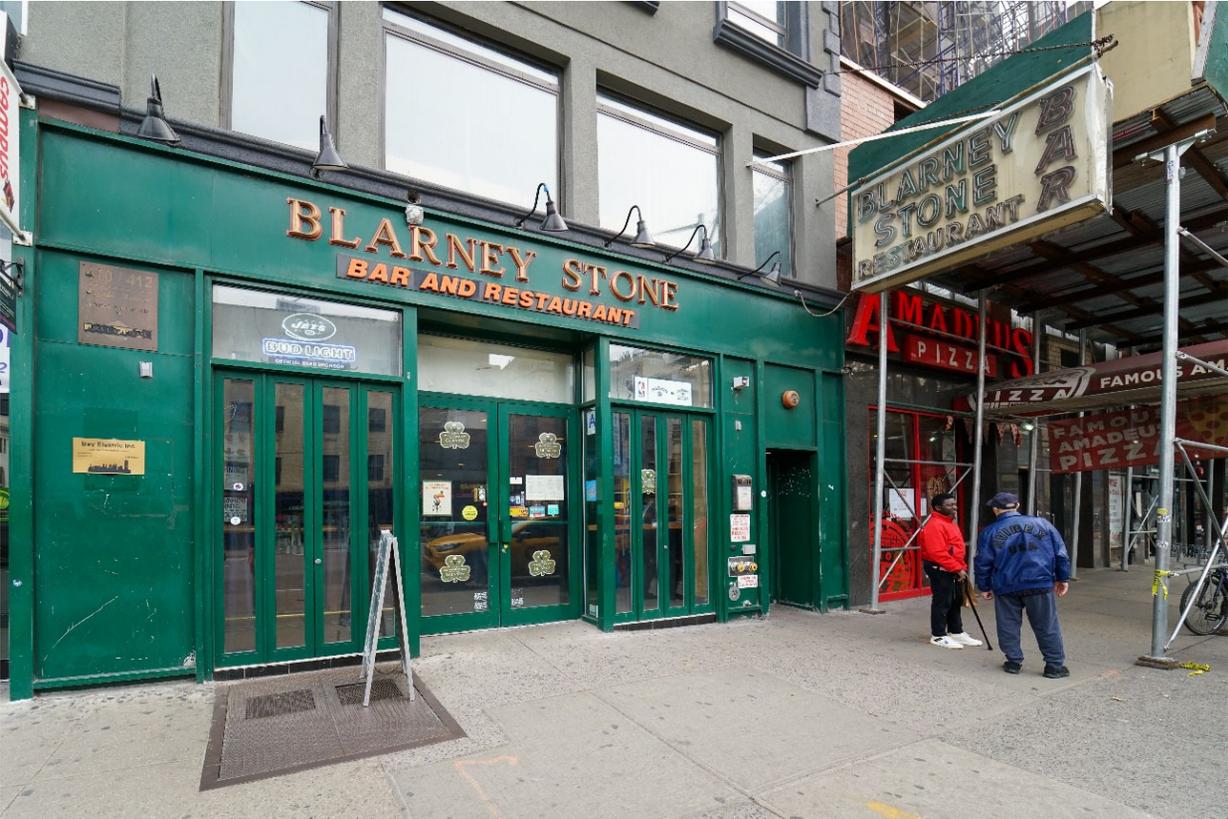
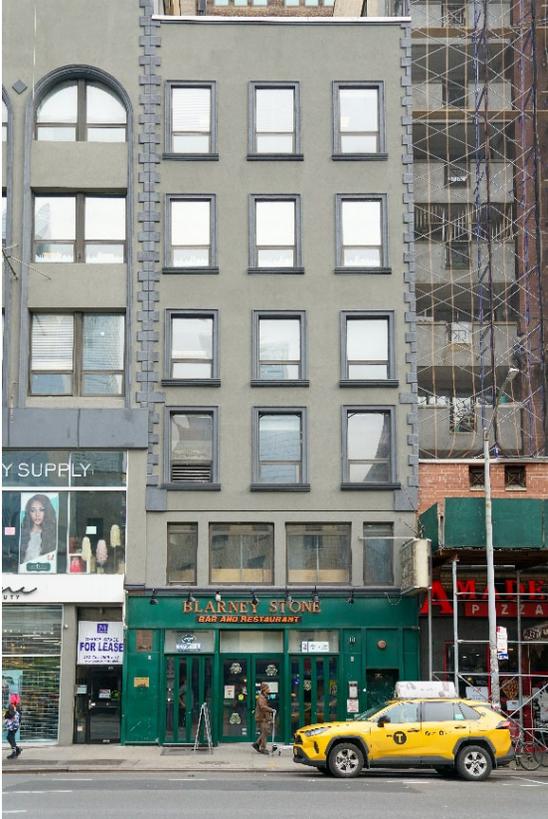
Figure 1-35 Block 780, Lot 76 Photographs

Lot 76 contains a six-story building, with retail on the ground floor, and office or residential space on the upper floors. The façade consists of a metal and glass storefront at the ground floor and stone, stucco, and glass on the upper floors. Its exterior wall is in fair condition, showing minor damage, while the windows and doors are in good condition. The sidewalk is in fair condition, showing minor cracking, staining, and debris. The building shows no barrier to accessibility at the ground floor entrances. Overall, the building and site conditions were given a rating of good condition.

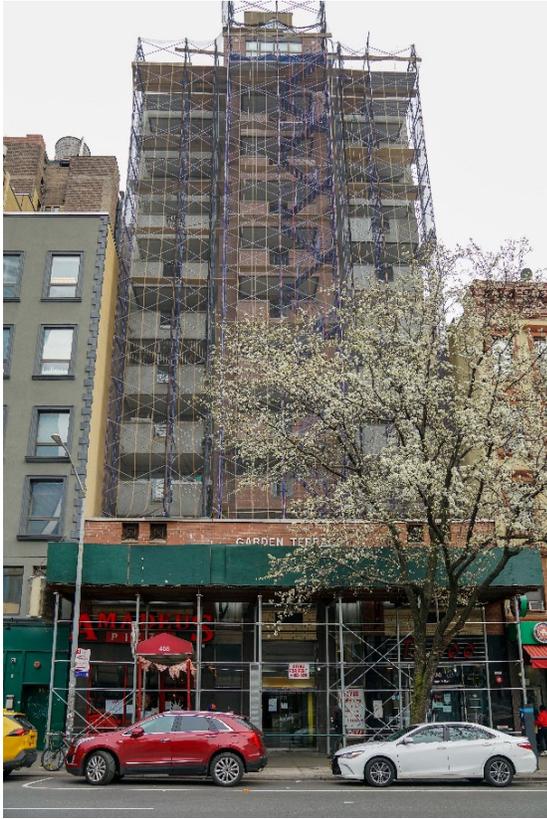
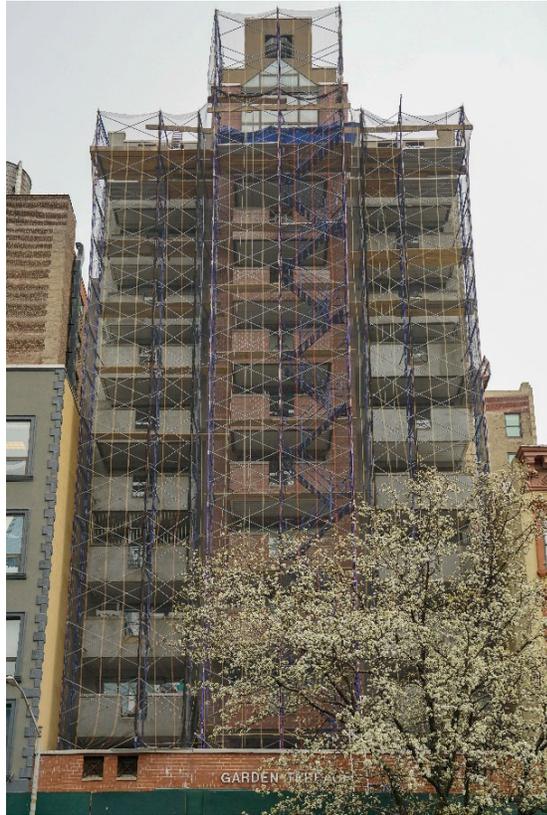
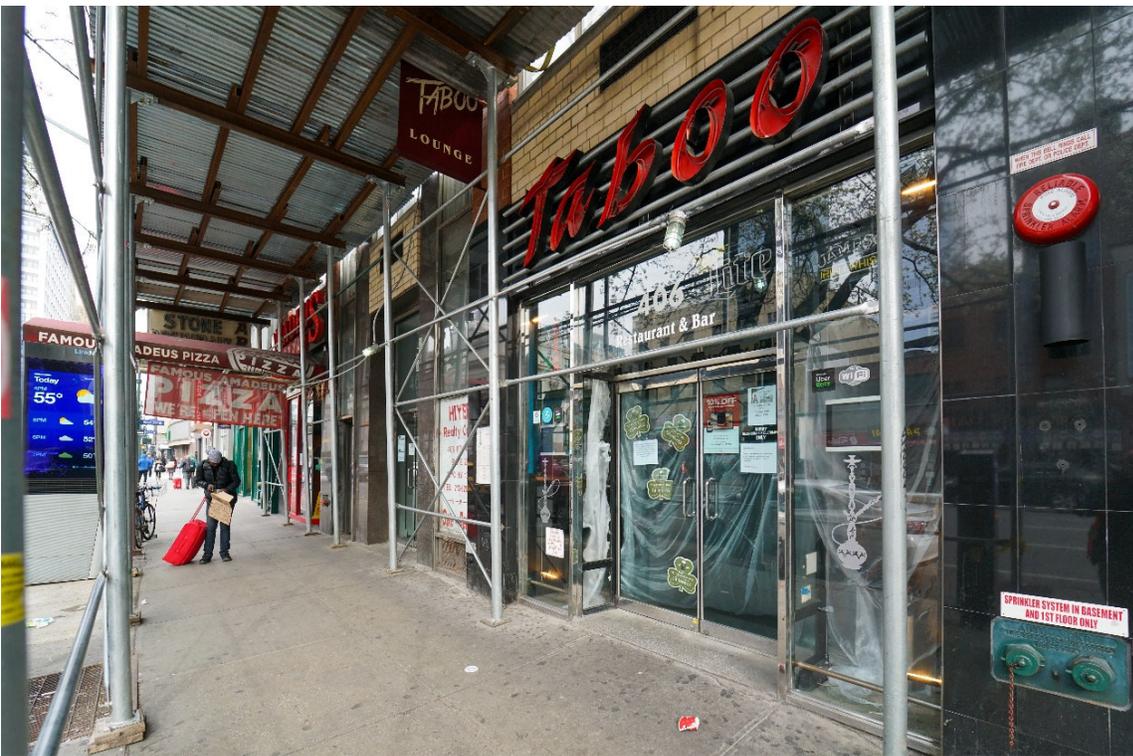
Figure 1-36 Block 780, Lot 7501 Photographs

Lot 7501 contains a 12-story building, with retail on the ground floor and residential space on the upper floors. The façade consists of stone, metal, and glass on the ground floor and brick and stucco on the upper floors. Because the building is currently under construction and surrounded by scaffolding, the façade and window conditions of the upper levels is unknown. However, at the street level, the exterior wall is in poor condition, showing heavy corrosion, and the doors are in fair condition. The sidewalk is in fair condition, showing minor cracking, staining, and debris. The ground floor entrances show no barrier to accessibility. Overall, the building and site conditions were given a rating of poor condition.

Lot 7501 has 19 open building code violations. Six of the 19 violations were issued by ECB, of which two are classified as hazardous and relate to the building's unsafe façade. The remaining four violations issued by ECB relate to the building's boiler, elevator, and failure to safeguard the public. The most recent violations (issued within the last five years) include the failure to maintain the building in a code-compliant manner in 2016 and the failure to safeguard the public from an unsafe façade in 2019. Thirteen of the 19 violations were issued by DOB and relate to construction and the building's boiler and elevators. One of the 13 DOB violations is classified as hazardous, due to the "failure to certify correction on immediately hazardous ECB violation." While most of the DOB violations were issued prior to 2015, two elevator violations was issued in 2017, façade violations were issued in 2018 and 2019, and a failure to benchmark violation was issued in 2019.

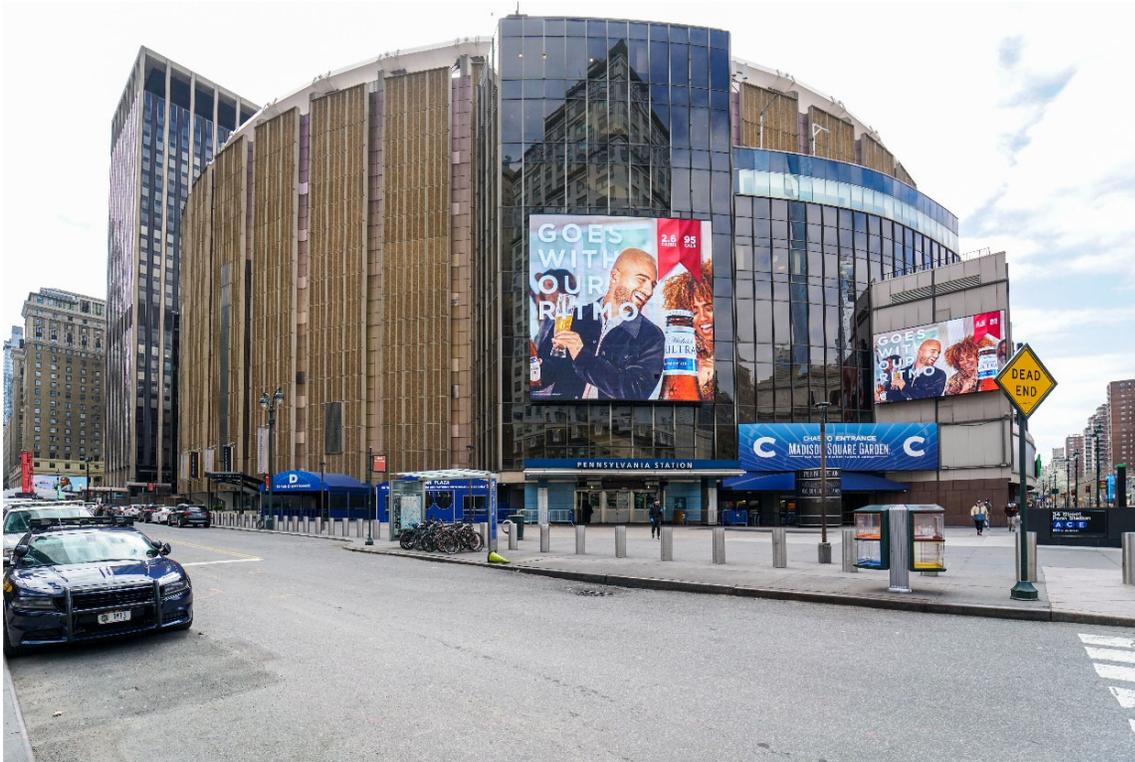
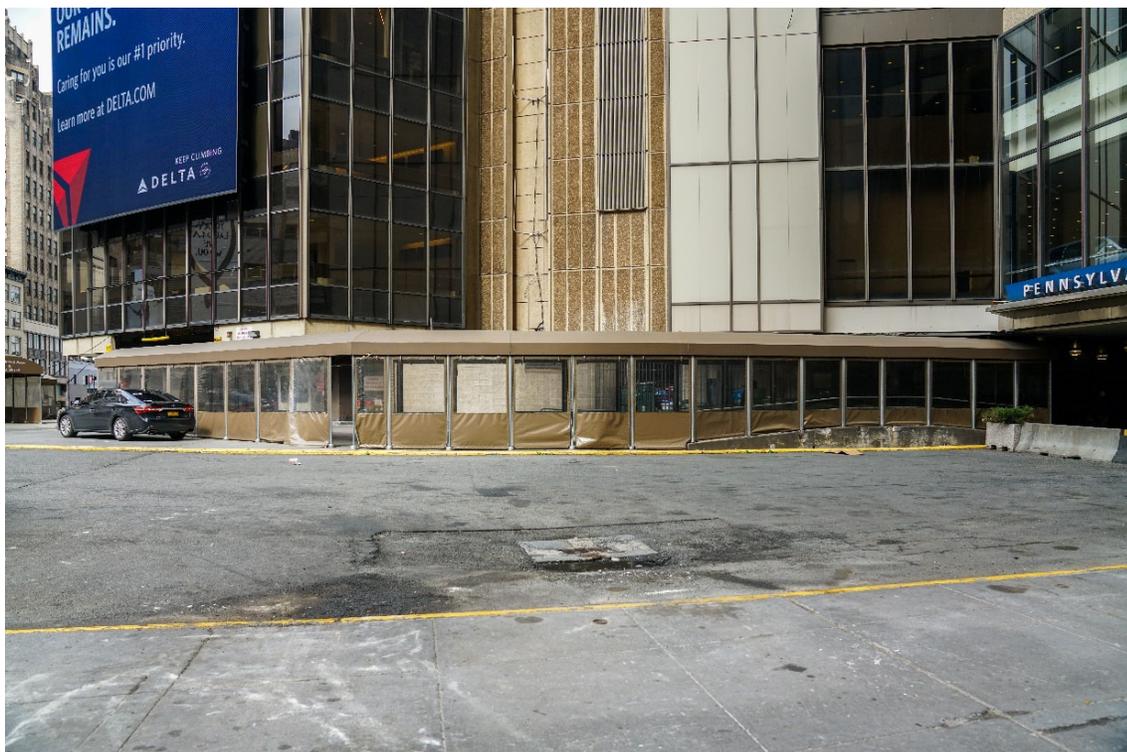
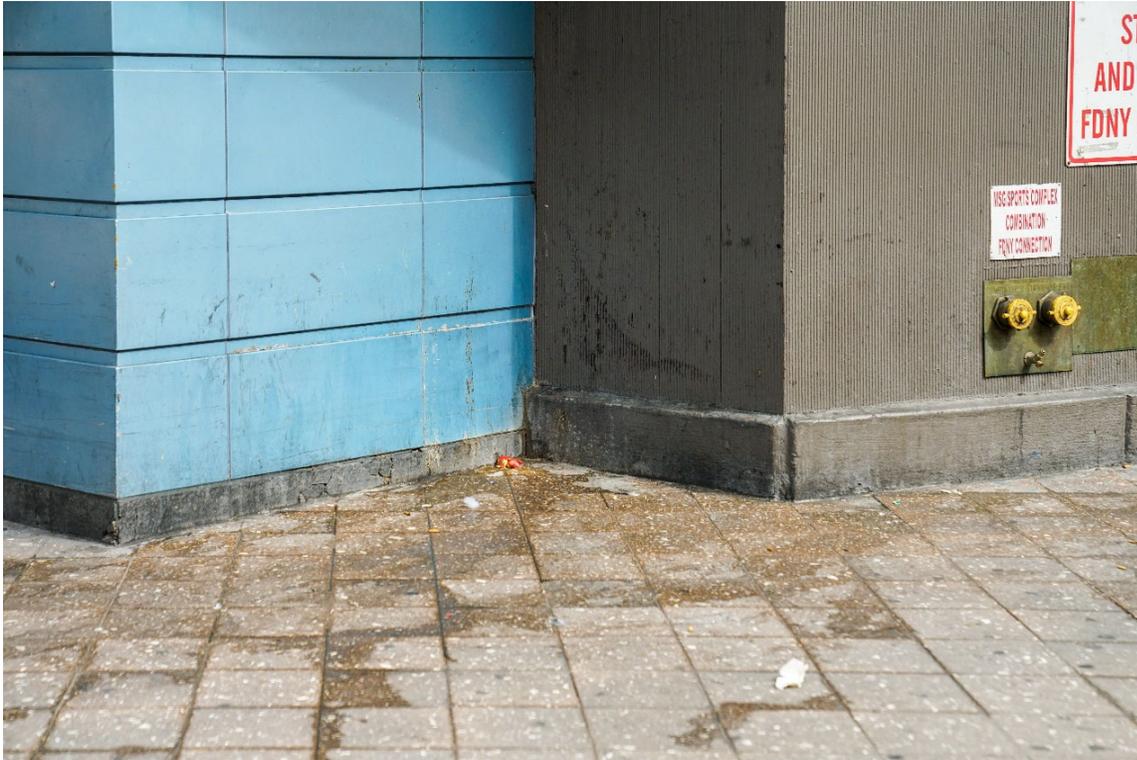
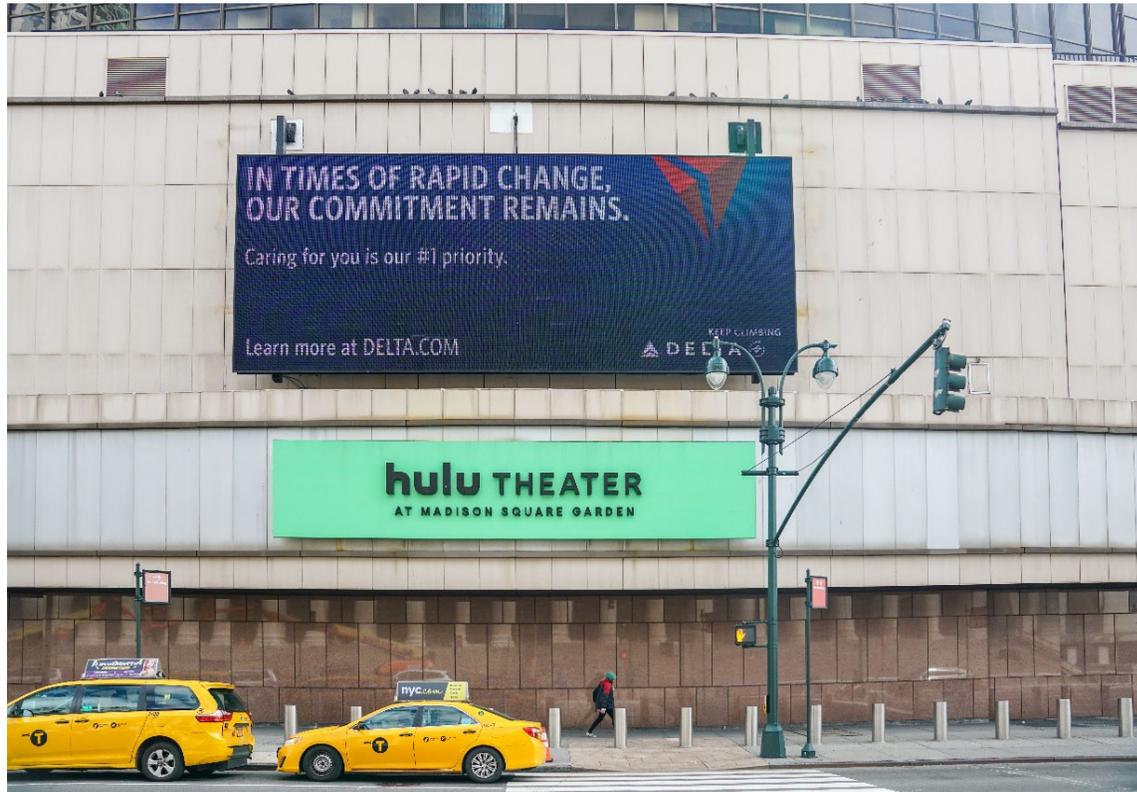
Figure 1-38 Block 781, Lot 1 Photographs

The building façade consists of a metal and glass curtain wall system alternating with sections of stone. The exterior walls are in fair condition, with moderate corrosion, staining, and peeling paint. The doors and windows are in fair condition, showing minor corrosion and staining. The sidewalk is in fair condition with minor cracking, staining, and debris, and the curb cuts are in good condition. The paved yard surface at some building corners is in poor condition, showing corroded tiles and an unsanitary environment. There are streetlights, planter boxes, and bollards adjacent to the building. The ground floor entrances show no barrier to accessibility. Overall, the building and site conditions were given a rating of fair condition.

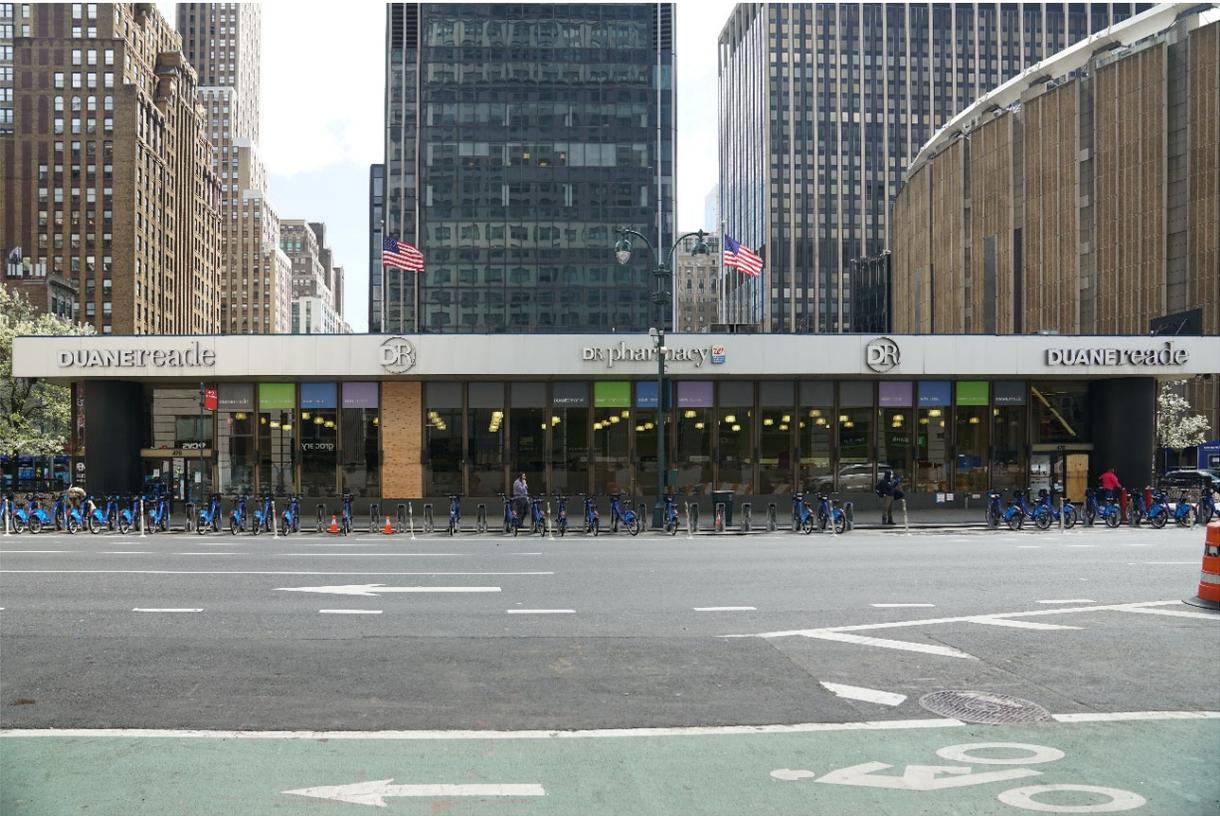
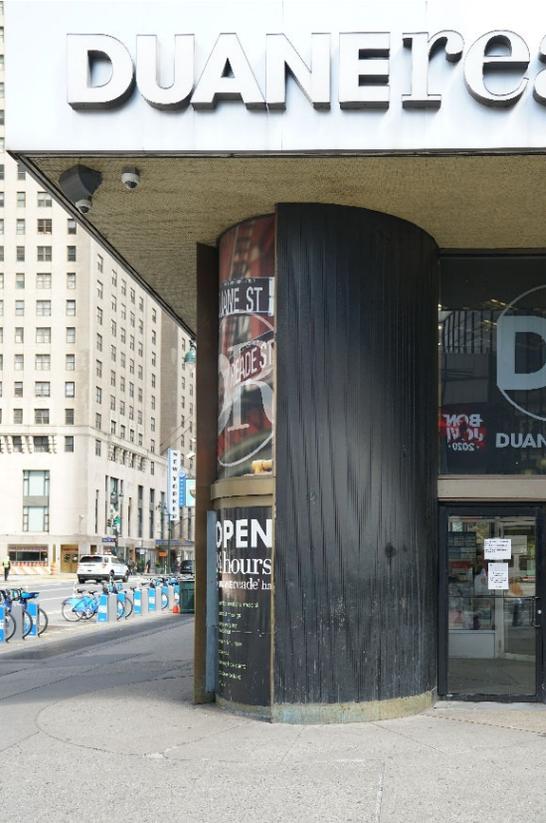
Figure 1-42 Block 783, Lot 1 Photographs

Lot 1 contains a one-story retail store with an adjacent public plaza area on the north and south sides of the lot that each contain a tree planted within an elevated brick container. The building has an overhang and the façade consists of metal and glass. The walls and doors are in fair condition, showing moderate corrosion and stain, and the windows are in good condition. The building shows no barrier to accessibility at the ground floor entrances but there are steps down to a service entrance on the northeastern side of the building due to sloped sidewalk. The sidewalk and curb cuts are in fair condition, containing minor

debris. The paved yard surface on the north and south sides of the lot are in poor condition. Streetlights, street trees, and planter boxes are adjacent to the building. Overall, the building and site conditions were given a rating of good condition.

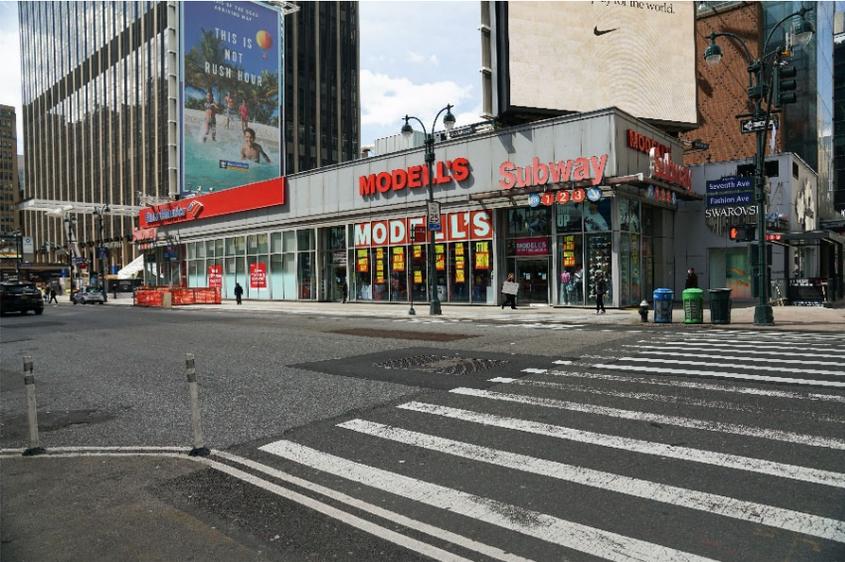
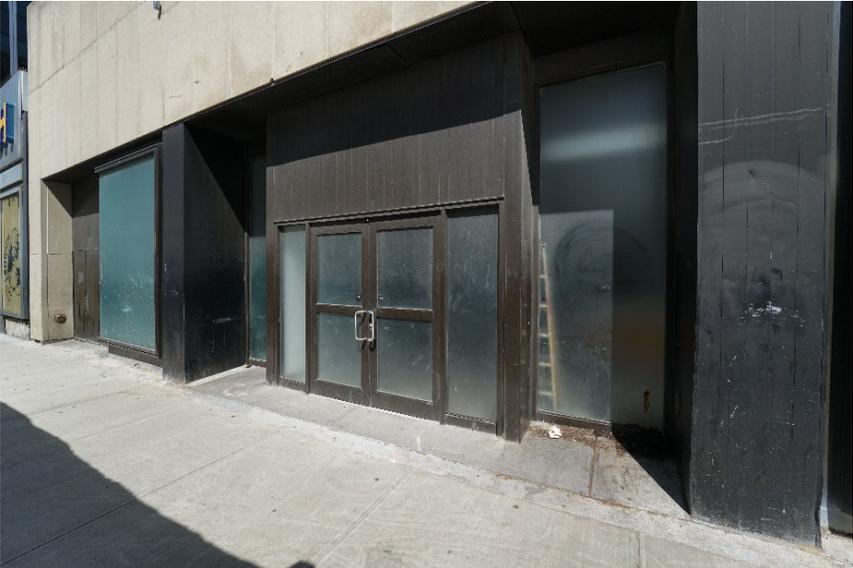
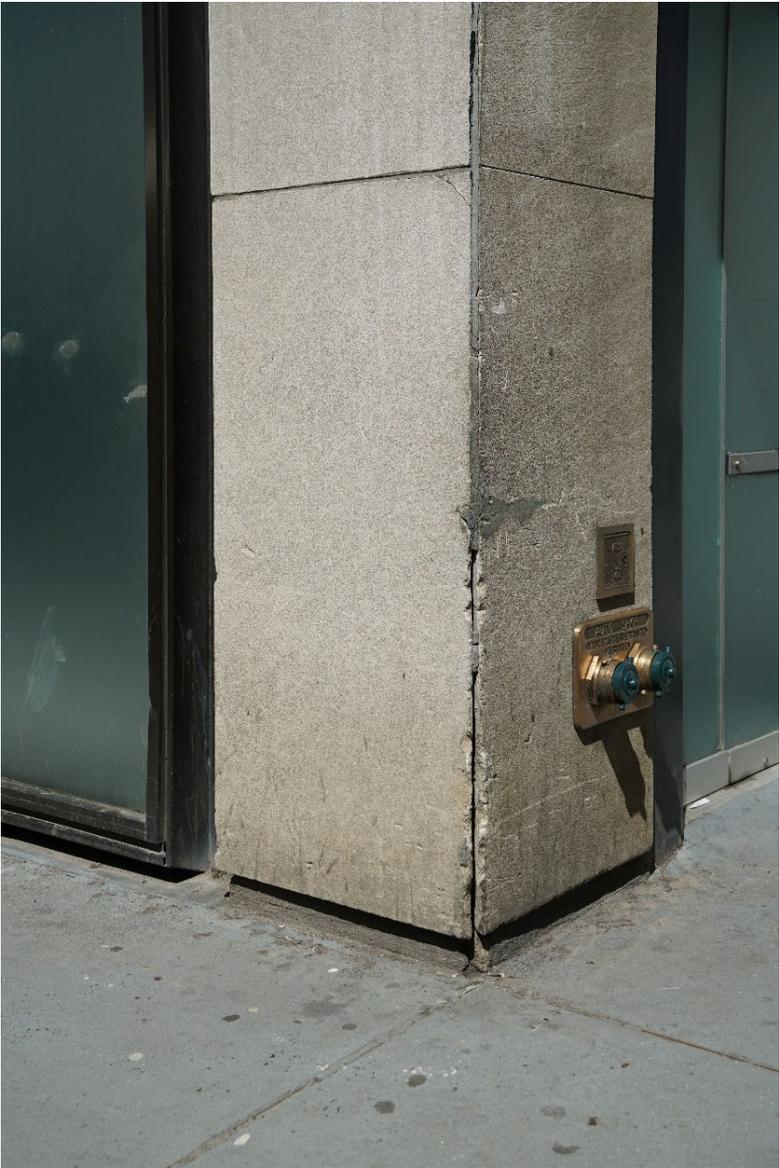
Figure 1-43 Block 783, Lot 34 Photographs

Lot 34 contains a one-story retail building with retail stores and a bank. The façade consists of a metal and glass storefront. The exterior walls are in poor condition, showing heavy corrosion and staining. Windows and doors are in fair condition, showing moderate corrosion and staining. The sidewalk and curb cuts are in good condition, showing minor cracking, staining, and debris. The building shows no barrier to accessibility. Overall, the building and site conditions were given a rating of fair condition.

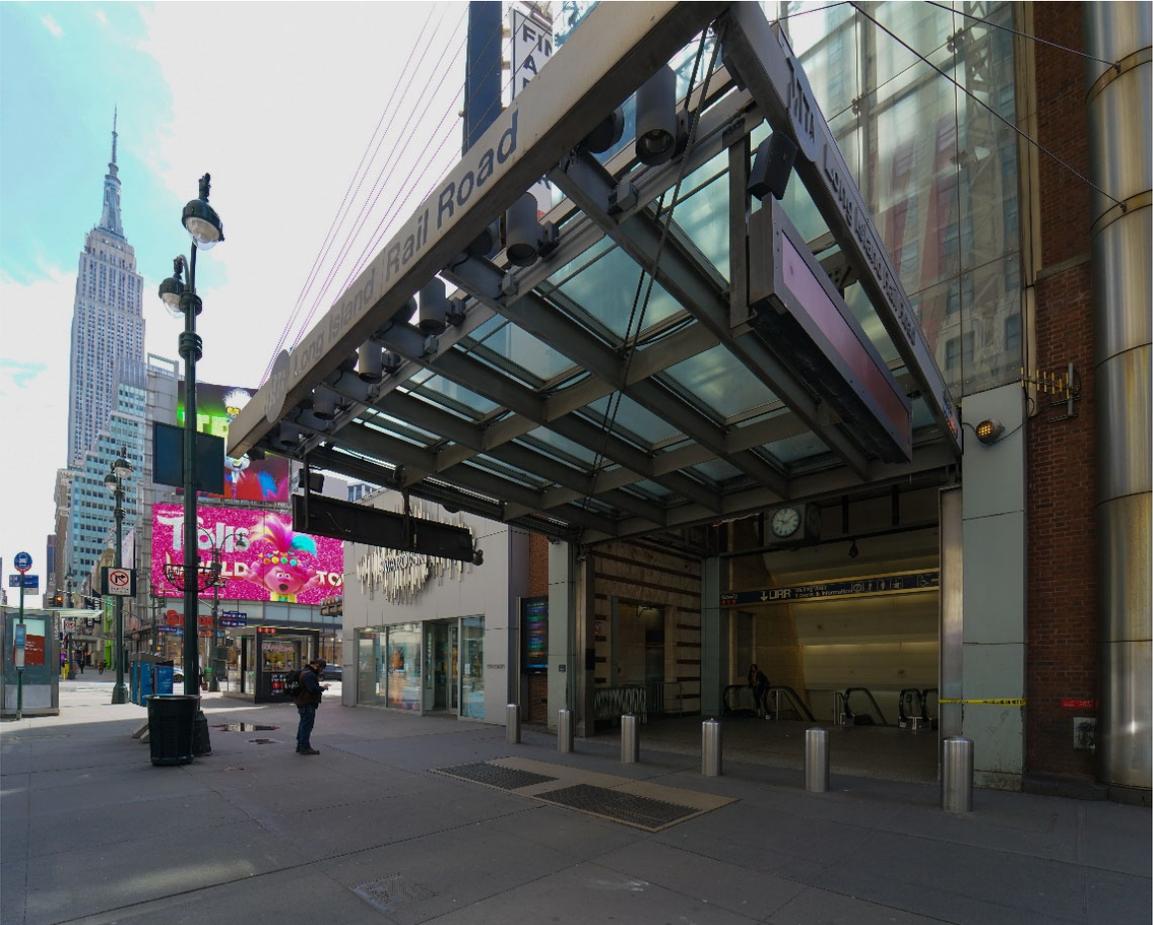
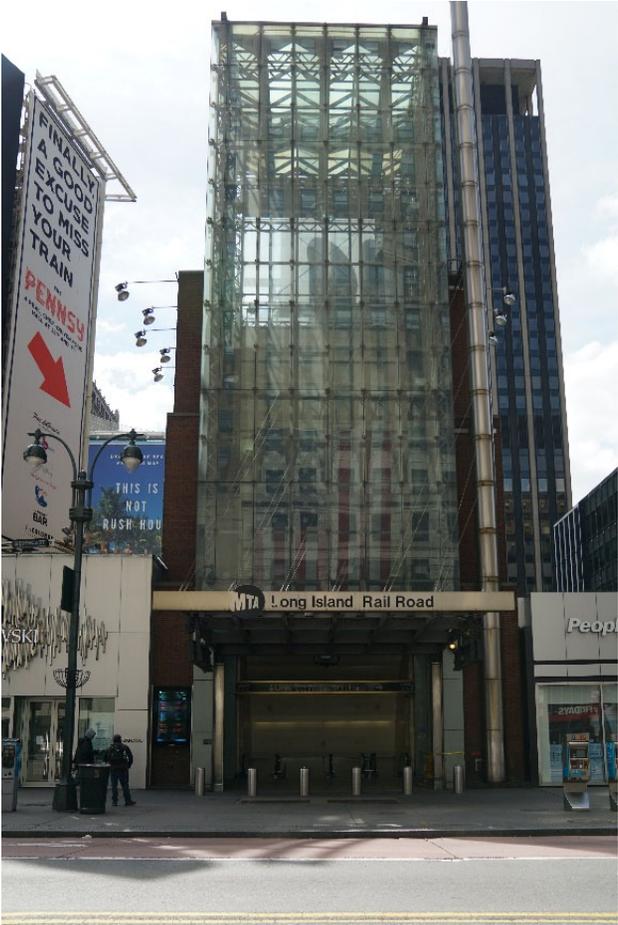
Figure 1-44 Block 783, Lot 48 Photographs

Lot 48 contains an entrance to Penn Station, which is underground. The façade consists of metal and terracotta on the ground floor and metal and glass curtainwalls on the upper structure. Its exterior wall is in fair condition, showing moderate corrosion and staining. The sidewalk is in fair condition, showing minor cracking, staining, and debris. Overall, the building and site conditions were given a rating of fair condition.

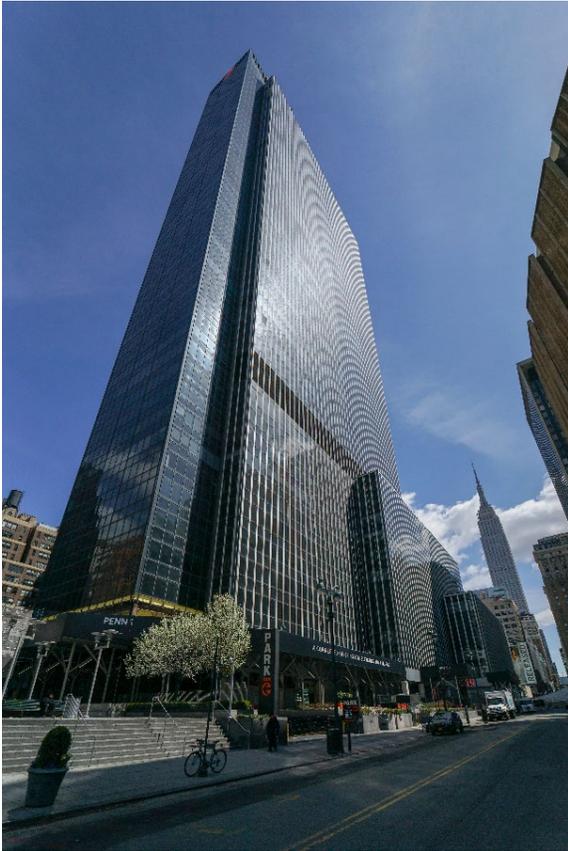
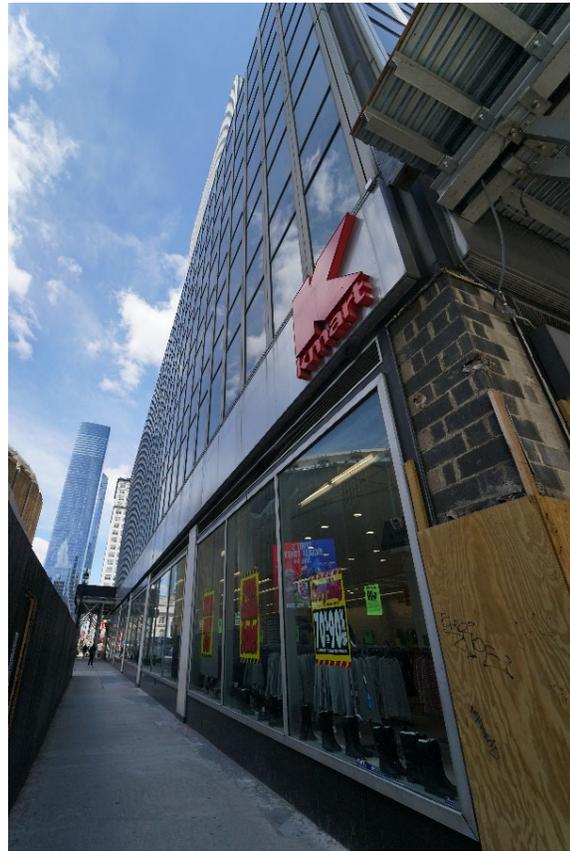
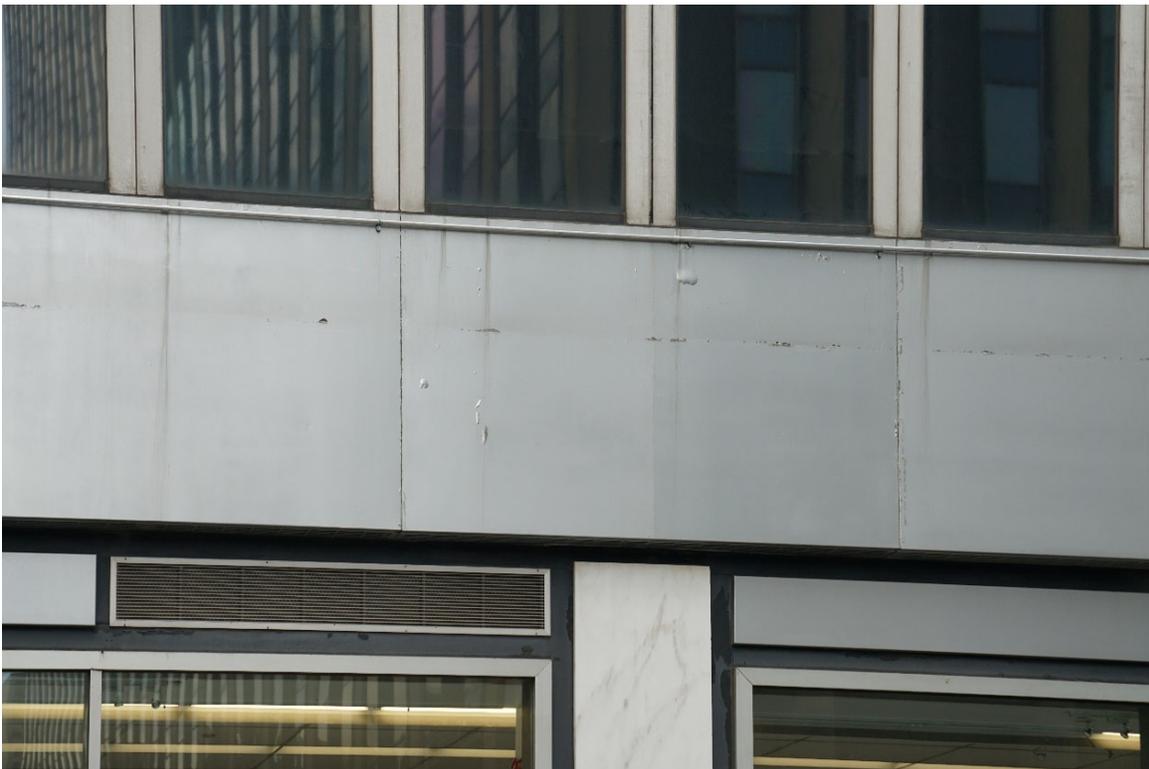
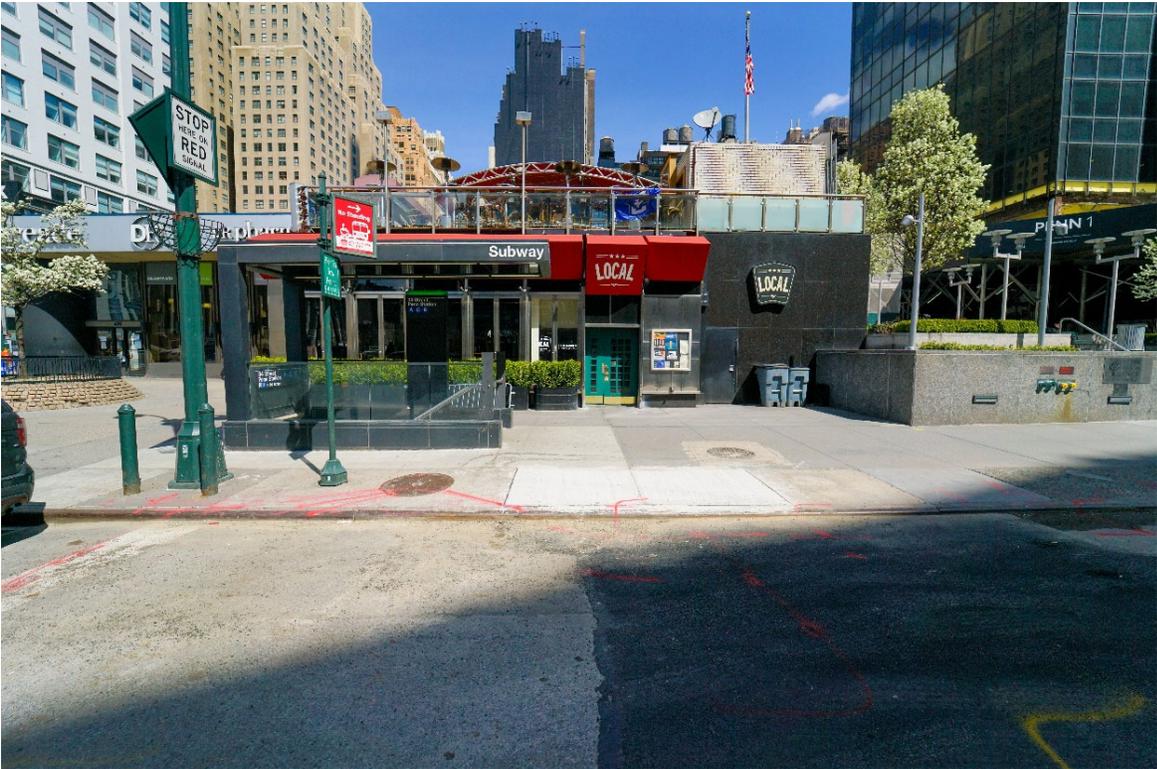
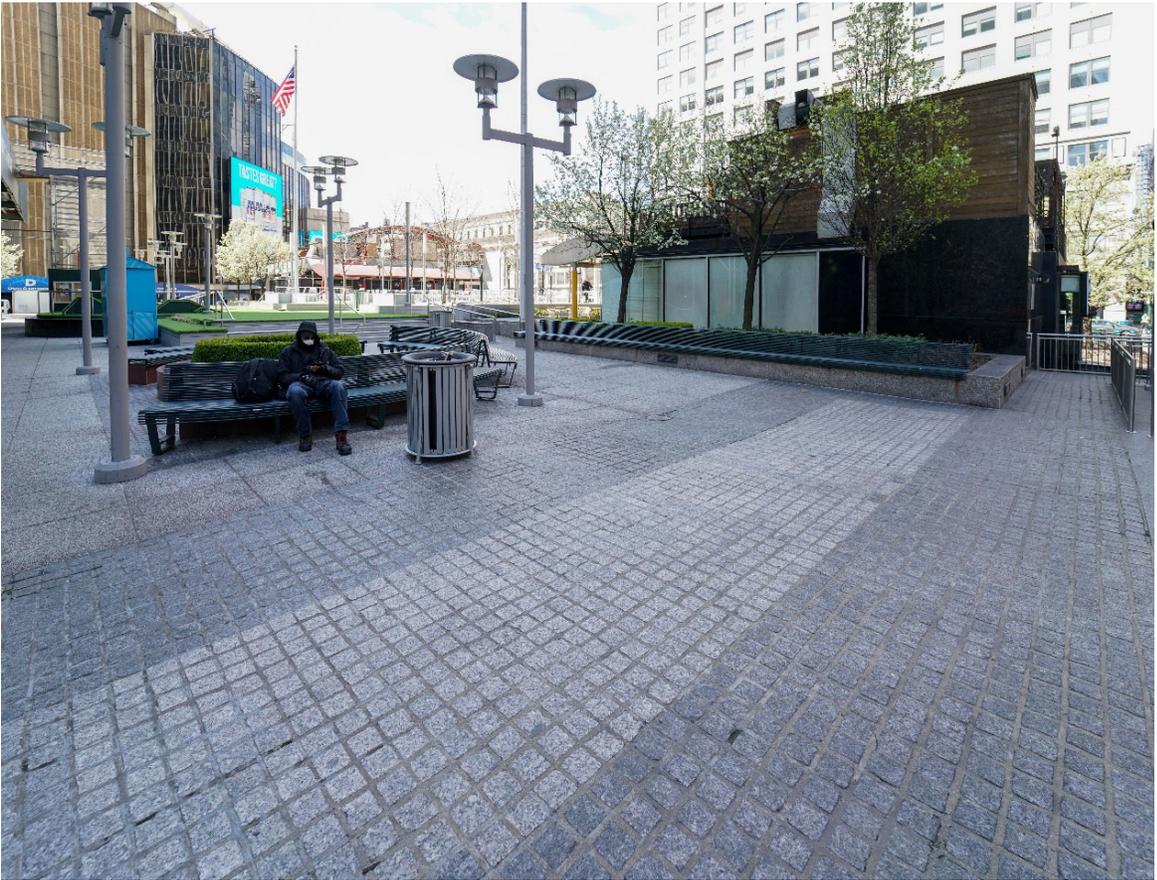
Figure 1-45 Block 783, Lot 70 Photographs

Lot 70 contains a 57-story office building known, two two-story retail buildings, and two public plazas areas. The office building, known as 1 Penn Plaza, has retail space on the ground floor. The façade consists of a metal and glass curtain wall system, a portion of which is undergoing construction and covered by scaffolding. The exterior walls, doors, and windows are in fair condition, showing moderate corrosion and staining. The building has an energy efficiency grade of B, as reported by the Mayor's Office of Sustainability.

The two-story retail store on the northwest portion of the lot (with frontage on West 34th Street) is occupied by a restaurant. The façade consists of a terracotta, metal, and glass storefront. The exterior walls, doors, and windows are in a fair condition, showing moderate cracking, staining, and corrosion. The building shows no barrier to accessibility at the ground-floor entrance.

The two-story retail store on the southwest portion of the lot (with frontage on West 33rd Street) is also occupied by restaurant. The façade consists of a stone, metal, and glass storefront. The exterior walls and doors are in fair condition, showing moderate corrosion and staining, while the windows are in good condition. Sidewalks are in fair condition, showing minor cracking, staining, and debris, while curb cuts are in good condition. Its ground floor entrance shows no barrier to accessibility.

The paved yard surface on the plaza is appears to be well-maintained, with minor staining.

Overall the building and site conditions were given a rating of fair, with each building being rated in fair condition.

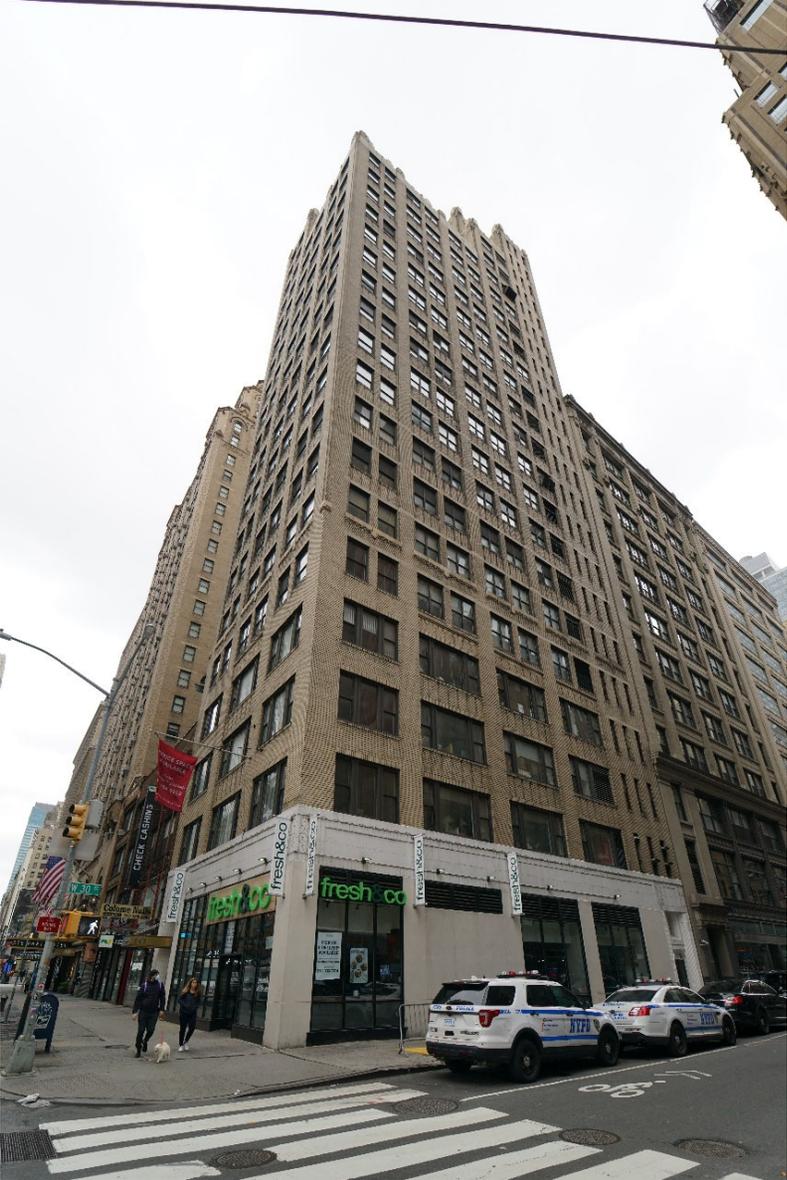
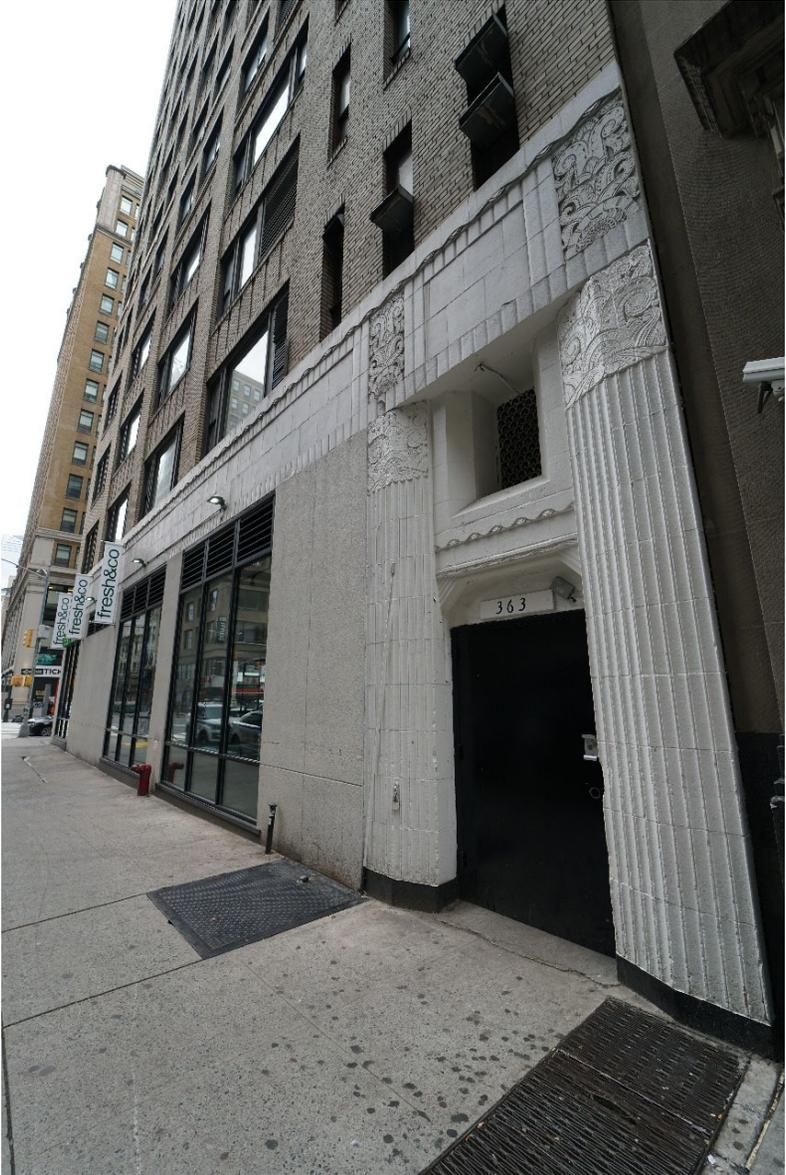
Figure 1-47 Block 806, Lot 1 Photographs

Lot 1 contains a 22-story building, with retail and an office lobby on the ground floor and office space on the upper floors. The façade consists of a metal, glass, and stone storefront on the lower floors, with bricks on the upper floors. The exterior wall on the lower floors is in good condition, but the upper brick wall is in fair condition, showing moderate corrosion and staining. The windows and doors are all in good condition. The sidewalk is in poor condition, showing cracking and staining, while curb cuts are in fair condition. The building shows no barrier to accessibility at the ground-floor entrance. Overall, the building and site conditions were given a rating of fair condition.
