EMPIRE STATION COMPLEX

Neighborhood Conditions Study

February 2021

FOR
Empire State Development

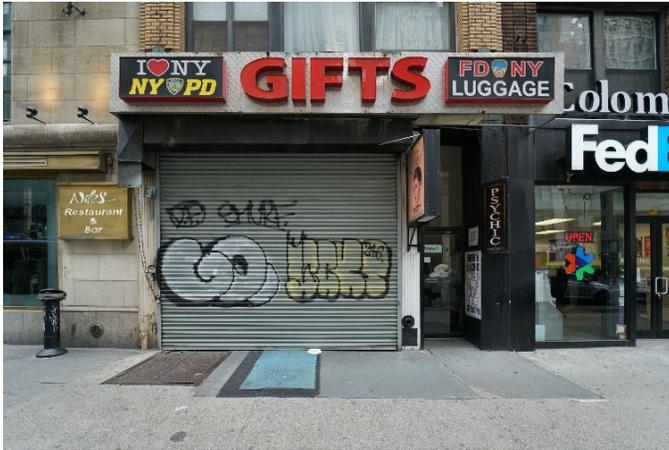
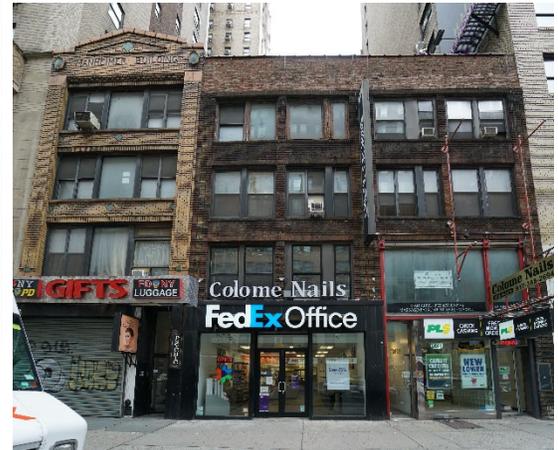
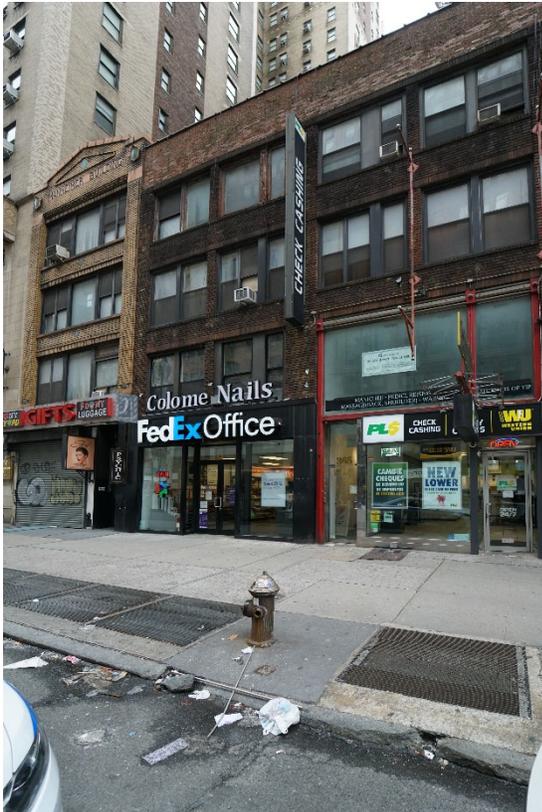
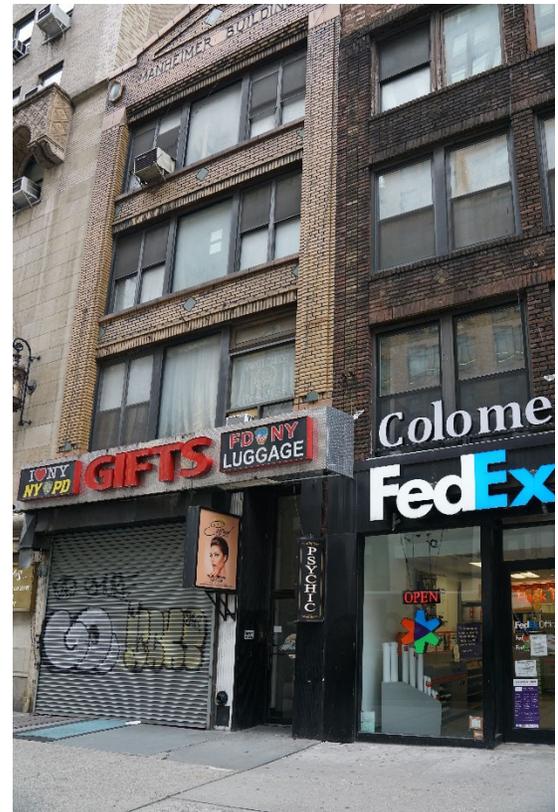
Figure 1-48 Block 806, Lot 3 Photographs

Lot 3 is shared by two four-story buildings, with retail on the ground floor and residential space on the upper floors. The façades of both buildings consist of a metal and glass storefront on the ground floor and brick on the upper floors. Building 101155's exterior wall is in poor condition, showing cracking, staining, and corrosion. Its doors are in good condition, and its windows in fair condition. The exterior wall of Building 101156 is in poor condition, showing cracking, staining, and corrosion. Its windows and doors are in fair condition. There are multiple spots of graffiti on the building's security shutter. Upper office space at Building 101156 was advertised for lease. The sidewalk is in fair condition, showing some cracking and staining, but has excessive amounts of garbage along the curb. Neither building shows a barrier to accessibility at the ground-floor entrance. The overall building and site condition was rated fair/poor with the two buildings scoring across both categories.

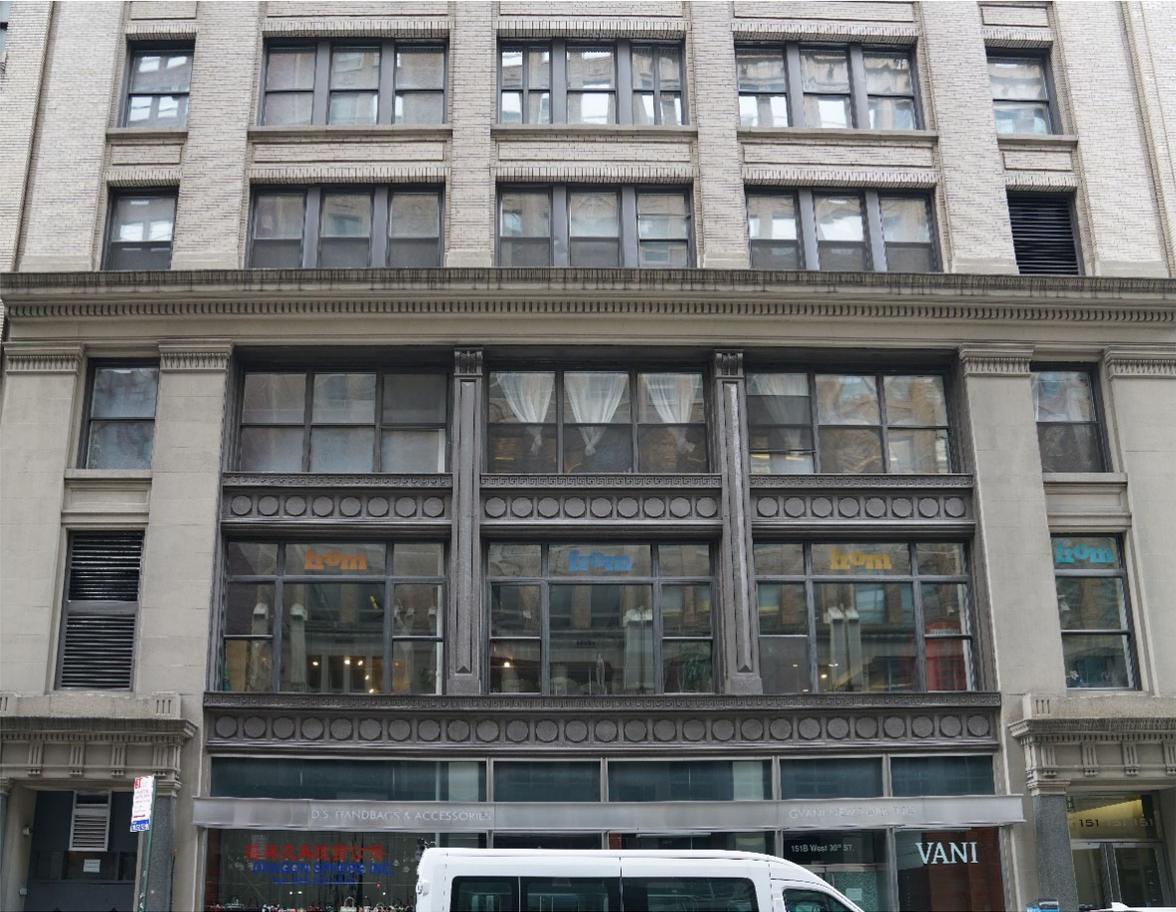
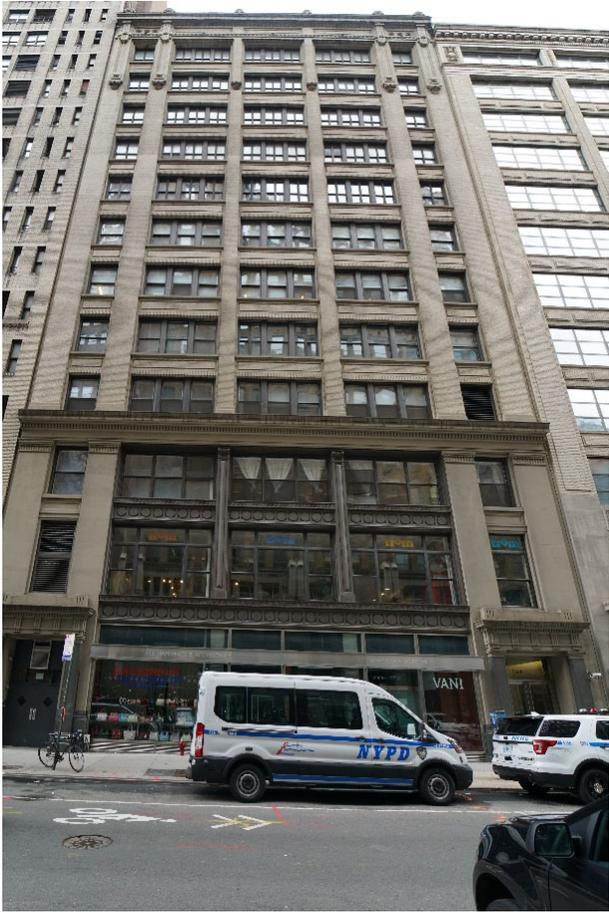
Figure 1-49 Block 806, Lot 6 Photographs

Lot 6 contains a 12-story building, with retail and an office lobby on the first three floors and office space on the upper floors. The façade consists of a metal, glass, and stone storefront on the lower floors and brick and stucco on the upper floors. The exterior walls are in fair condition, showing some staining and corrosion of the brick on the upper floors. The windows and doors are in good condition. The sidewalk is in fair condition, showing minor cracking and staining. The site is littered with a large amount of debris and garbage. The building has an energy efficiency grade of D, as reported by the Mayor's Office of Sustainability. The building shows no barrier to accessibility at the ground-floor entrance. Overall, the building and site conditions were given a rating of good condition.

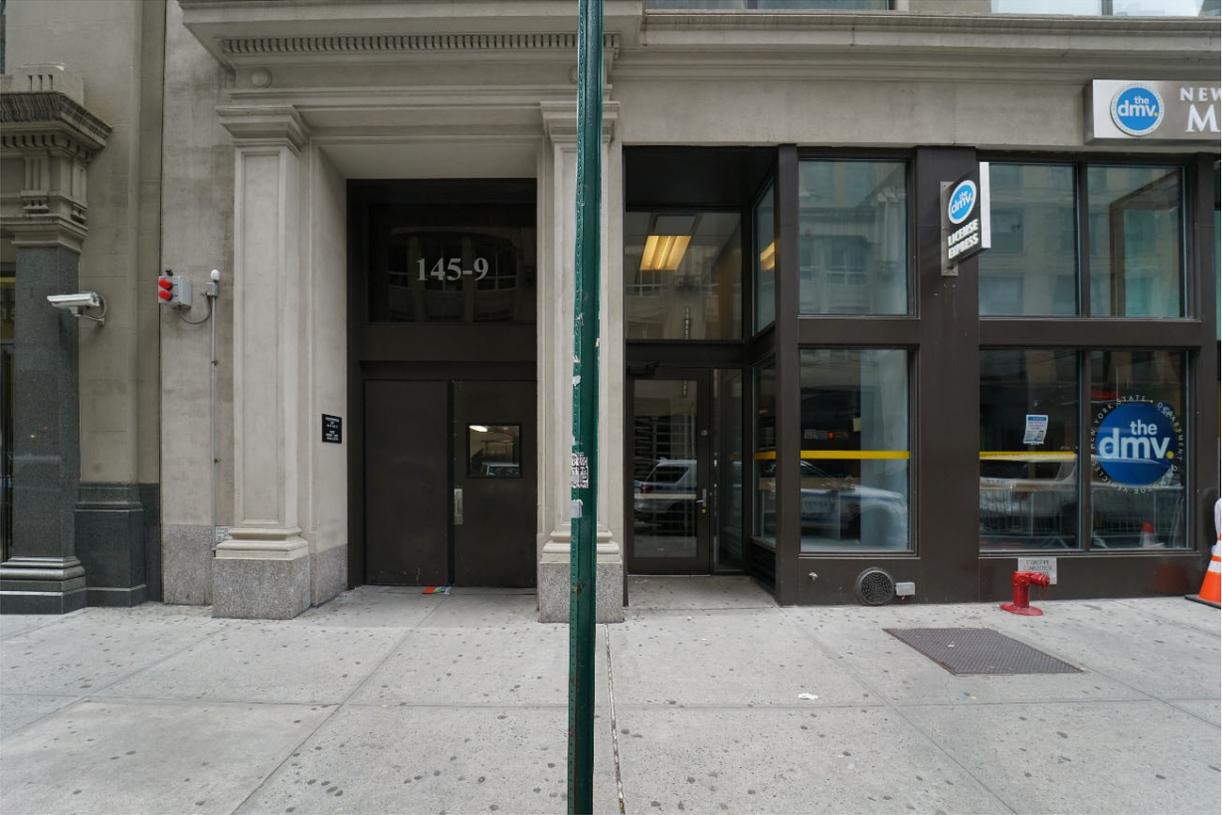
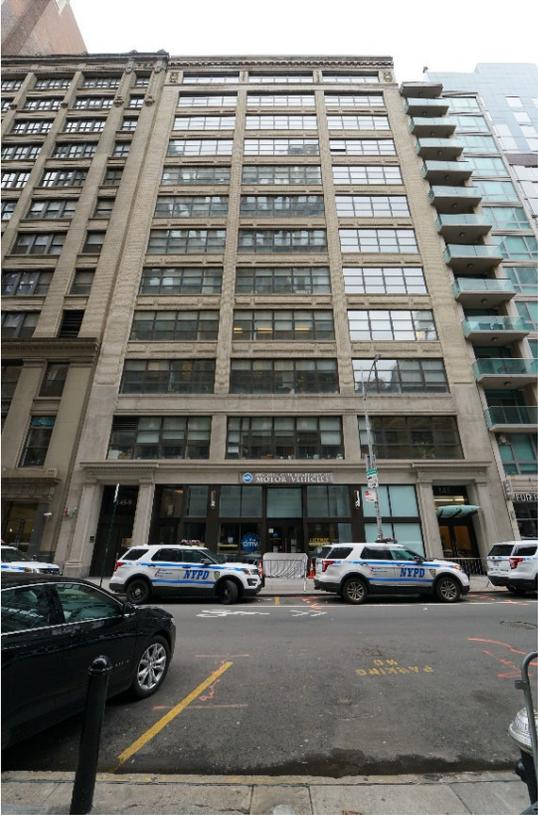
Figure 1-50 Block 806, Lot 9 Photographs

Lot 9 contains a 12-story building with a public office (the New York State Department of Motor Vehicles) and an office lobby on the ground floor, and office space on the upper floors. The façade consists of a metal, glass, and stone storefront on the ground floor and brick on the upper floors. The exterior walls, windows, and doors are in good condition. The sidewalk is in fair condition, showing minor cracking and staining, and is littered with a fair amount of debris and garbage. The building has an energy efficiency grade of A, as reported by the Mayor's Office of Sustainability. The building shows no barrier to accessibility at the street-level entrances. Overall, the building and site conditions were given a rating of good condition.

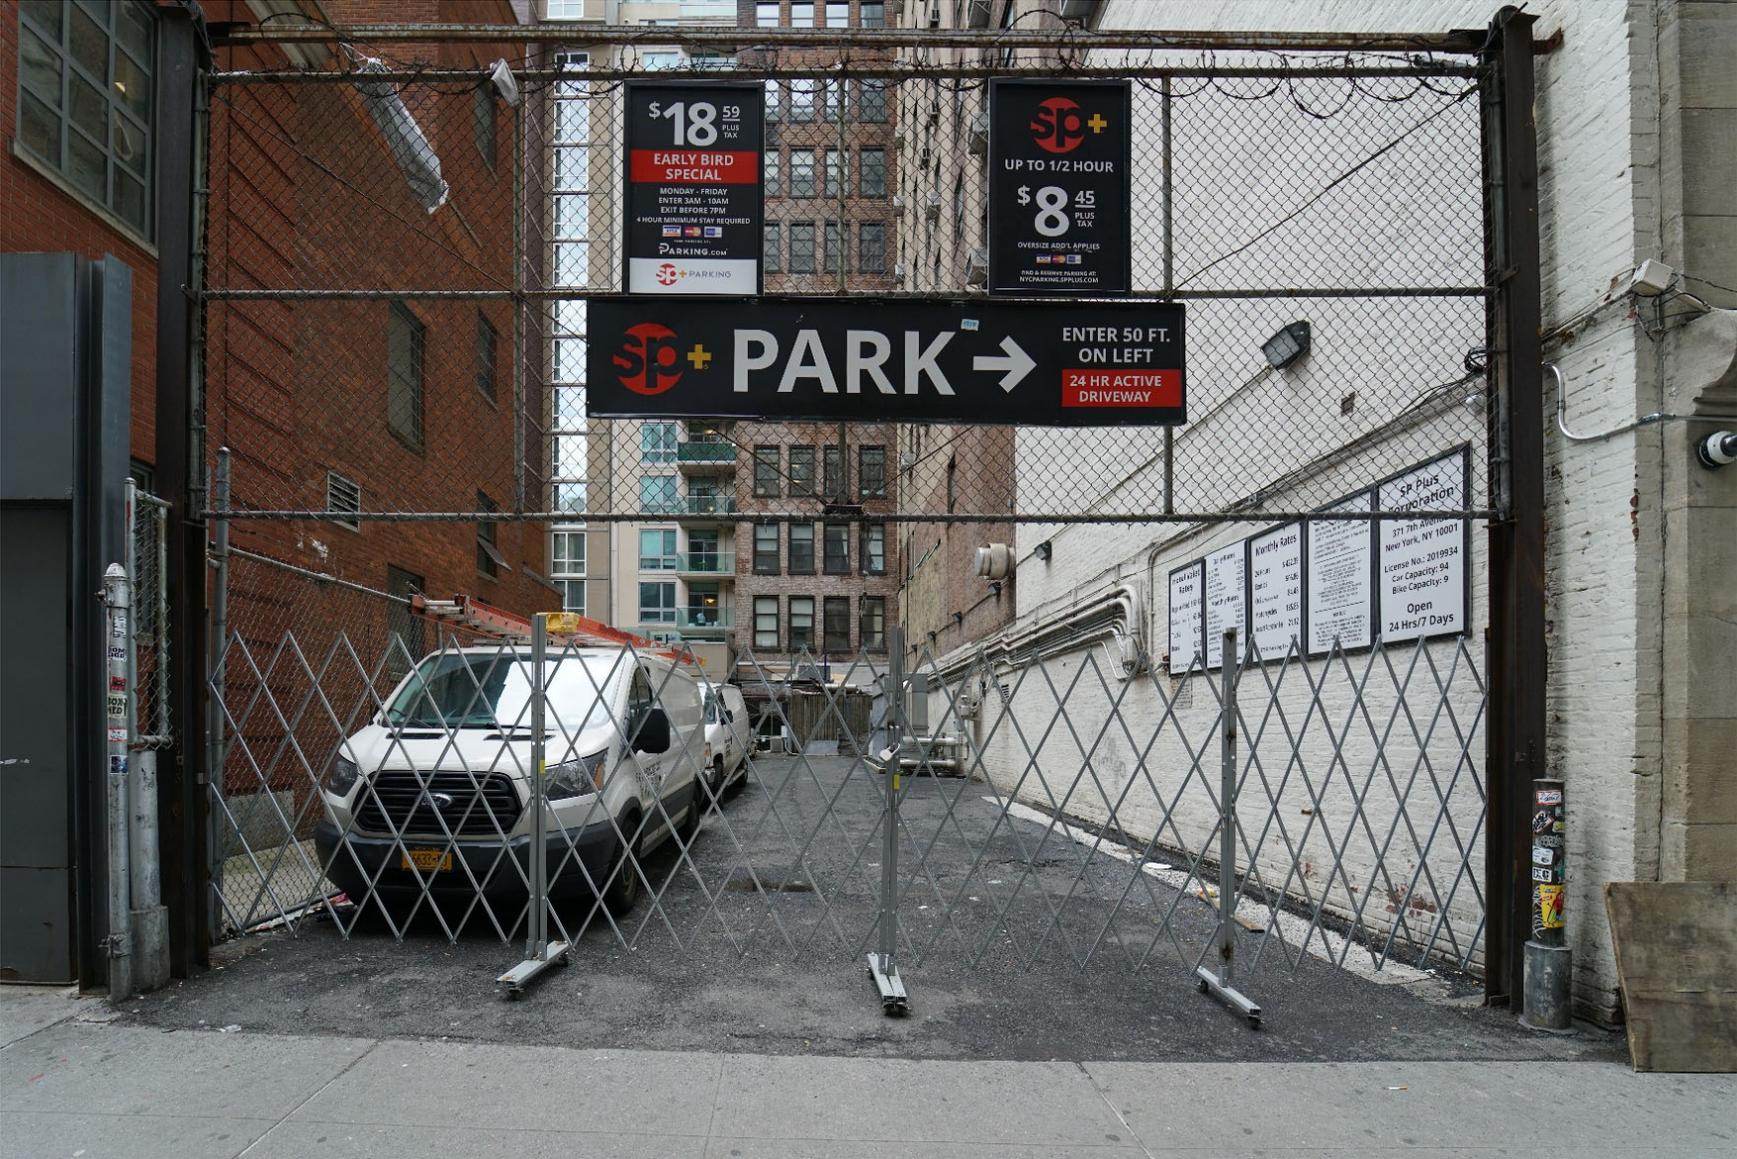
Figure 1-51 Block 806, Lot 69 Photographs

Lot 69 contains a parking lot. The sidewalk and curb cuts are in fair condition, showing some cracking. The security fence is also in fair condition, showing minor damage. The lot's surface is in poor condition and the cracking concrete has been covered with gravel. The sidewalk is littered with a moderate amount of garbage and debris. Overall, the building and site conditions were given a rating of fair condition.

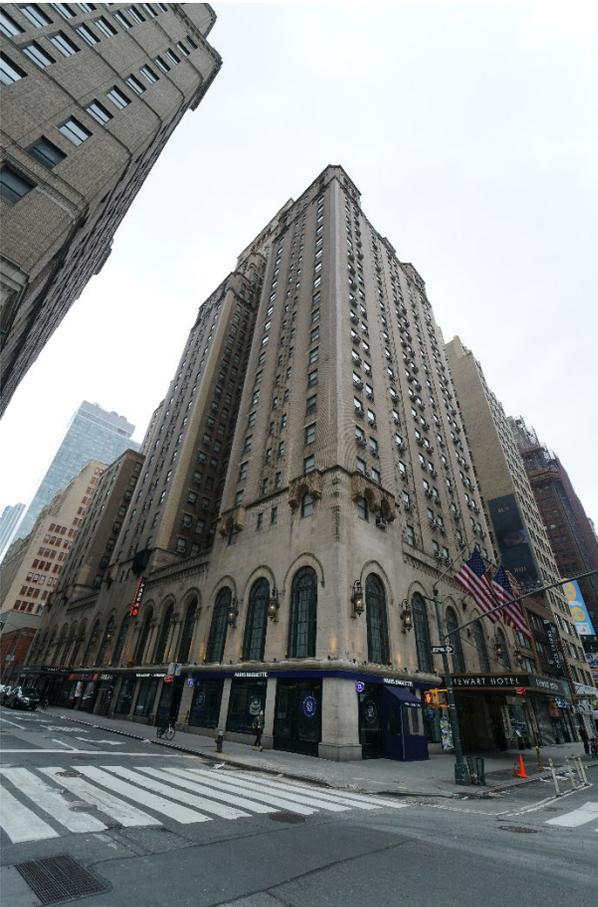
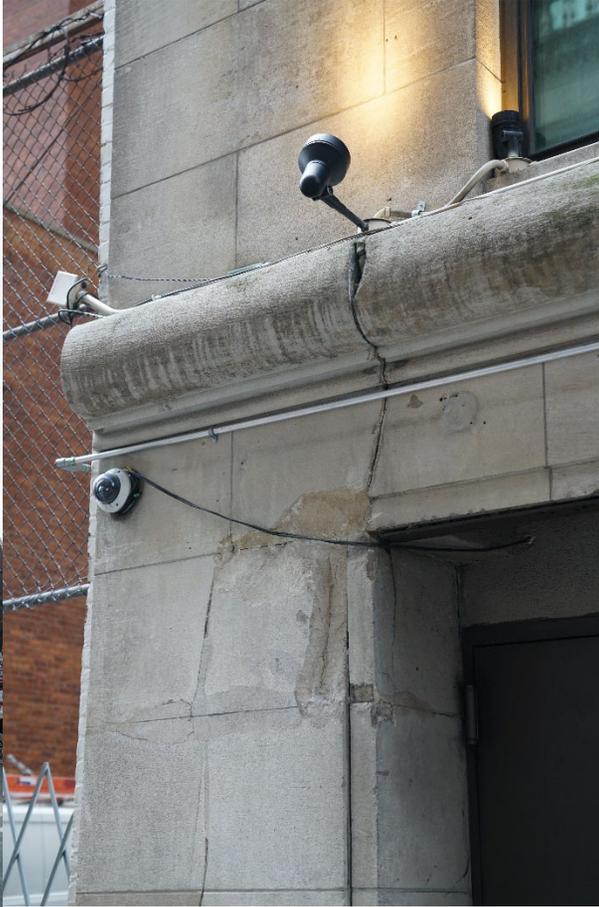
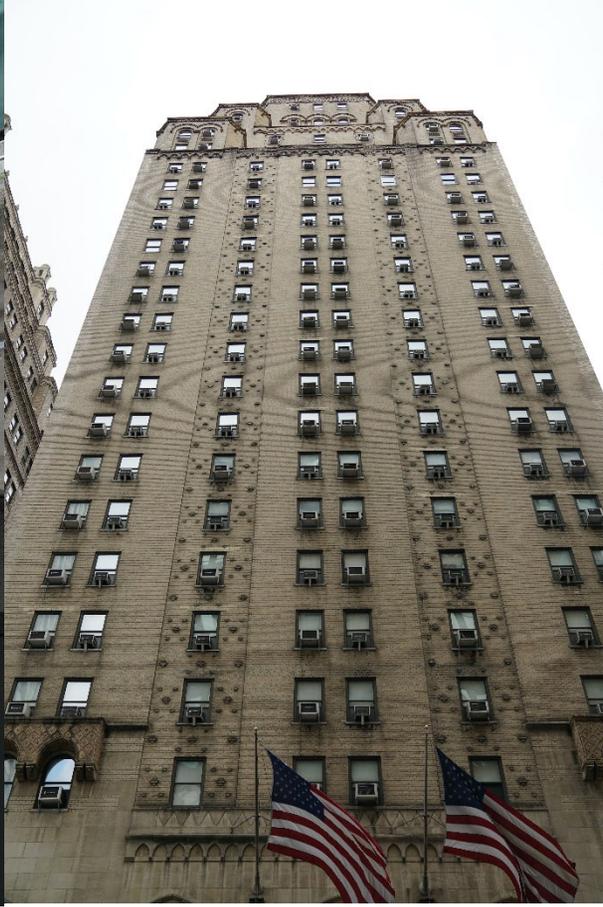
Figure 1-52 Block 806, Lot 76 Photographs

Lot 76 contains a 28-story building, with retail and a hotel lobby on the ground floor and a hotel on the upper floors. The façade consists of metal and stone on the first six levels and brick on the upper floors. The exterior walls are in poor condition, showing cracking, staining, and corrosion. The windows are in fair condition and the doors are in good condition. The sidewalk is in fair condition, but the curb cuts are in poor condition, showing cracking and staining. A large amount of garbage and debris can be found around the building. The building has an energy efficiency grade of D, as reported by the Mayor's Office of Sustainability. The building shows no barrier to accessibility at its ground-floor entrances. Overall, the building and site conditions were given a rating of poor condition.

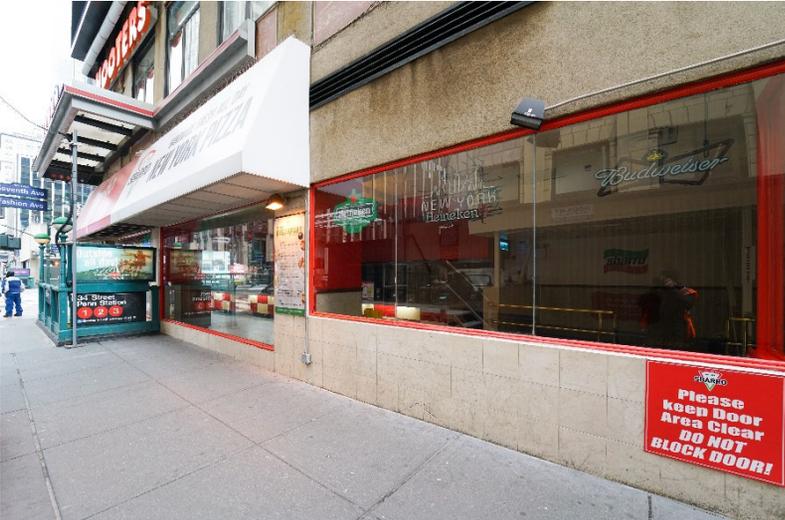
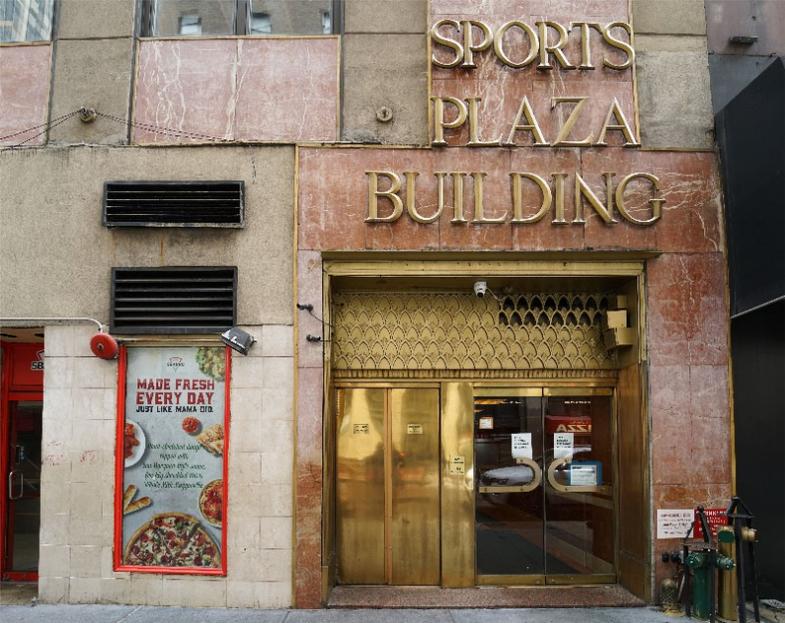
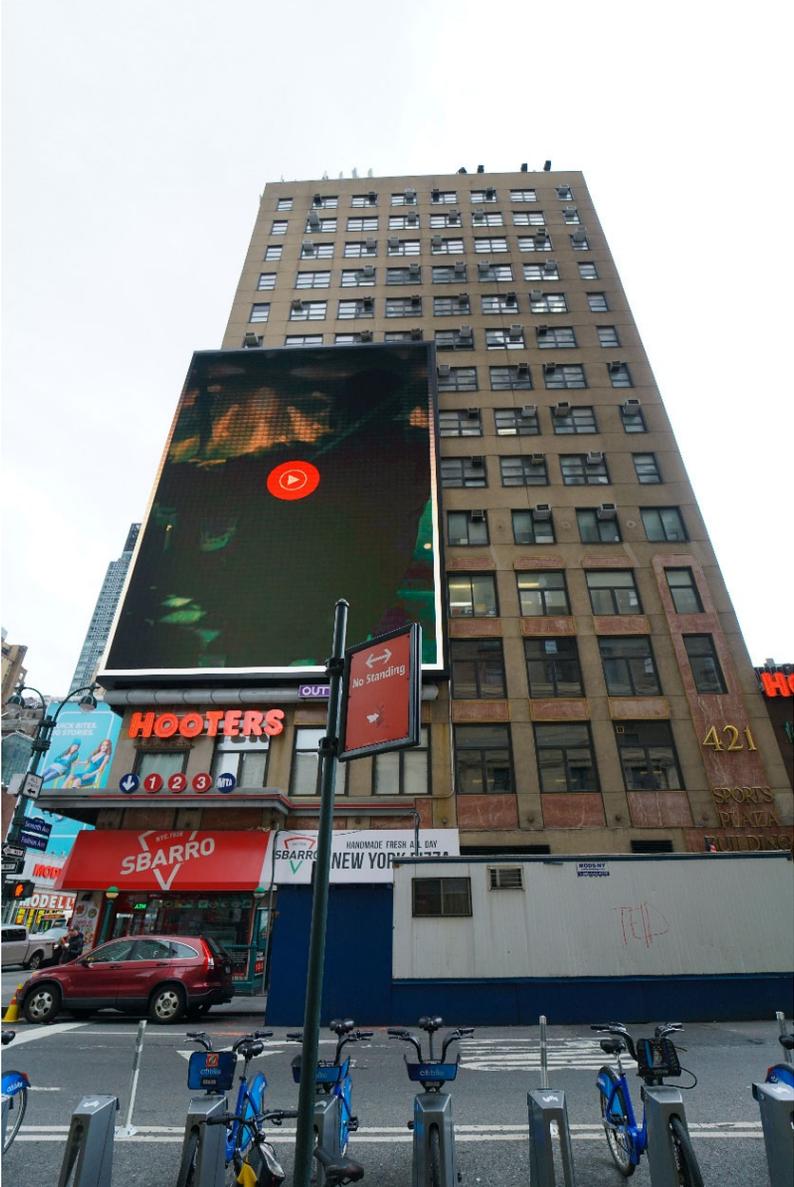
Figure 1-59 Block 809, Lot 1 Photographs

Lot 1 contains a 14-story office building, with retail on its lower two floors. A subway station entrance also occupies part of the ground floor. The façade consists of glass, metal, and stone on the two lower floors, and brick on the upper floors. A six-story digital display is attached to the south façade. The exterior walls are in poor condition, showing large amounts of cracking, staining, and erosion. The windows and doors are in fair condition. The sidewalk and curb cuts are in fair condition, showing some cracking and staining. A fair amount of garbage litters the sidewalks. The building has an energy efficiency grade of D, as reported by the Mayor’s Office of Sustainability. The building entrance is accessible by a small ramp. Overall, the building and site conditions were given a rating of fair condition.

Lot 1 has 15 open building code violations. One of the violations was issued by ECB in 2019 and relates to the building's sprinkler system. The remaining 14 violations were issued by DOB, most of which relate to construction and zoning at this property. No further details were provided by DOB records. Other DOB violations include those relating to the building's boilers and façade. There are two DOB violations that were issued within the last five years. They pertain to the façade (2017) and sprinkler system (2019).

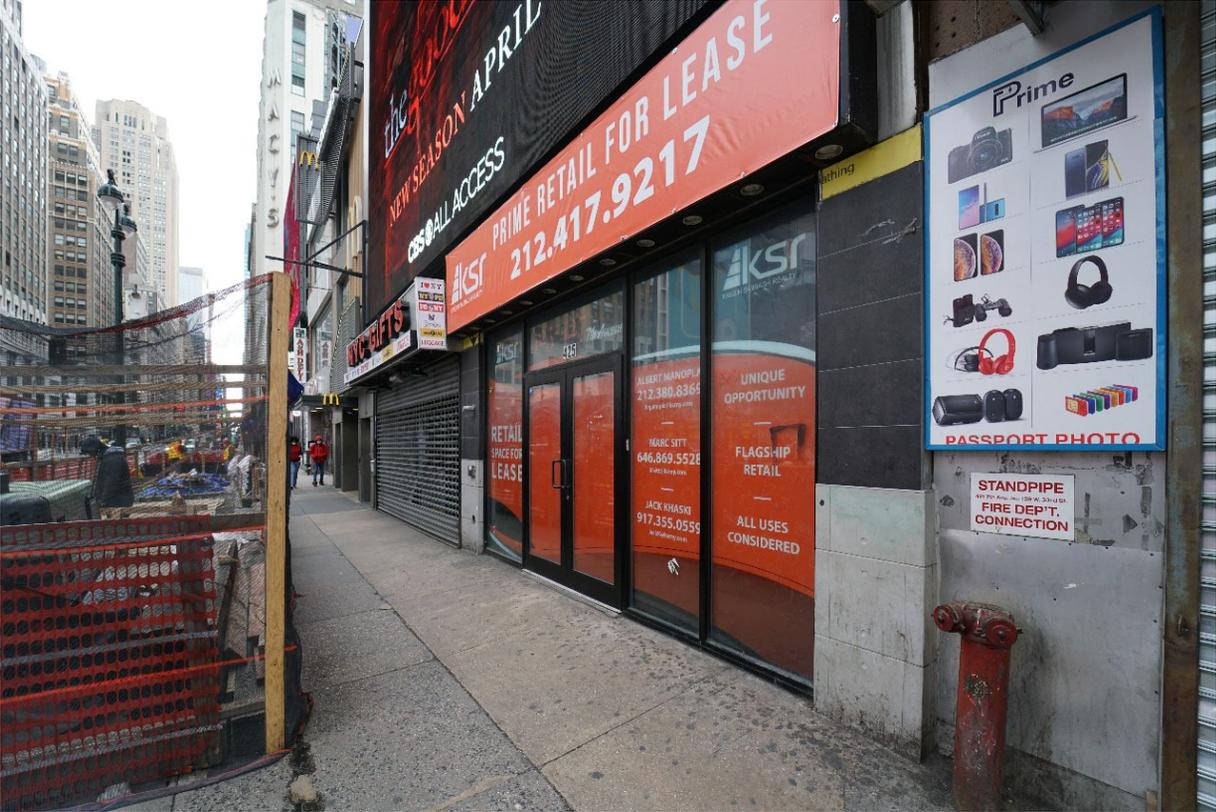
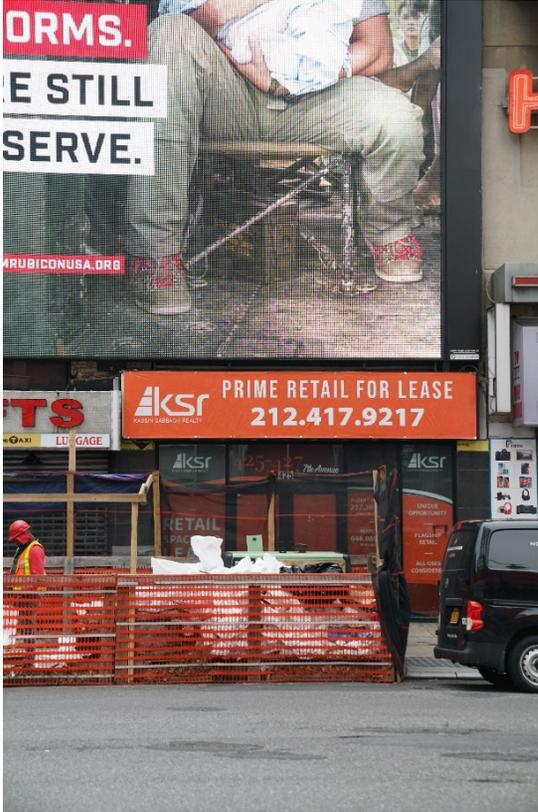
Figure 1-60 Block 809, Lot 3 Photographs

Lot 3 contains a three-story building, with retail on the ground floor and residential space on the upper floors. The façade consists of a metal and glass storefront on the ground floor and a digital display on the upper levels. The retail store appears to be vacant, showing a sign for lease. The exterior walls are in poor condition and the storefront is damaged. The windows are in fair condition and the doors are in good condition. The sidewalk is in poor condition, showing cracking and staining; it appears to be under construction. A fair amount of garbage litters the sidewalks. The building has an energy efficiency grade of D, as reported by the Mayor's Office of Sustainability. The building entrance shows no barrier to accessibility. Overall, the building and site conditions were given a rating of good condition.

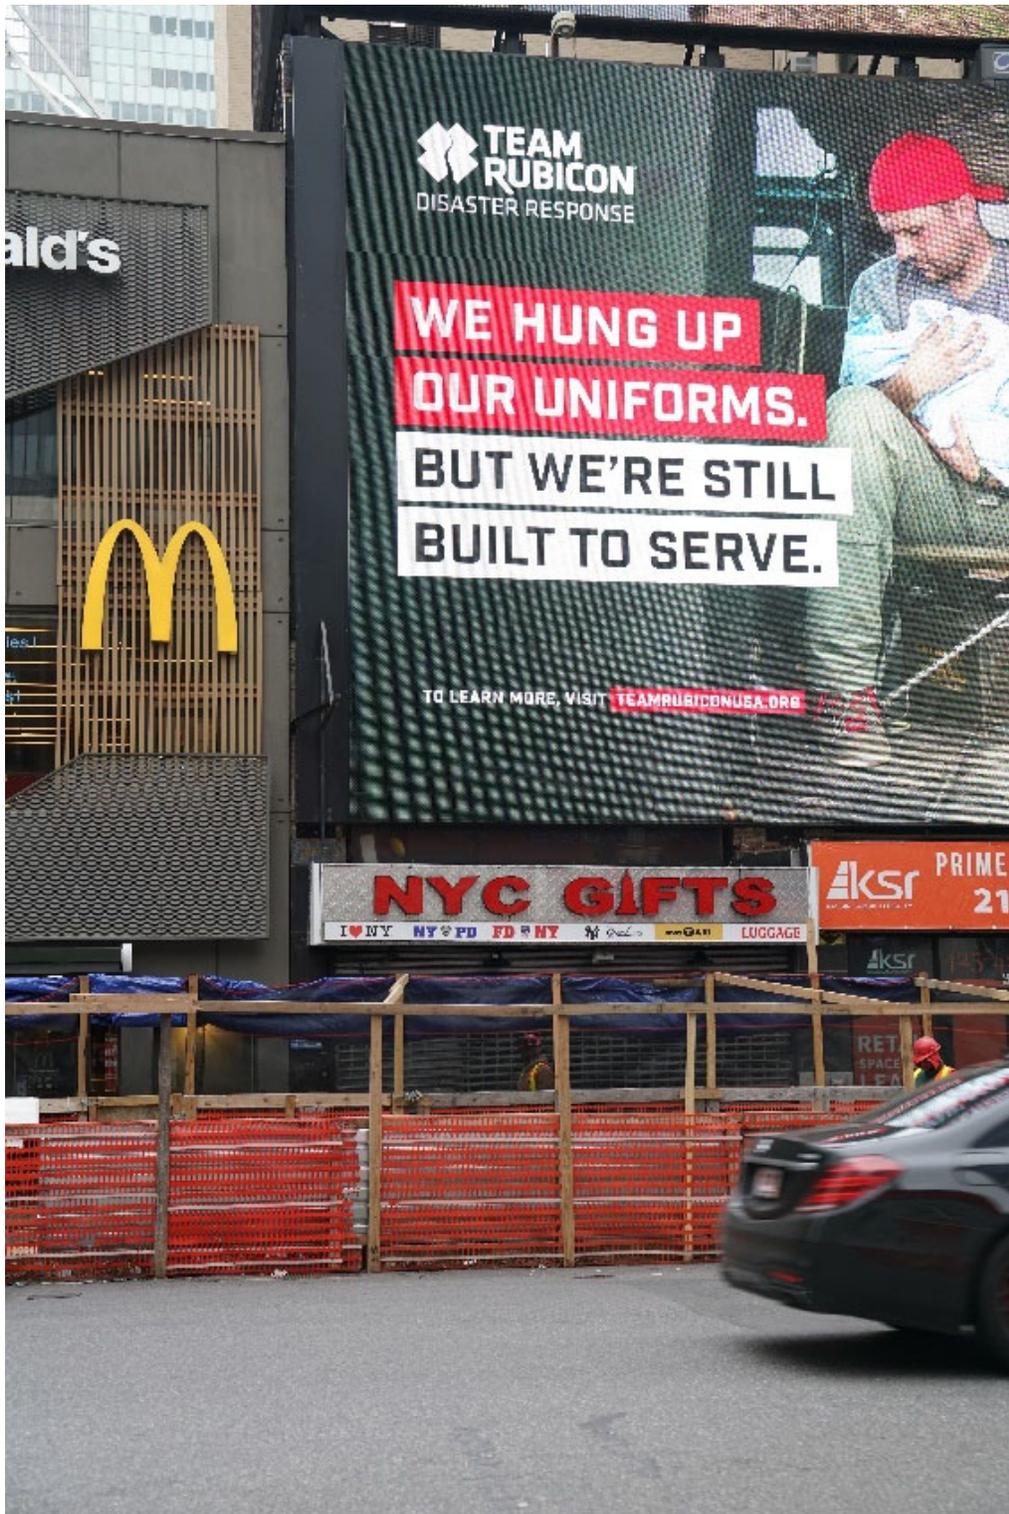
Figure 1-61 Block 809, Lot 4 Photographs

Lot 4 contains a three-story building, with retail on the ground floor and residential space on the upper floors. The façade consists of a metal and glass storefront on the ground floor and a digital display on the upper floors. The exterior walls are in fair condition, with some damage to the storefront. The doors and windows are in fair condition. The sidewalk is in fair condition, showing some cracking and staining; it appears to be under construction. A fair amount of garbage litters the sidewalks. The building entrance shows no barrier to accessibility. Overall, the building and site conditions were given a rating of fair condition.

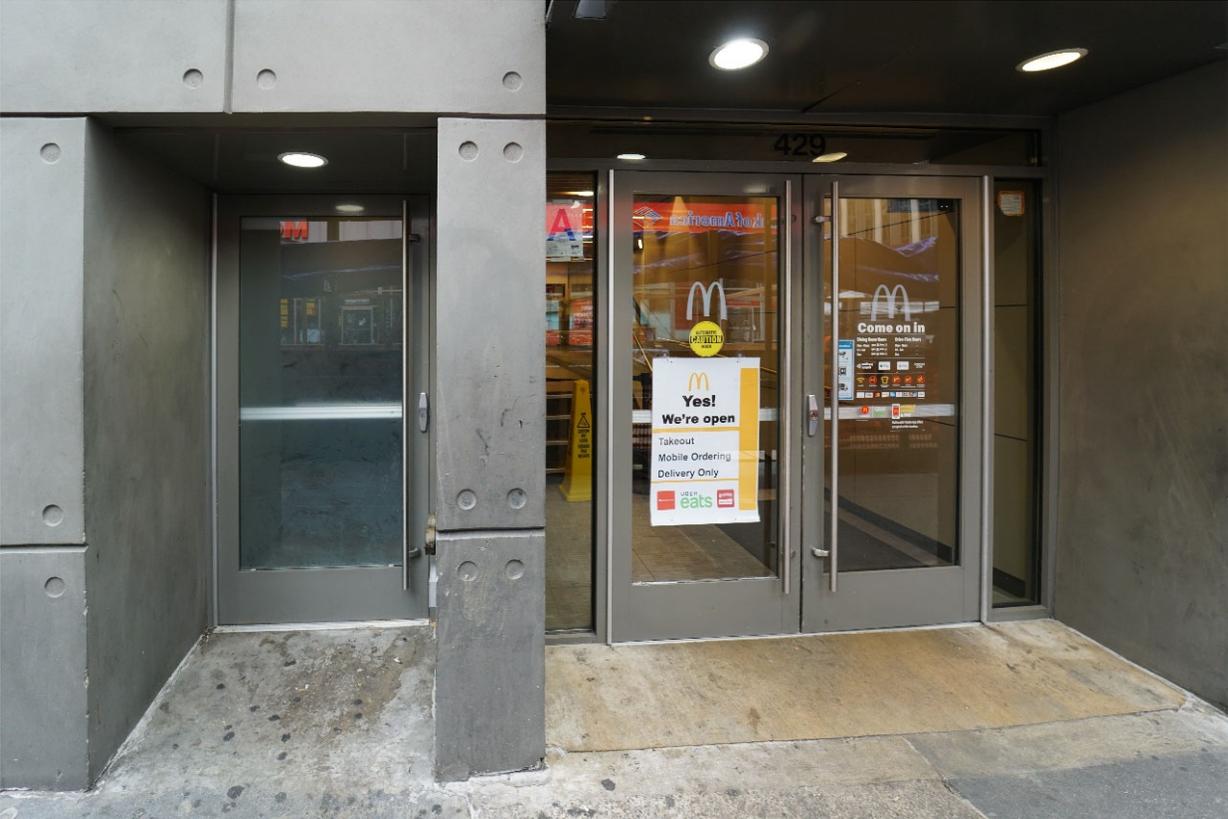
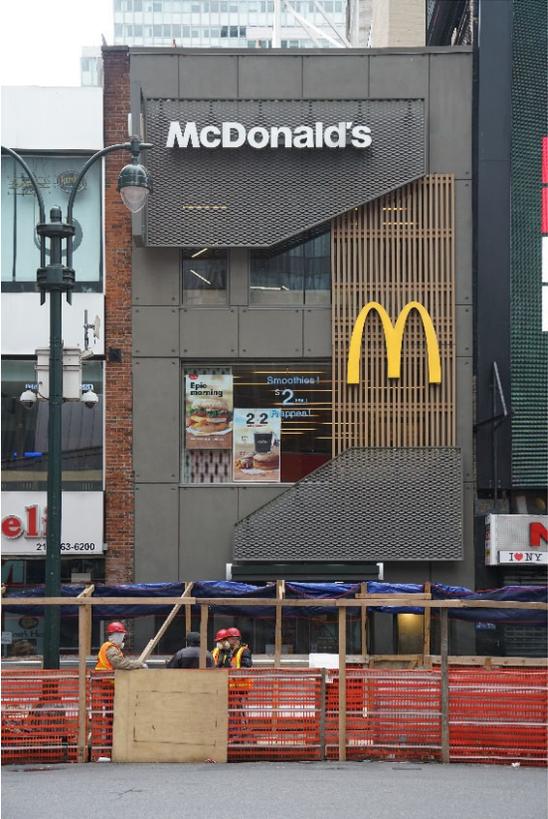
Figure 1-62 Block 809, Lot 5 Photographs

Lot 5 contains a three-story retail building. The façade consists of a metal and glass storefront, with some decorative wood. The exterior walls, windows, and doors are in good condition. The sidewalk is in fair condition, showing some cracking and staining, and appears to be under construction. A fair amount of garbage litters the sidewalks. The building shows no barrier to accessibility at the ground-floor entrance. Overall, the building and site conditions were given a rating of good condition.

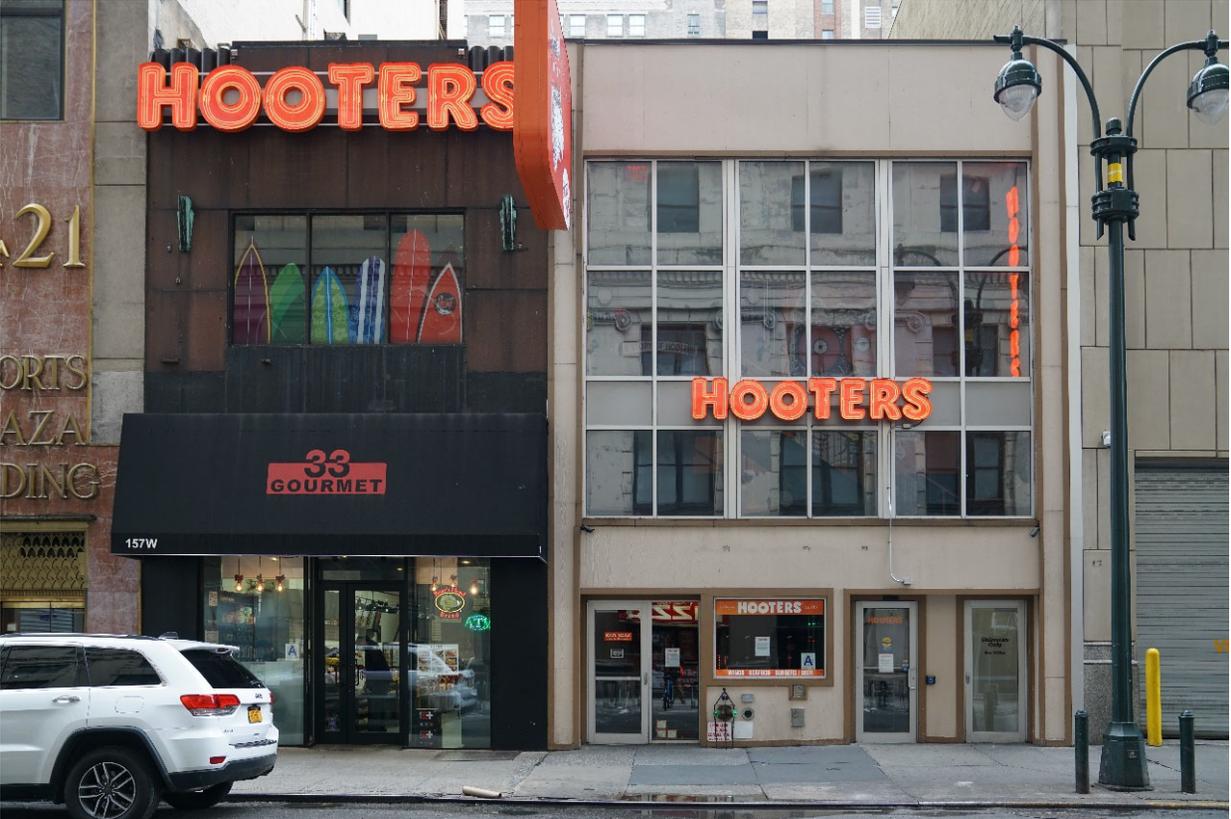
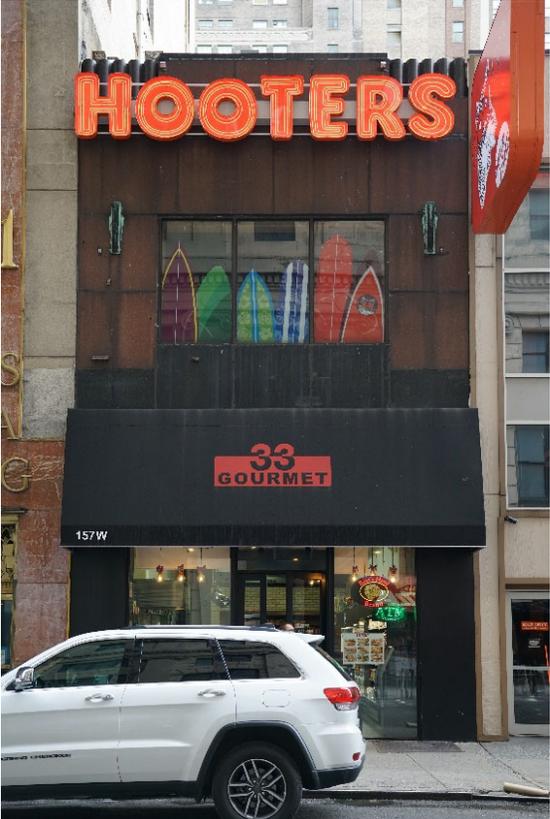
Figure 1-63 Block 809, Lot 8 Photographs

Lot 8 appears to contain two two-story retail buildings leased by the same tenant. The westernmost building's façade consists of a metal and glass storefront on ground floor and stone on the upper floors. The easternmost building's façade consists of stucco and glass on the ground floor and stucco, metal, and glass on the upper floors. The exterior walls, doors, and windows are in fair condition. The sidewalk is in poor condition, showing large cracking and staining. A fair amount of garbage litters the sidewalk. Both buildings show no barrier to accessibility at their ground floor entrances. Overall, the building and site conditions were given a rating of fair condition.

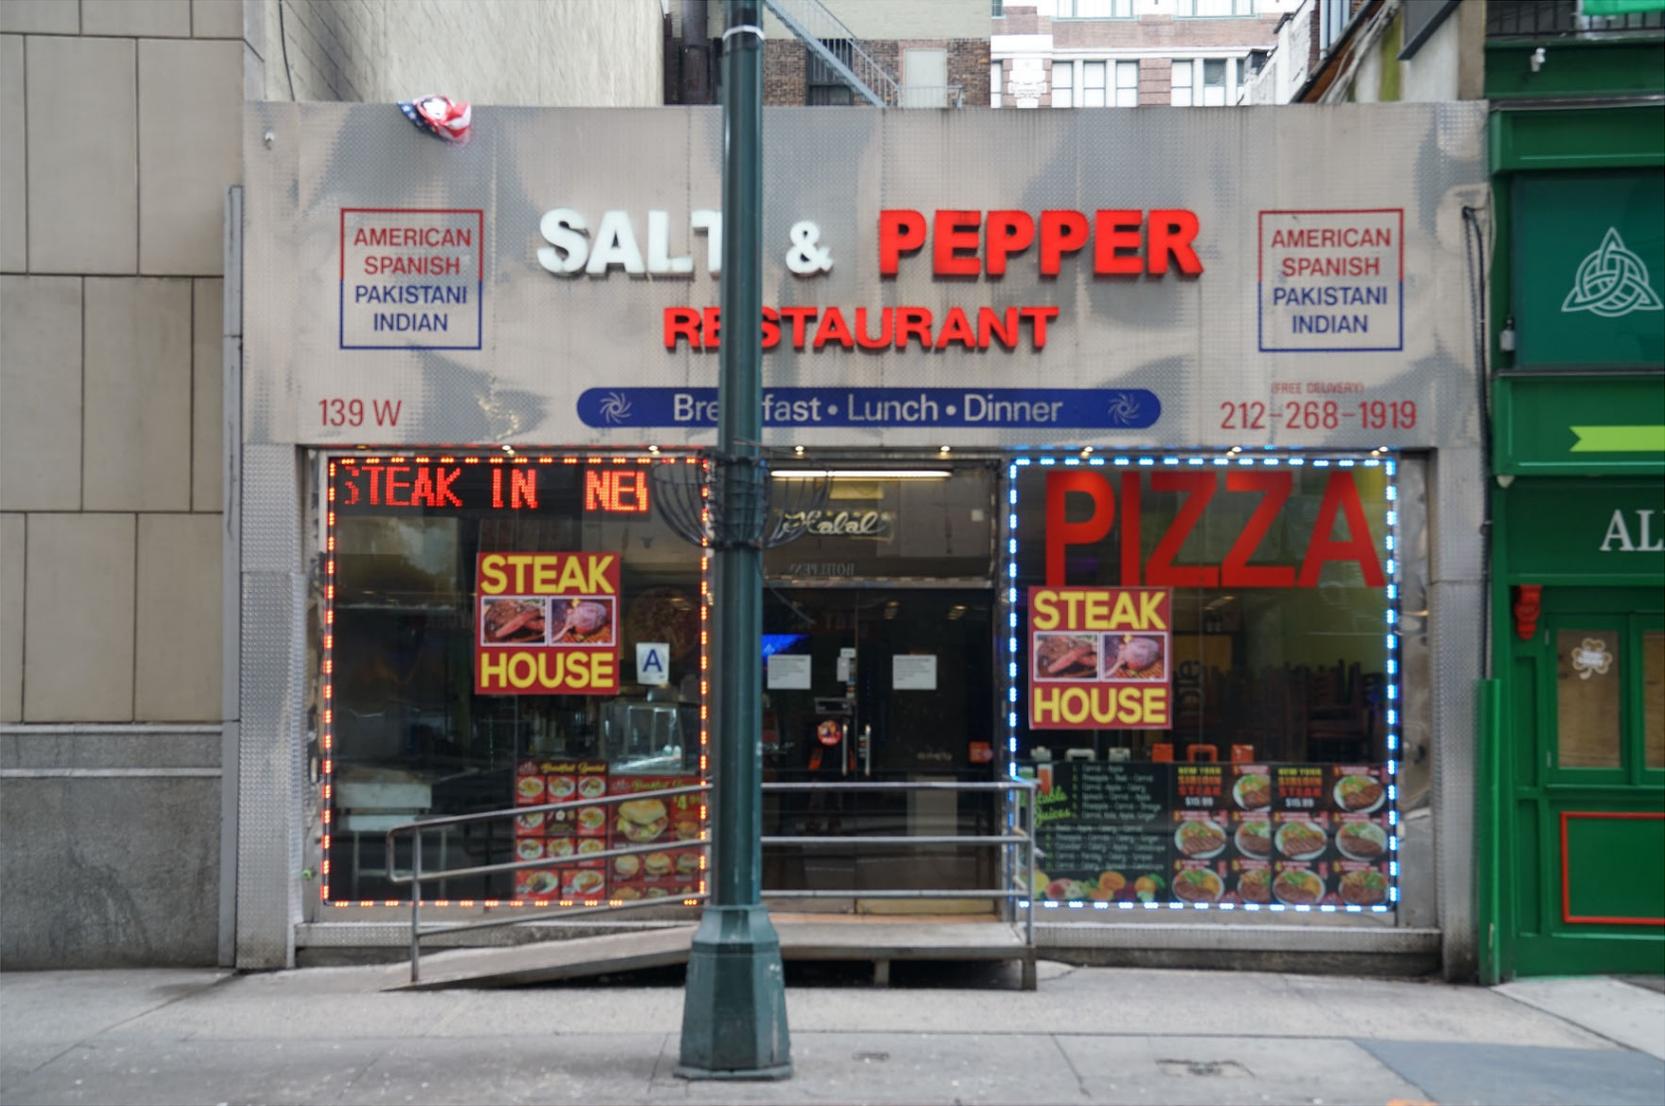
Figure 1-64 Block 809, Lot 16 Photographs

Lot 16 contains a one-story retail store. The façade consists of a metal and glass storefront. The exterior walls, windows, and doors are all in fair condition. The sidewalk is in fair condition, showing some cracking and staining. A fair amount of garbage litters the sidewalks. The building is accessible via an entry ramp. Overall, the building and site conditions were given a rating of fair condition.

Lot 16 has one open building code violation that was issued by ECB in 2011. This violation is for “failure to maintain building in code-compliant manner.” Although not classified as hazardous by ECB, the violation notes a large vertical crack in the eastern concrete and brick wall. In addition, an approximately 12-inch section of brickwork on the front facing façade was dislodged.

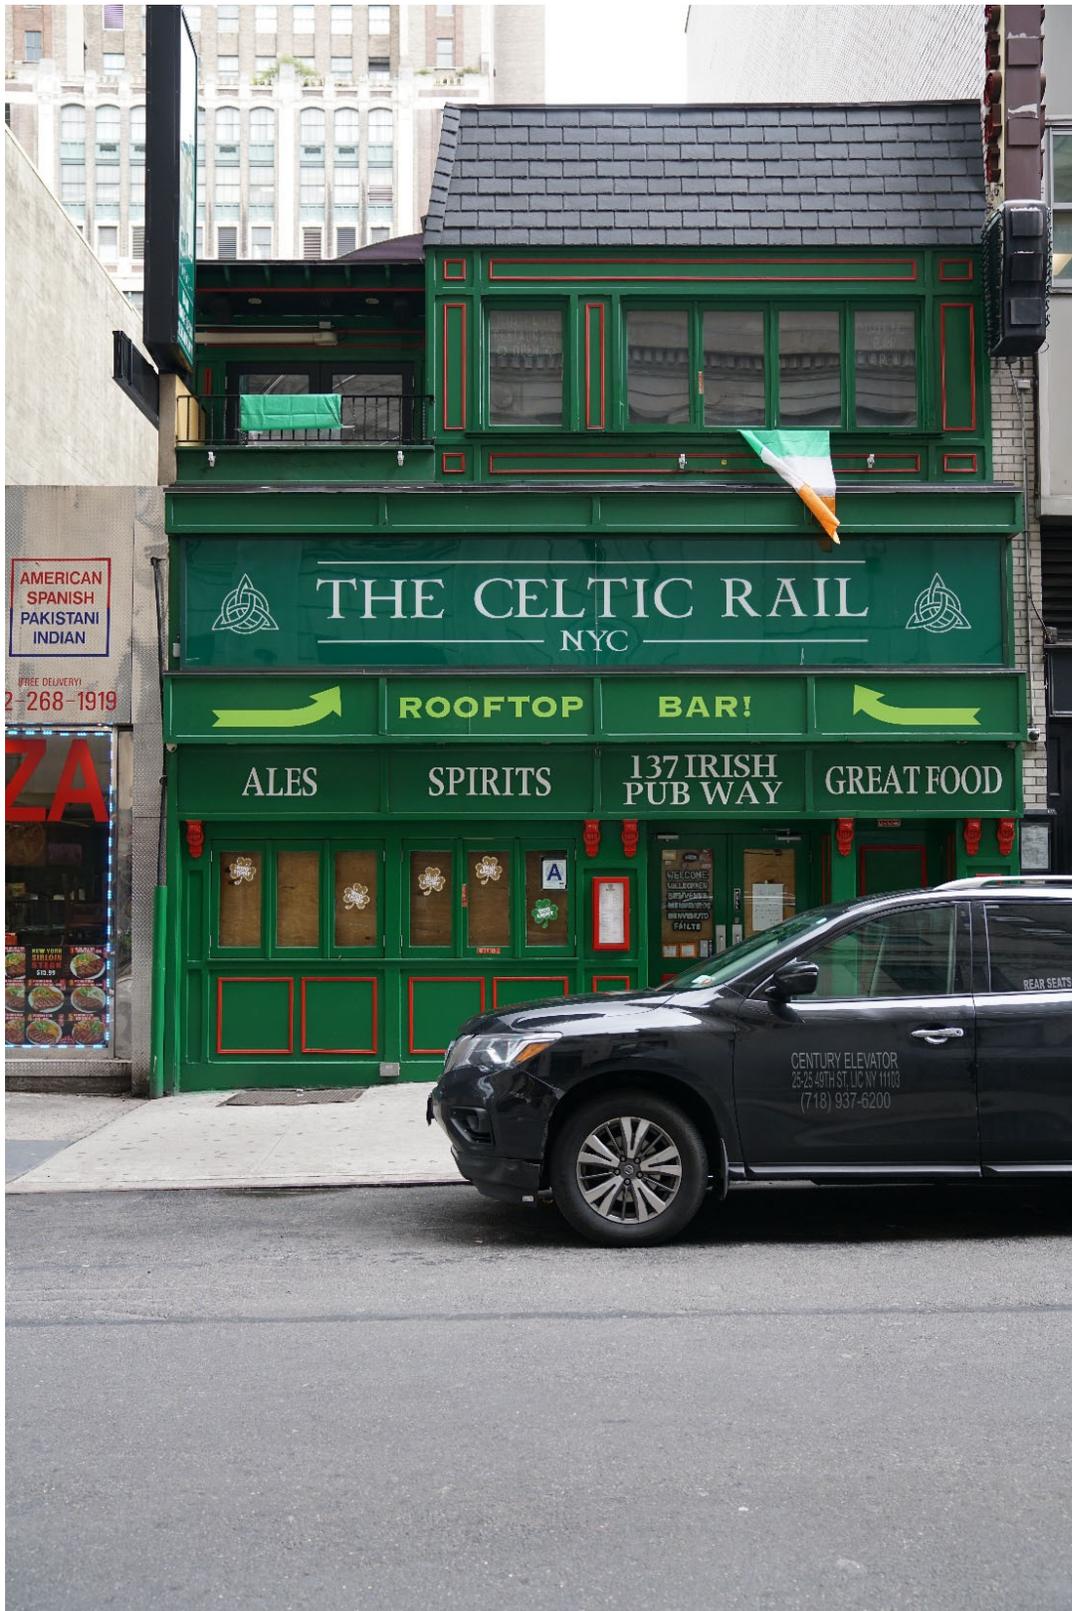
Figure 1-65 Block 809, Lot 17 Photographs

Lot 17 contains a two-story retail building. The façade consists of a glass and wood-paneled storefront. The exterior walls, windows, and doors are all in good condition. The sidewalk is in good condition, though there was a fair amount of garbage. The entrance shows no barrier to accessibility at the street level. Overall, the building and site conditions were given a rating of good condition.
