EMPIRE STATION COMPLEX

Neighborhood Conditions Study

February 2021

FOR
Empire State Development

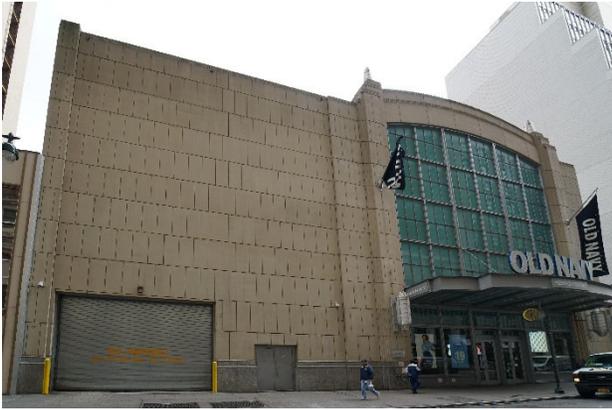
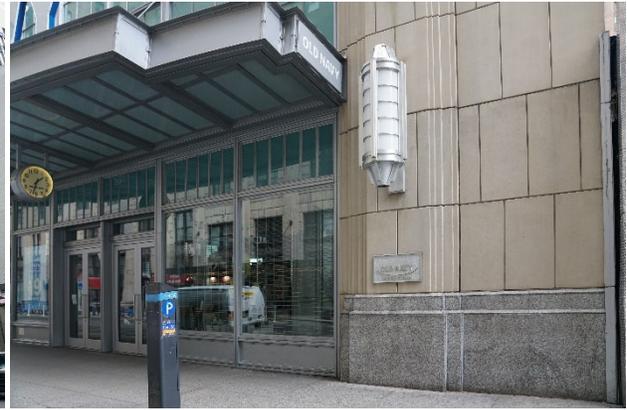
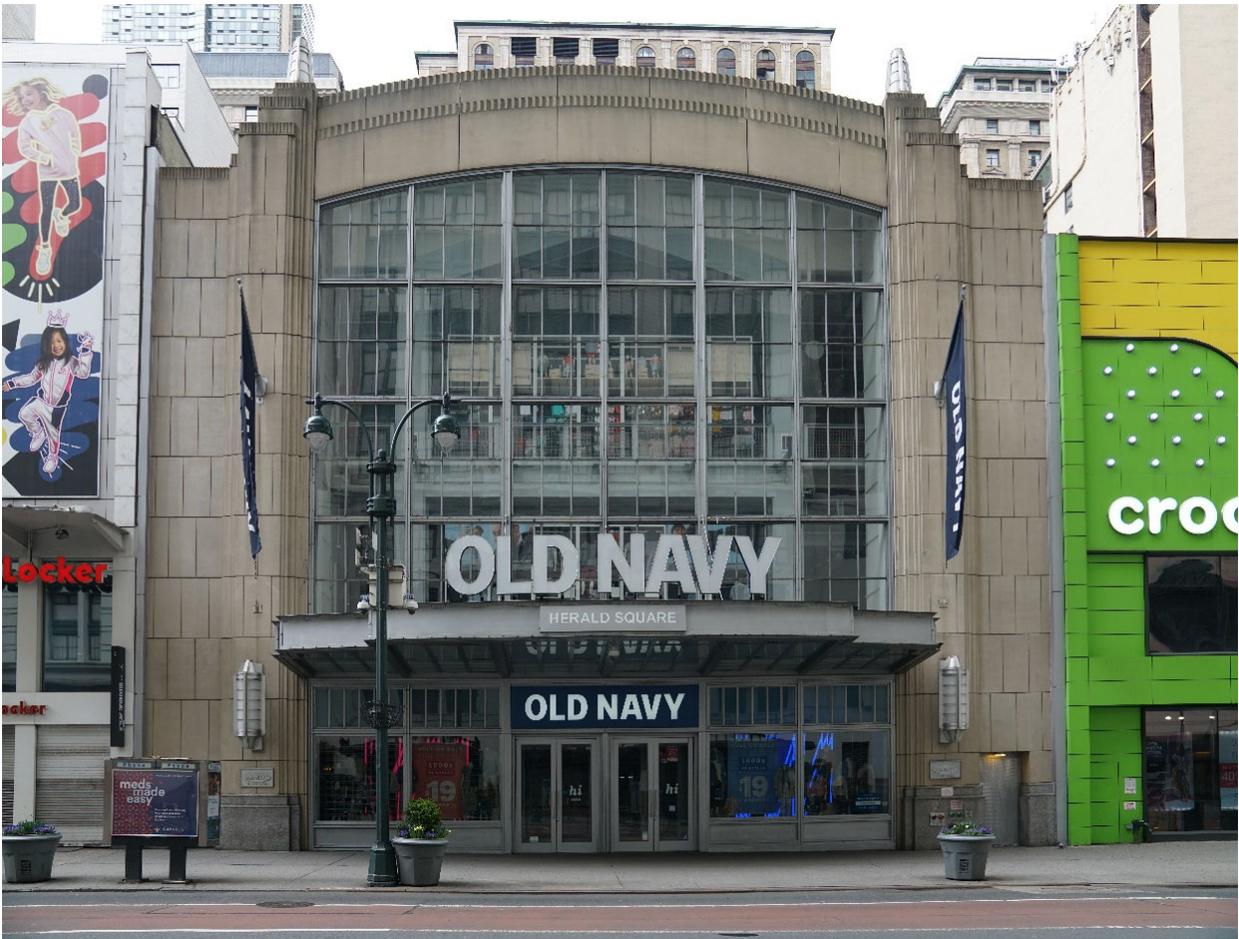
Figure 1-66 Block 809, Lot 69 Photographs

Lot 69 contains a three-story retail building, with entrances on West 33rd Street and West 34th Street. The façade consists of stone, metal, and glass. The exterior walls and windows are in fair condition, showing some corrosion and staining. The doors are in good condition. The sidewalk is in fair condition, showing some cracking and staining, and a fair amount of garbage litters the sidewalk. The building shows no barrier to accessibility at the ground-floor entrance. Overall, the building and site conditions were given a rating of fair condition.

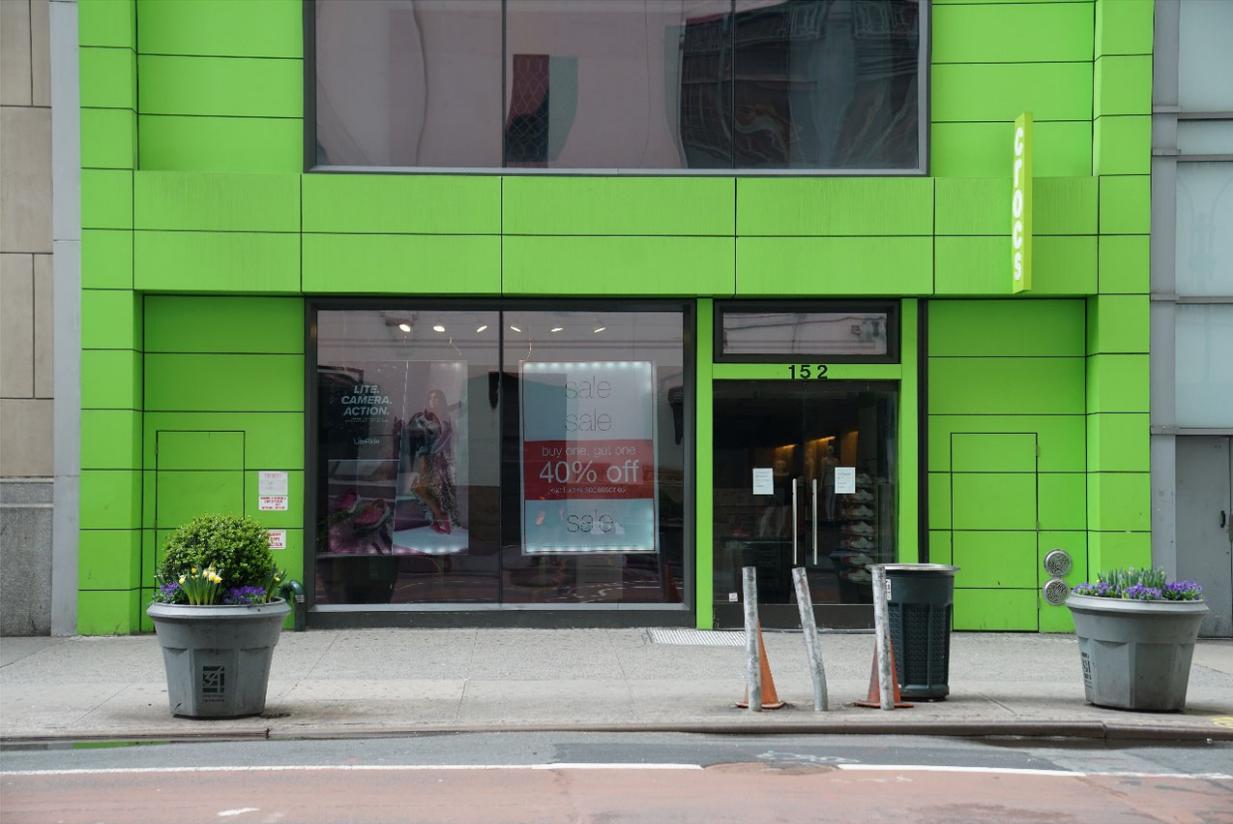
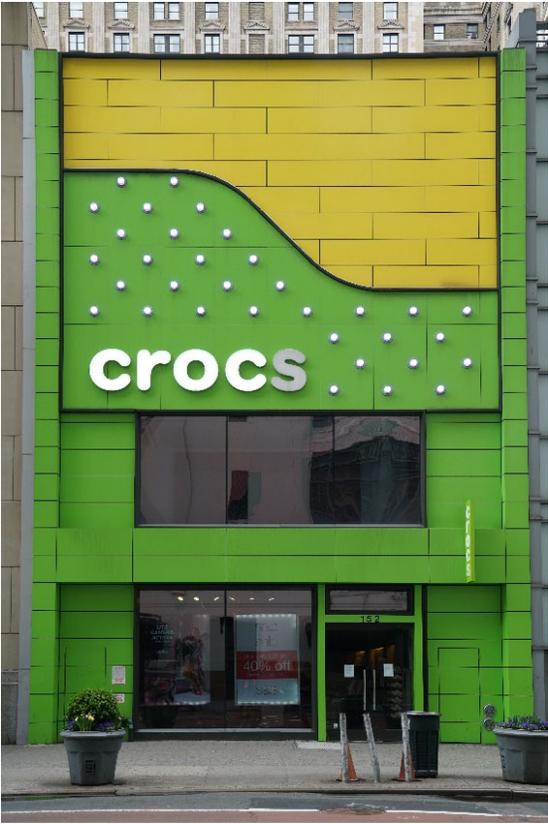
Figure 1-67 Block 809, Lot 73 Photographs

Lot 73 contains a three-story retail building. The façade consists of metal panels and a glass storefront on the ground floor. The exterior walls, doors, and windows are in good condition. The sidewalk is in fair condition, showing some cracking and staining, and is littered with a fair amount of garbage. The building shows no barrier to ADA accessibility at its ground-floor entry. Overall, the building and site conditions were given a rating of good condition.

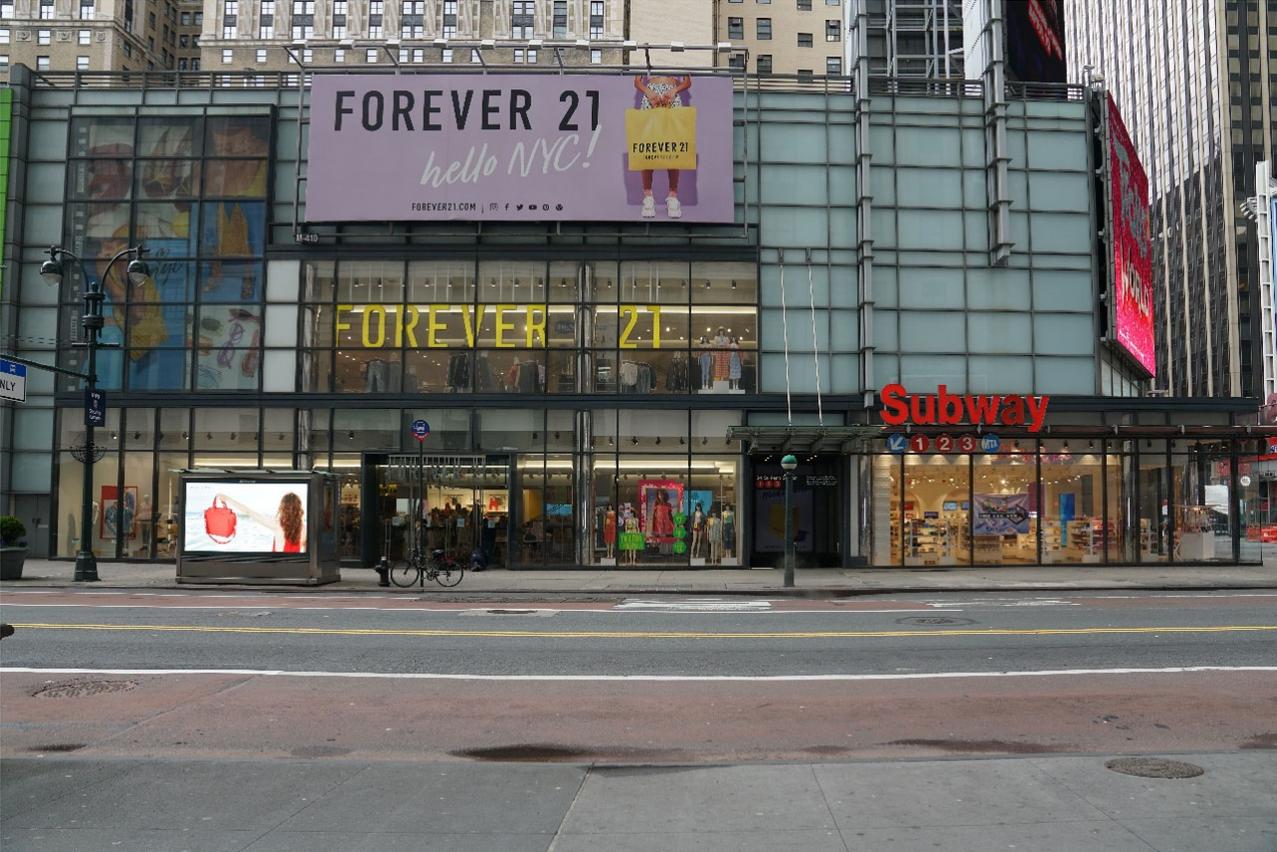
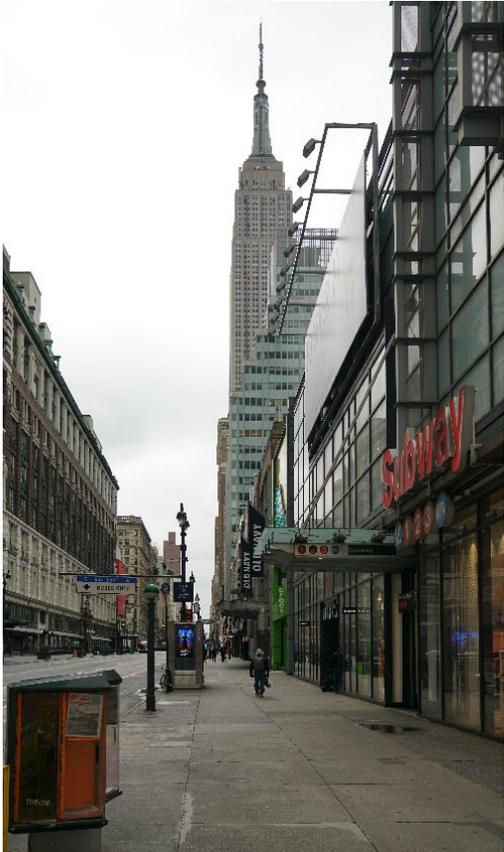
Figure 1-68 Block 809, Lot 80 Photographs

Lot 80 contains a three-story retail building. Part of the ground floor is also occupied by a subway station entrance. The façade consists of metal and glass. The exterior walls and doors are in fair condition. The building's doors are in good condition. The sidewalk and curb cuts are in fair condition, showing some cracking and staining. They are littered with a large amount of garbage and debris. The building shows no barrier to ADA accessibility at its ground-floor entrance. Overall, the building and site conditions were given a rating of fair condition.

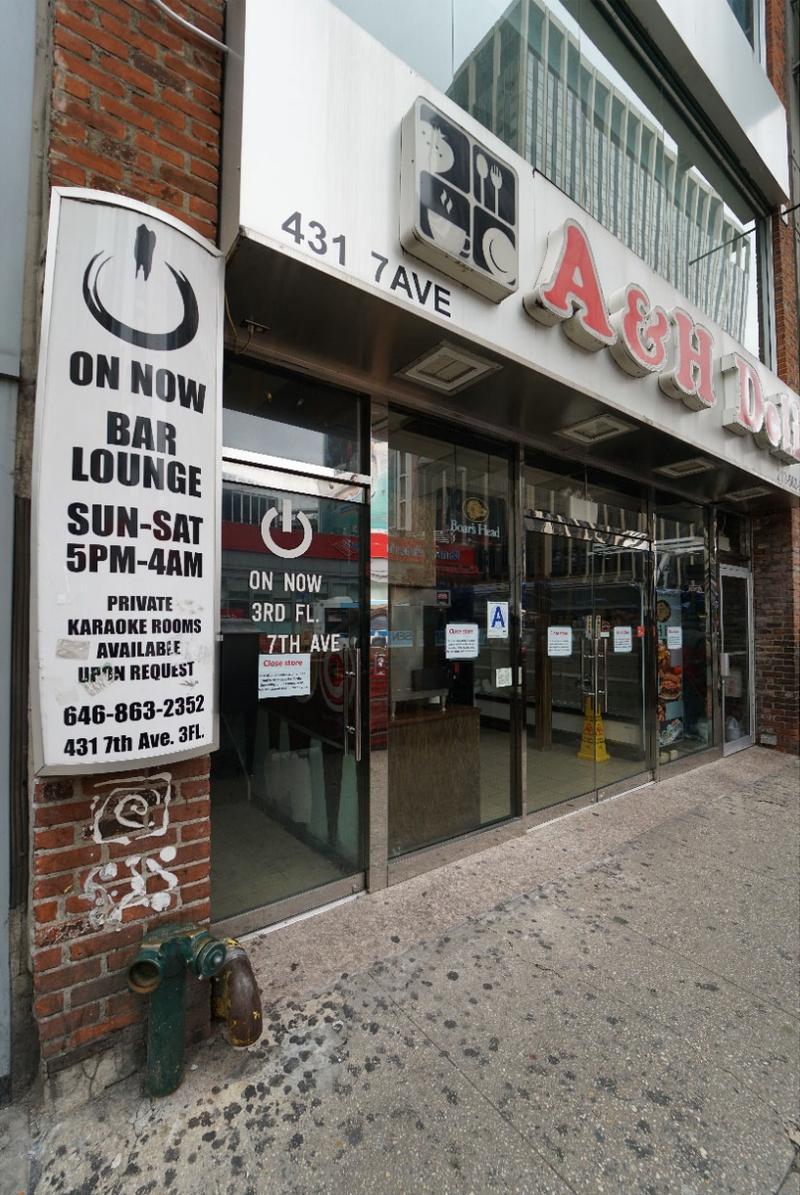
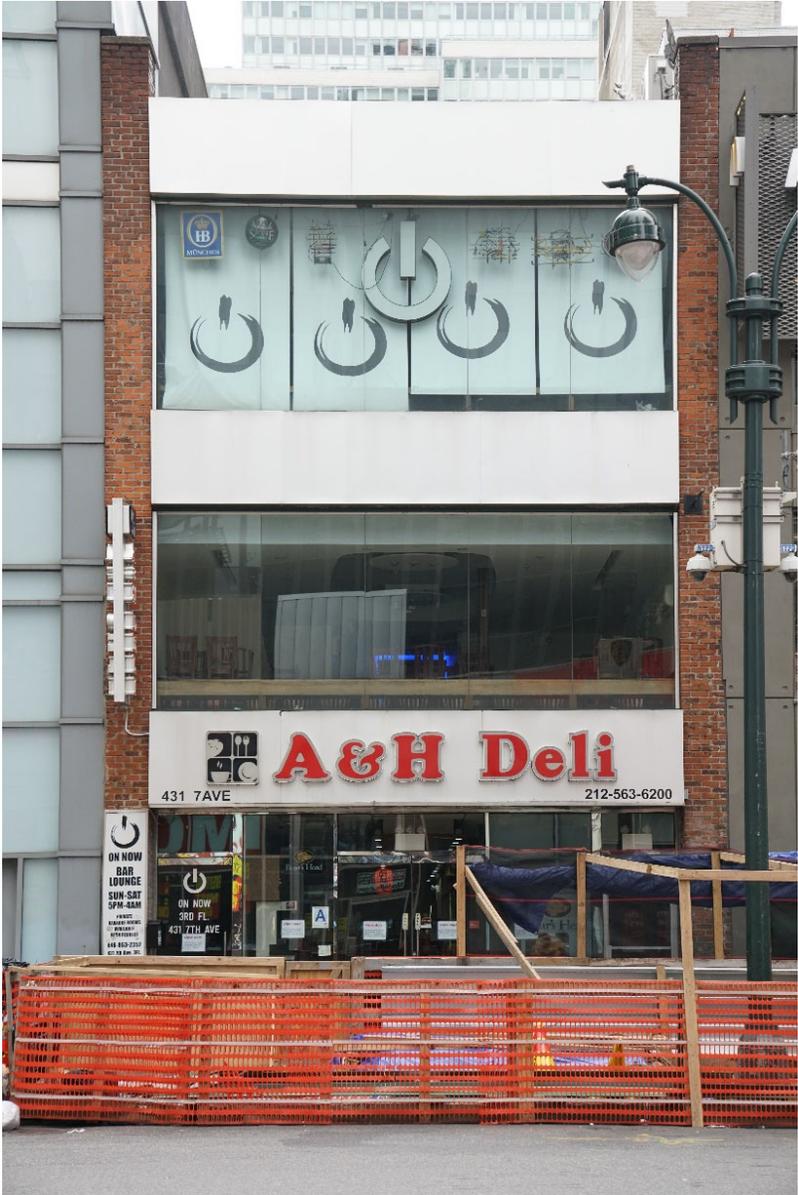
Figure 1-69 Block 809, Lot 82 Photographs

Lot 82 contains a three-story building with retail stores on the ground floor and mixed commercial and residential space on the upper floors. The façade consists of brick, metal, and glass. The exterior walls are in fair condition, showing some damage. The windows and door are intact and show no signs of damage. The sidewalk has minor cracking, staining, and debris. The building shows no barrier to ADA accessibility at its ground-floor entry. Overall, the building and site conditions were given a rating of good condition.
