CITY OF BUFFALO
BROADWAY MARKET
BUILDING CONDITIONS SURVEY REPORT

May 29, 2018
Compiled & Issued By:

A | Executive Summary

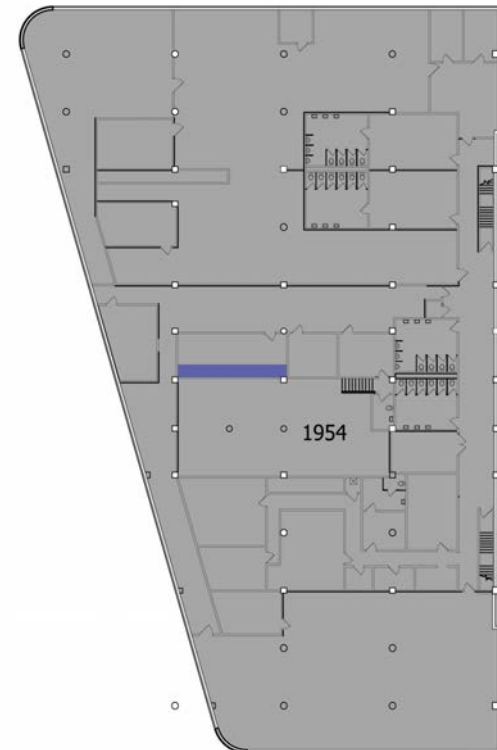
Basement Plan

4" ductile iron domestic water service enters within the basement. Piping is insulated.
 4" gate type shut-off valve on water service is showing signs of rust.
 Water Meter: Neptune "TruFlo" model #E-B4.
 Backflow Prevention Device: Watt's model #909RP, serial #192626. 2" drain from device terminates indirectly above floor drain.
 Piping and devices were observed to be in good operating condition.
 No issues reported.

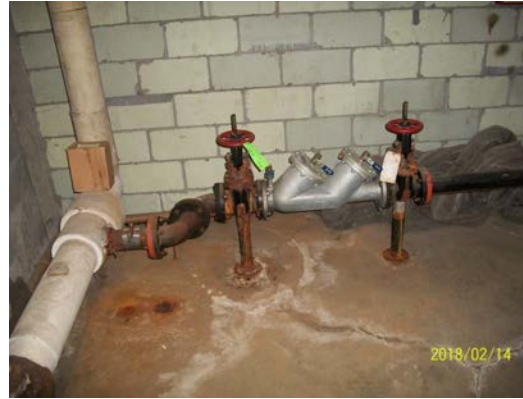
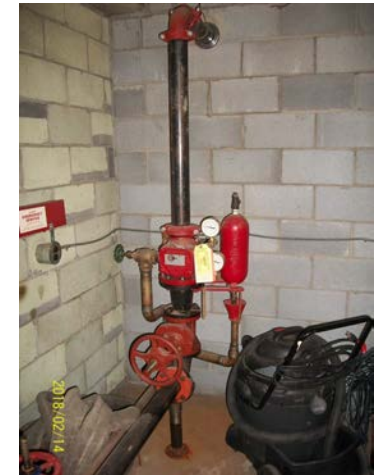
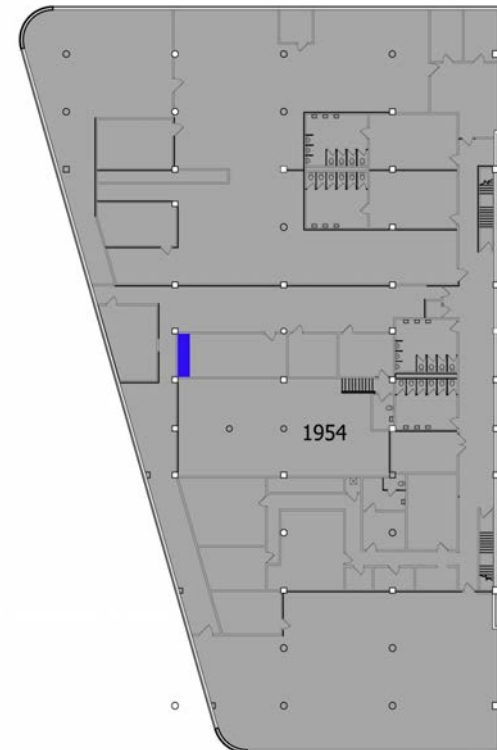
Basement Plan

3" fire service is fed off of the 6" domestic water service.
Backflow Prevention Device: Hersey model #2 double check valve, serial #101499.
Alarm Check Valve: GEM model #F2001. Inspection 9/7/2011 by Elwood Fire Protection. 2" drain piping from valve terminates indirectly above floor drain.
Piping from check valve serves sprinkler heads located within the Entry Vestibule located on the 2nd level of the parking garage.
Piping and devices were observed to be in good operating condition.
No issues reported.

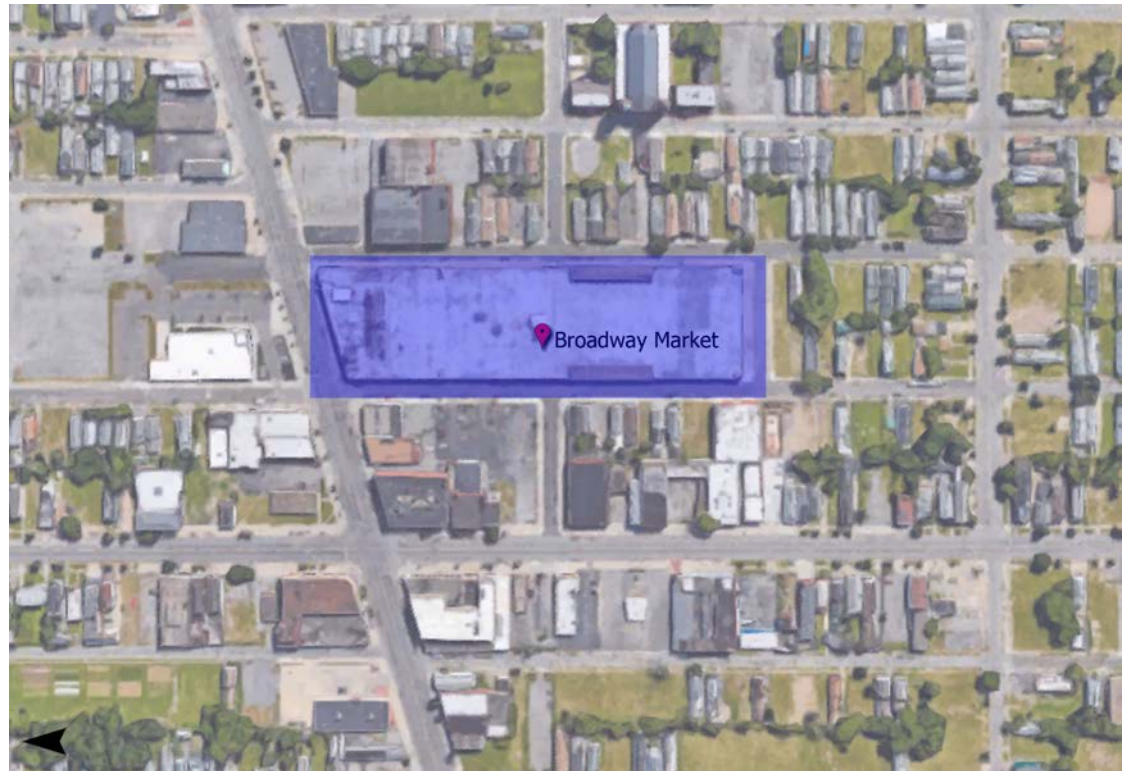
The building is separated into three sections by expansion joints- north (front), center and south (rear)
North (front) Deep foundations-driven piles or drilled caissons are assumed- foundation information not available
Center Concrete pile caps and driven piles- construction documents provide an option for an alternate of concrete caissons
South (rear) Concrete pile caps and driven piles-construction documents provide an option for an alternate of concrete caissons

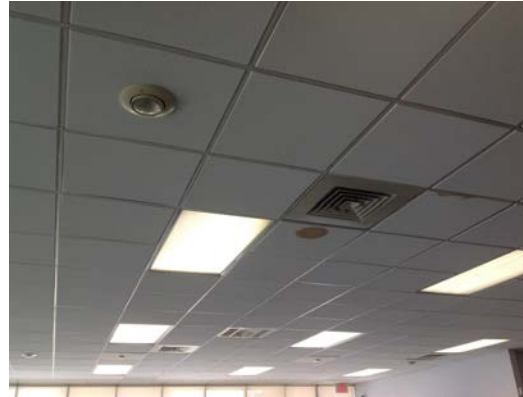
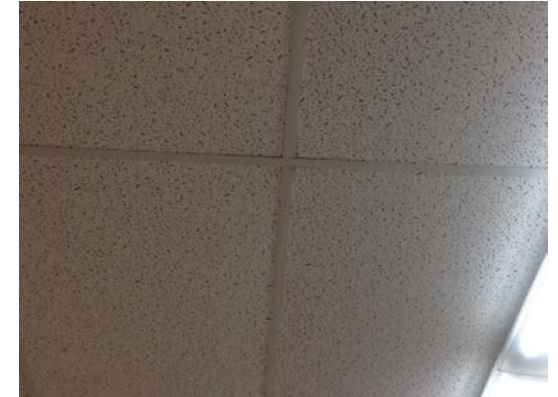
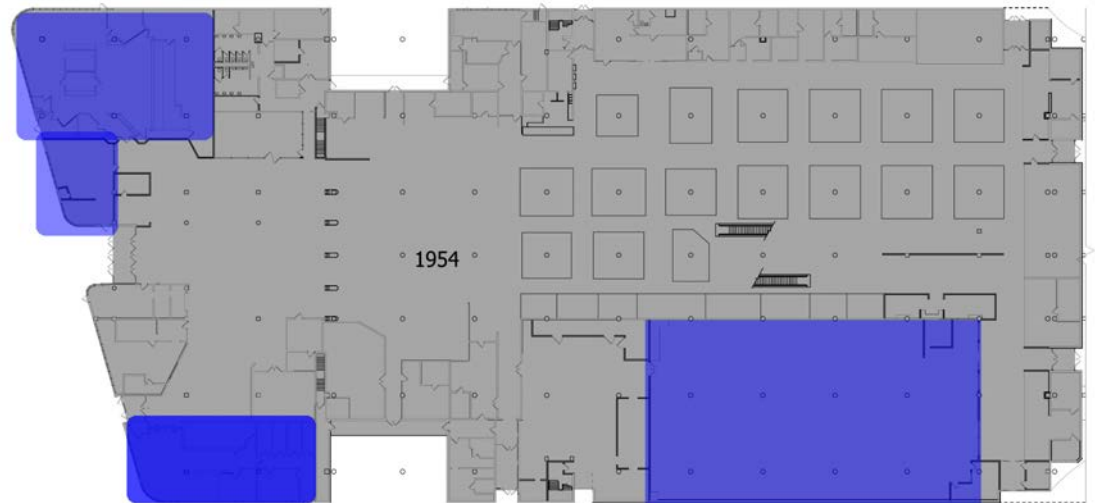
First Floor Plan (North)

There is different ACT tile in multiple locations and installed during different projects that are either in size of 2x2 or 2x4 type drop in style. They have signs of water damage and some tiles are missing.

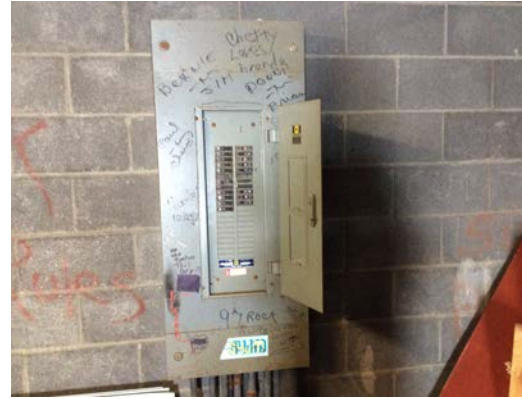
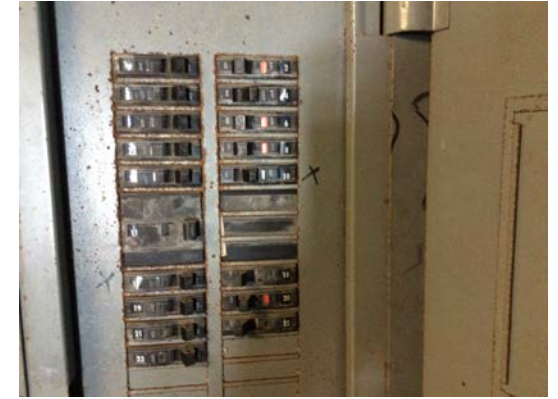
Square D type panel board rusted and corroded and not suitable for environment.

Recommend replacing with suitable type panel board.

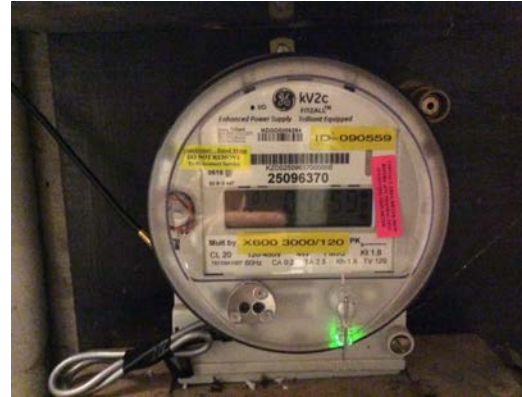
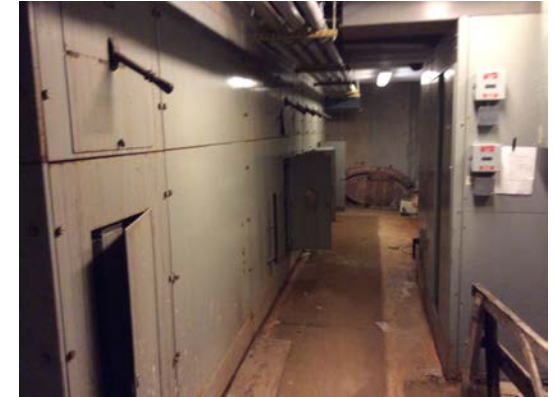
Existing continental switchgear for swbd-dp3, molded case breakers rated for 2000 amps. 120/208 volt service, gear showing signs of corrosion, second row of switchboard is disconnected and all breakers have been turned off.

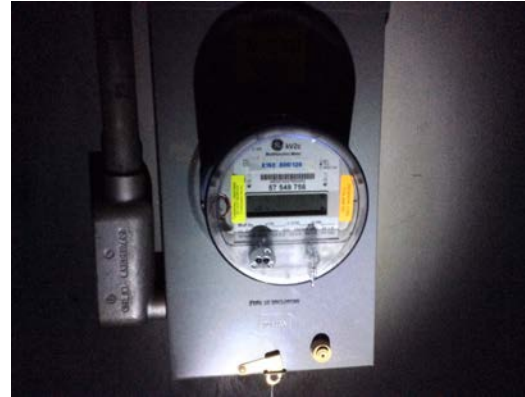
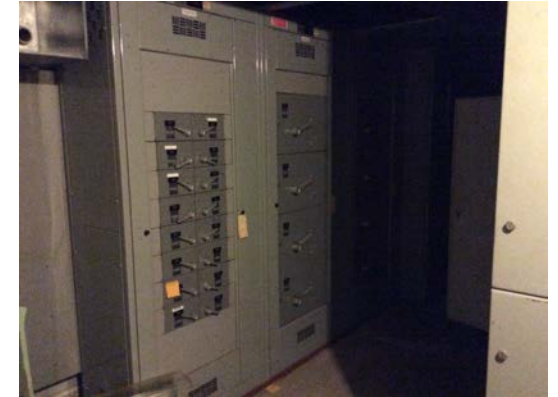
Continental switchgear for swbd-dp2, fused buckets rated for 1600 amps.120/208 volt service, gear showing signs of corrosion and has exceeded its useful life.

Replace switchboard in its entirety with new draw out type breakers or molded case switch board.

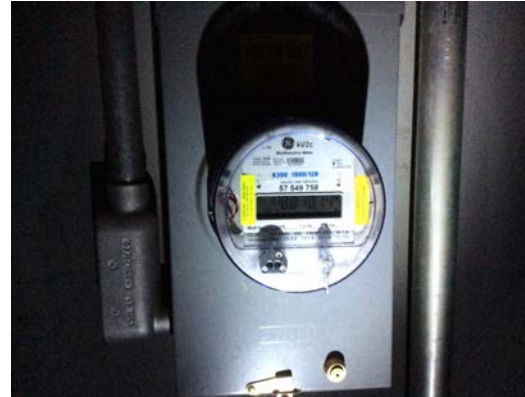
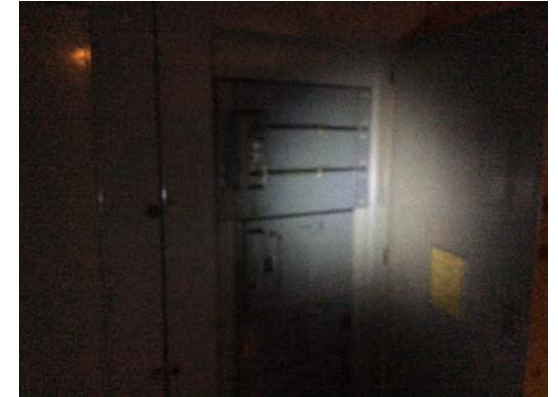
Existing continental switchgear for swbd-dp1, fused buckets rated for 800 amps.120/208 volt service, gear showing signs of corrosion and has exceeded its useful life.

Replace switchboard in its entirety with new draw out type breakers or molded case switch board.

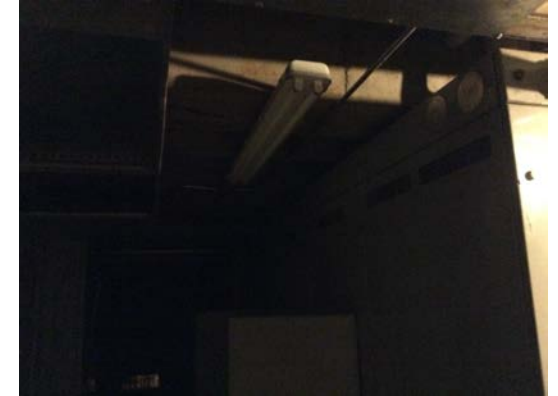
Mechanical spaces have incandescent lamp holders and fluorescent strip lighting fixtures illuminating the area. some are not operable and or missing lenses.

Recommend replacing lighting fixtures one for one with led strip fixture with lenses cover.

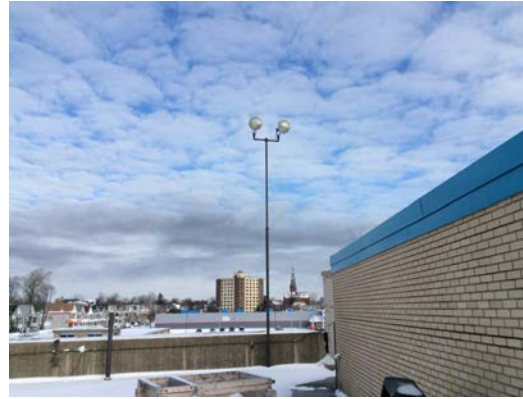
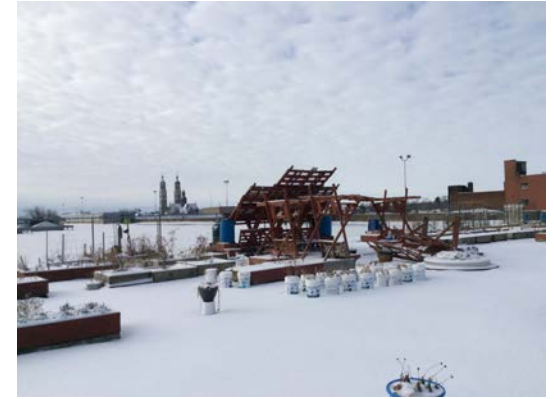
Poles show signs of rust and wear, lighting fixtures are metal halide and high pressure sodium, operate by time switch only, lenses are cracked and damaged.

Recommend replacing with led type luminaries, with integral photocells for control, replace damaged and rusted poles.

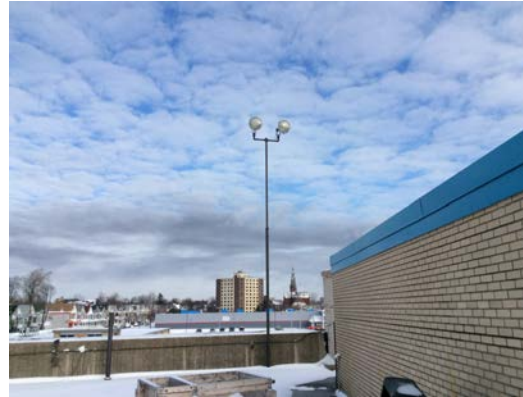
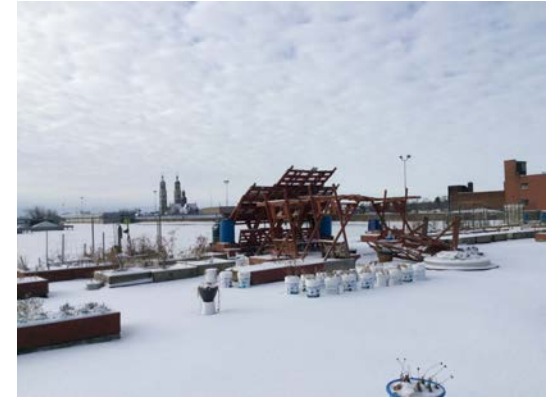
Poles show signs of rust and wear, lighting fixtures are metal halide and high pressure sodium, operate by time switch only, lenses are cracked and damaged.

Recommend replacing with led type luminaries, with integral photocells for control, replace damaged and rusted poles.

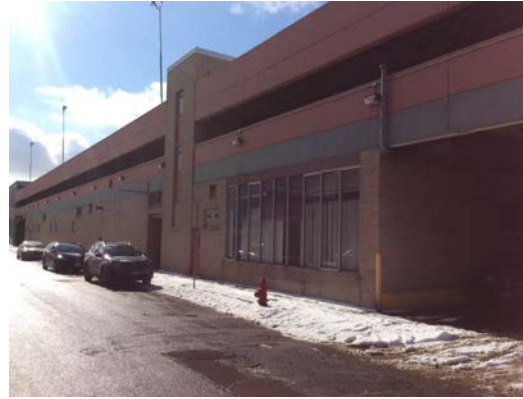
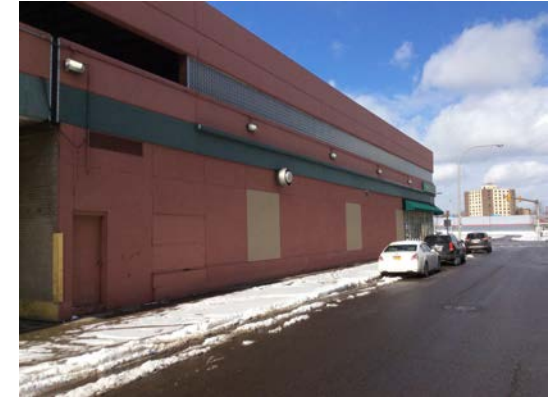
Metal halide wall mounted flood lights, yellowed and cracked lenses, were currently on during the day, controlled via time switch in second floor parking ramp electrical room.

Recommend replacing the lighting fixtures one for one with led type with integral photocell for operation and to only operate at night.

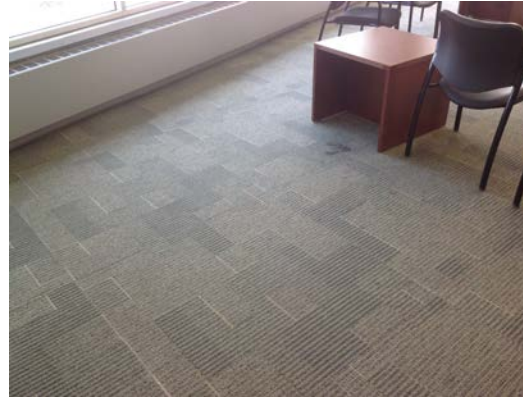
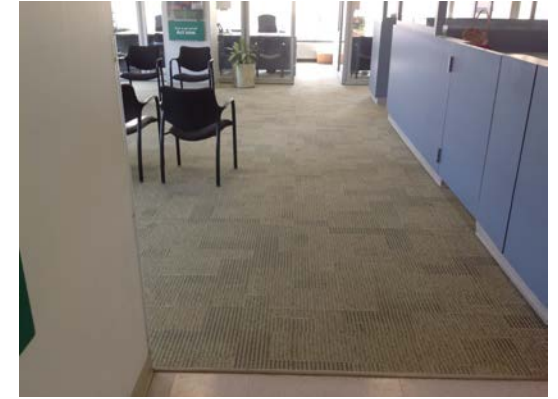
Carpet tile in M&T bank along with Jackson Hewitt. Carpet does show some staining and signs of wear along with the Broadloom carpet in the community space.

Replace all with new carpet tile.

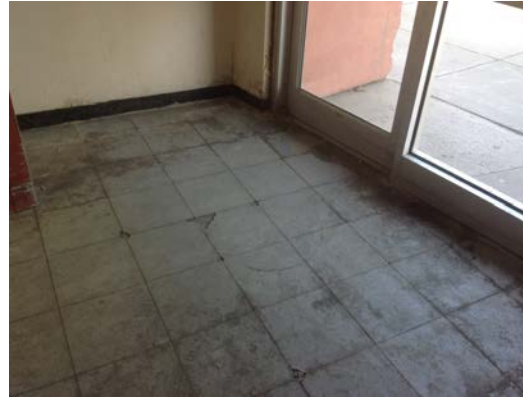
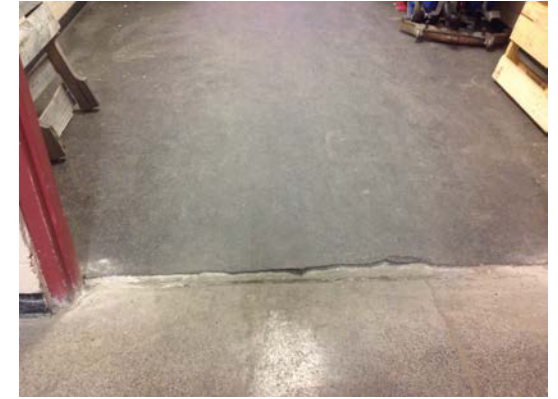
There is 12x12 vinyl tile missing, loose and curling in the front main entry, rubber flooring in the corridor exit ways at interior entrances also curling and bunching creating trip hazards.

Replace with new non slip tile at all areas.

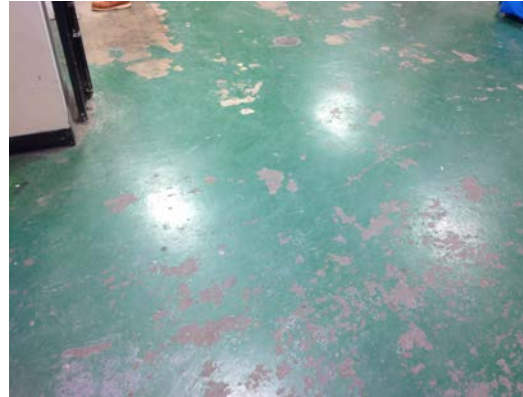
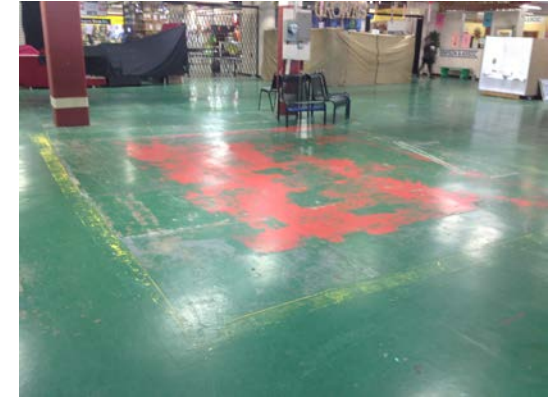
Areas of the floor have been painted numerous times along with cutting and patching throughout. Paint is peeling and worn.

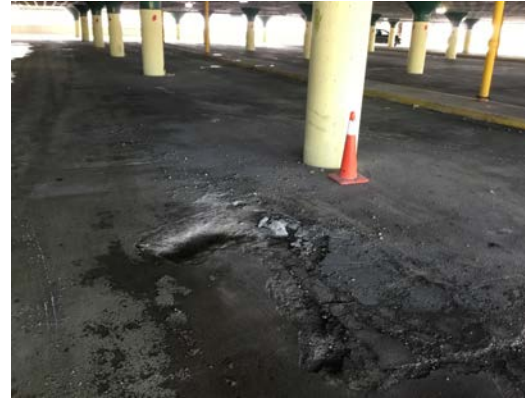
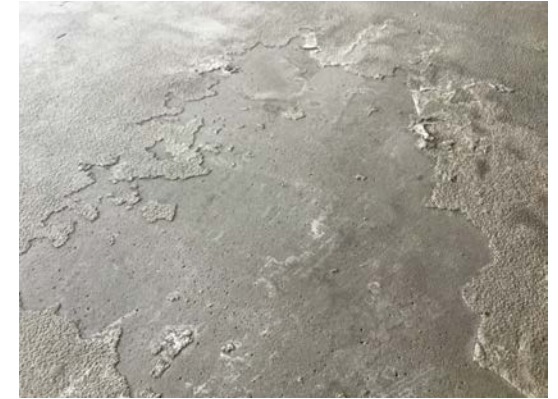
Cracks have been filled over the north portion of the second floor. New ones appear to be in need of filler. General area of the 1955 parking portion of the second floor appears to be satisfactory. One area shown in the pictures needs to be filled. The parking surface has a coating system over it that is failing and peeling off.

Remove existing coating system, provide new coating to surface approximately \$18/sf assume 163,000 sf; Total \$2,934,000. Crack injection: Epoxy crack injection, approximately \$30/lf, assume 1,000 lf. Total \$30,000. Slap Patch (overhead): Cementitious patch, approximately \$55/SF conservatively assume 1% of bottom of roof slab to be patched, approximately 1,400 sf. Total \$77,000. This number is separate from new coating.

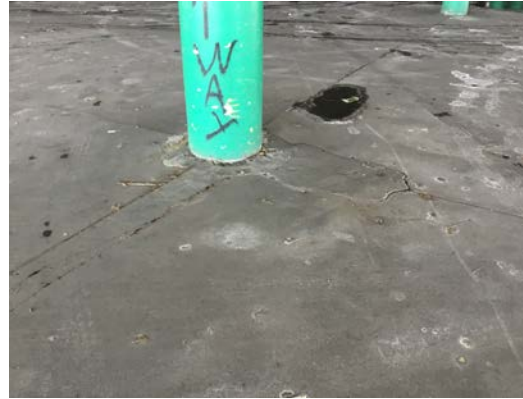
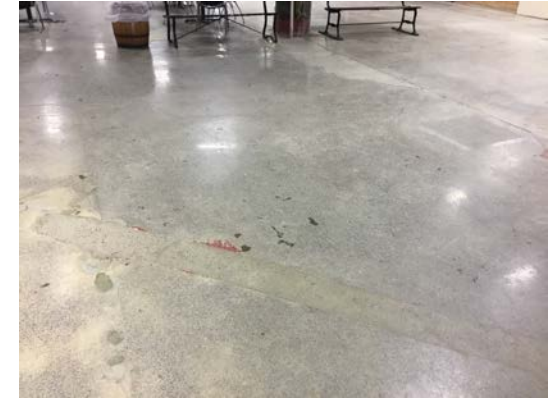
Floor does not demonstrate any signs of structural distress however cracks are frequent. Many patches have been cut into concrete and terrazzo floor. Some areas of terrazzo have been patched with standard concrete. Others have been painted to suit ground floor parking is concrete as well. Many cracks exist there as well.

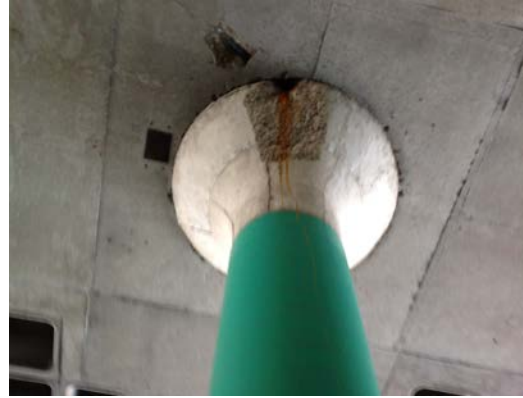
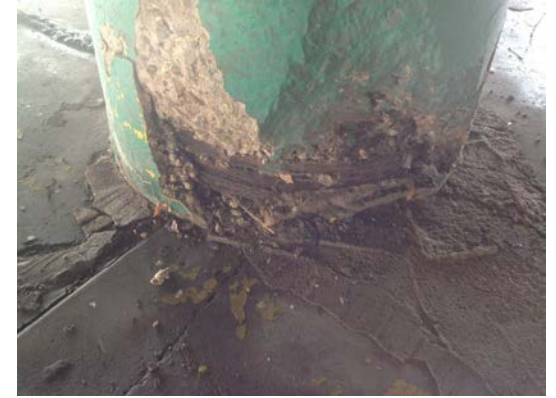
First Floor (South): multiple fractures and spalling with rebar exposed.

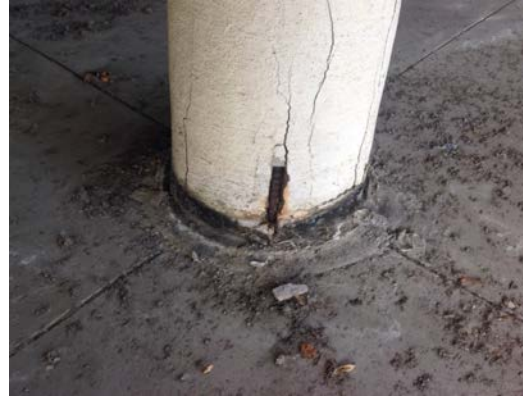
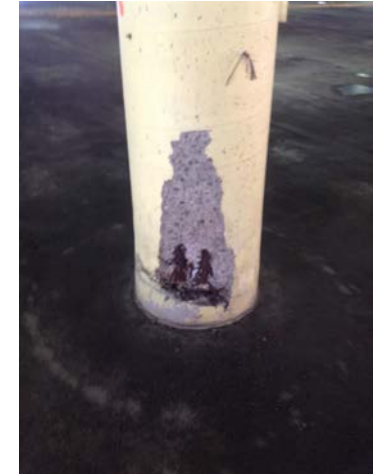
Second Floor (North): multiple fractures and spalling with rebar exposed

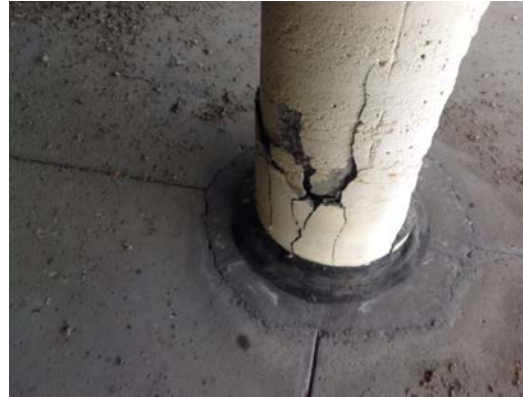
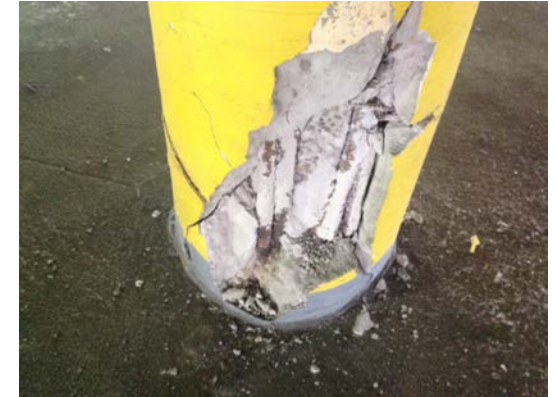
Second Floor (South): multiple fractures and spalling with rebar exposed

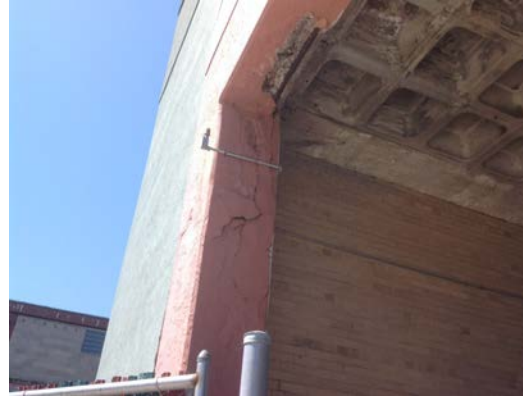
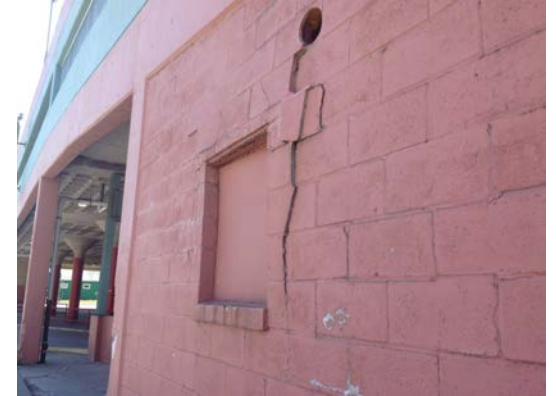
Spalling of concrete allowing structural rebar to be exposed. Damaged cinder block around window allowing water to enter allowing freeze thaw actions to exist near Lombard Street parking entrance and near dumpster storage entrance

Replace broken or moved CMU with new.

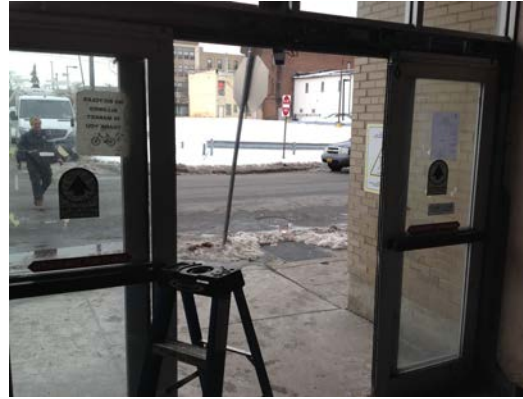
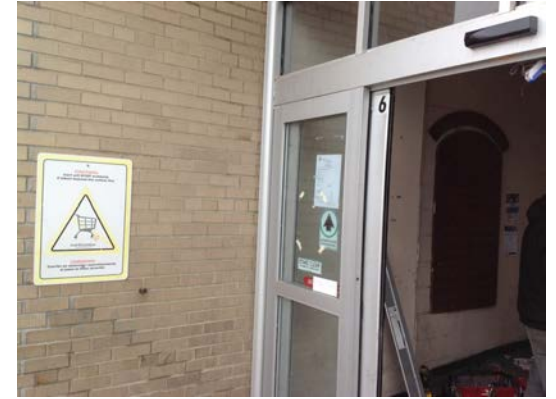
Aluminum slider - not operable - being repaired at time of survey identified in red.

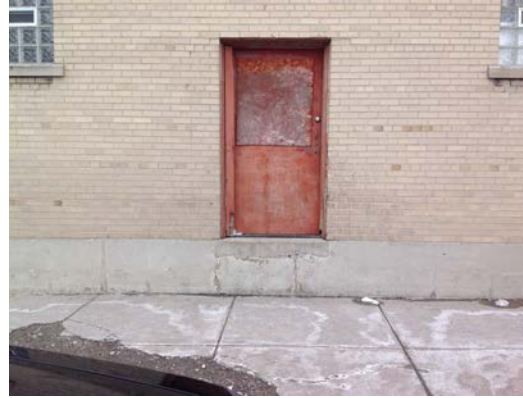
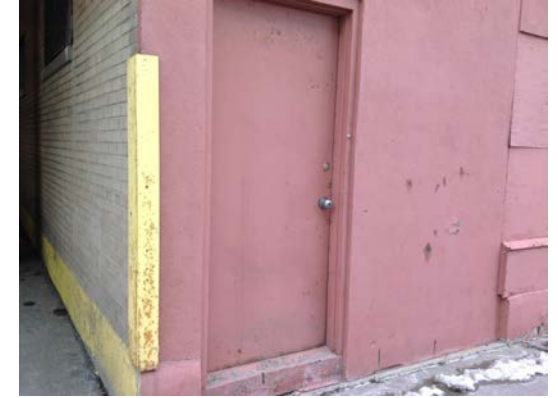
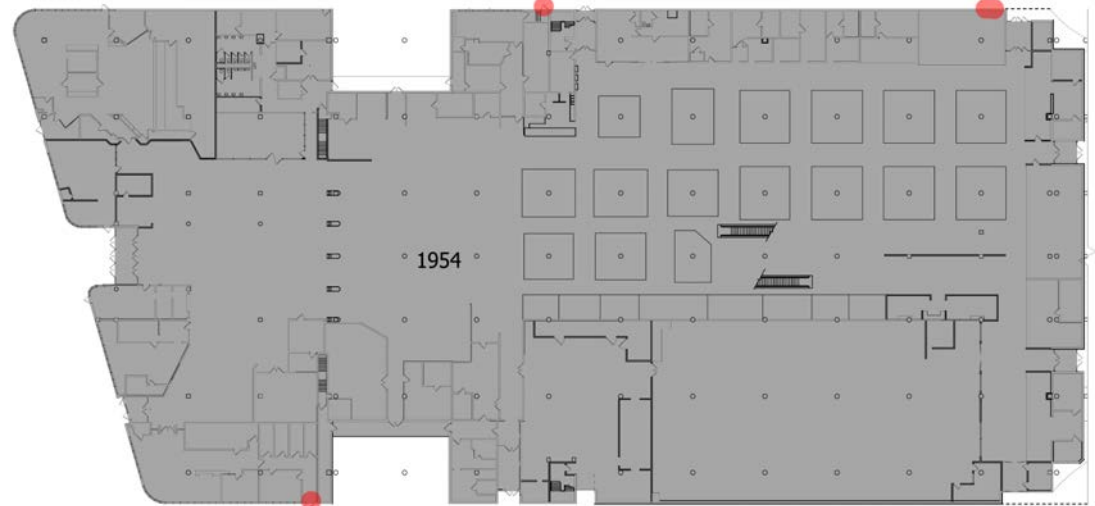
First Floor Plan (North)

Rust on frames and door bottoms. Steel door installed in deteriorating wood frame and plywood covering window.

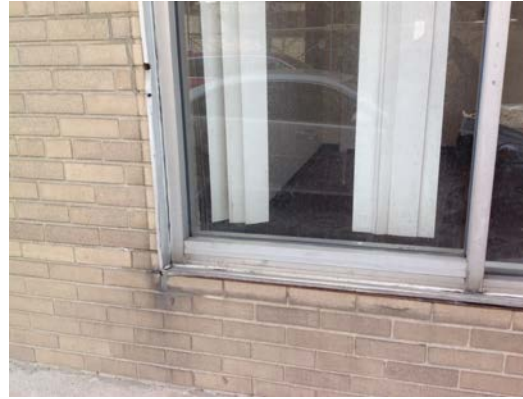
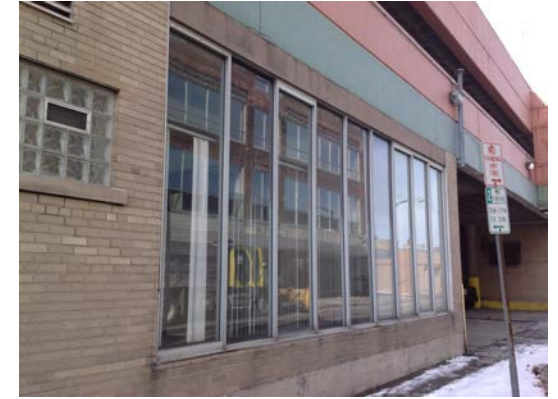
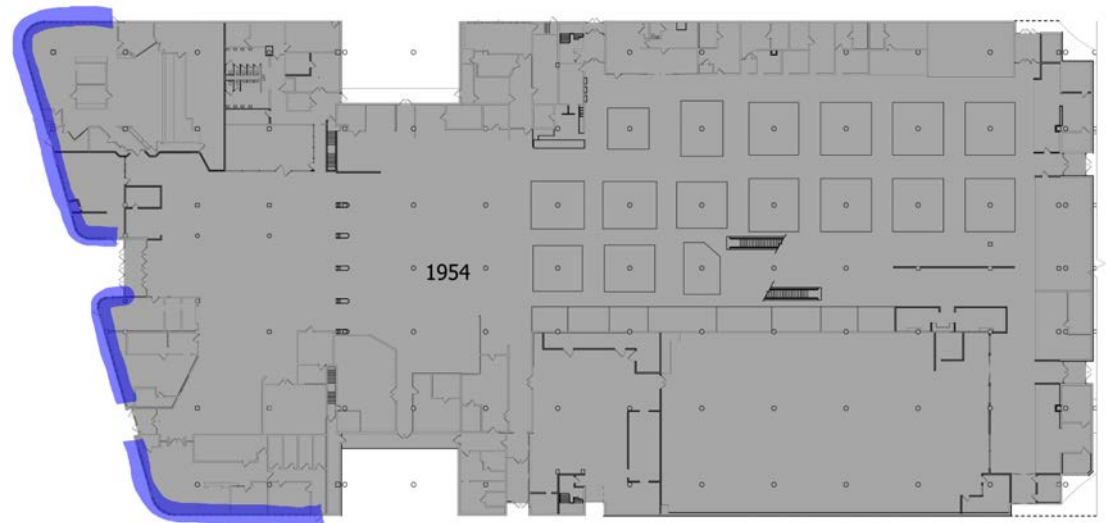
First Floor Plan (North)

Smaller windows (15sf per opening) have been covered over with plywood and other material. Larger storefront aluminum windows have damaged frames and seals.

Replace units with energy efficient insulated glass.

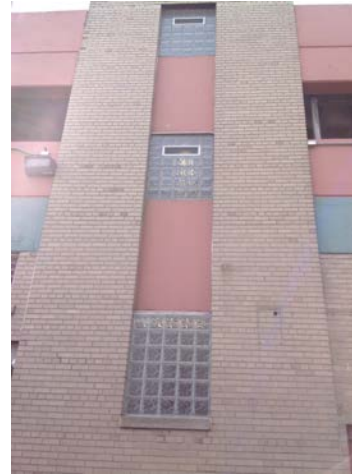
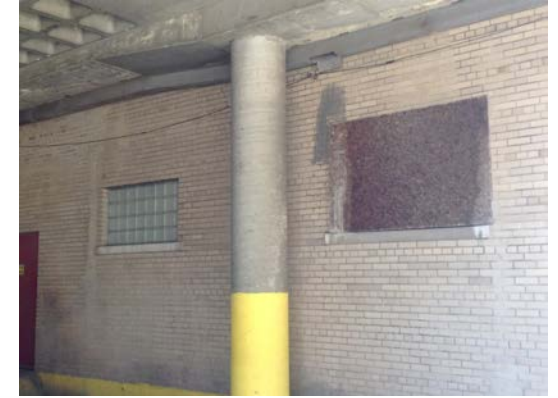
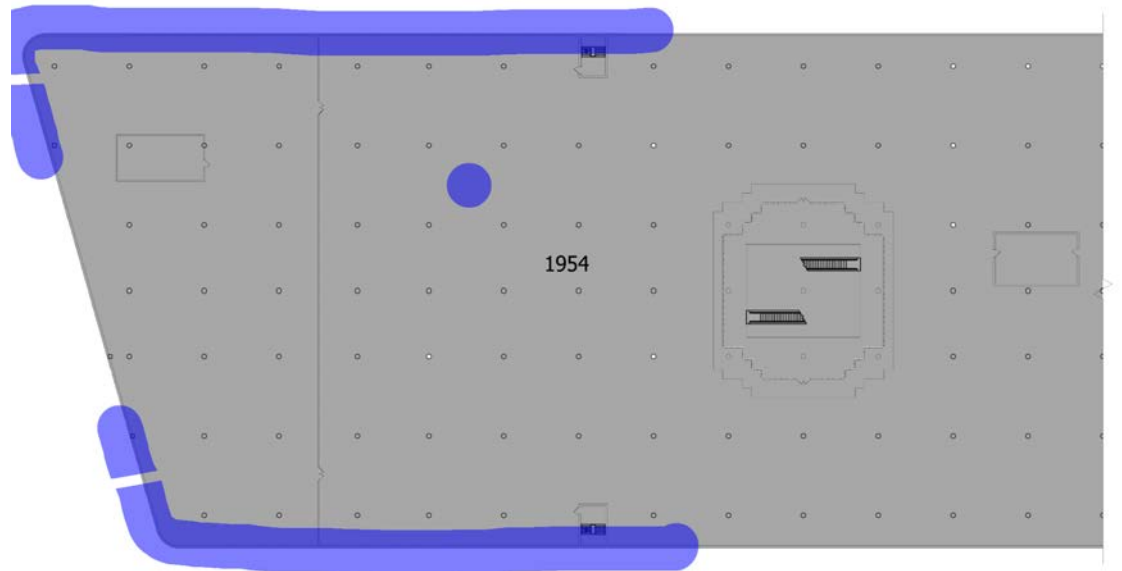
Second Floor Plan (North)

There are broken glass blocks and some openings covered with plywood or other material allowing water and insects to enter.

Clean and repaint lentsils, replace broken individual glass, re-caulk and install complete units in covered openings

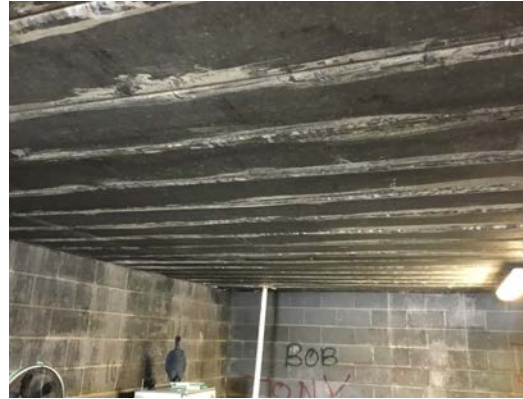
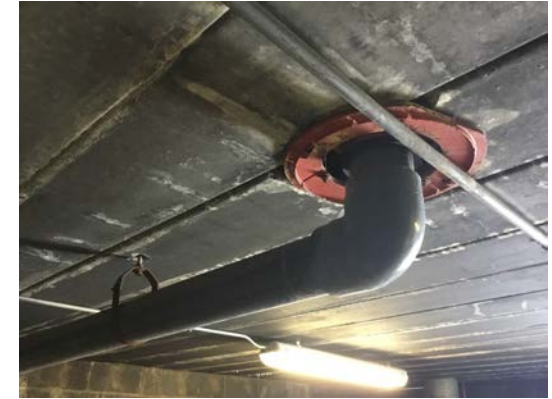
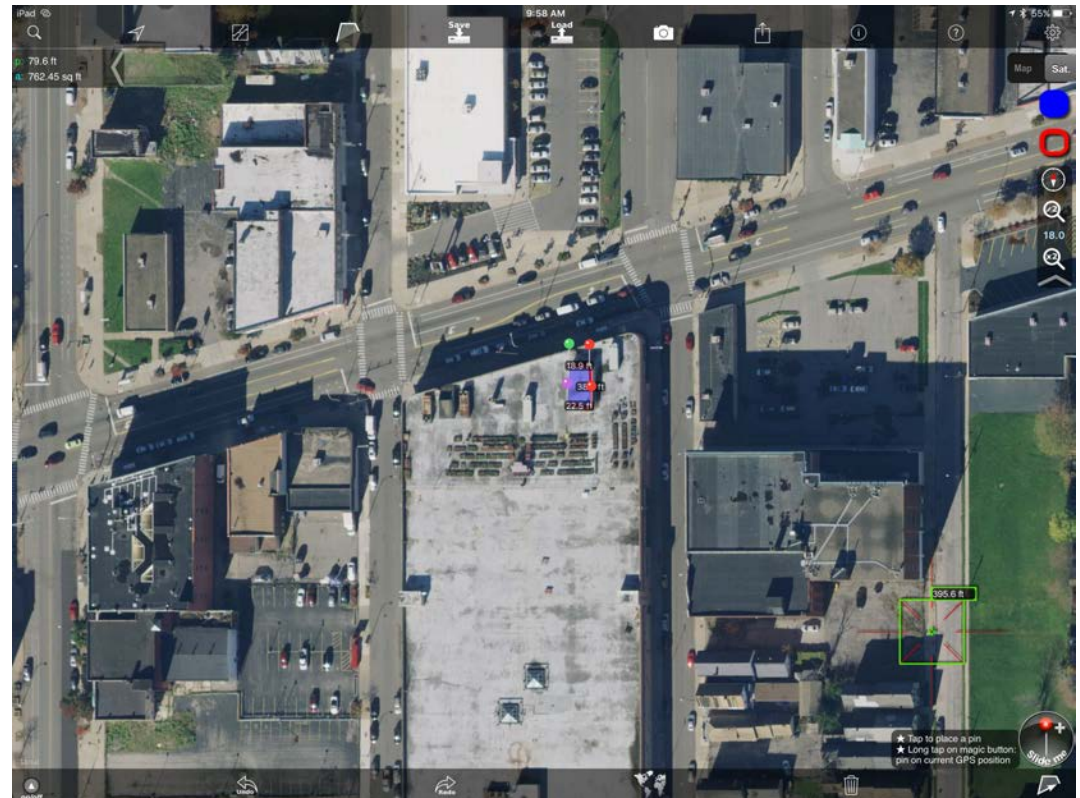
Concrete plank deck. Minor cracking but no major concerns.

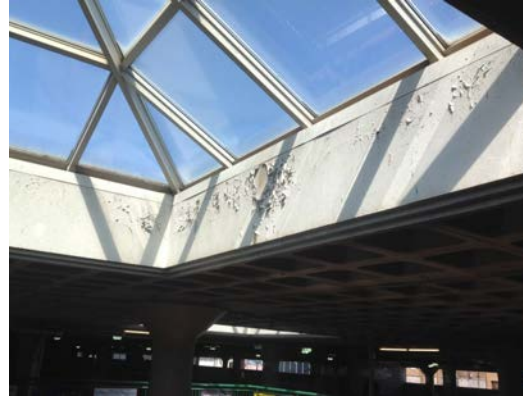
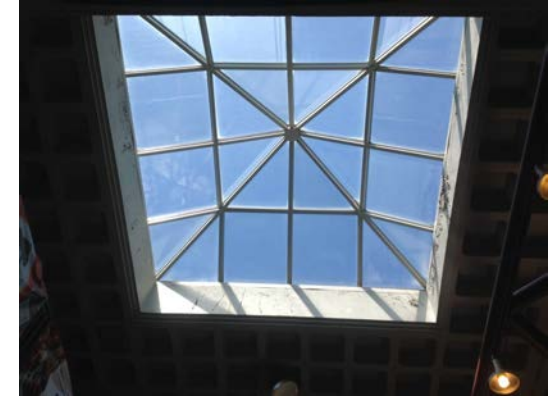
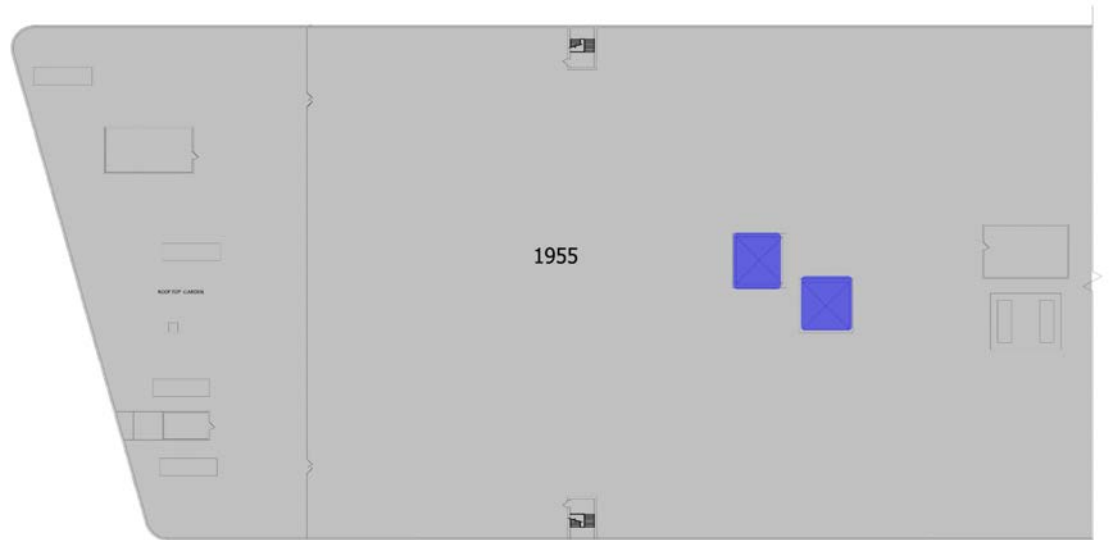
069 Skylights | 1984

Evidence of water leaks and general moisture penetration causing paint to peel and flake.

Replace with new aluminum frame, insulated glass complete with new flashing on curb.

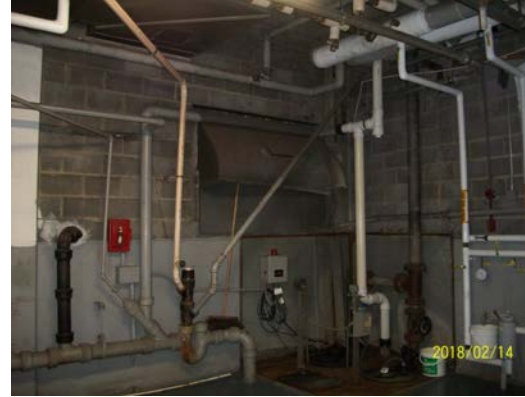
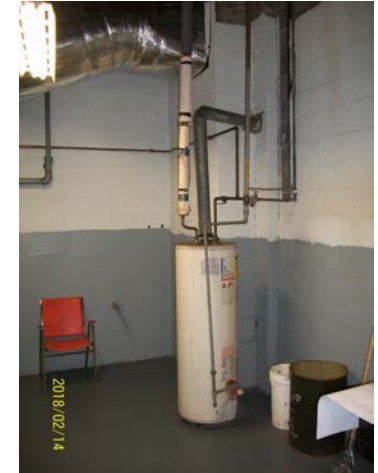
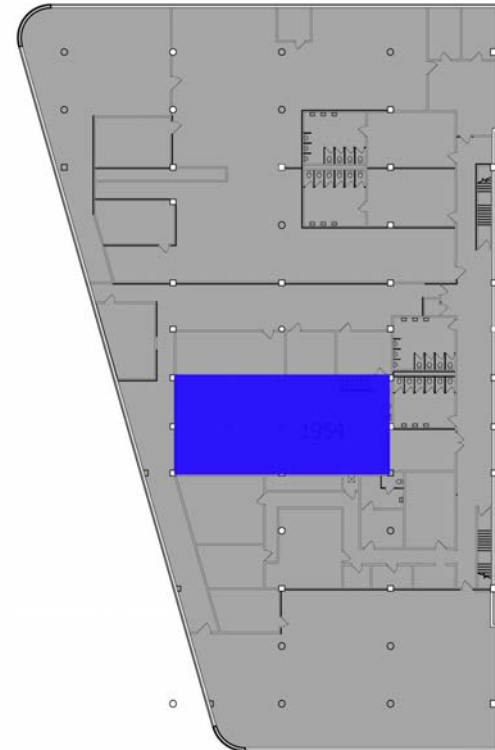
Basement Plan

Copper piping with solder type joints. Piping is insulated and identified in some locations. Some piping observed to be not insulated or identified. No issues reported.

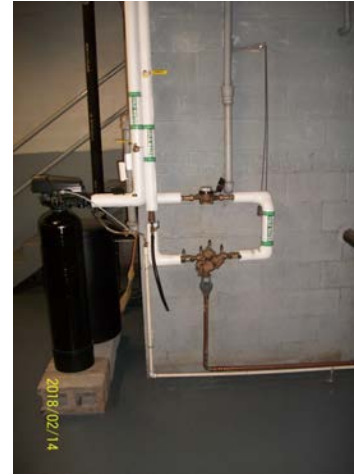
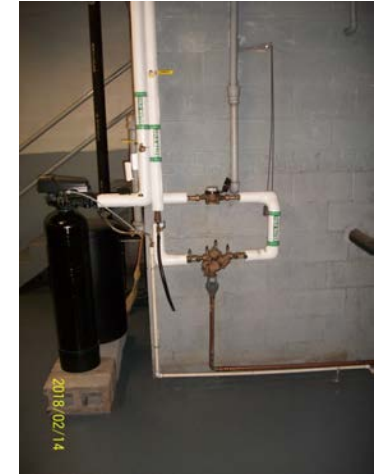
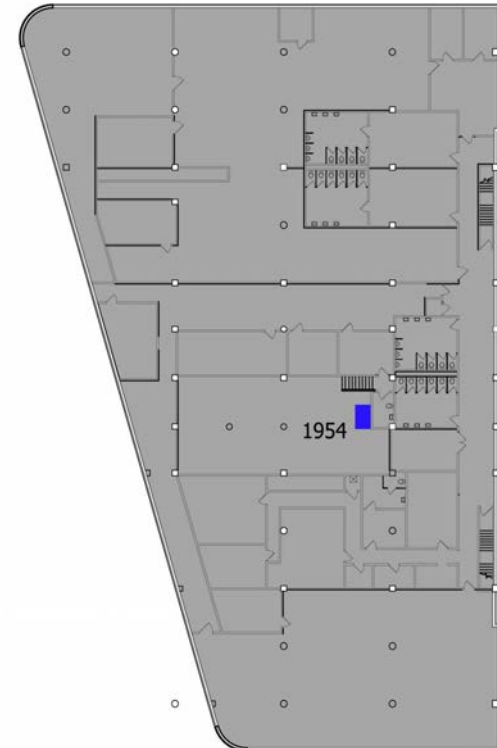
Basement Plan

1 - Water softener with brine tank. Water softener is currently not plugged in and operational.
Cold make-up water piping to system has a water meter and backflow prevention device installed.
Water Meter: Sensus PMM series.
Backflow Prevention Device: 3/4" Watts model #909QT.
Water softener, brine tank observed to be in good condition, but are currently non-operational.
No issues reported.

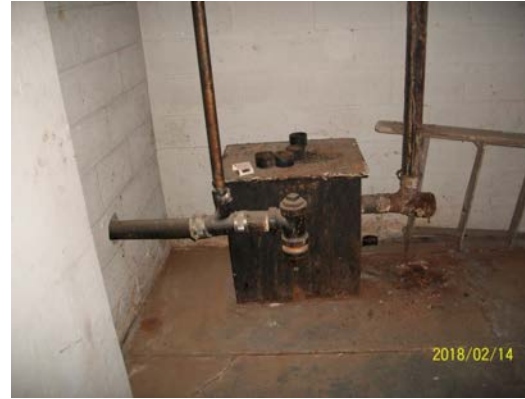
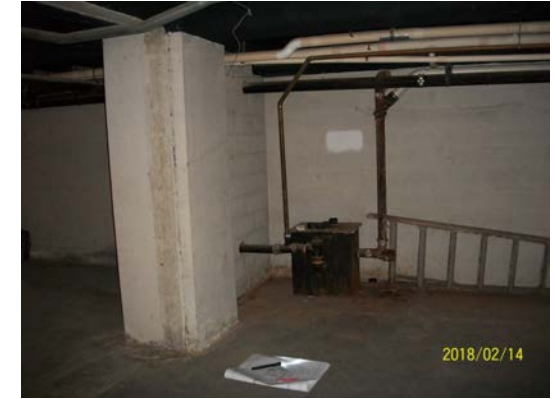
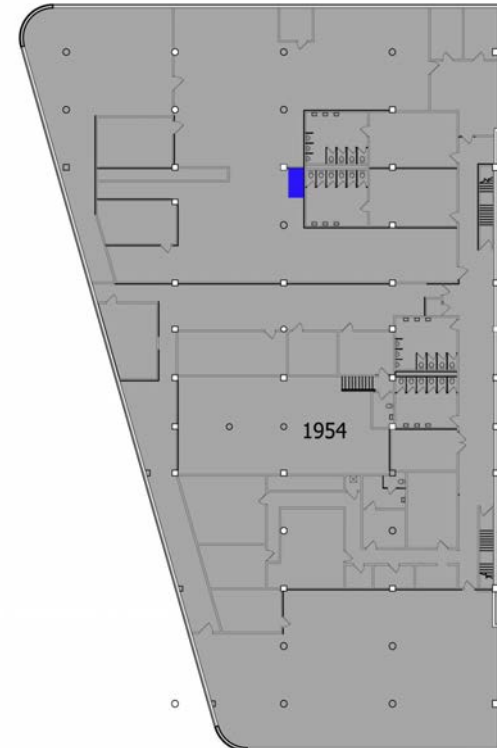
Basement Plan

1 - Cast iron, floor mounted grease interceptor located within basement.
Cast iron inlet and outlet piping with no-hub type fittings.
Copper vent piping.
Interceptor and piping observed to be in good operating condition.
No issues reported.

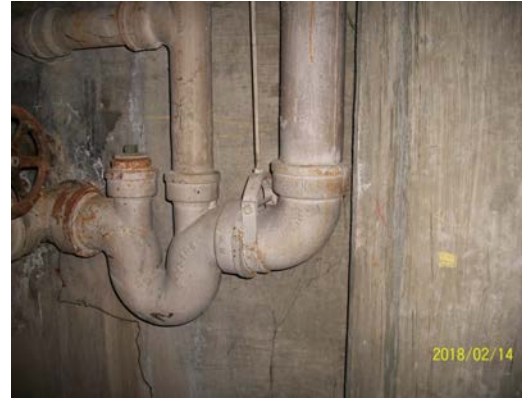
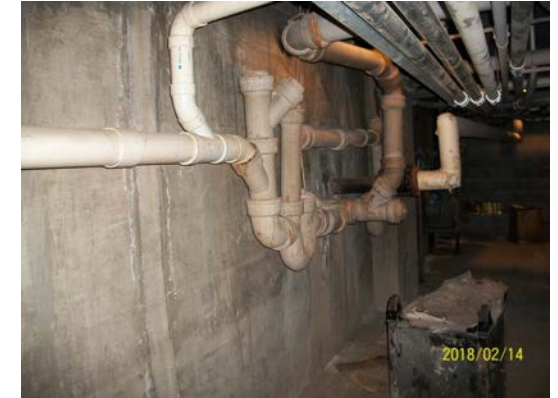
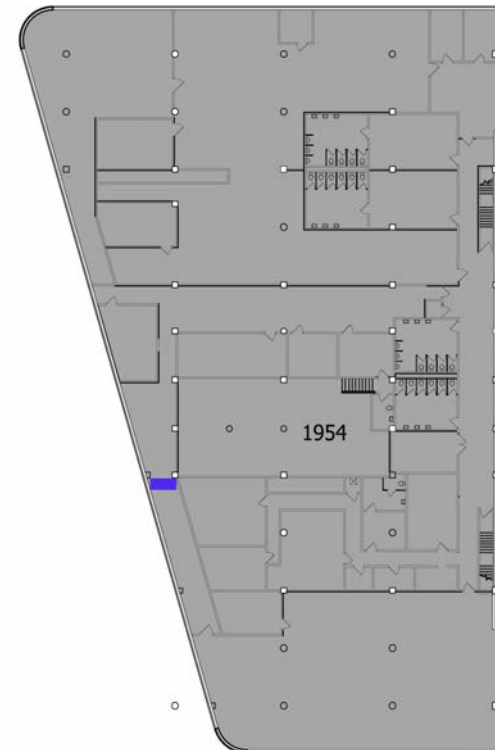
Basement Plan

Cast iron piping with lead and oakum joints.
Surface rust appears in various locations but piping appears to be in good overall condition.
No issues reported.

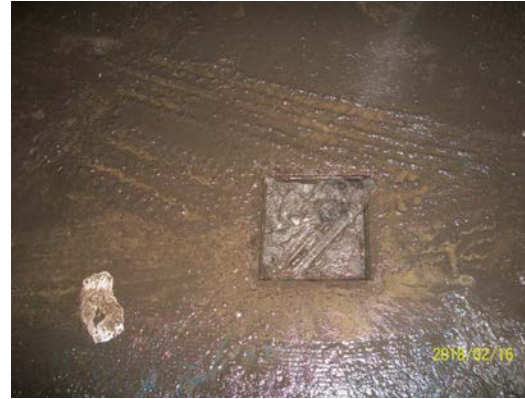
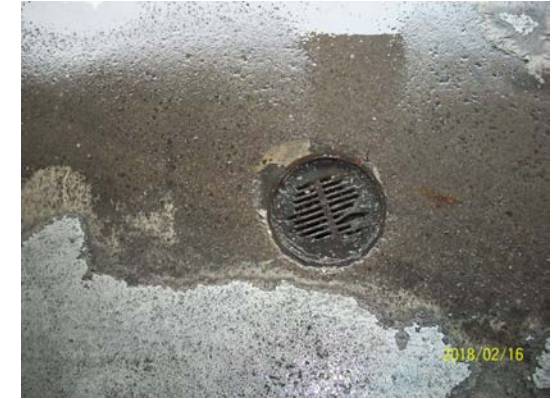
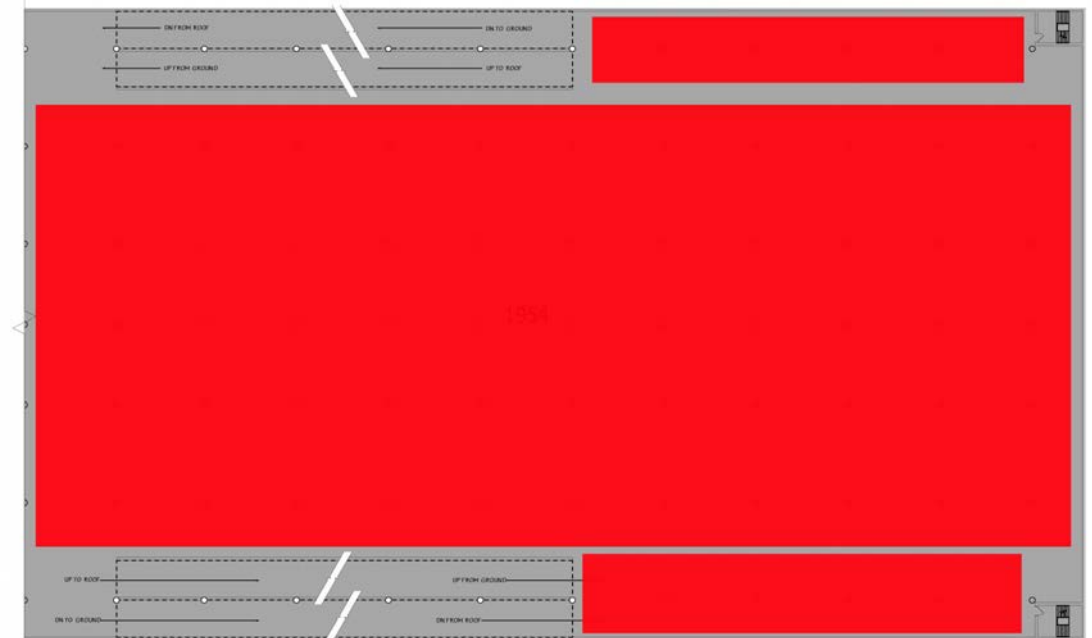
Second Floor Plan (South)

South Parking deck drains are cast iron construction.
Some drains in various locations have been capped or covered over.
Operable drains observed to be in poor to fair working condition.
Drains observed to have reached their useful life expectancy.

Replace parking deck drains in their entirety.

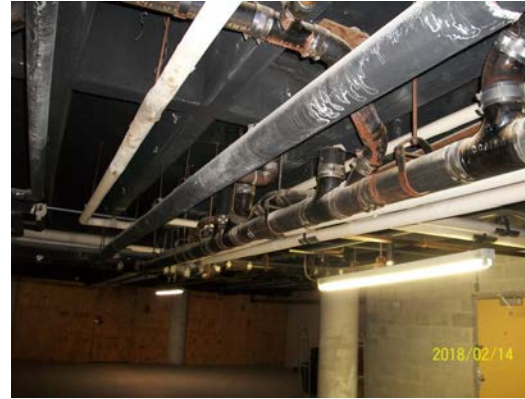
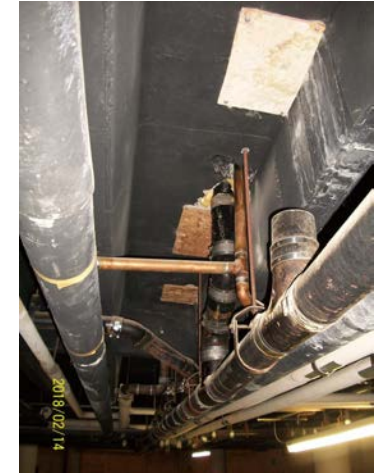
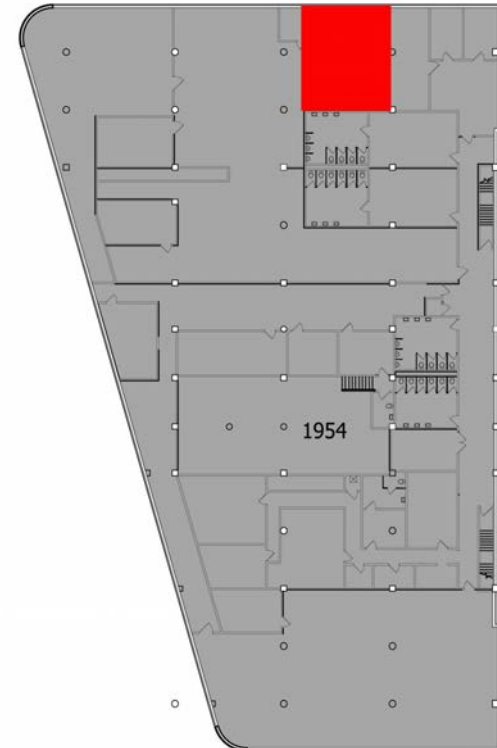
Basement Plan

4" (average size) Cast iron piping with "no-hub" type joints.
Rusting, corrosion and pitting of piping observed in various locations.

Replace cast iron piping and "no-hub" type fittings in their entirety where condition of piping dictates.
