CITY OF BUFFALO
BROADWAY MARKET
BUILDING CONDITIONS SURVEY REPORT

May 29, 2018
Compiled & Issued By:

A | Executive Summary

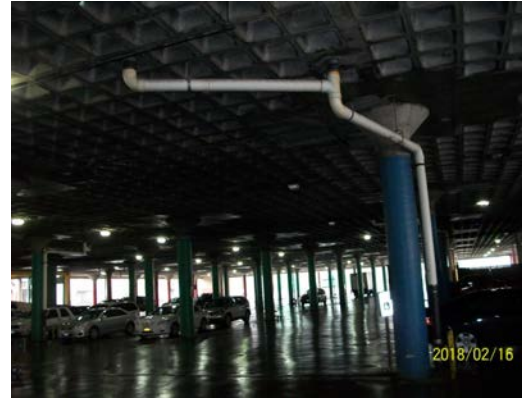
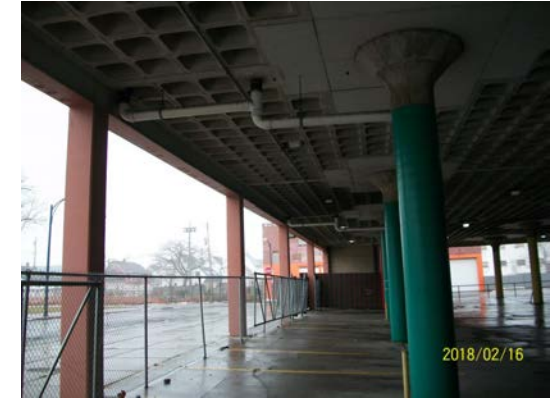
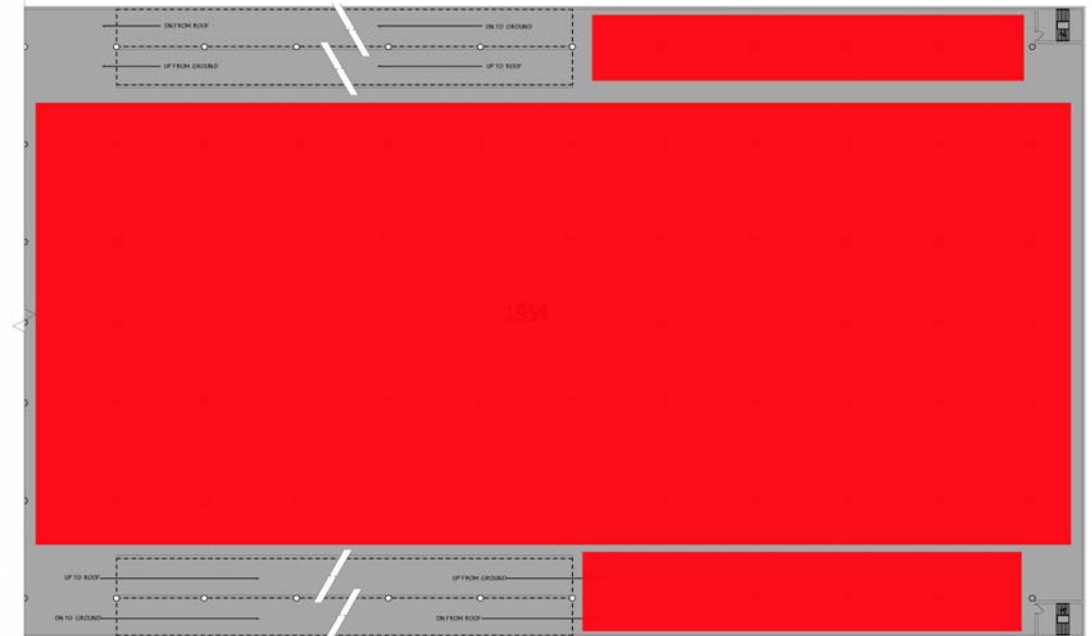
Second Floor Plan (South)

Drainage piping from parking deck drains is of varying materials (cast iron or PVC). Piping is leaking in some locations and has reached its useful life expectancy.

Replace drainage piping from parking deck drains.

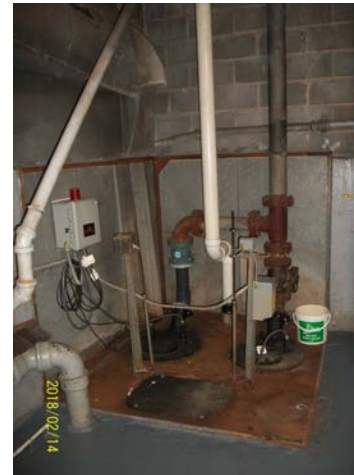
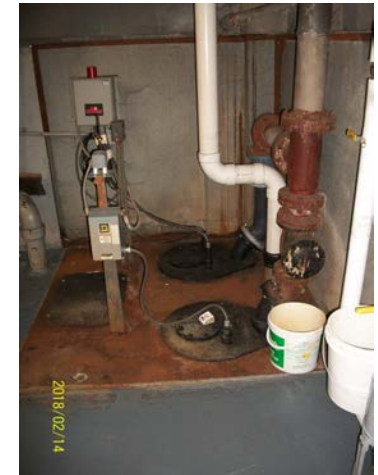
4" discharge piping terminates into 5" sanitary sewer. Piping schedule 40 black steel with flanged joints. Fittings observed to be showing signs of rusting.

4" vent piping from sump basin terminates to atmosphere. Piping is schedule 40 PVC with solvent joints and "No"Hub" type fittings. Piping observed to be in good operating condition.

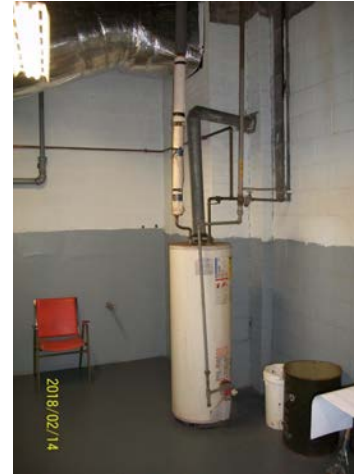
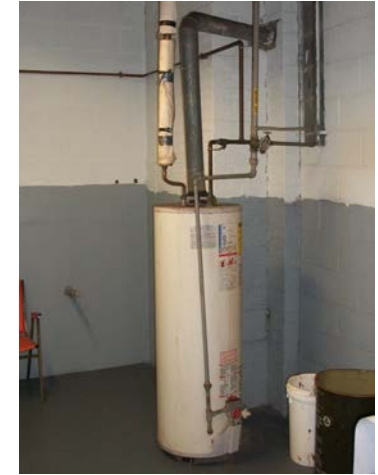
Location ☐ Site ☒ Basement ☐ 1st Flr ☐ 2nd Flr ☐ Roof

1 - Gas fired, 50 gallon storage type water heater.
1/2" gas and 3/4" hot and cold piping connections.
Galvanized flue piping.
Water Heater is operational but reaching it's useful life expectancy. Unit is showing signs of rusting.

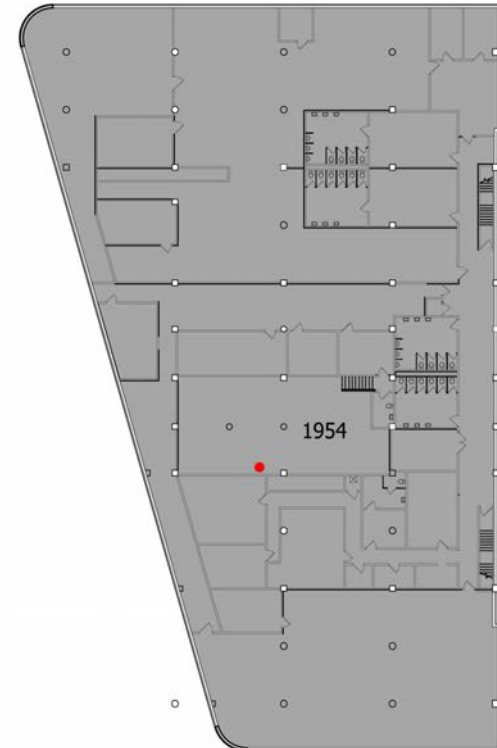
Basement Plan

1- Bi-Level, ADA compliant, stainless steel drinking fountain. ADA unit observed to be covered and is non-operational.

Replace fixture with new bi-level, ADA compliant electric water cooler.

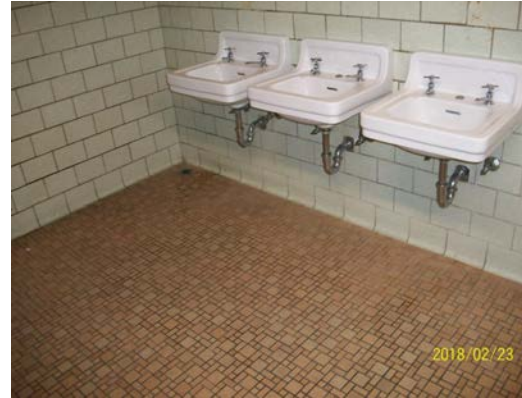
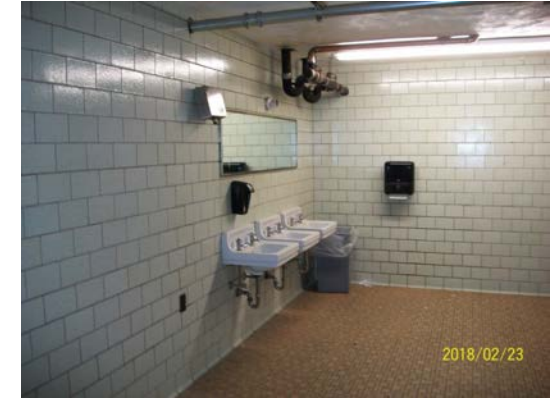
8 - Vitreous china, under-mount lavatories with manually operated faucets.
1 - Vitreous china, wall mounted lavatory with manually operated faucet.
Fixtures and faucets observed to be in good operating condition.
No reported issues.

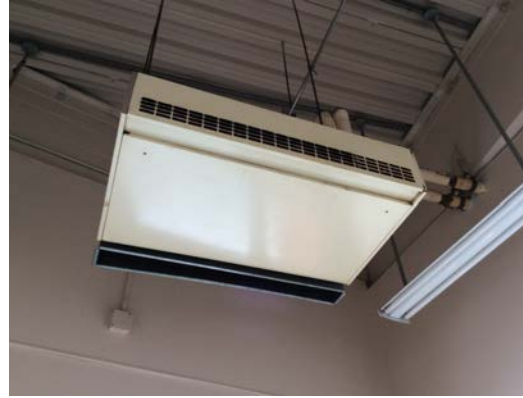
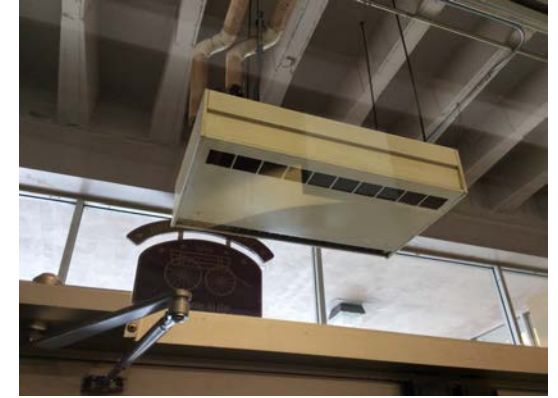
Hot water vertical unit heaters nearing end of useful life. Piping insulation may contain asbestos or other hazardous material.

Replacement of hot water vertical unit heater. Make all modifications required for connection. Upgrade all controls.

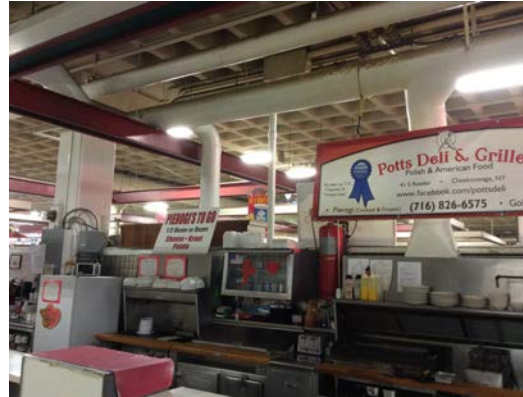
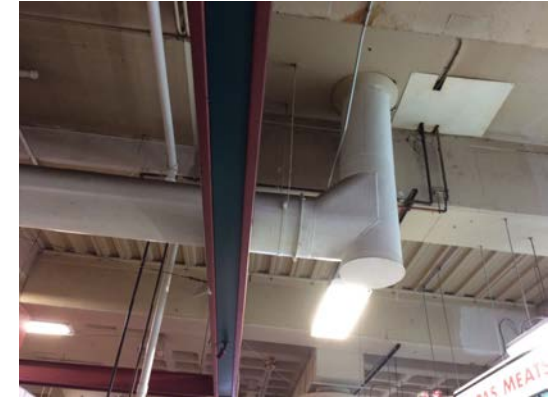
Kitchen grease ductwork has no clean outs per IMC requirements. Construction is unknown due to paint on ductwork. Potential paint is lead based and may be hazardous. No exhaust fan located.

Recommend providing kitchen grease ductwork, 16 gauge black steel with joints welded, flanged, and gasketed at kitchen hood. Provide with clean outs in horizontal runs and vertical risers in accordance with NFPA 96.

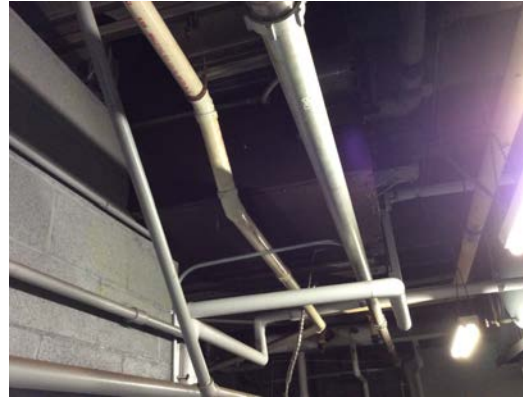
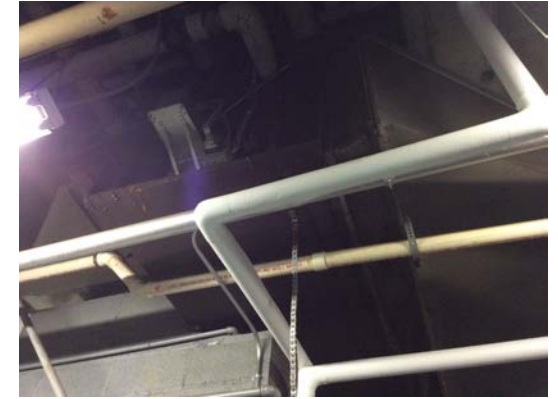
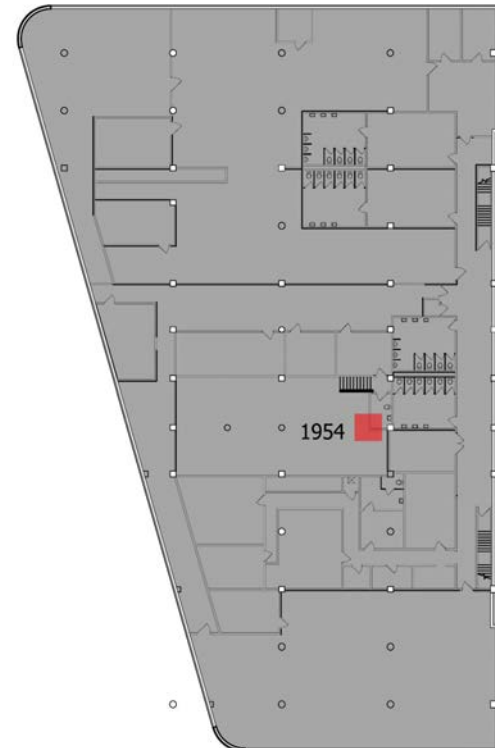
Basement Plan

Air handling unit no longer functioning. Basement has no means of make up air for toilet rooms or ventilation to spaces. Unit is ceiling suspended. Hot water heating. Piping insulation may contain asbestos or other hazardous material.

Replacement of hot water ventilation air handling unit. Provide all ductwork and piping modifications required. Upgrade controls. Support units from building structure.

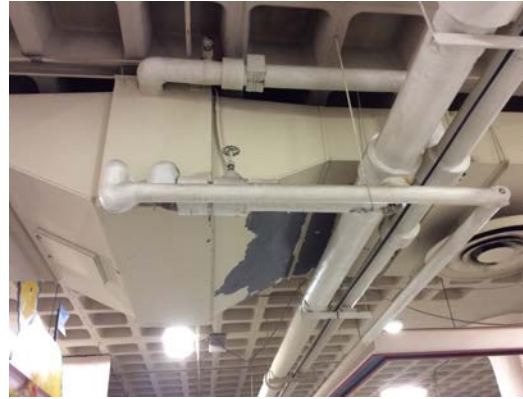
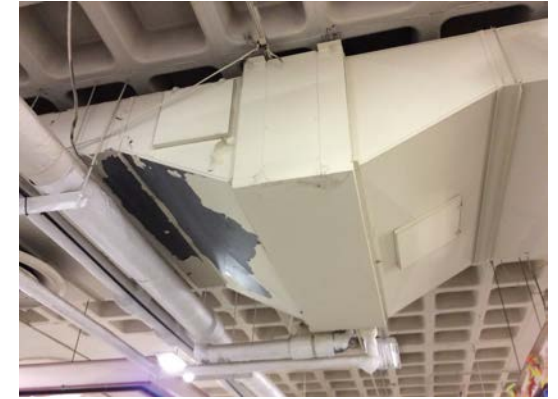
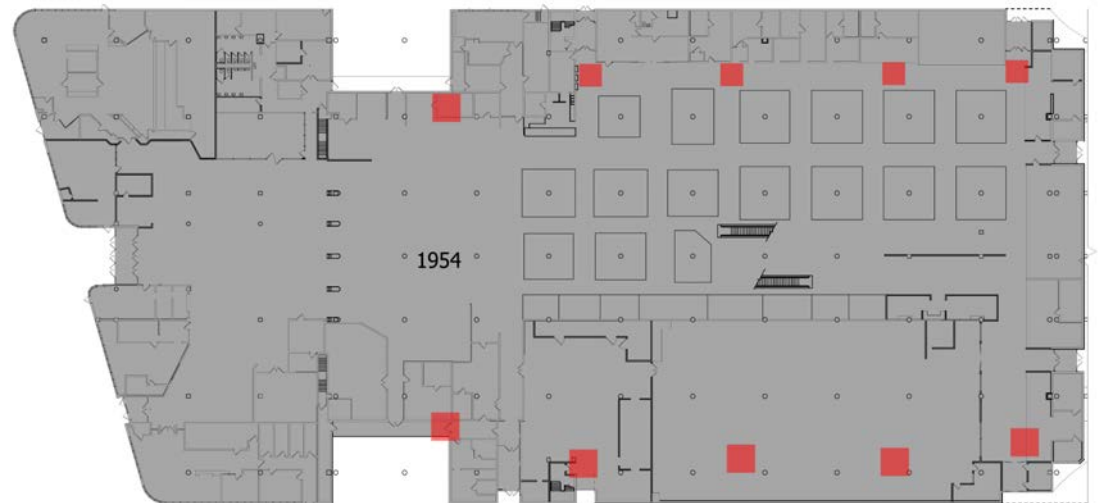
First Floor Plan (North)

Air handling units nearing end of useful life. Units have hot water heating. Units have remote duct mounted chilled water cooling. Air handling units are older than duct mounted cooling coil. Units bring in ventilation to main floor. Ventilation rates may increase per IMC requirements. Units are ceiling suspended. Piping insulation may contain asbestos or other hazardous material.

Replacement of hot water and chilled water ventilation air handling units. Provide all ductwork and piping modifications required. Upgrade controls. Support units from building structure. Provide means of relief in space to relieve outside air.

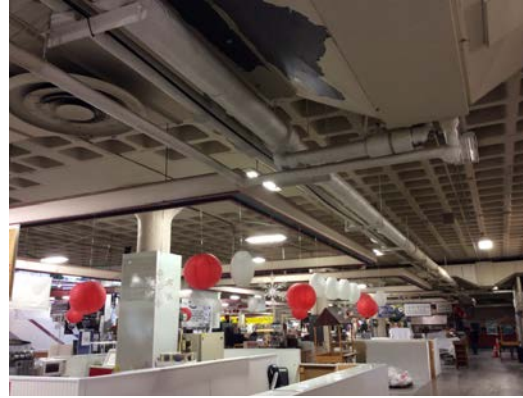
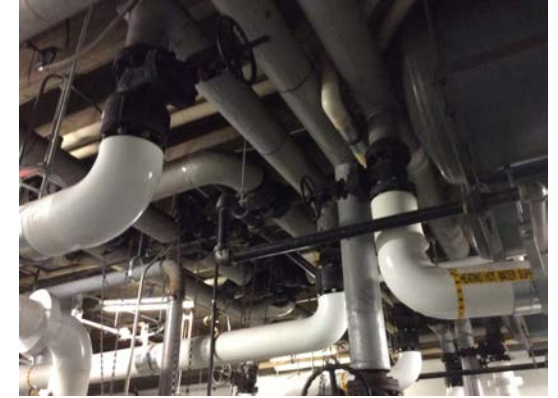
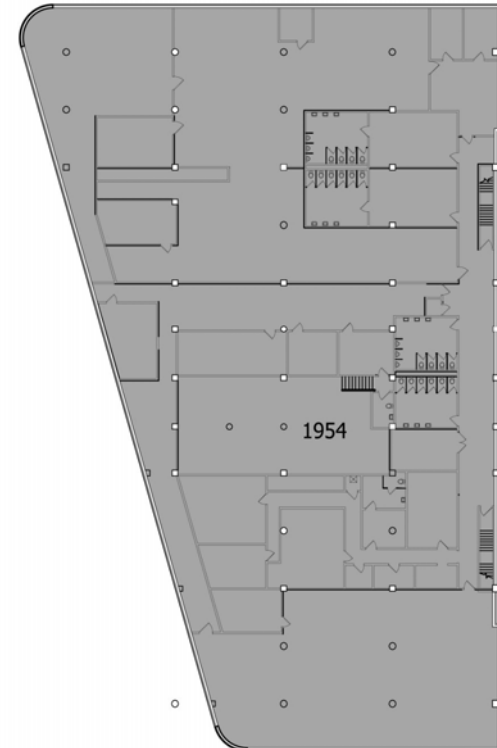
Basement Plan

Piping insulation generally in good working order in boiler room. Other places throughout the building appears to have some asbestos insulation or other hazardous material. Piping may be disturbed during other work.

Remove insulation on hot water and chilled water supply and return piping on first floor and third floor mech/electric room and replace with fiber glass insulation.

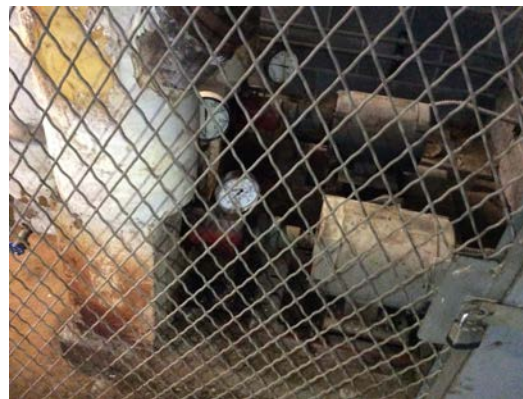
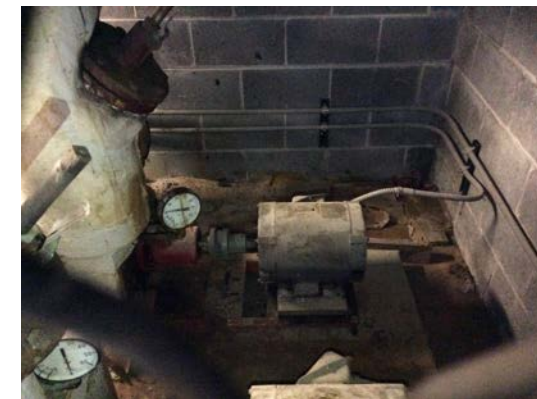
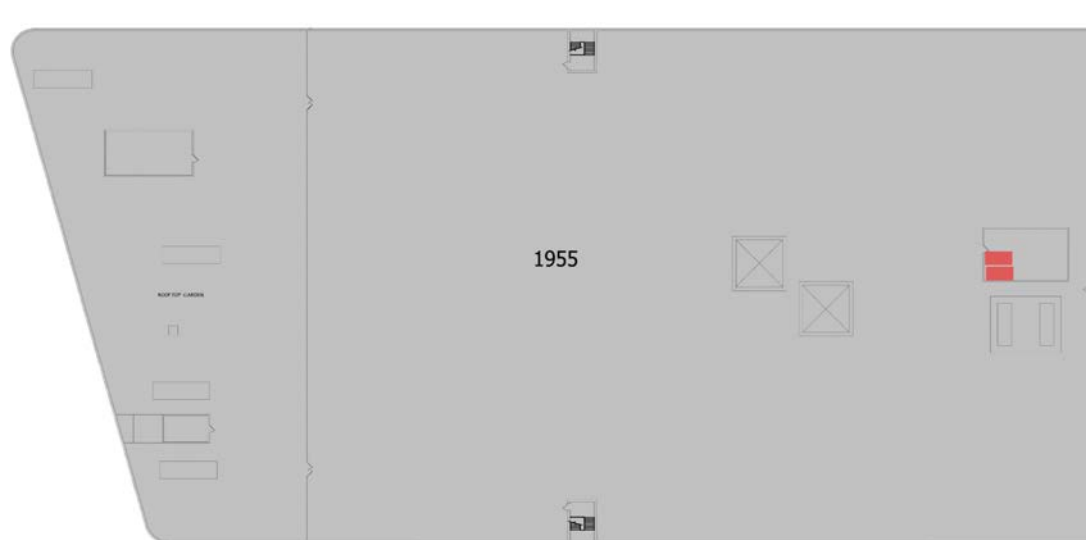
Third Floor Plan (North)

Chilled water pumps nearing end of useful life. Base mounted. Nameplate info not available. Piping insulation may contain asbestos or other hazardous material. Units located in mech/elec room on 3rd floor parking level.

Replacement of chilled water base mounted pumps. Provide piping modifications as required. Upgrade all controls. Provide pumps with flex connectors and VFDs.

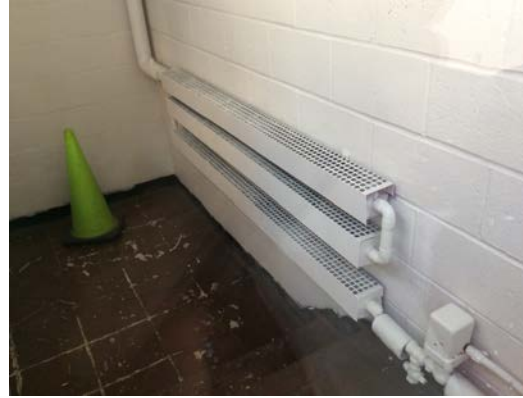
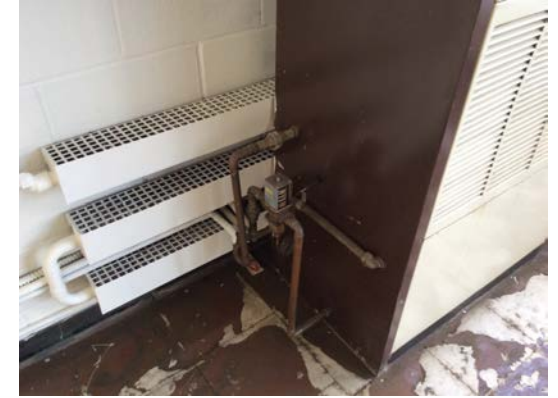
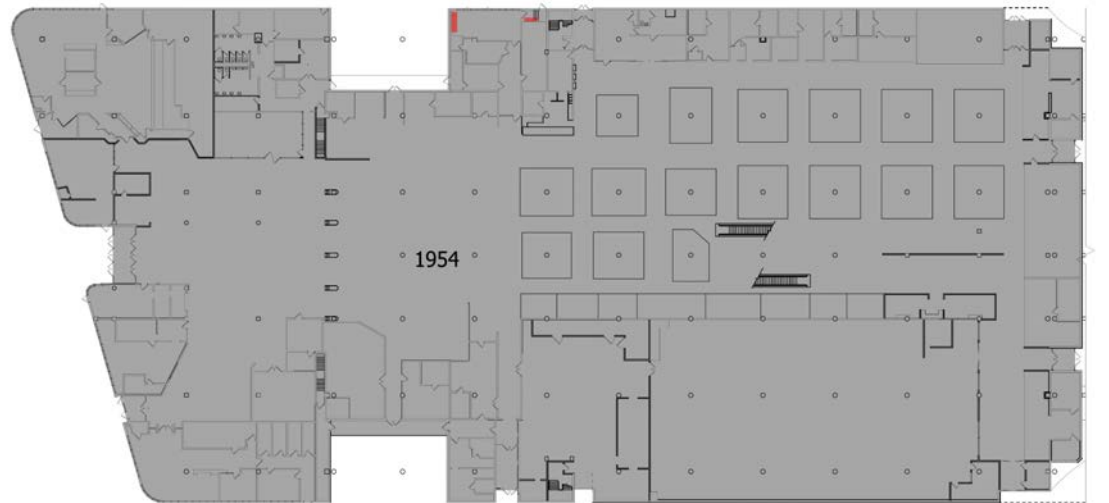
First Floor Plan (North)

Hot water radiation nearing end of useful life. Piping insulation may contain asbestos or other hazardous material.

Recommend replacement of hot water radiation. Provide all control modifications required.

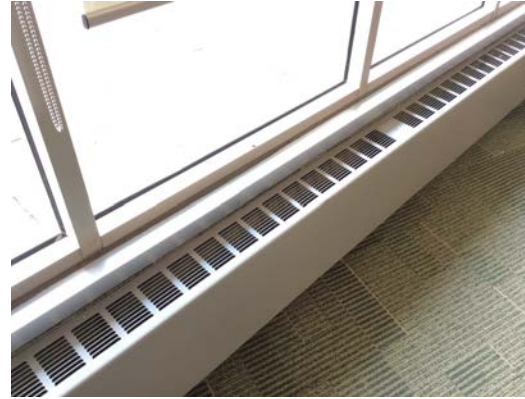
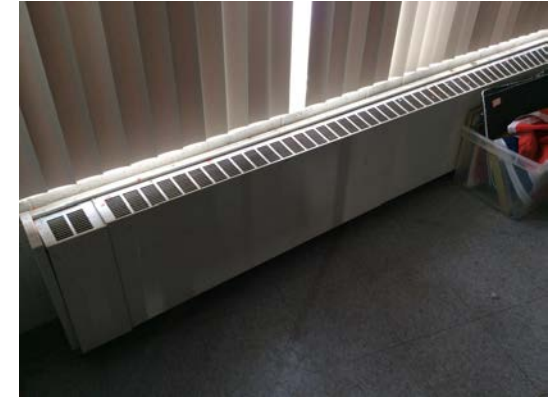
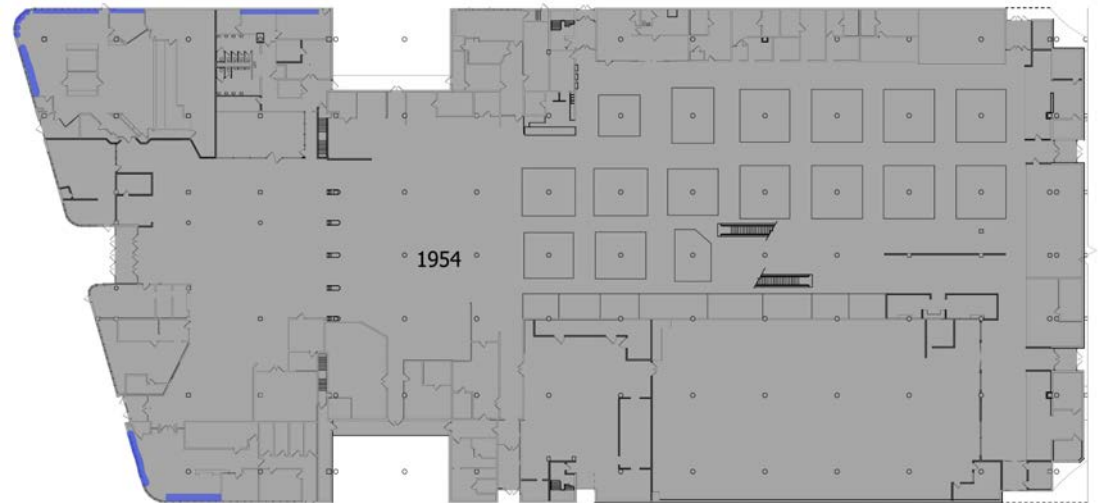
First Floor Plan (North)

Hot water radiation in good working order. Piping insulation may contain asbestos or other hazardous material.

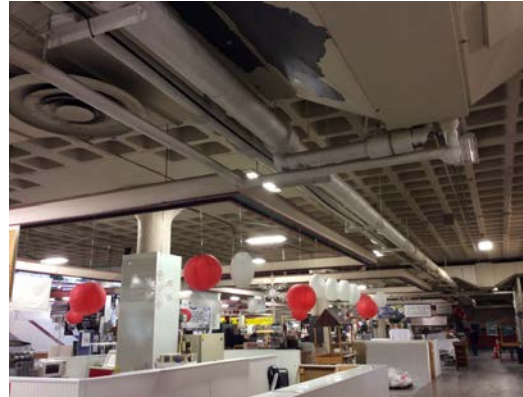
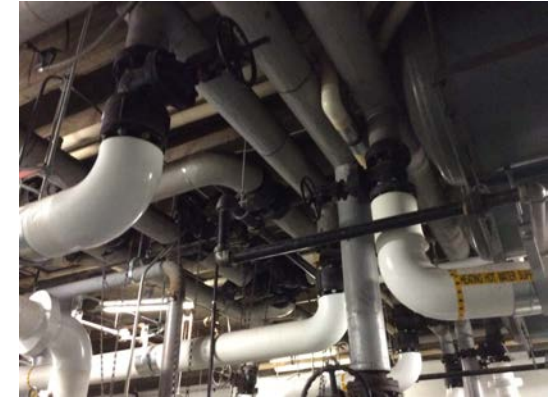
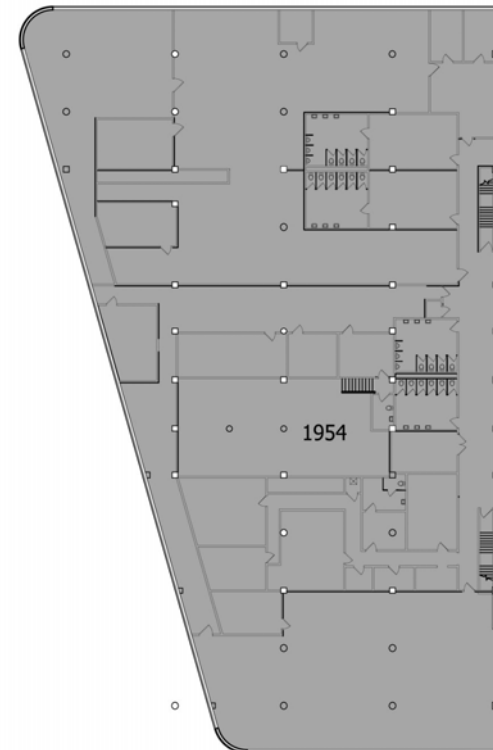
Basement Plan

Most valves in good working order. Recommend replacement of some gate valves in basement in the future, not necessary at this moment.

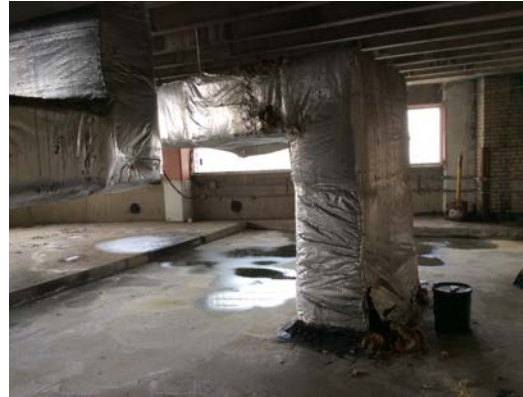
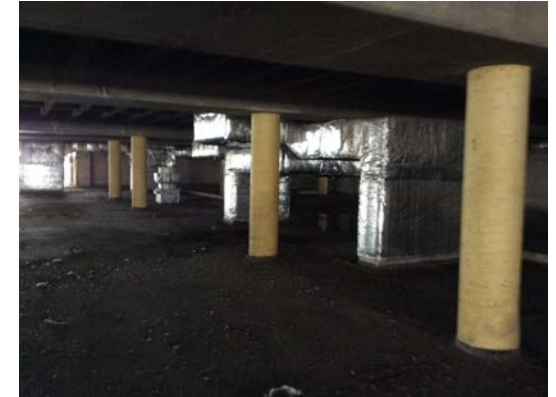
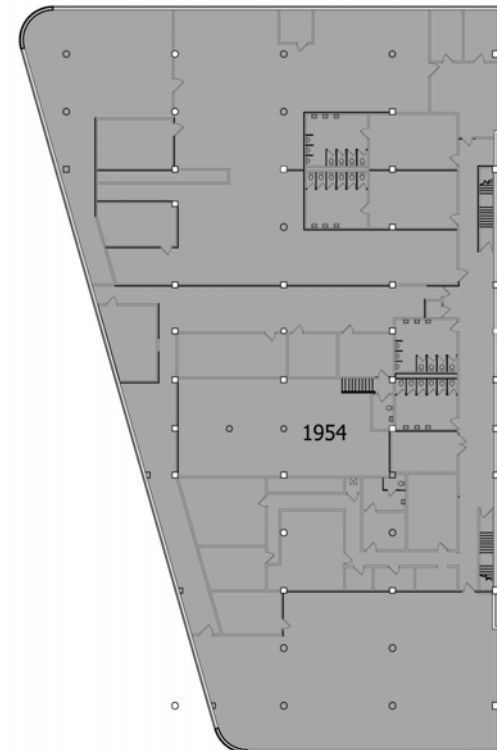
Basement Plan

Generally interior ductwork insulation in good working order. All exterior insulation is deteriorating.

Recommend replacement of ductwork insulation and provide weatherproof insulation with proper drainage. Provide bird screening or protection from nests at top of ductwork.

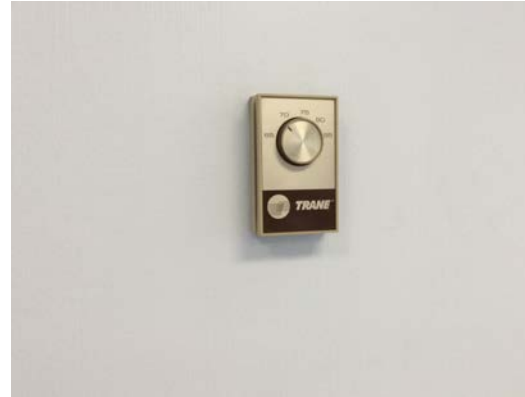
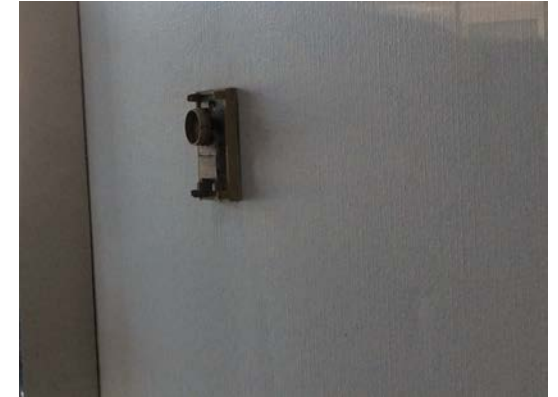
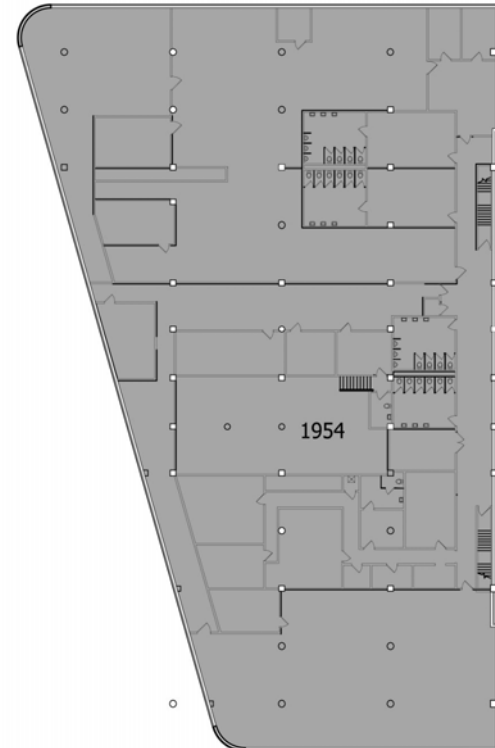
Basement Plan

Some pneumatic or line voltage controls in building with few exceptions. Old compressor not found.

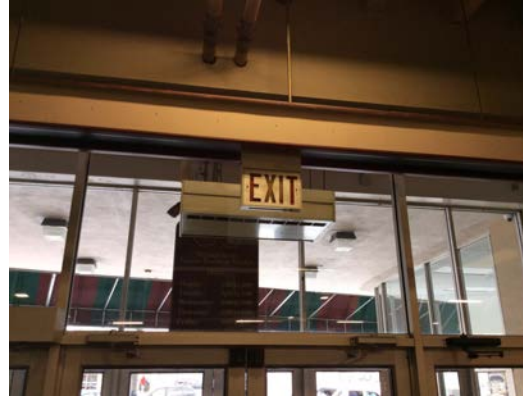
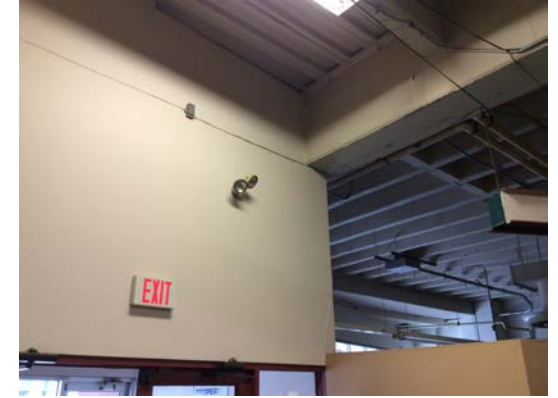
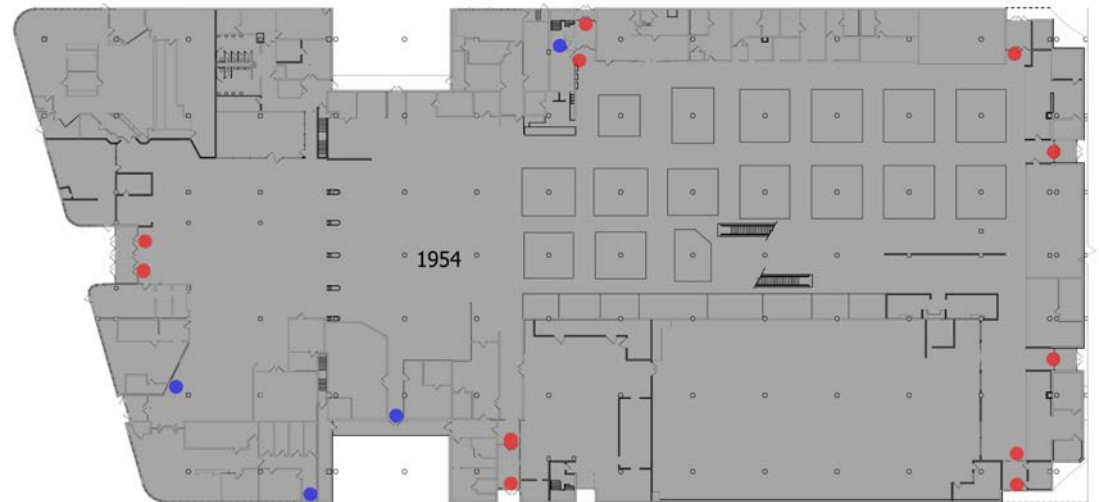
First Floor Plan (North)

Various types of exit signs from thermoplastic to metal and from incandescent to led technology, incandescent exit signs are not operational, exit signs in parking ramp are damaged and not operational, exit signs are only placed above exit doors and provide no way finding.

Recommend replacing incandescent exit signs in kind, and providing additional to help with way finding and egress.

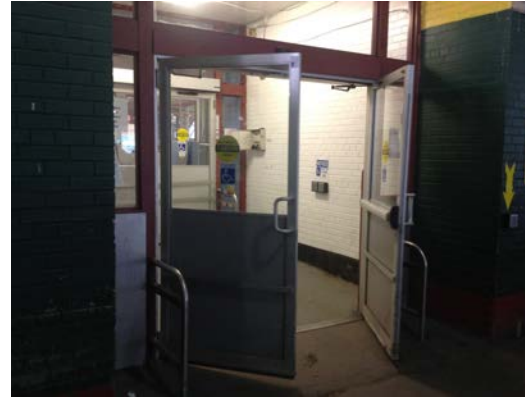
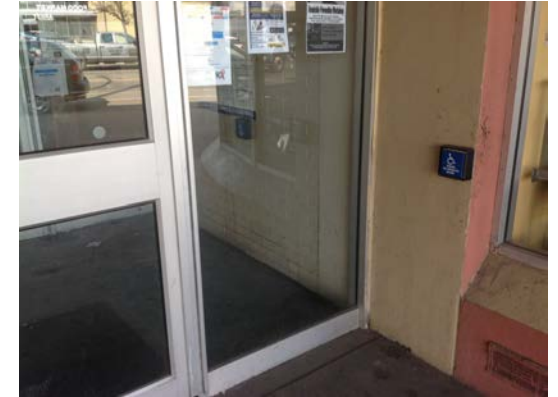
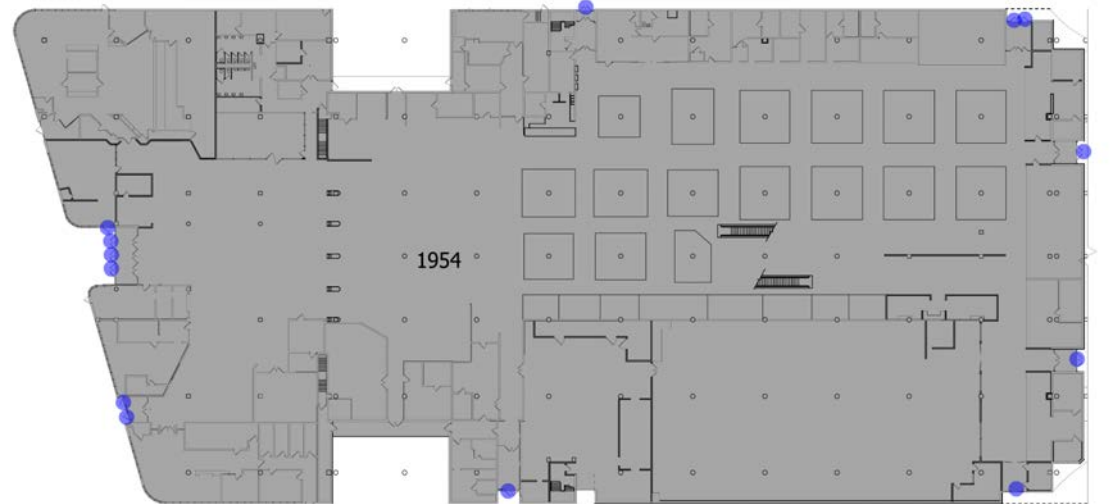
First Floor Plan (North)

Automatic door openers are a variety of paddle switches with motion detection operation on hinged aluminum and one slider type doors. During one site visit the slider was under repair and non functioning.

Replace with new doors, frames and hardware along with consistent operating devices along with electronic strikes and card access

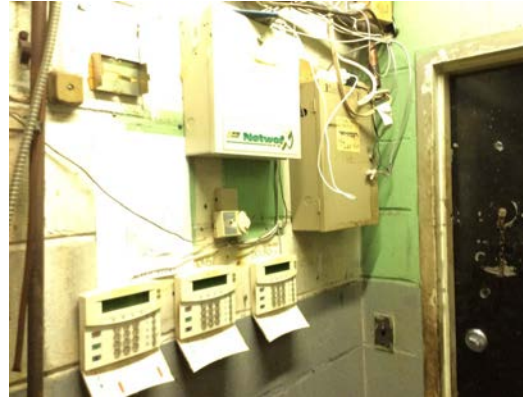
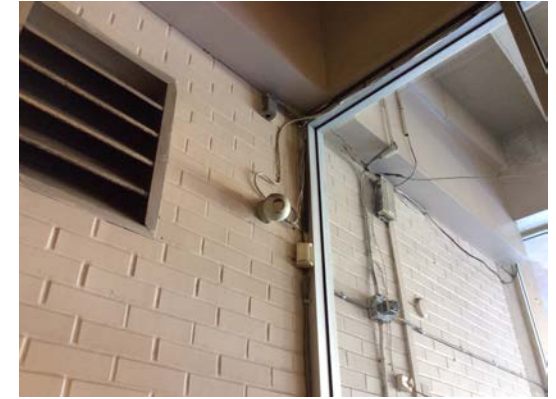
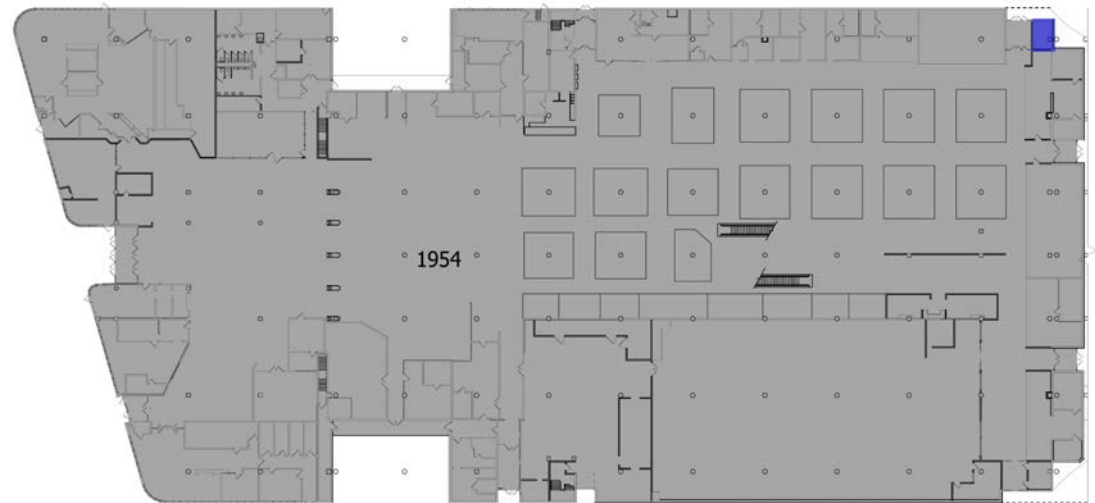
First Floor Plan (North)

System is operational some perimeter doors are not provided with door contacts recommend providing for all.

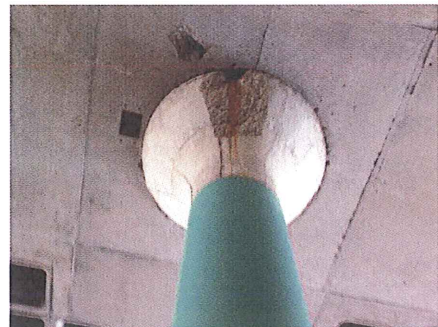
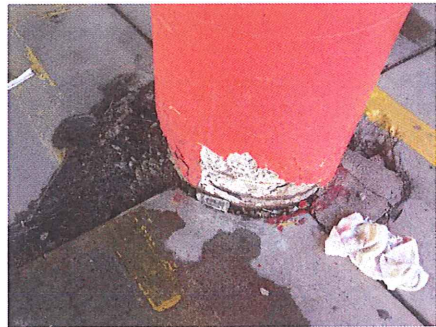
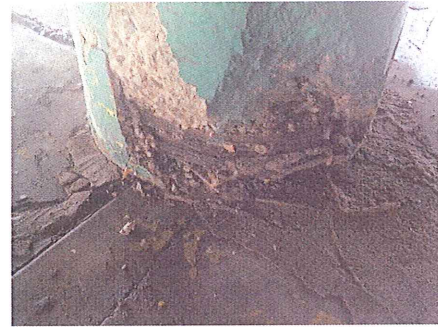
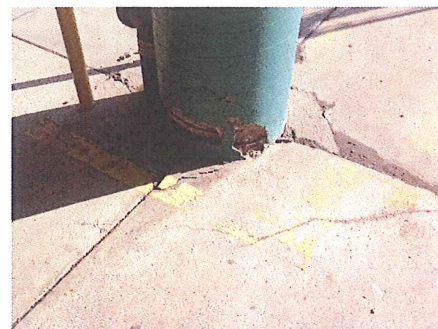
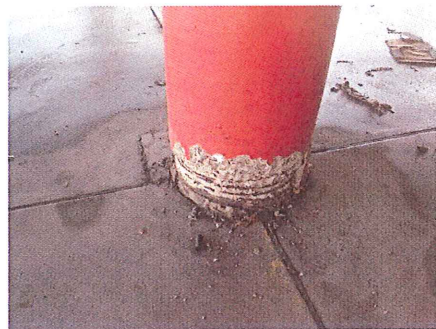
Unsatisfactory Column Location Plan as prepared by YWA

1041	061 Exterior Wall/Columns (HSW)	Unsatisfactory	3 years +/-	75	EA.	\$ 600.00	\$ 45,000.00	Cementitious patch and epoxy-carbon fiber wrap. Assume +/- 10 sf per column (average). Refer to structural report.	First Floor (South): multiple fractures and spalling with rebar exposed.
1042	061 Exterior Wall/Columns (HSW)	Unsatisfactory	3 years +/-	49	EA.	\$ 1,200.00	\$ 58,800.00	Cementitious patch and epoxy-carbon fiber wrap. Assume +/- 20 sf per column (average). Refer to structural report.	Second Floor (North): multiple fractures and spalling with rebar exposed
1043	061 Exterior Wall/Columns (HSW)	Unsatisfactory	3 years +/-	49	EA.			Refer to structural report.	Second Floor (South): multiple fractures and spalling with rebar exposed

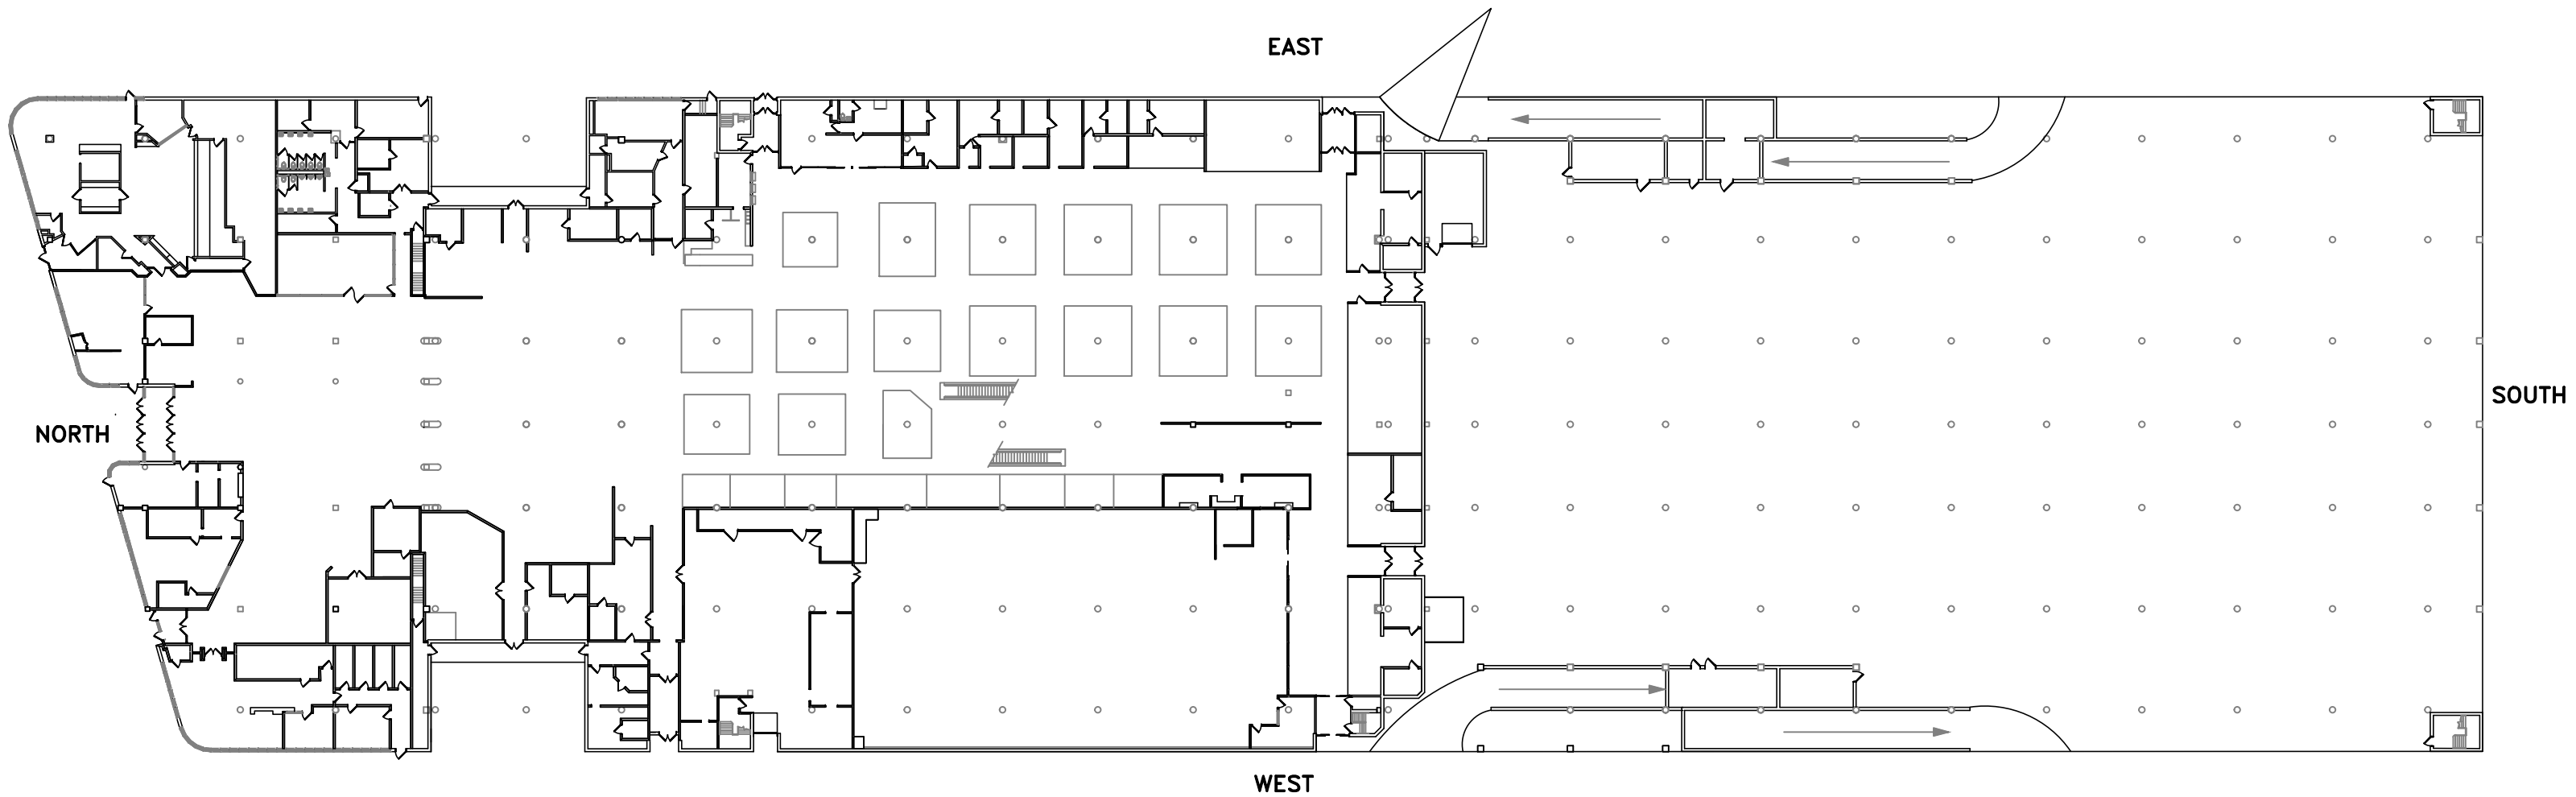
XRF TESTING WAS CONDUCTED ON MARCH 5 & 9, 2018.

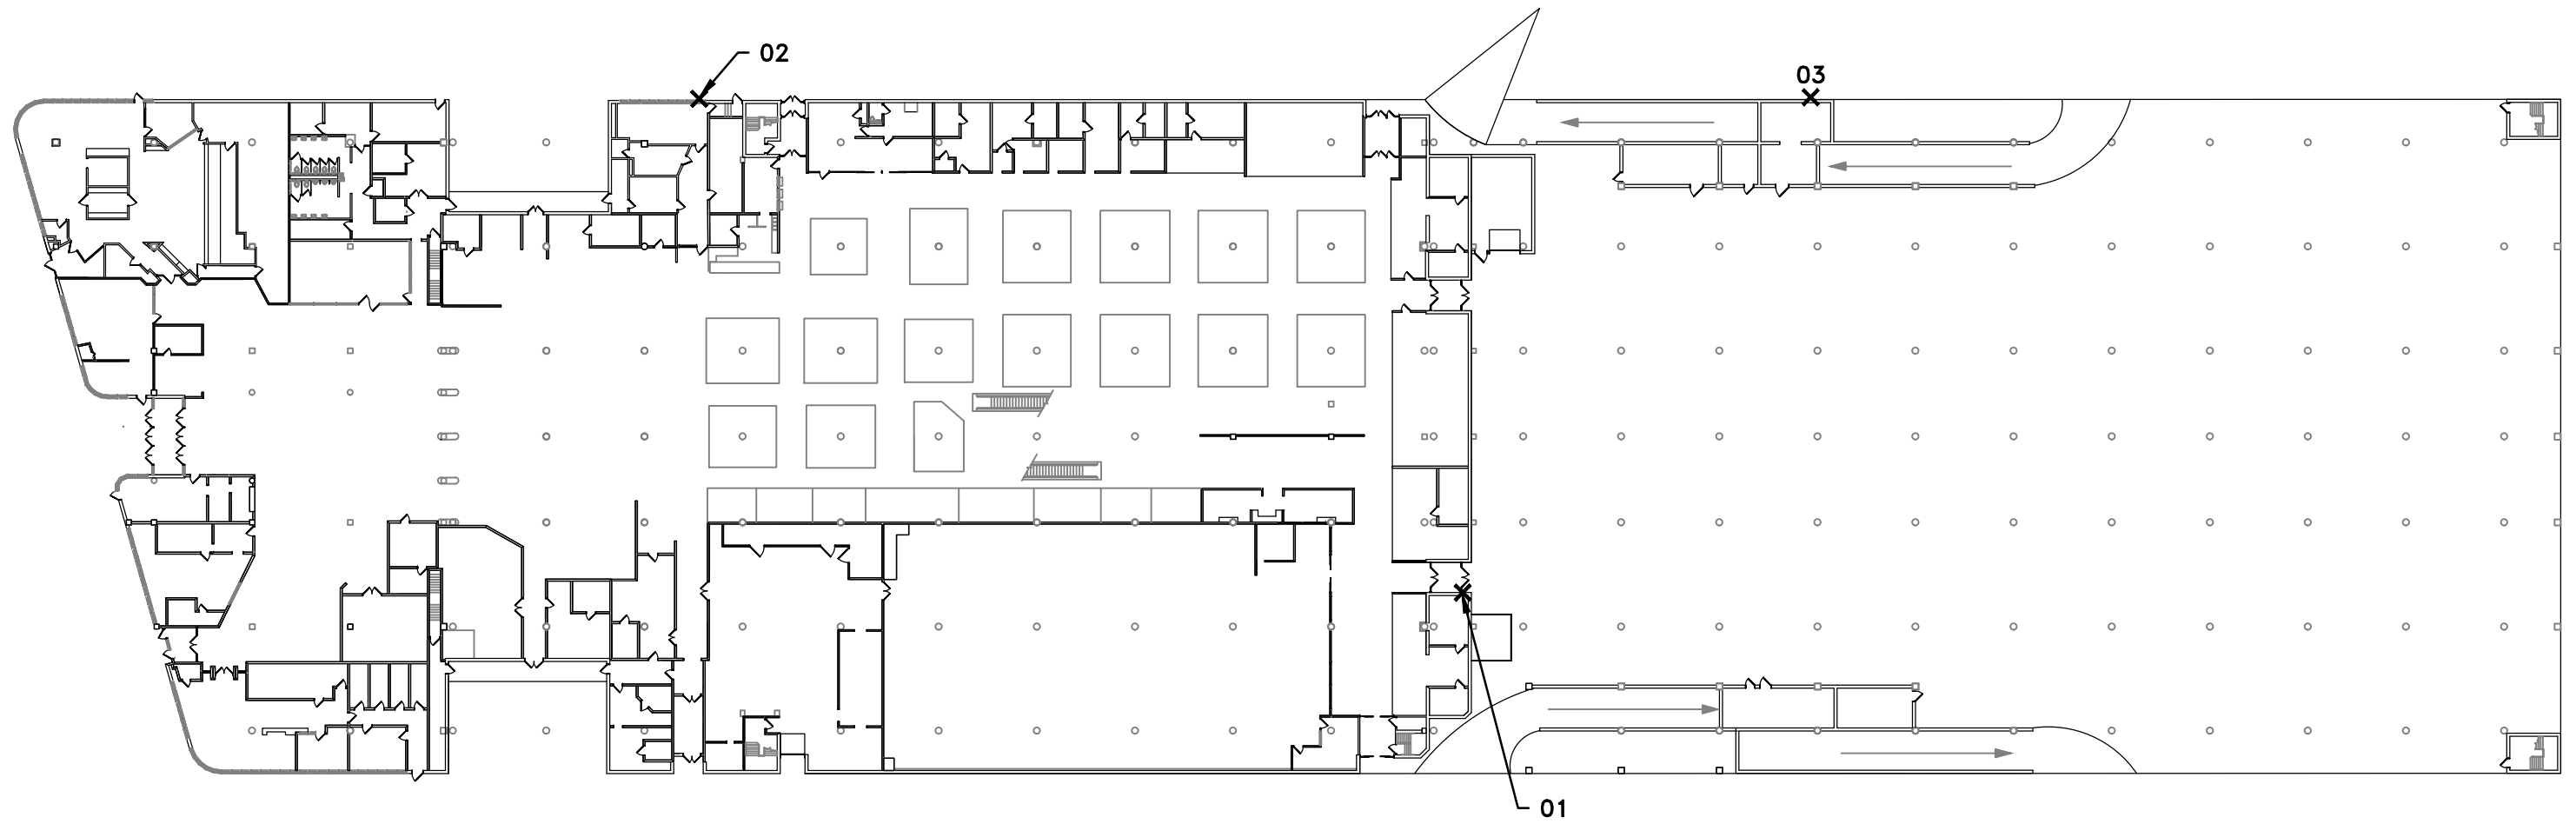
4.1 – PCB BULK SAMPLE LOCATION DRAWINGS

Drawings depicting the approximate PCB sample locations are included in Section 4.1. It is the belief of Watts that this investigation has identified all suspect PCB-containing materials that will be disturbed by this project. However, if additional suspect materials are identified during the construction period that have not been previously sampled or sampled as part of this assessment, samples of each material should be collected and analyzed for PCB content.
