E-Comm Square Building Assessment

Structural, Electrical & HVAC

CHA Project Number: 16433

April, 2010

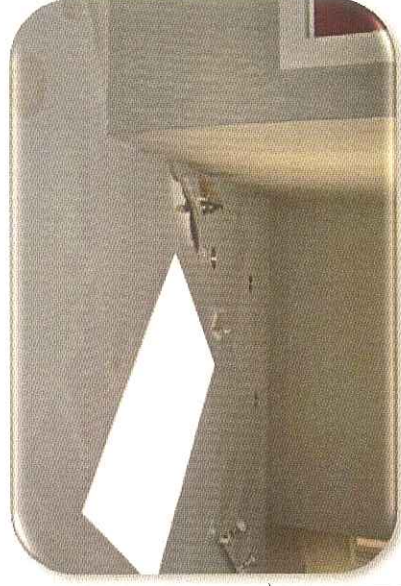
Photo 17

- + Finishes cover all of the structure on the fourth floor. Several minor water stains were observed on the ceiling. However significant water damage was observed near the skylight. Paint was peeling and some of the sheetrock was beginning to come down at this location (Photo 17).
- + No additional cracks, leaks or other signs that would indicate a structural deficiency were observed on this floor.

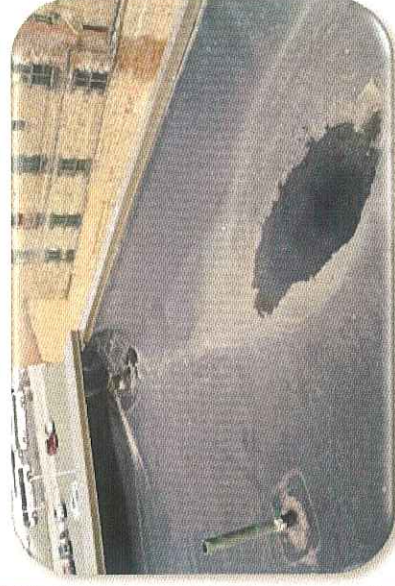
Photo 19

- + The roofing consists of an adhered EPDM membrane roofing system. There is a failure in the roof seam near the skylight where the water damage was observed on the fourth floor (Photo 18).
- + The EPDM roofing is coming up and pulling away from the parapet where the roof meets the parapet at several locations (Photo 19).
- + Two roof drains on the roof appear to be undersized and not properly flashed. The drains consist only of a pipe that comes up to the surface of the roof with no actual recessed drain grate cover assembly. The EPDM roofing is folded into and glued to the inside of the pipe (Photo 20).
- + The brick facade of the machine room, stairwell penthouse and the parapet at the roof step has minor mortar joint deterioration (Photo 21).

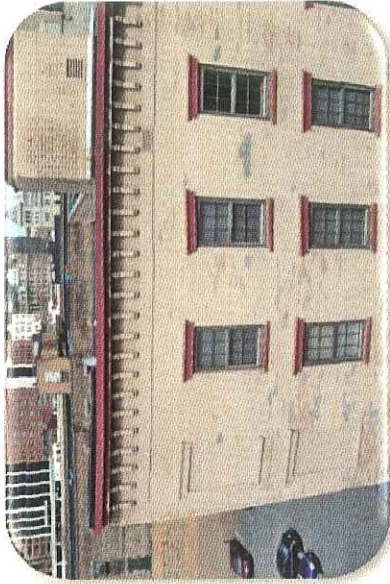
Photo 23

- + Step cracking and outward displacement of the brick facade was observed over the door on the south facade of the building (Photo 22).
- + The window heads and sills on the first row and third row of windows from the southeast corner of the building slope down towards the second row (Photo 23). It appears the building has settled at this location sometime in the past. It was observed that the head of one of the windows bears on a different course of brick than the other. This indicates that the settlement could have possibly occurred during construction of the building.

It is also recommended that the existing paint be removed from the facade, all deteriorated mortar joints in the facade be repointed and a waterproofing silane sealer be applied to the entire facade.

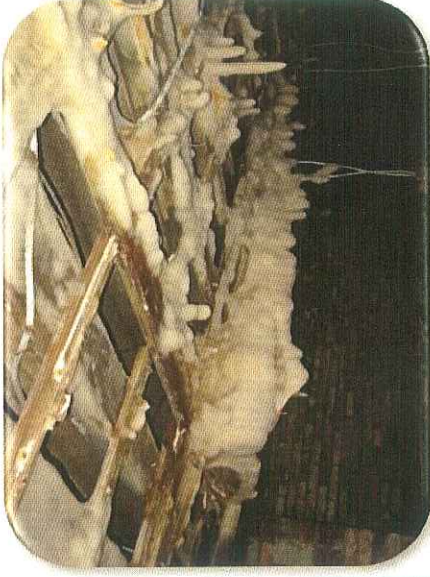
Photo 28

- ✦ Mortar joints in the fieldstone foundation walls are deteriorated.
- ✦ A significant area of the underside of the first floor wood framing is covered in a thick layer of mold and/or fungus. This would indicate that this wood framing is wet and could be deteriorated (Photo 28). Due to very poor lighting and the risk of disturbing the mold/fungus it was difficult to determine the actual condition of the framing.

It is recommended to repair the roof to halt the infiltration of water into the building. All of the interior finishes should be removed to inhibit the growth of mold and expose the structure for a thorough structural inspection.

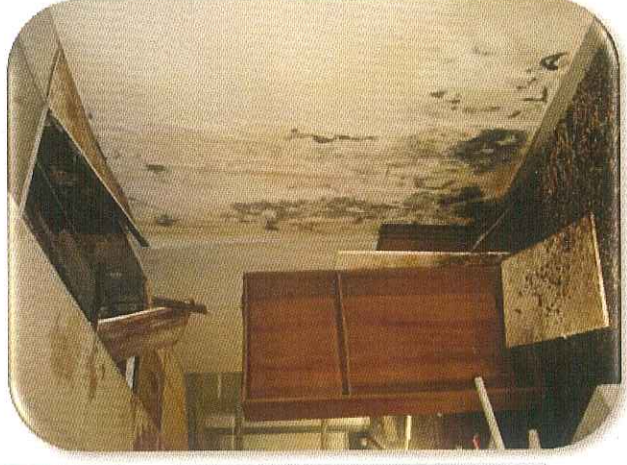
Photo 29

- ✦ Extensive water damage was observed in the front half (east end) of the building. Ceiling tiles were falling, sheetrock walls were damaged and the entire floor area was saturated with water. Significant mold growth was observed in this area (Photos 29 & 30). Based on the conditions observed on the floors above, the water infiltration appears to be occurring at the roof and working its way down through the building.

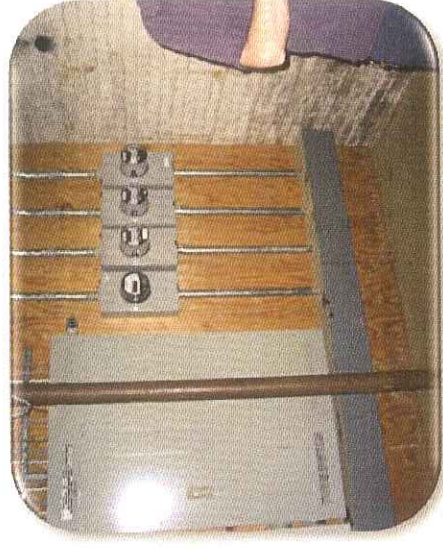
Photo 2 Housekeeping Panelboards and Tenant/Housekeeping Meters

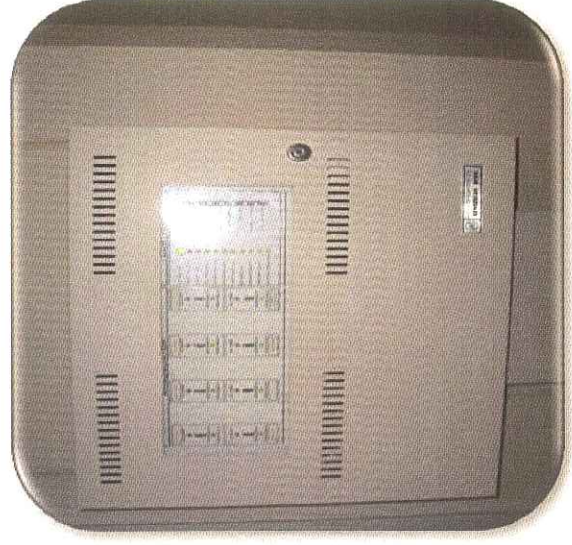
Photo 4 Main 8-Zone Fire Alarm Panel Located in the Main Lobby at Ground Floor.

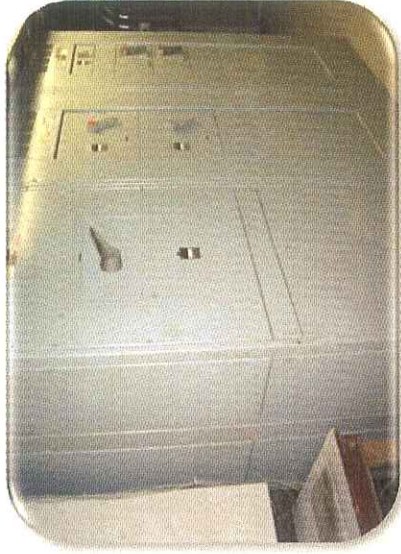
Lack of panic hardware in the basement on the doors to the room with the service switchboard was observed.

Photo 1 Federal Pacific Main 1200A, 208/120V Service Switchboard in Basement.

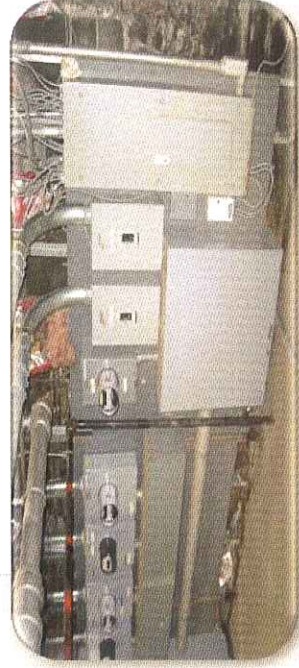
Photo 2 Housekeeping Panelboards and Tenant/Housekeeping Meters Located in the Basement.

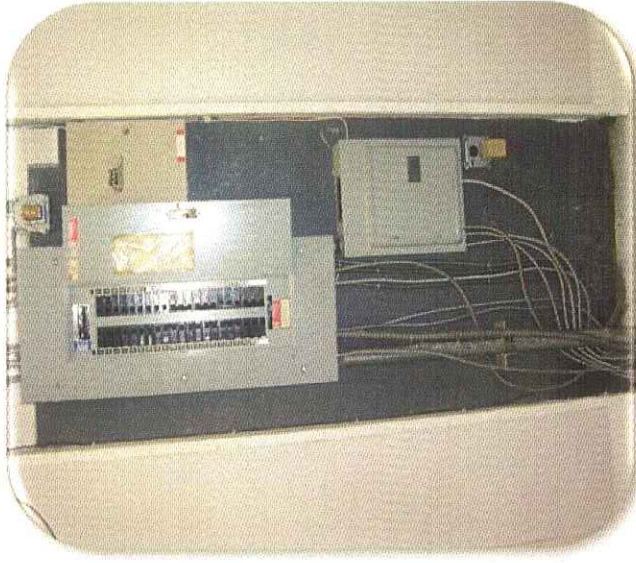
Photo 3. Electrical Closet with two Panel-boards on Each Floor

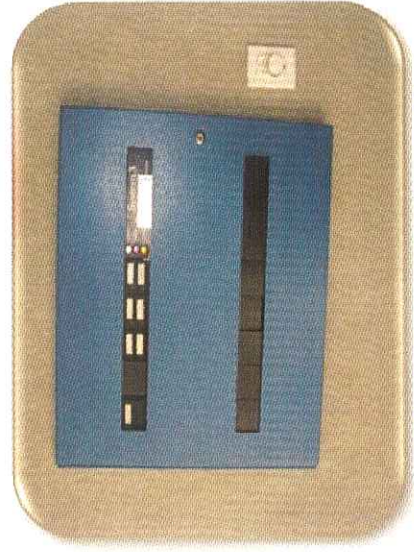
Photo 4 6-Zone Fire Alarm Panel Located in the Main Lobby of building.

This equipment is approaching the end of its normal life expectancy. For a major building renovation project, it is recommended that the fire alarm system be replaced with a new addressable intelligent fire alarm system, including alarm initiation devices and notification appliances to meet current codes. Until a new system can be installed, we recommend that the existing system be tested, including all initiating devices, notification appliances, etc. to verify proper operation and in particular test the notification appliances to insure that the system is audible throughout the building.
