2017 PROPERTY CONDITION ASSESSMENT REPORT – Volume I – Structure Assessment

**Buffalo Outer Harbor Access and Activation Civic
Improvement Project**

801 FUHRMANN BLVD., BUFFALO, NEW YORK

May 19, 2017

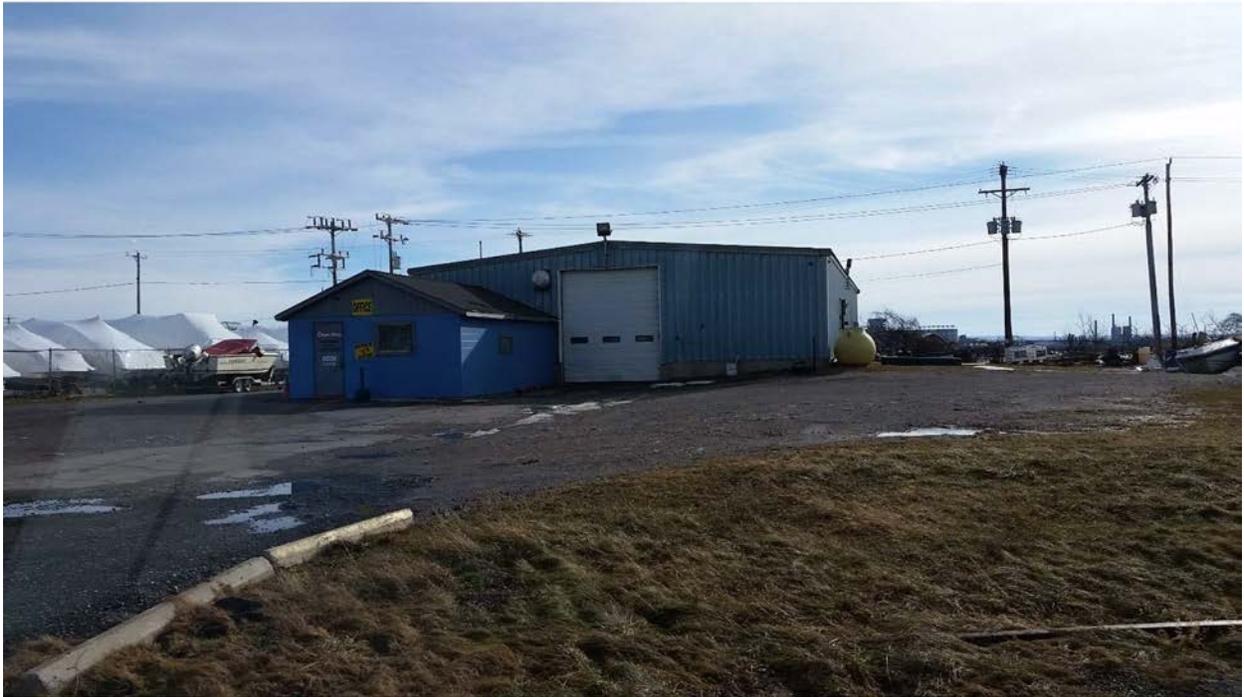
General_BlueBuilding

The Blue Building appears to be in Good Condition overall. There was minor settlement cracking apparent in the CMU of the office section, and the metal panels of the garage portion showed signs of being hit at various locations, especially on the corners, but the structure is generally sound.
