A. INTRODUCTION

This chapter assesses the potential for the presence of hazardous materials in the project site, the potential for exposure to hazardous materials during and following construction, and the specific measures that would be employed to protect public health, worker safety, and the environment. A “hazardous material” is generally defined as any substance that poses a threat to human health or the environment. It is often used interchangeably with “contaminated material,” but should not be confused with the term “hazardous waste,” which is a regulatory term.¹

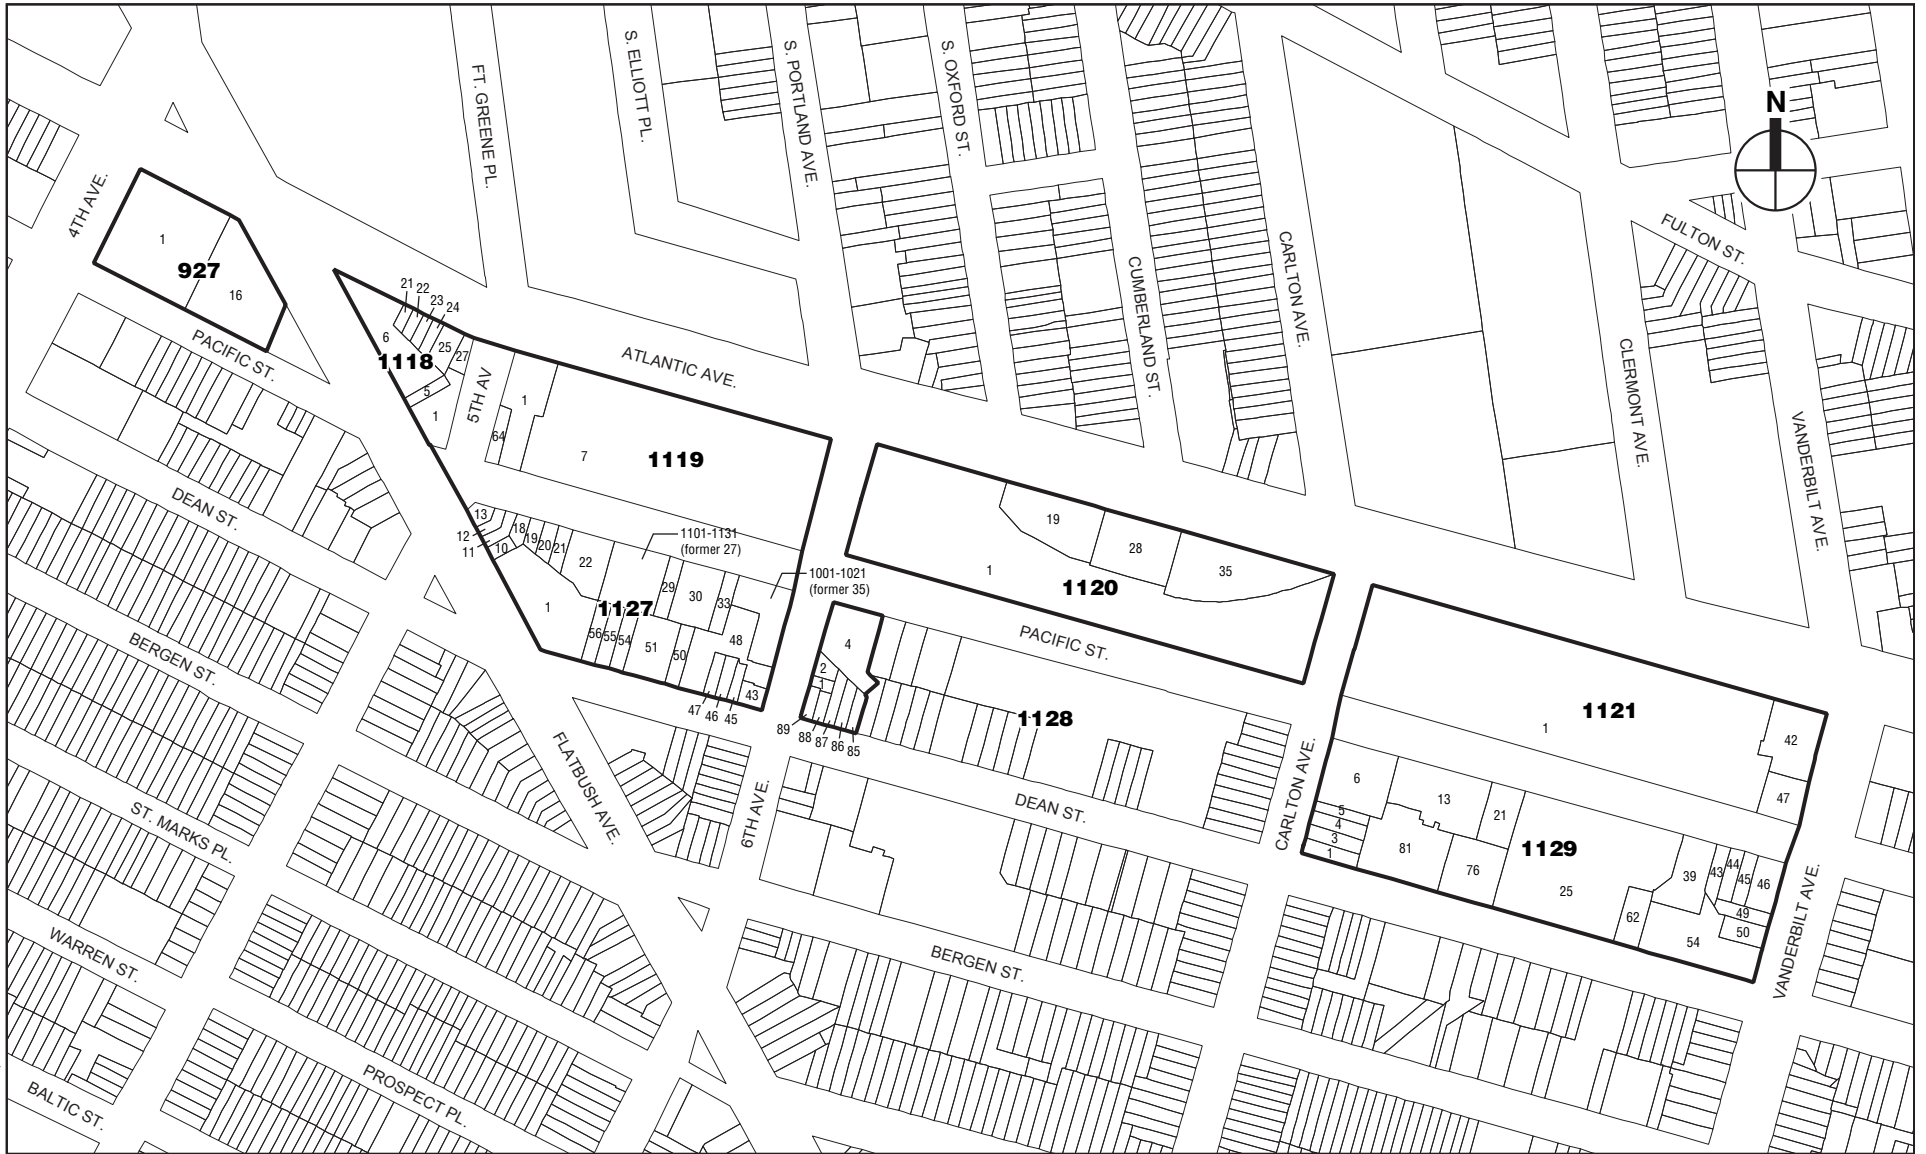
Source: AKRF, Inc.

- Project Site
- 1120** Blocks
- 7501 Lots

Based on the sitewide Phase 1 ESA, and using the information from the individual Phase 1 ESAs and the Phase 2 ESA, the next section describes the findings common to all blocks. Table 10-1 also contains a summary, broken down by tax block, of known and potential environmental conditions. Additional environmental conditions are anticipated to be of a similar nature and
