MEP/FP SYSTEM INVENTORY AND ASSESSMENT – FINAL REPORT

Project Title:	Buffalo Outer Harbor Access & Activation Civic Improvements
----------------	--

REP-17055-001, REV. 2

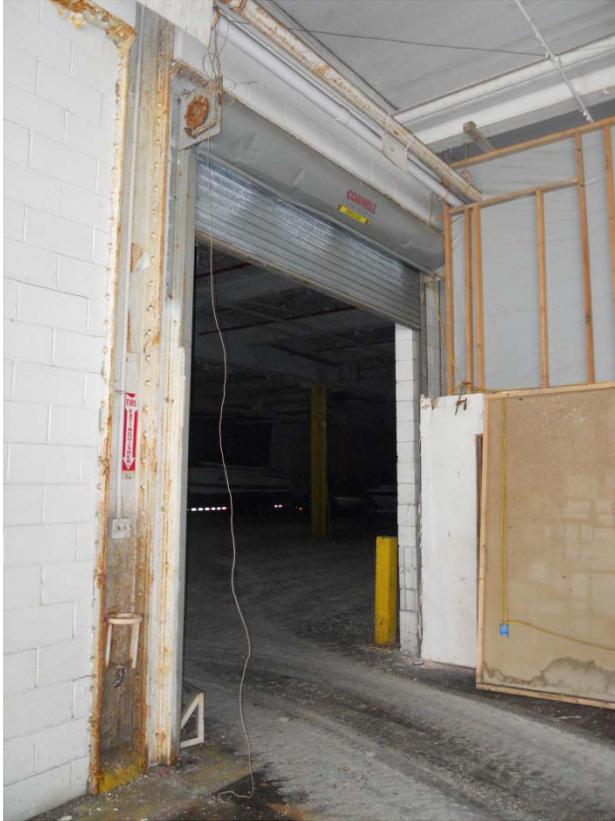
Figure F-009

Roll up Fire Door has not been maintained. Required for Fire Area separation. Wall to right hand side was built for some type protection. The left end of the wall encroaches on the fire door frame and prevents fire closing. This requires remediation.

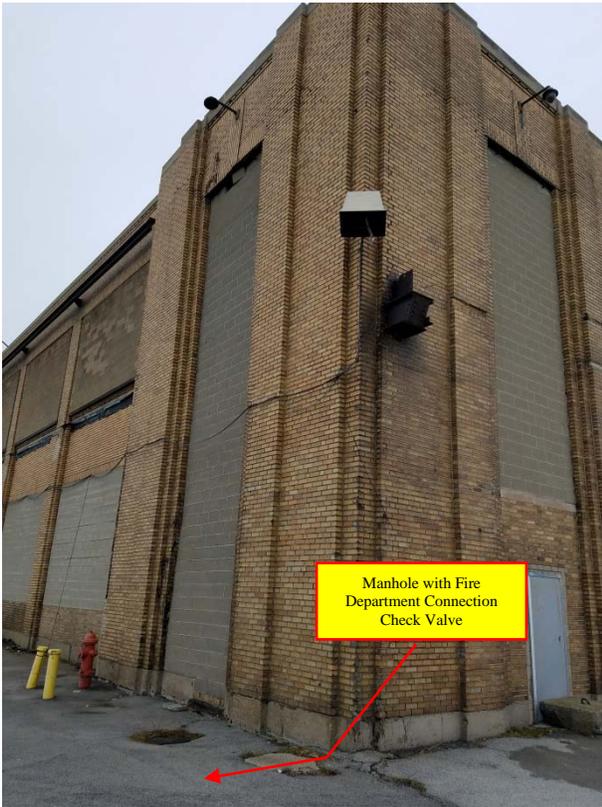
Figure F-011

On South side of Terminal A at the East and West Corner a “Fire Boat” connection or Fire Department Connection is provided to all fire department pumpers to supplement water pressure to the water system. Each connection has a check valve. The South west check valve is located in a manhole as shown in the drawing. The east end is located inside the crane bay area entrance.

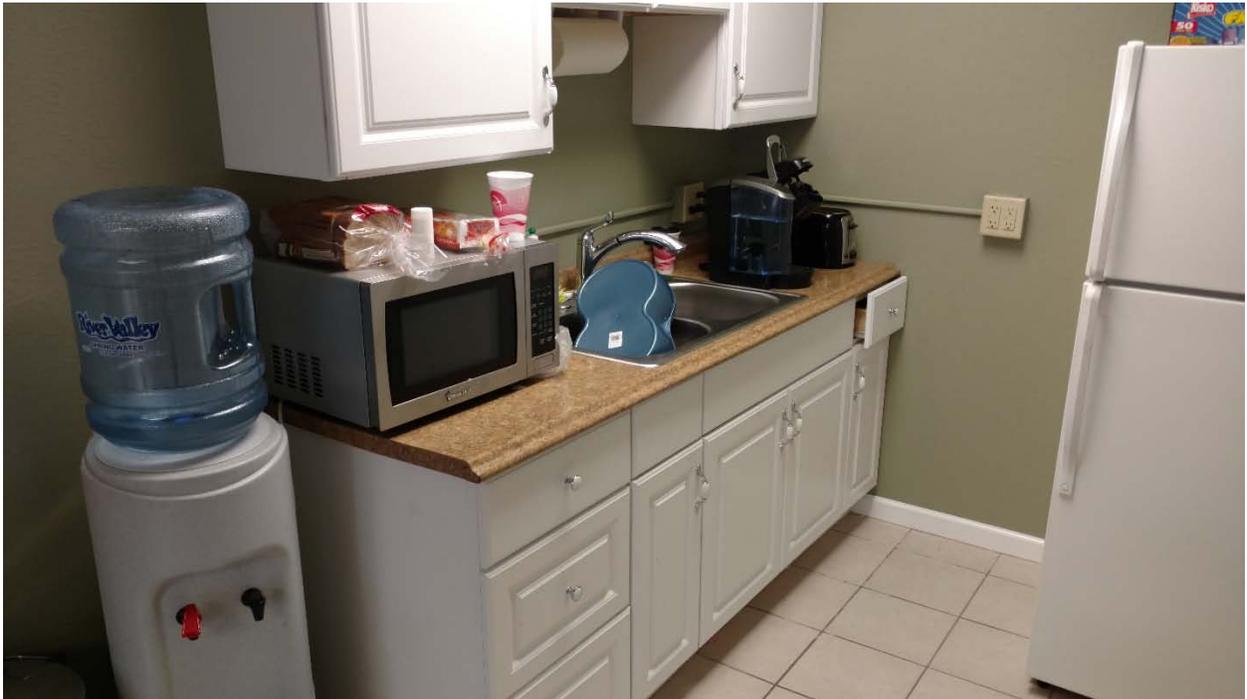
Figure P-017

All plumbing systems observed within the building were in accordance with the original construction drawing set, dated May 2011, with the exception of the kitchen sink location in office 01, shown in figure P-017 and the addition of a sink in office 07, shown in figure P-018. All equipment was observed to be in good, working condition.

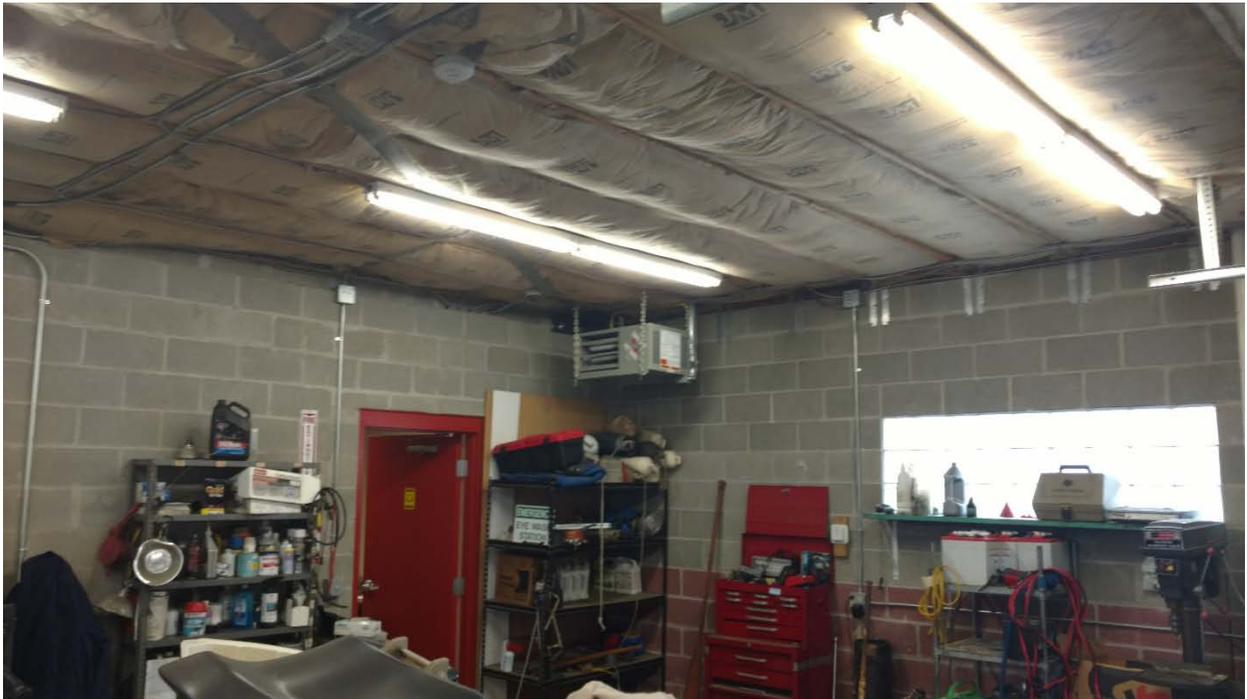
Figure M-047

All mechanical systems observed were in accordance with the original construction drawing set, dated May 2011, with the exception of an added unit heater located within garage 06, shown in figure M-047. All equipment was observed to be in good, working condition.

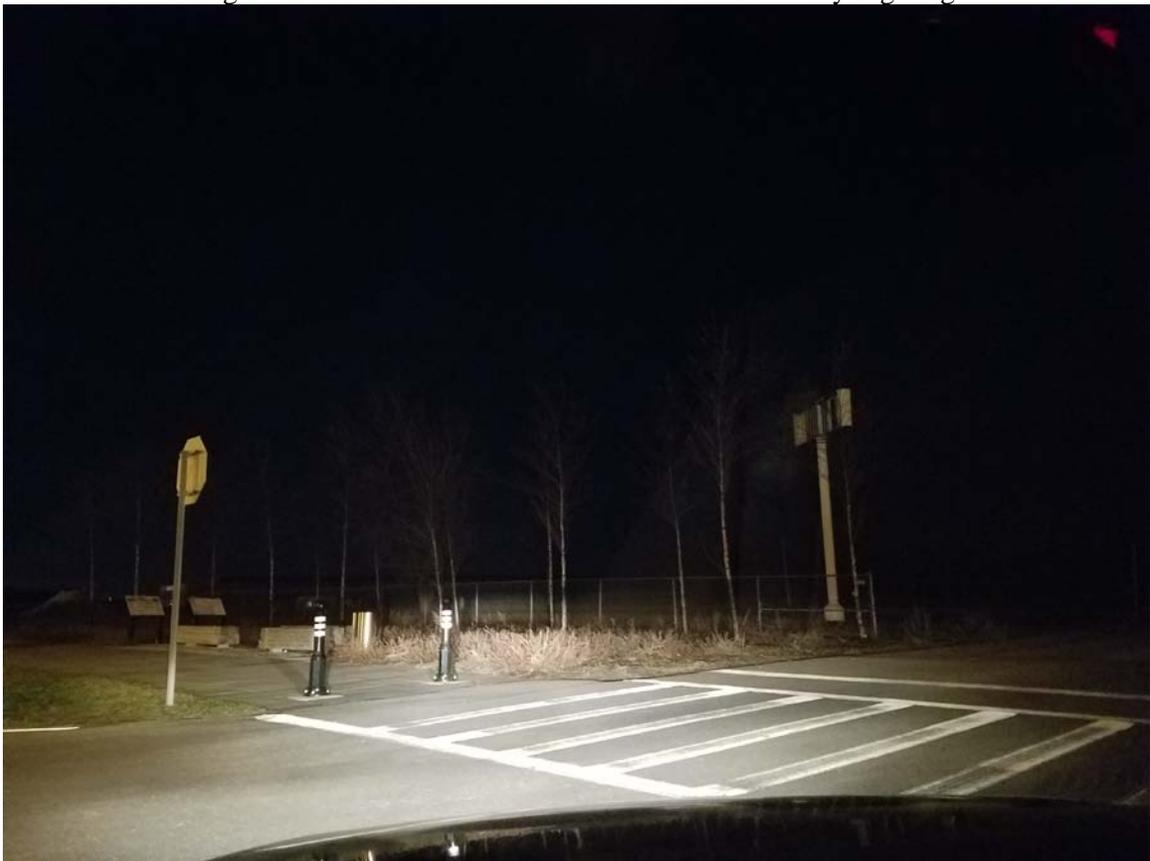
Figure E-012. 901 Fuhrmann Blvd Site at Night, Showing Inactive Driveway Lighting

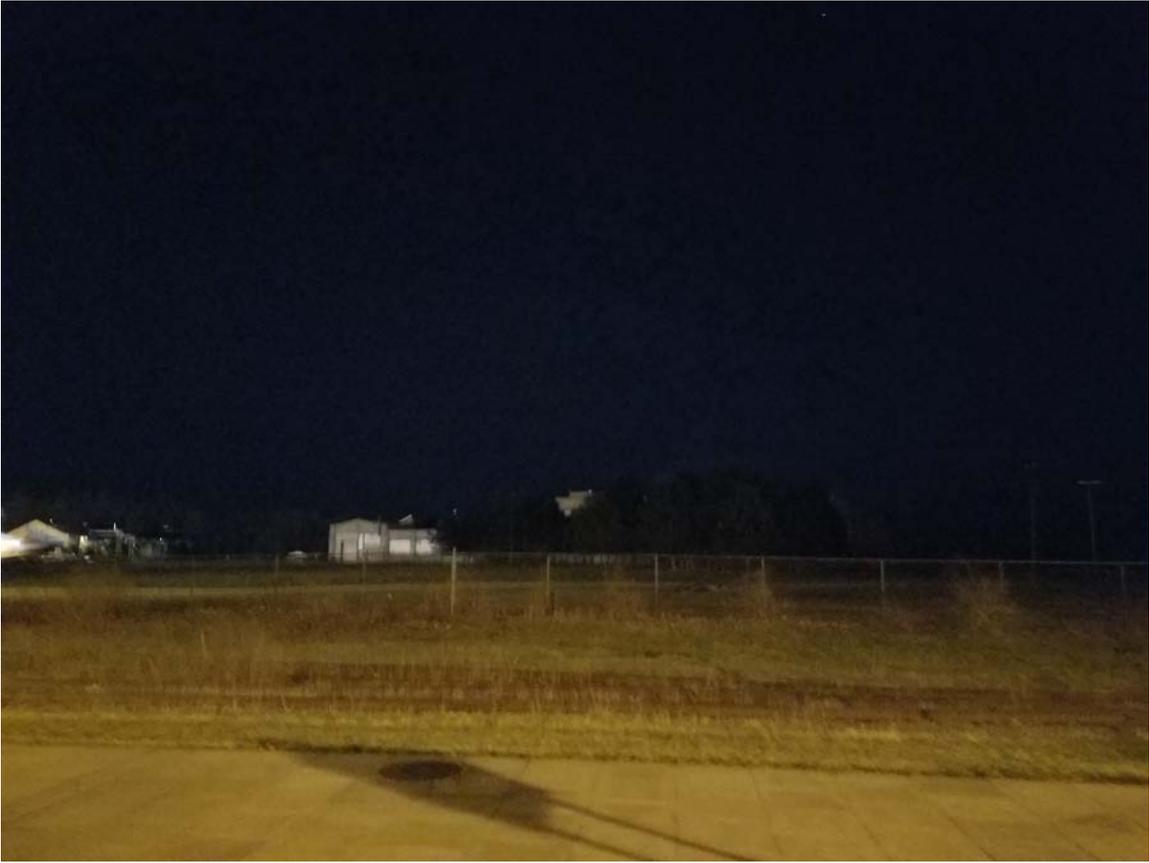
Figure E-013. 901 Fuhrmann Blvd Site at night, Showing Inactive Site Lighting

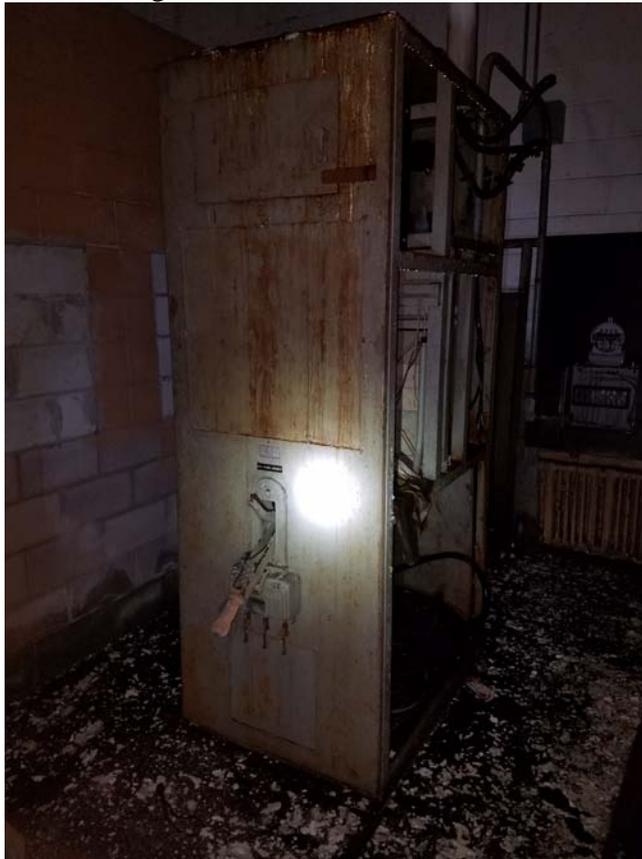
Figure E-024. Abandoned Terminal A Service Disconnect Switch

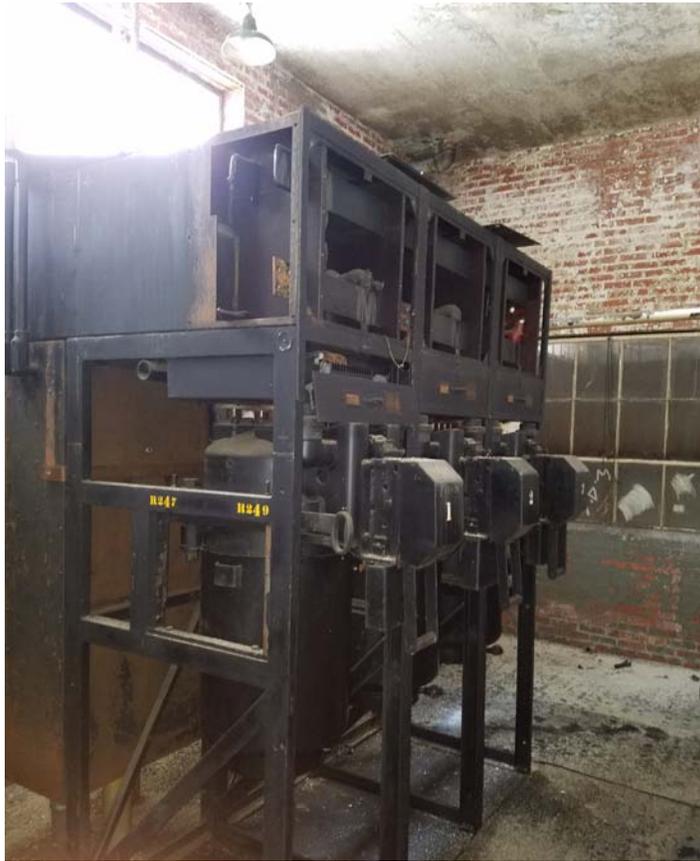
Figure E-025. Abandoned Terminal A Open Frame Medium Voltage Disconnect Switch

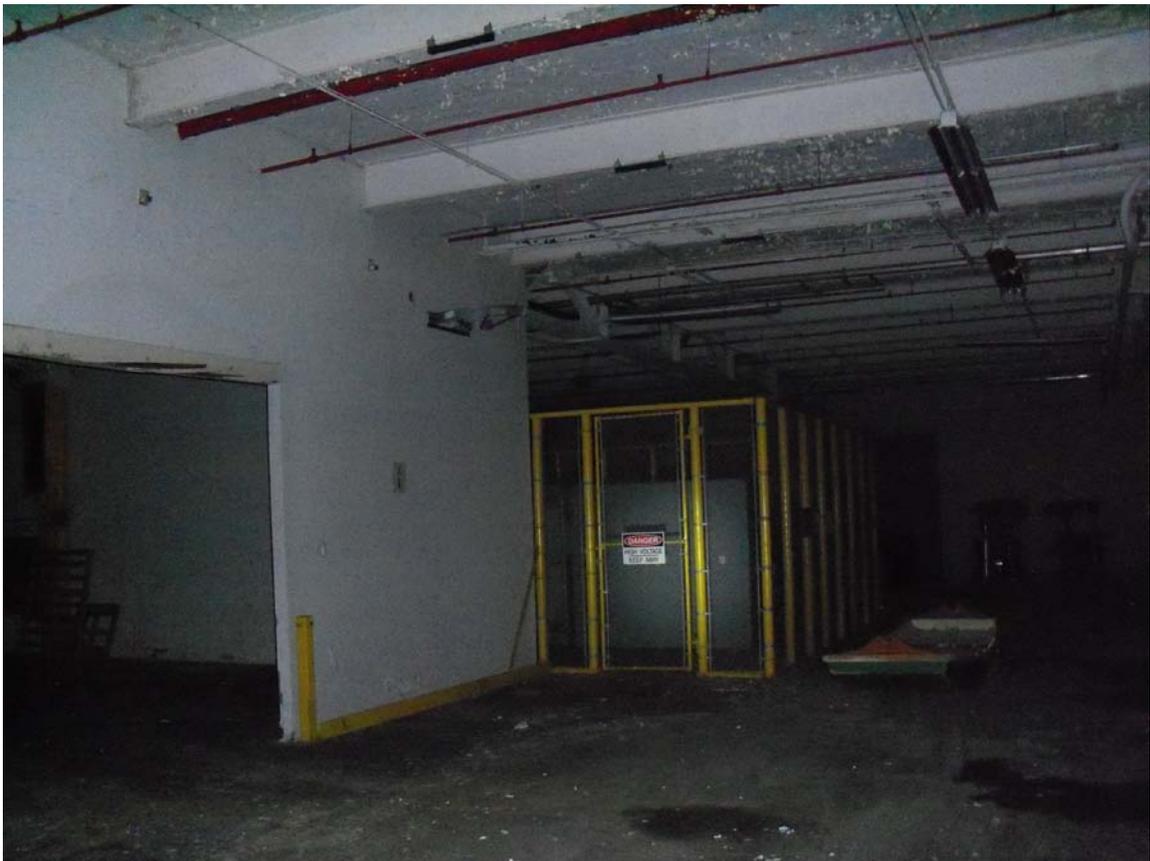
Figure E-026. Substation 1

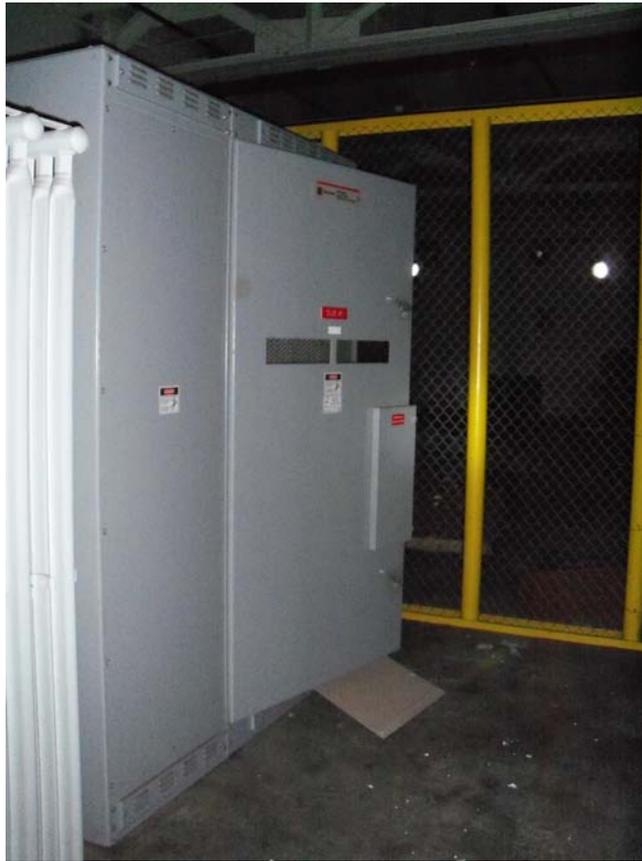
Figure E-027. Substation 1 Medium Voltage Switch

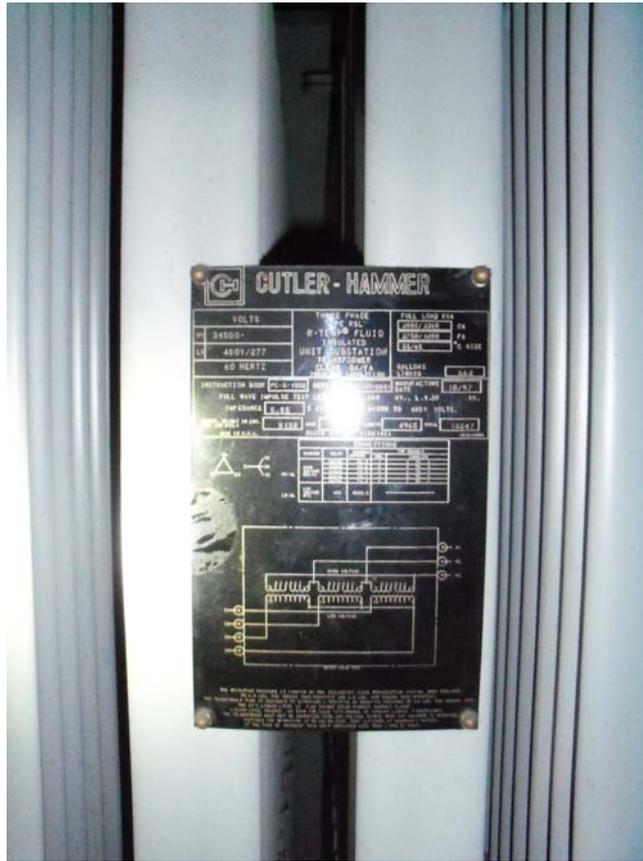
Figure E-029. Substation 1 Transformer Name Plate

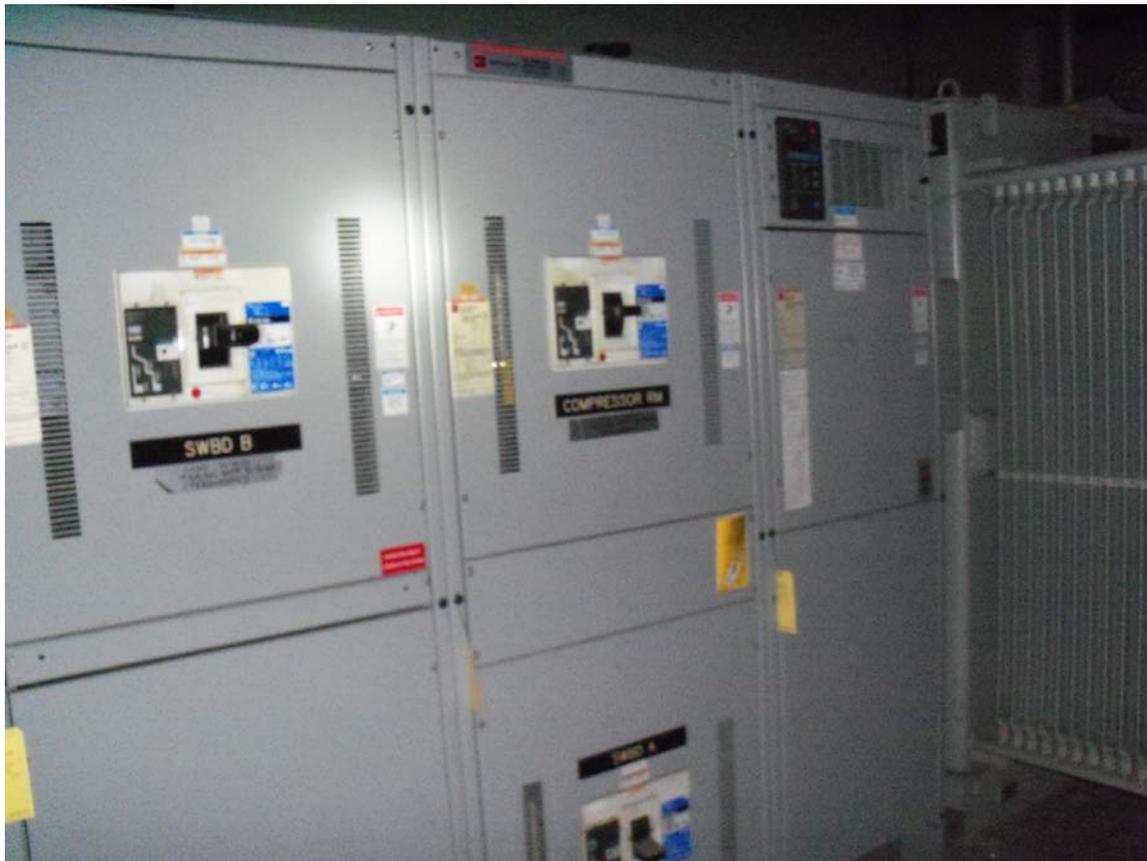
Figure E-030. Substation 1 Low Voltage Switchgear

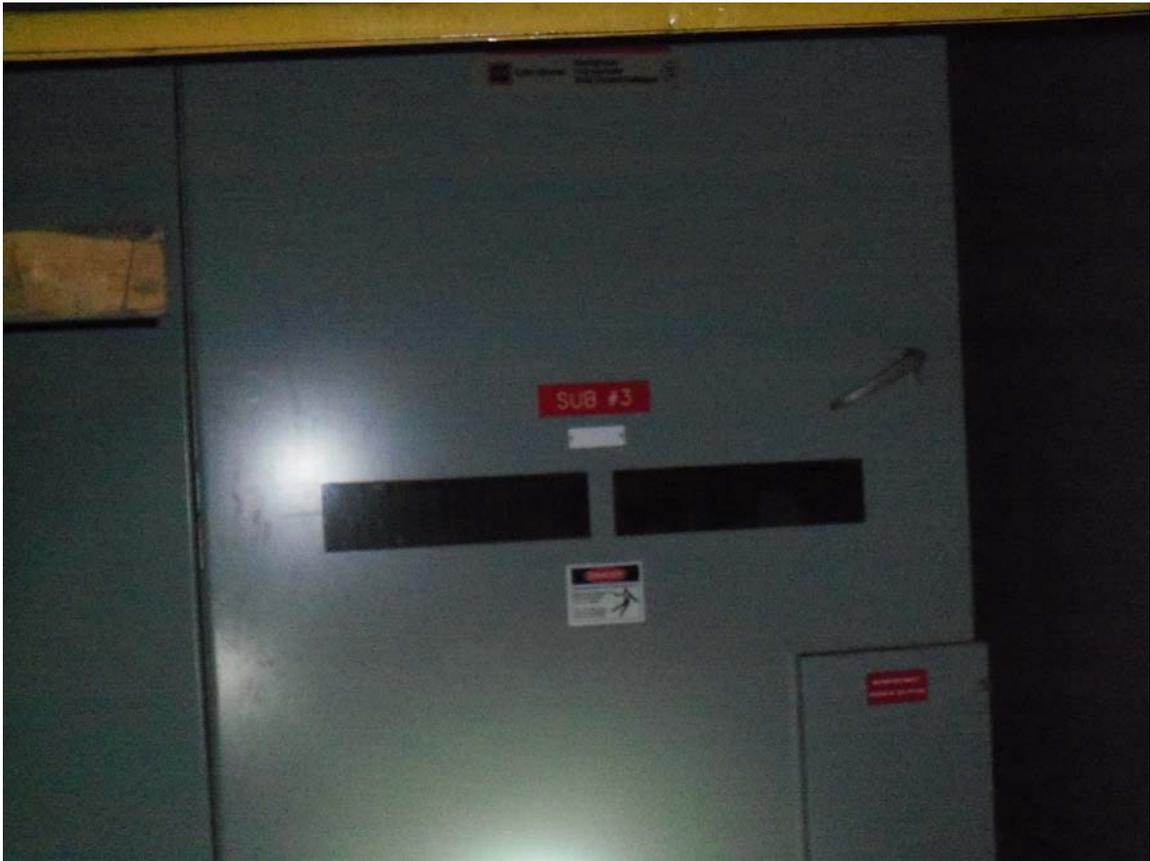
Figure E-031. Substation 3 Medium Voltage Switch

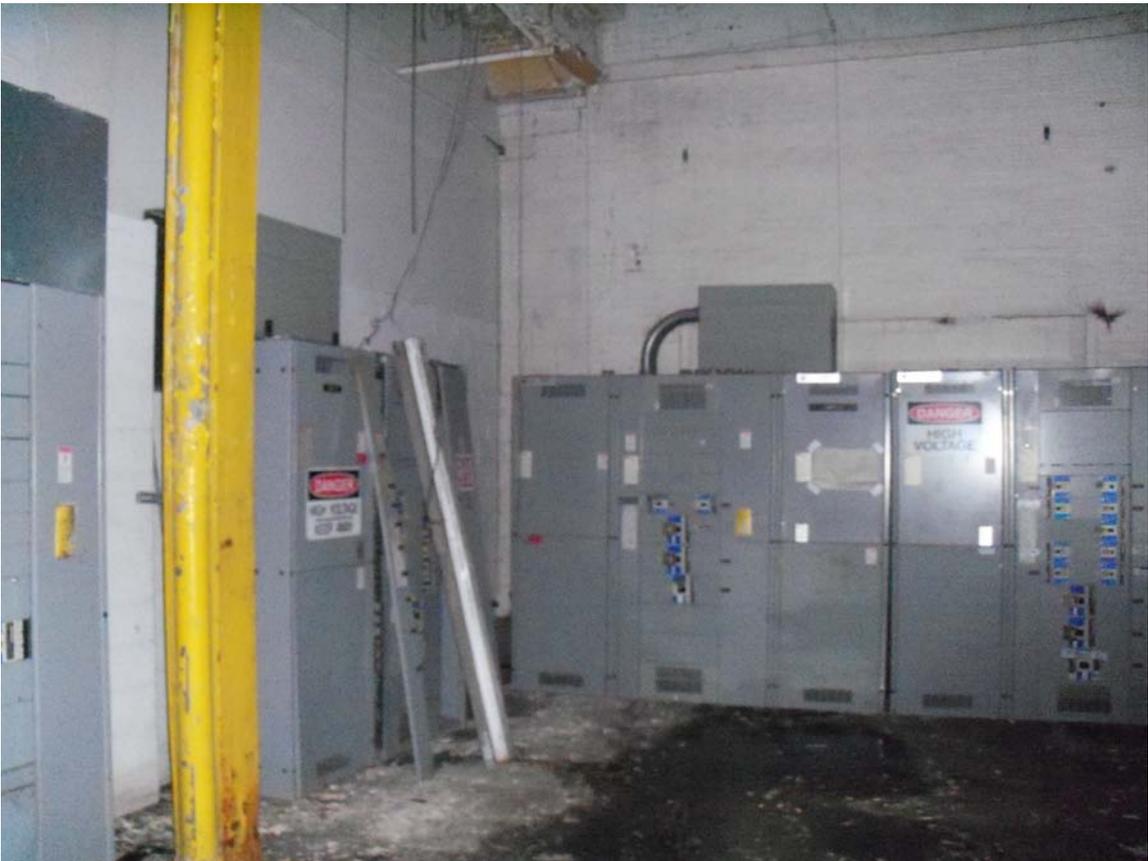
Figure E-034. Switchboards A, B, C, and D

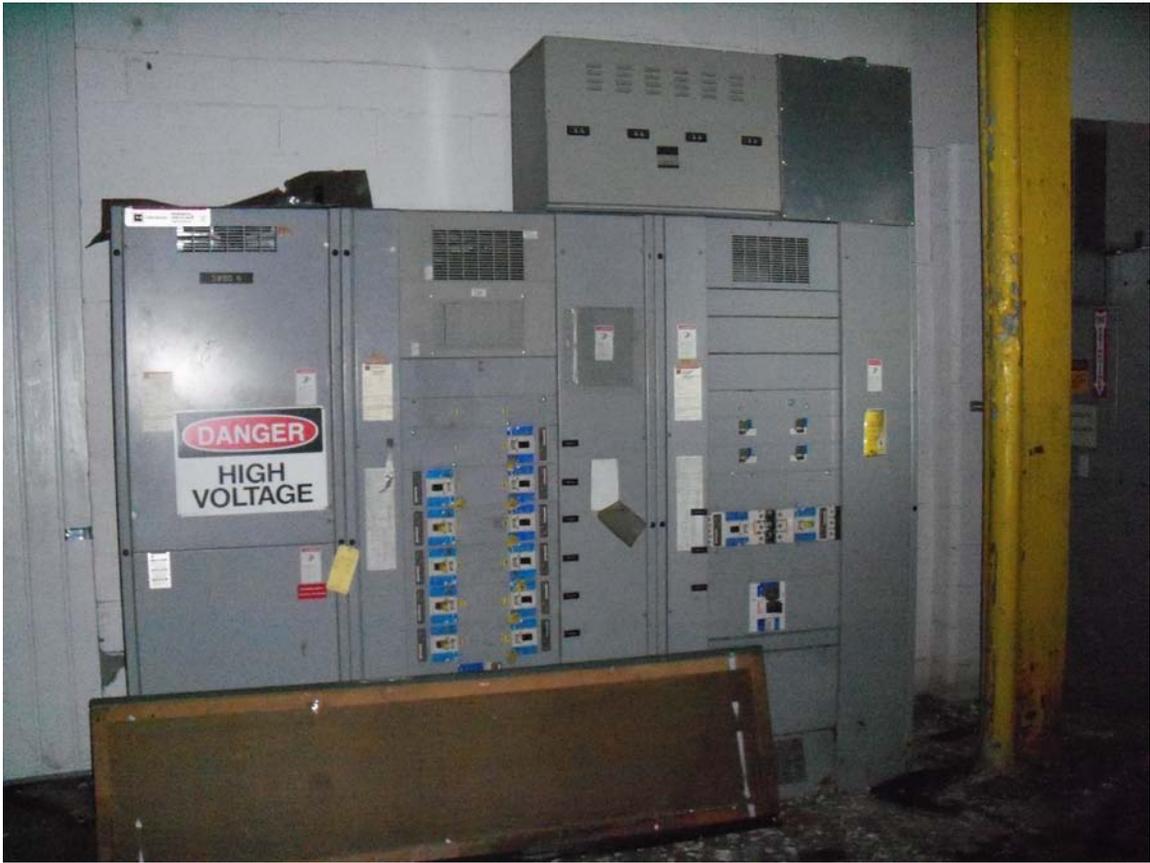
Figure E-035. Switchboard A

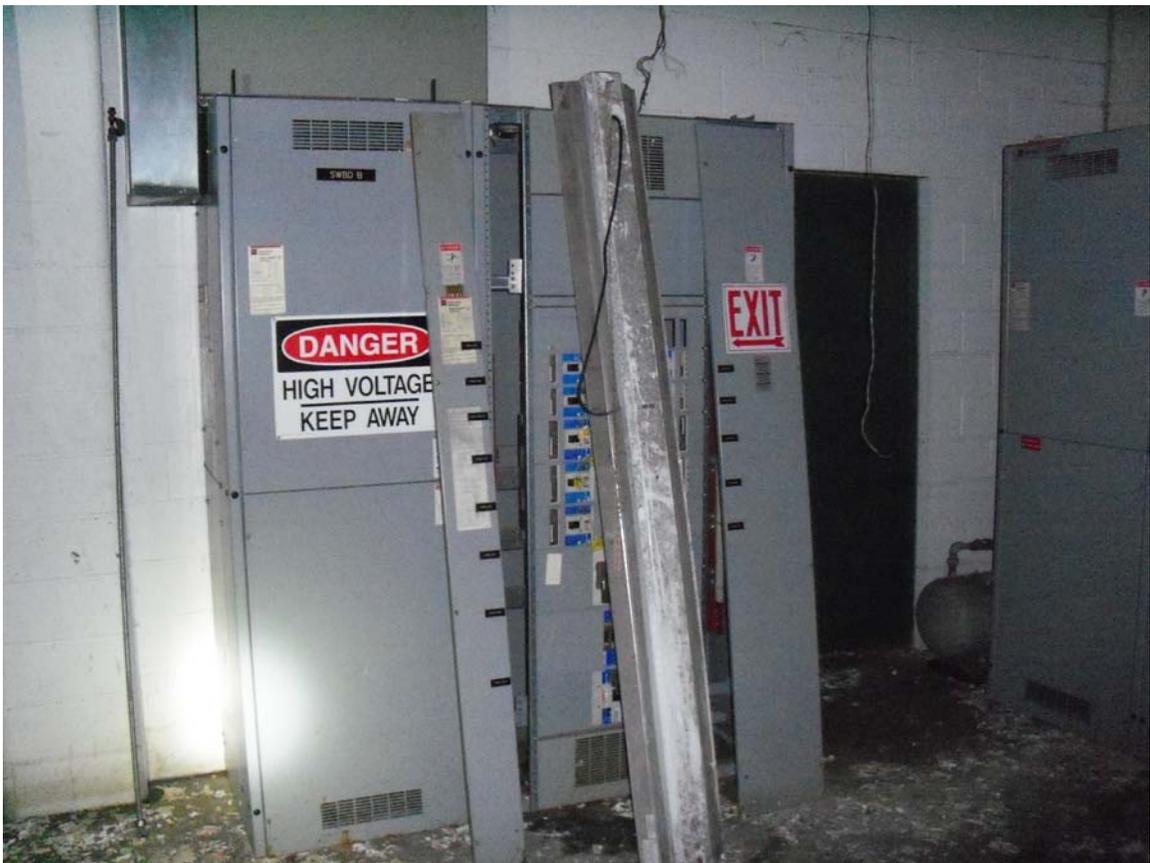
Figure E-036. Switchboard B

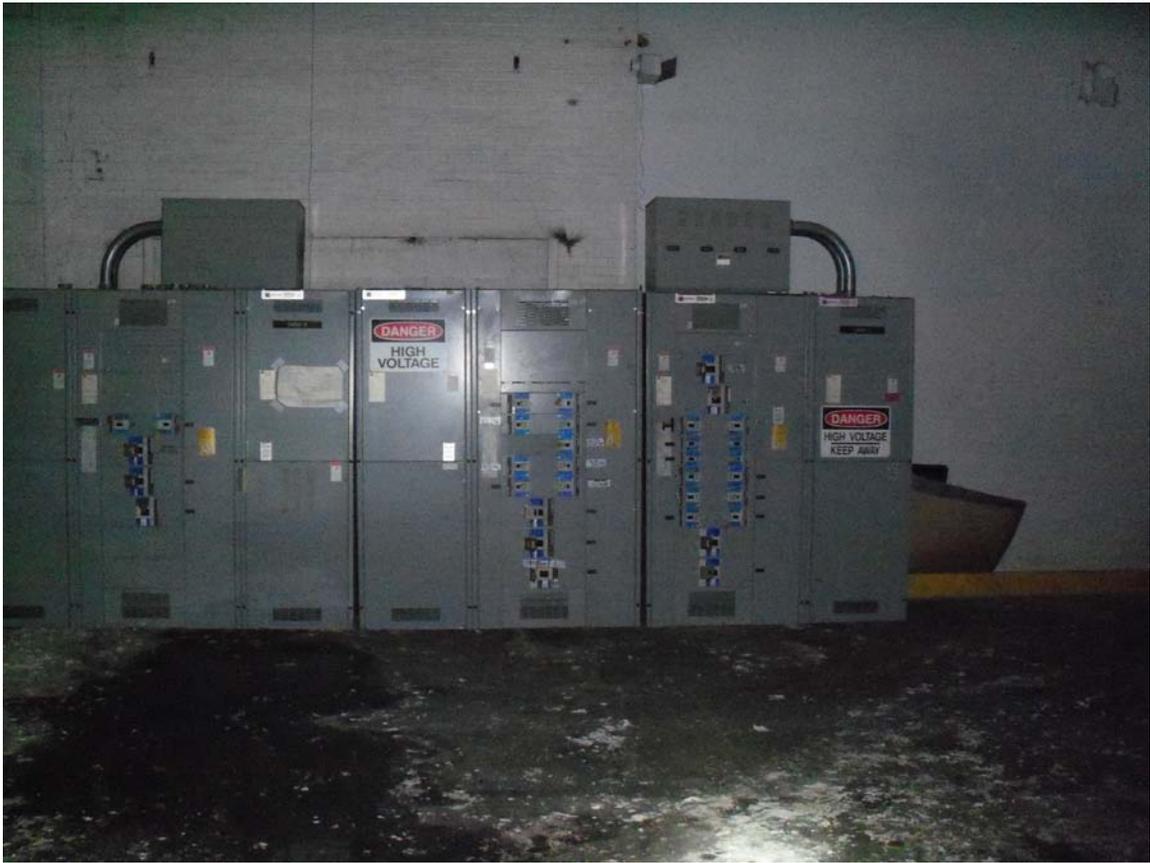
Figure E-037. Switchboards C and D

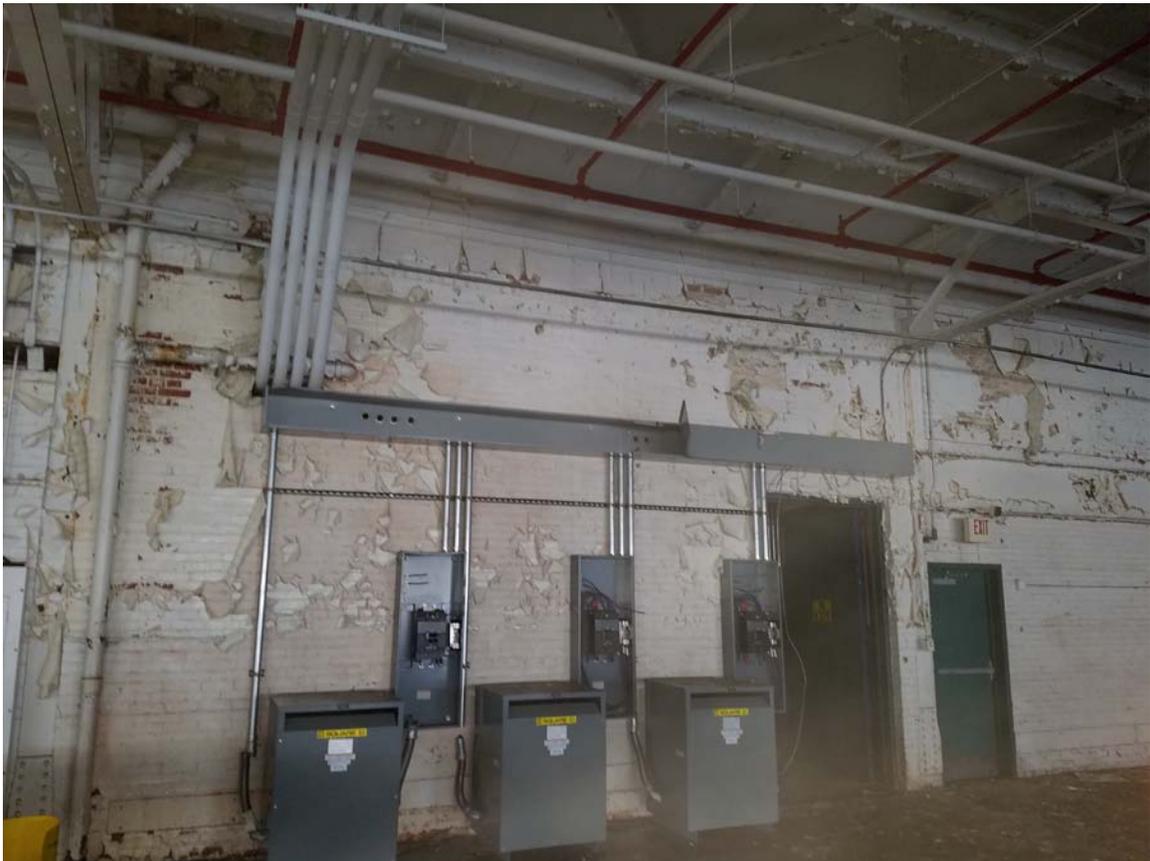
Figure E-038. Transformers Feeding LVSWBD, Notice All Wiring Removed

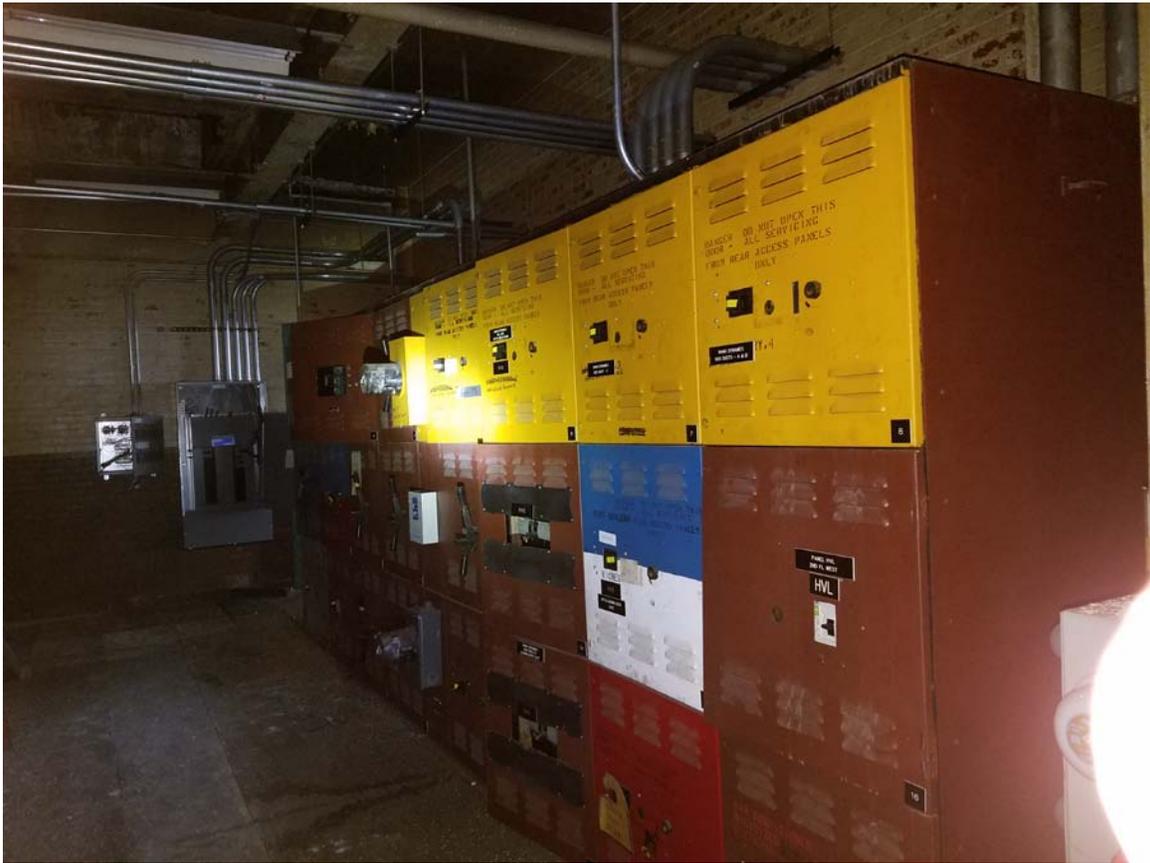
Figure E-039. LVSWBD

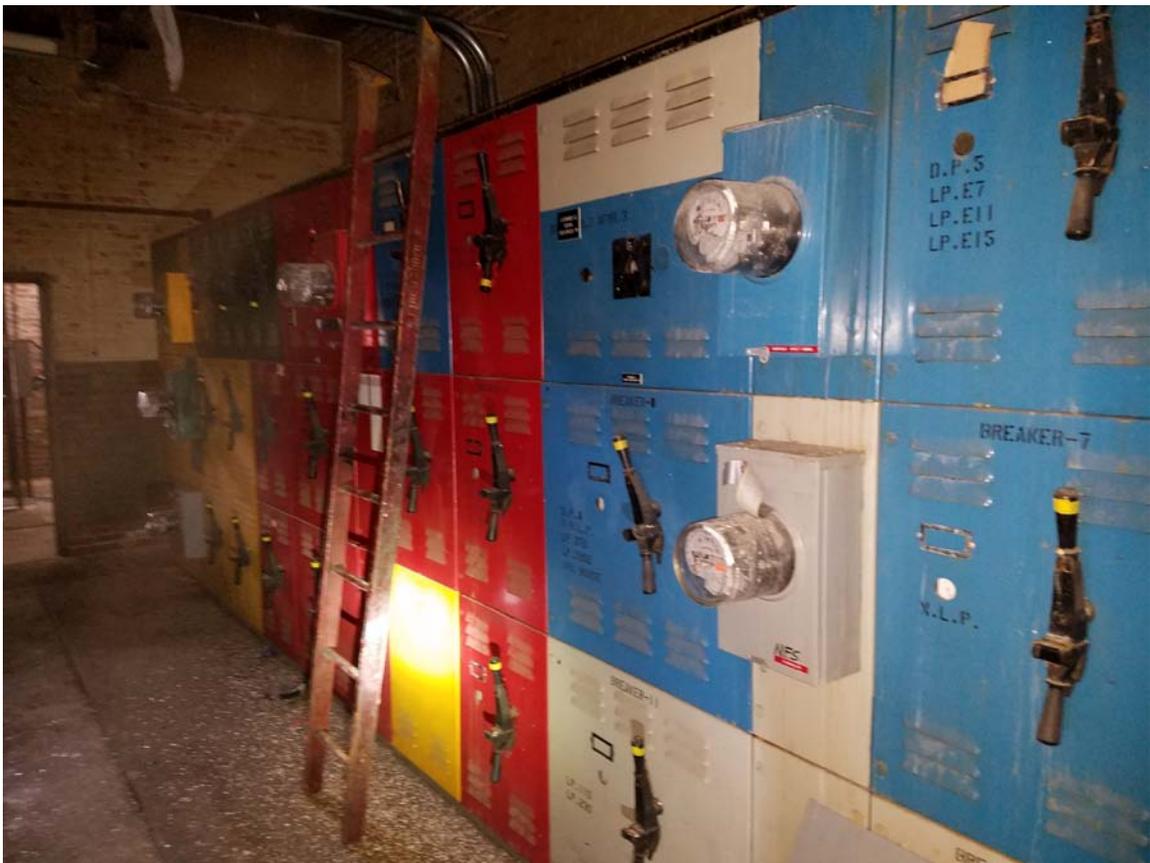
Figure E-040. HVSWBD

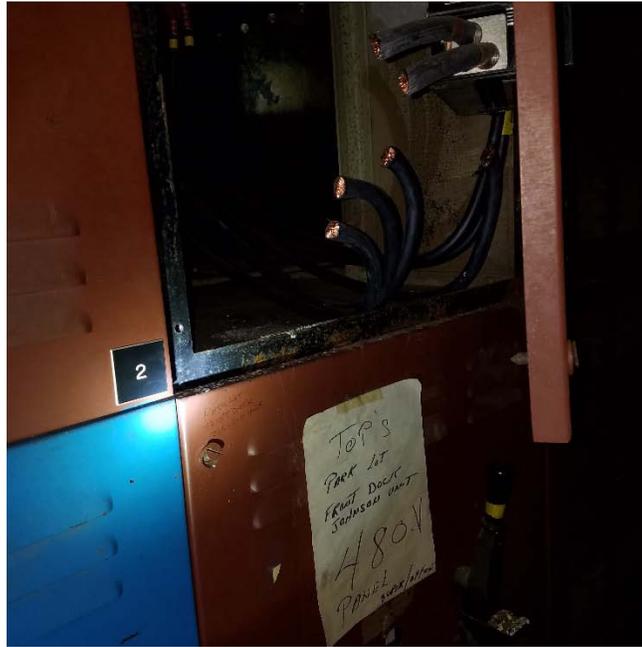
Figure E-041. Cut Wiring at LVSWBD

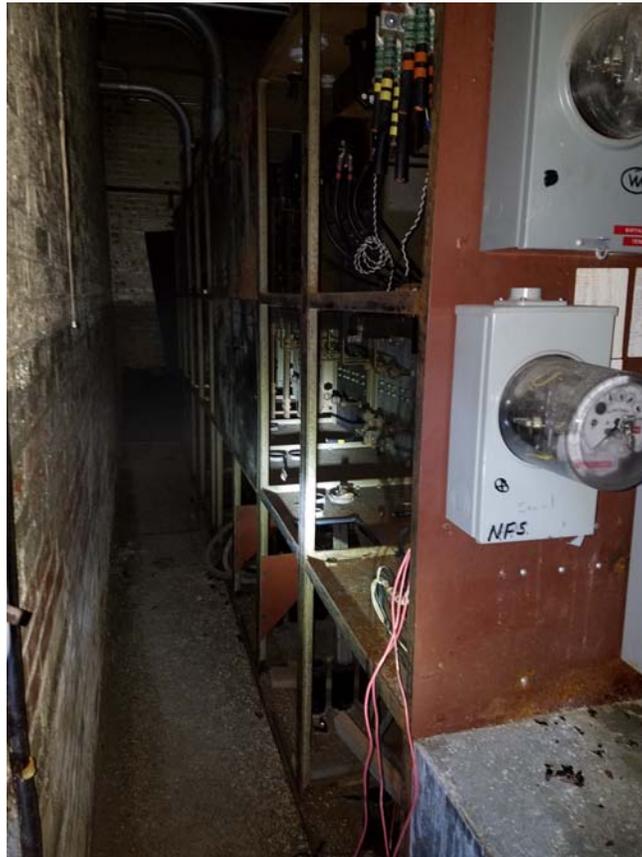
Figure E-042. Rear of LVSWBD

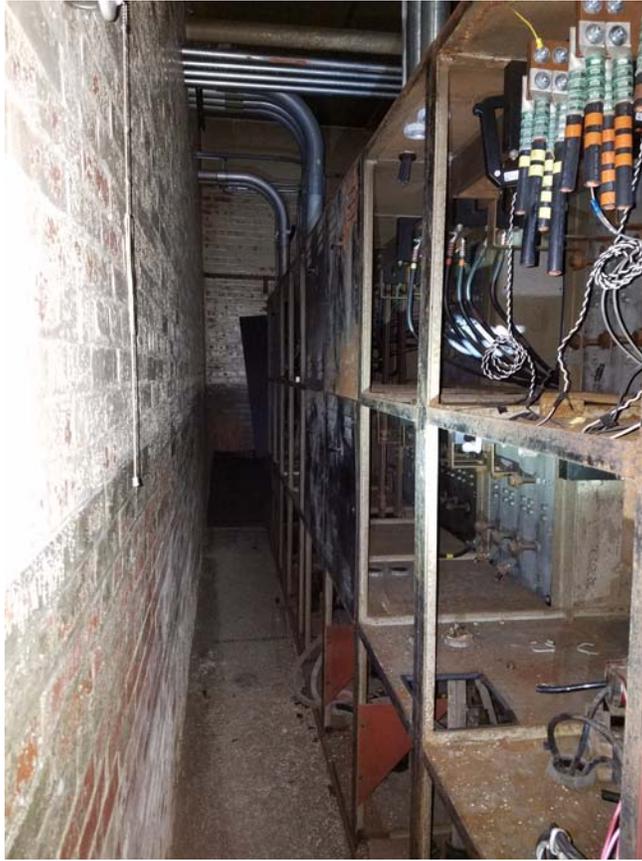
Figure E-043. Rear of LVSWBD

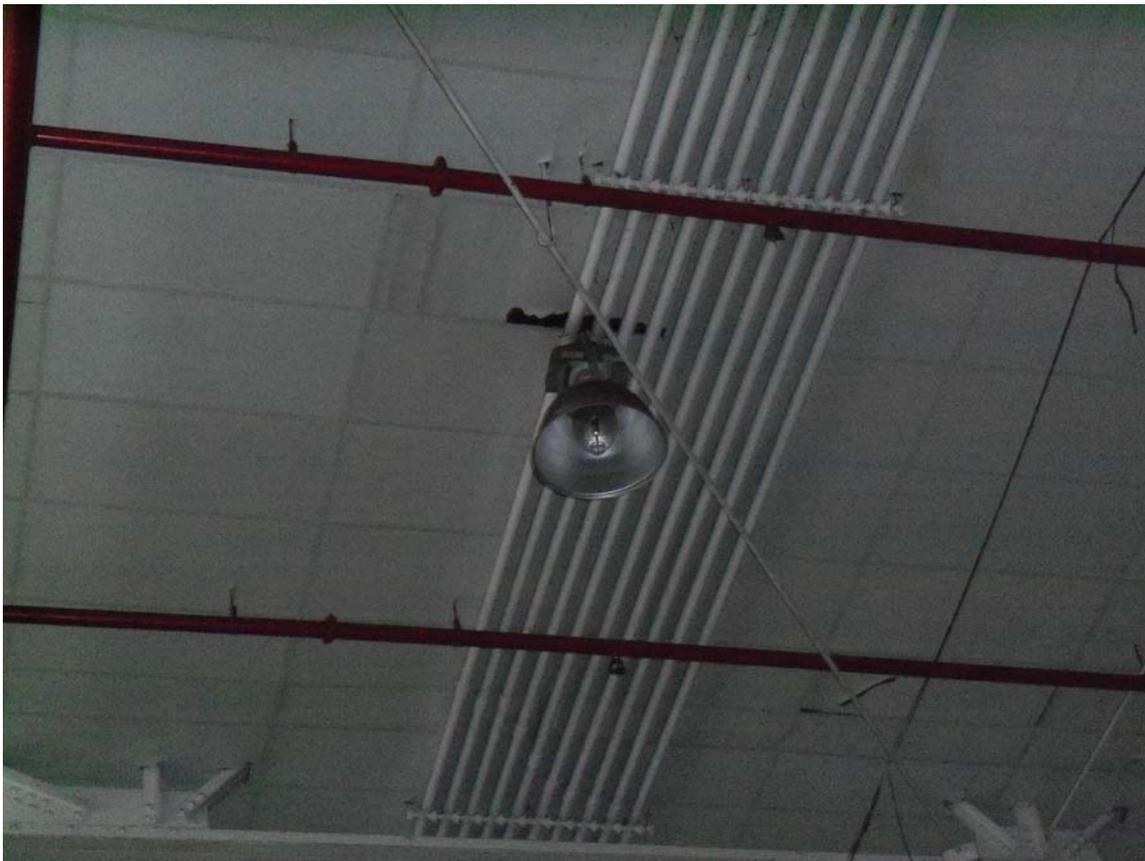
Figure E-050. Representative High Bay Lighting

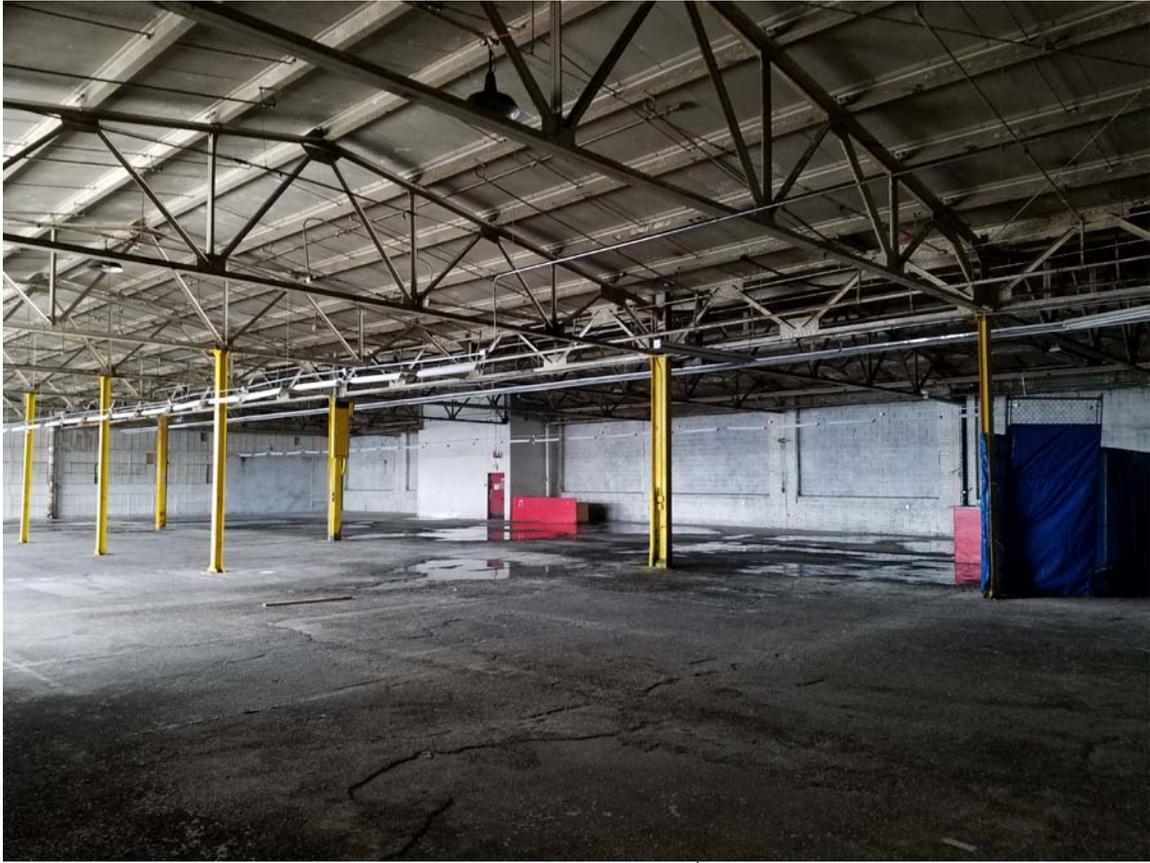
Figure E-053. Lighting, 2nd Floor

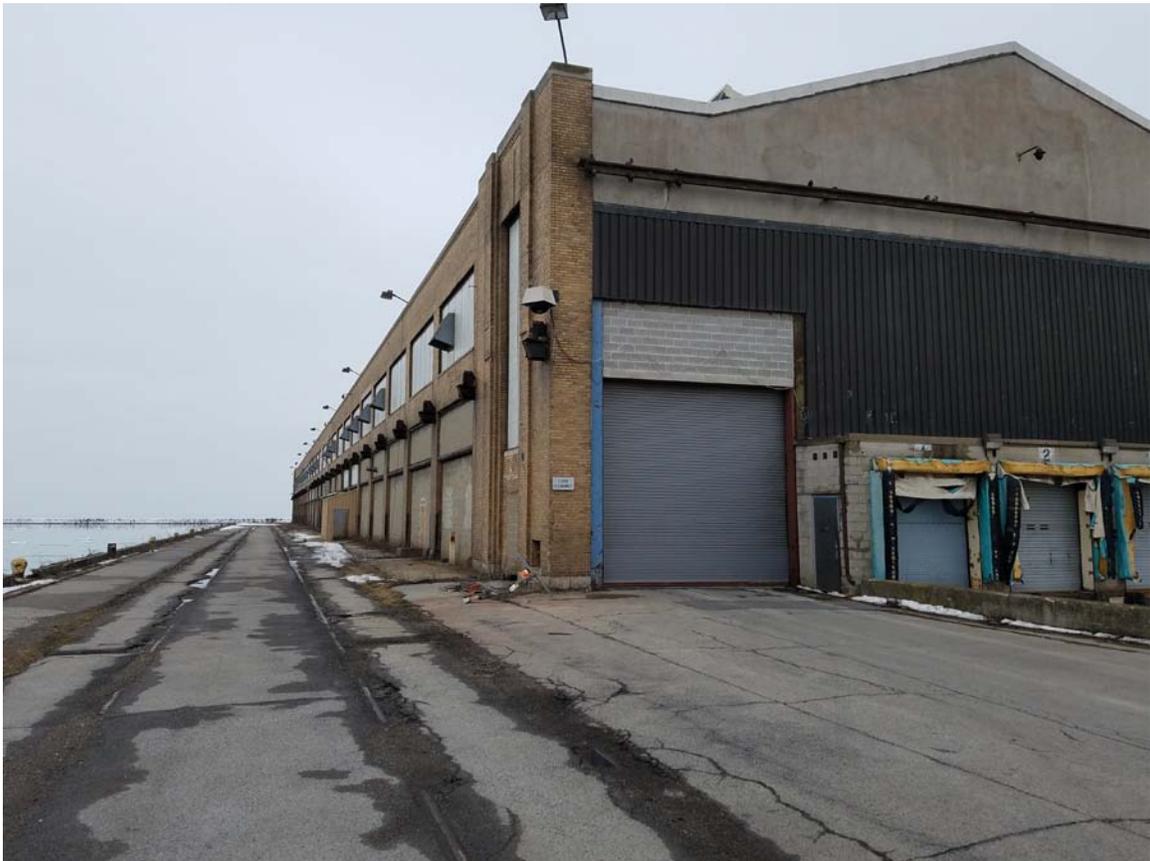
Figure E-054. Exterior Lighting, South East Corner

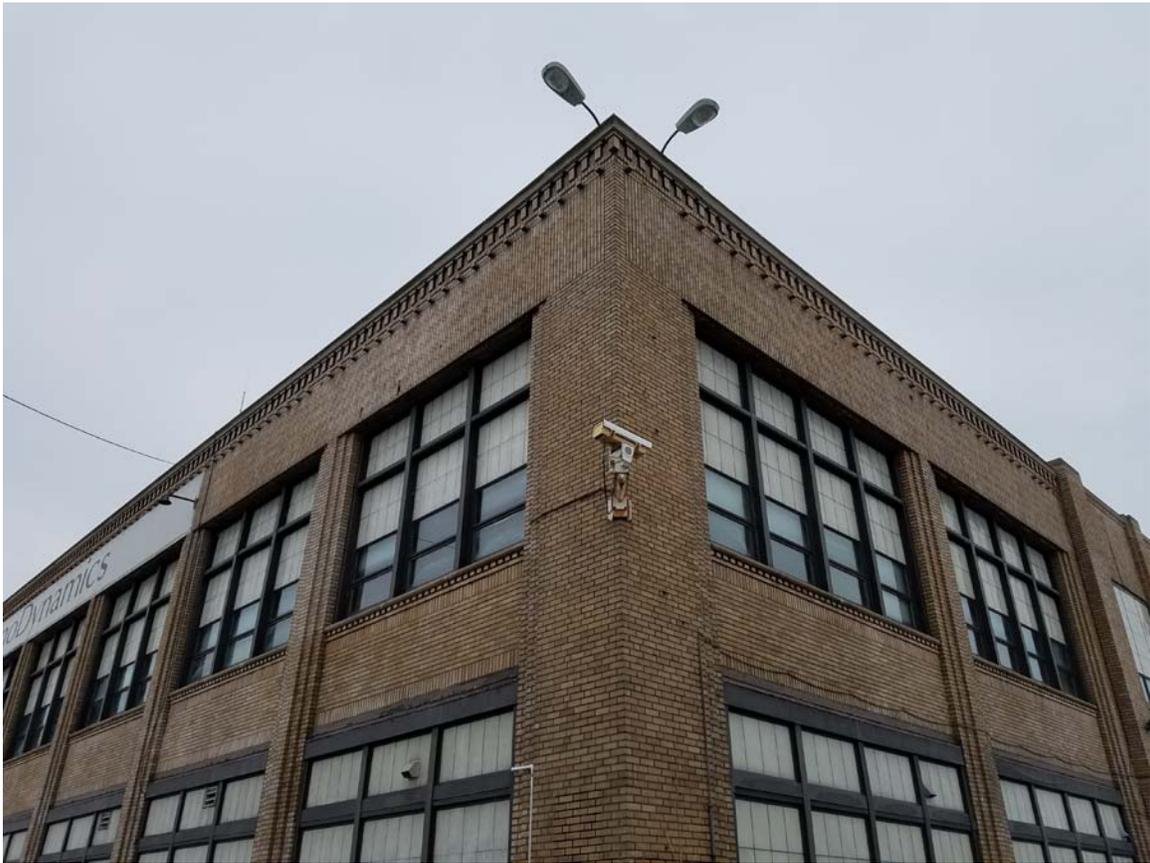
Figure E-055. Exterior Lighting, North East Corner
