MEP/FP SYSTEM INVENTORY AND ASSESSMENT – FINAL REPORT

Project Title:	Buffalo Outer Harbor Access & Activation Civic Improvements
----------------	--

REP-17055-001, REV. 2

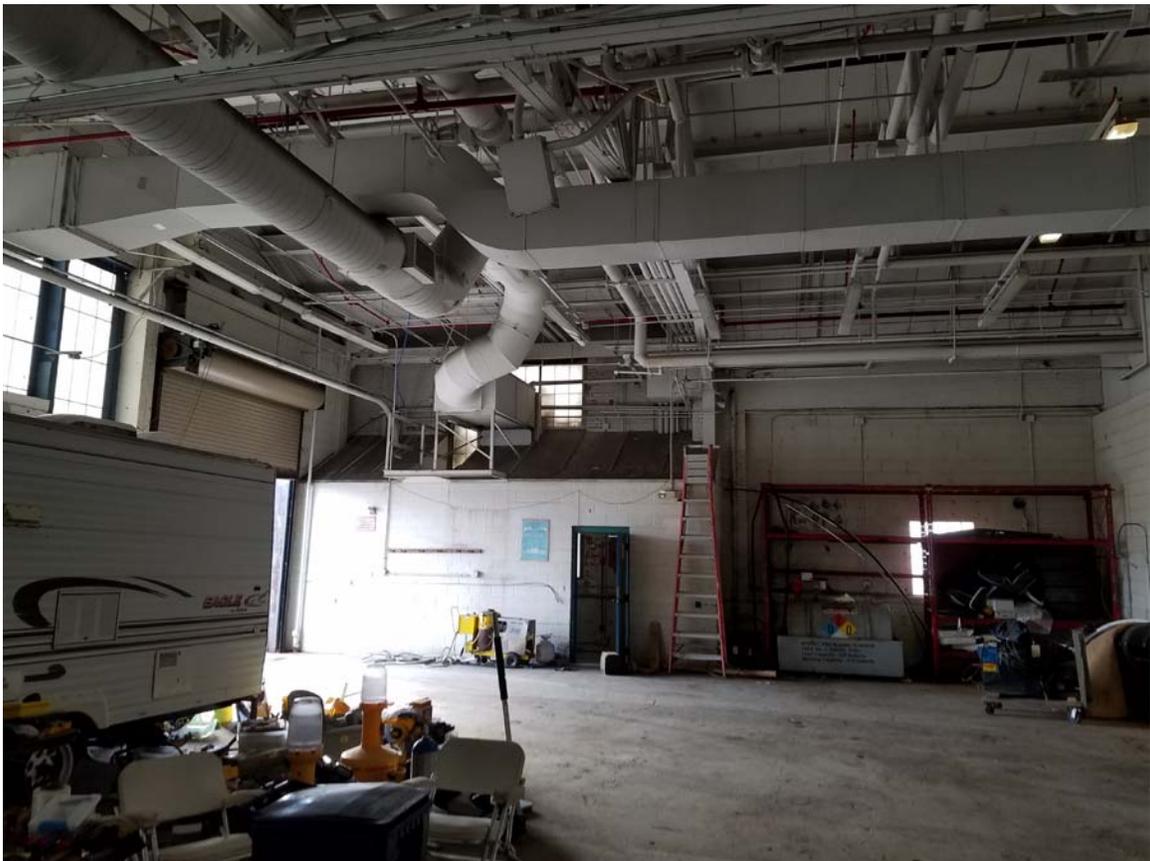
Figure E-062. Maintenance Shop Area

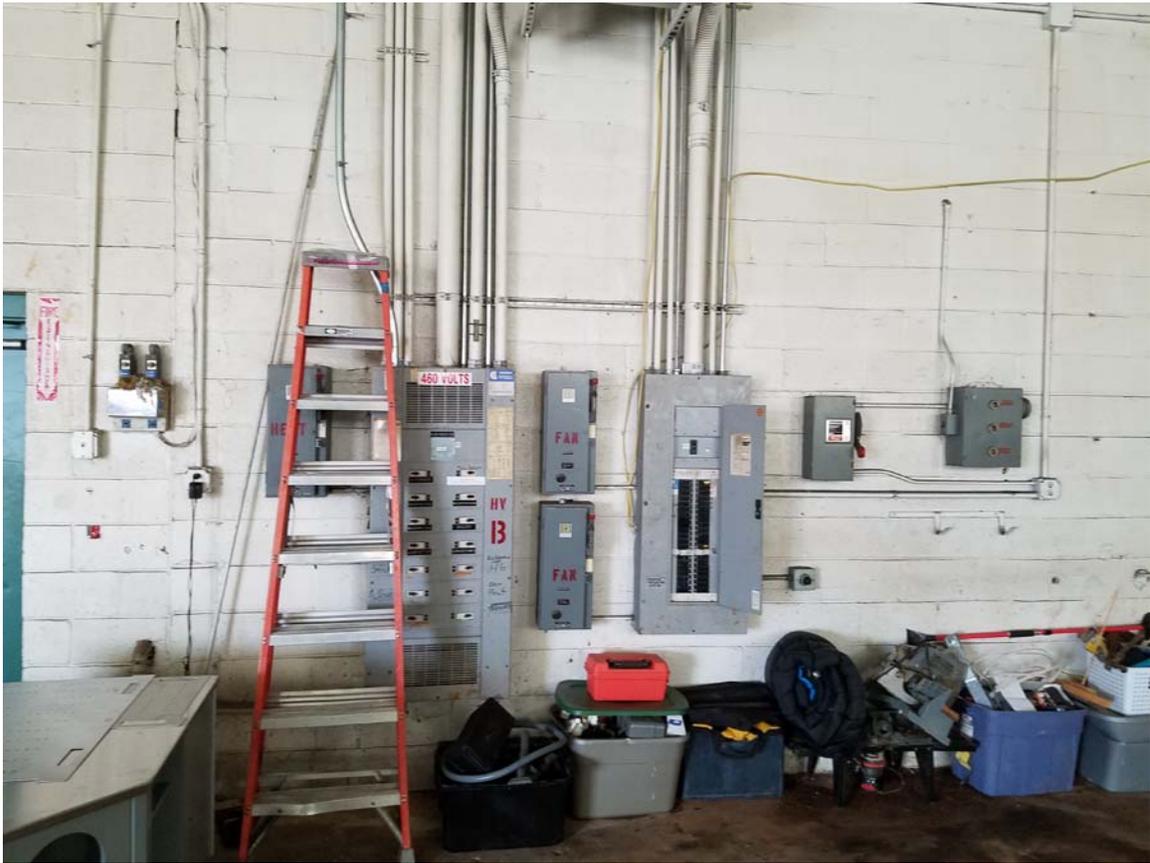
Figure E-063. Maintenance Shop Area Power Panels

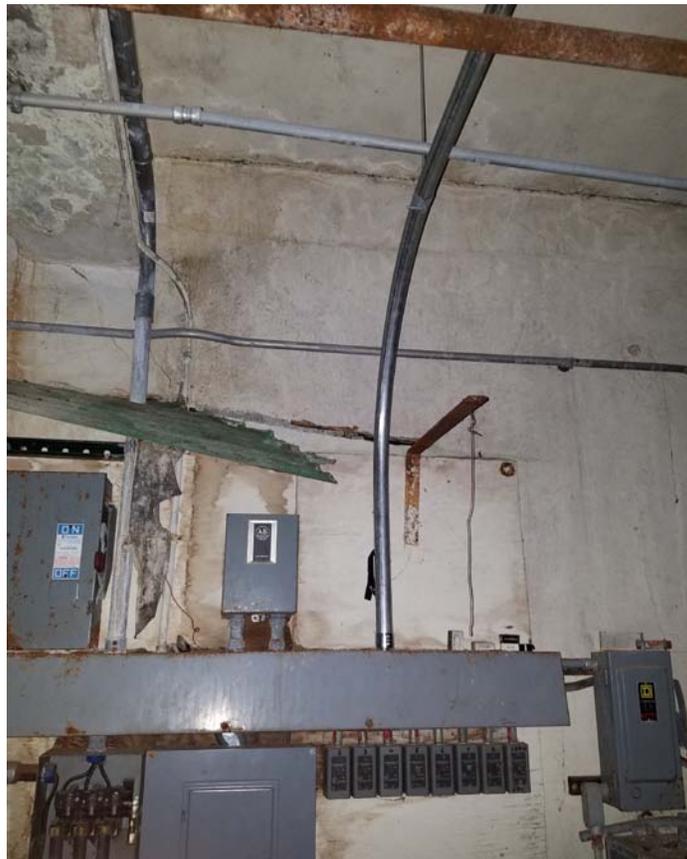
Figure E-064. Maintenance Shop Area Power Source

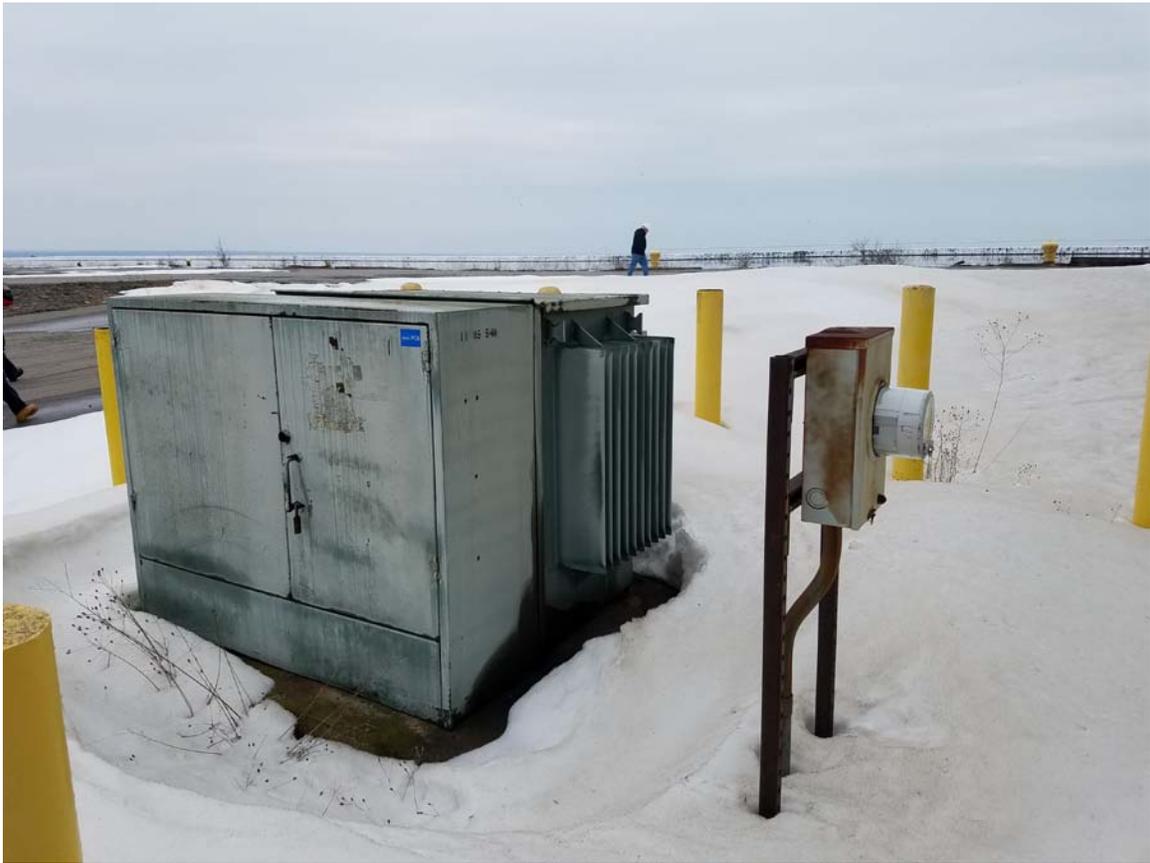
Figure E-064. Terminal B Service Equipment

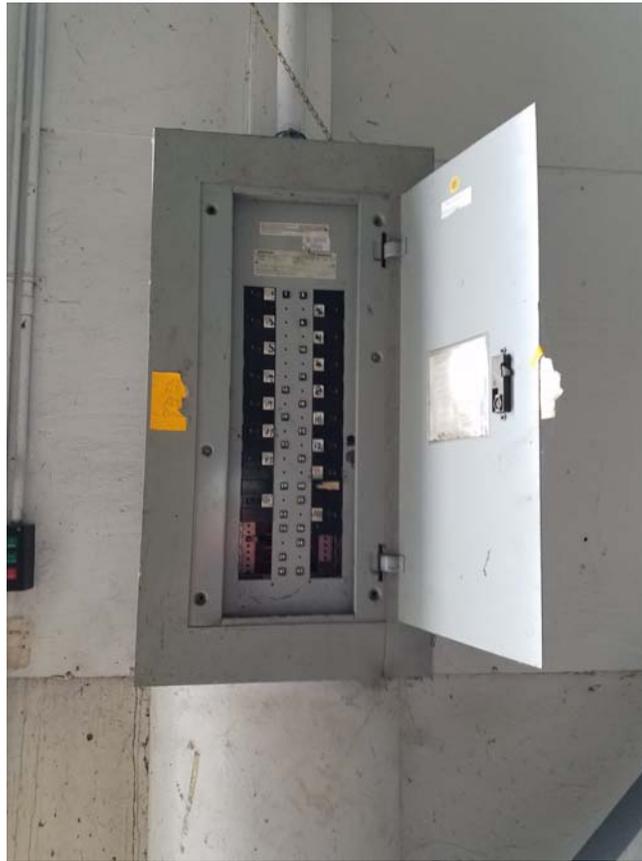
Figure E-066. Panelboard with Exposed Busbars

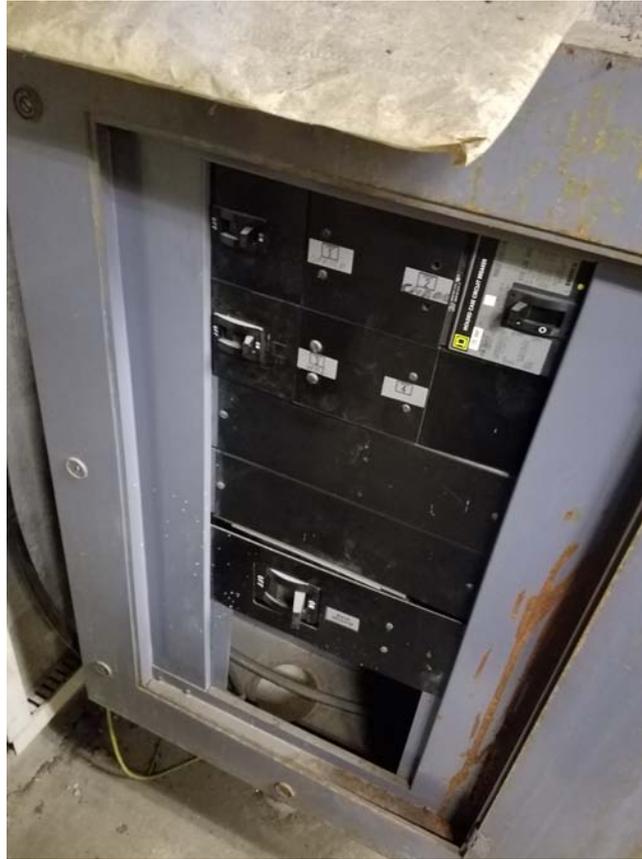
Figure E-068. Panelboard with Exposed Busbars and Mounted Low to Ground

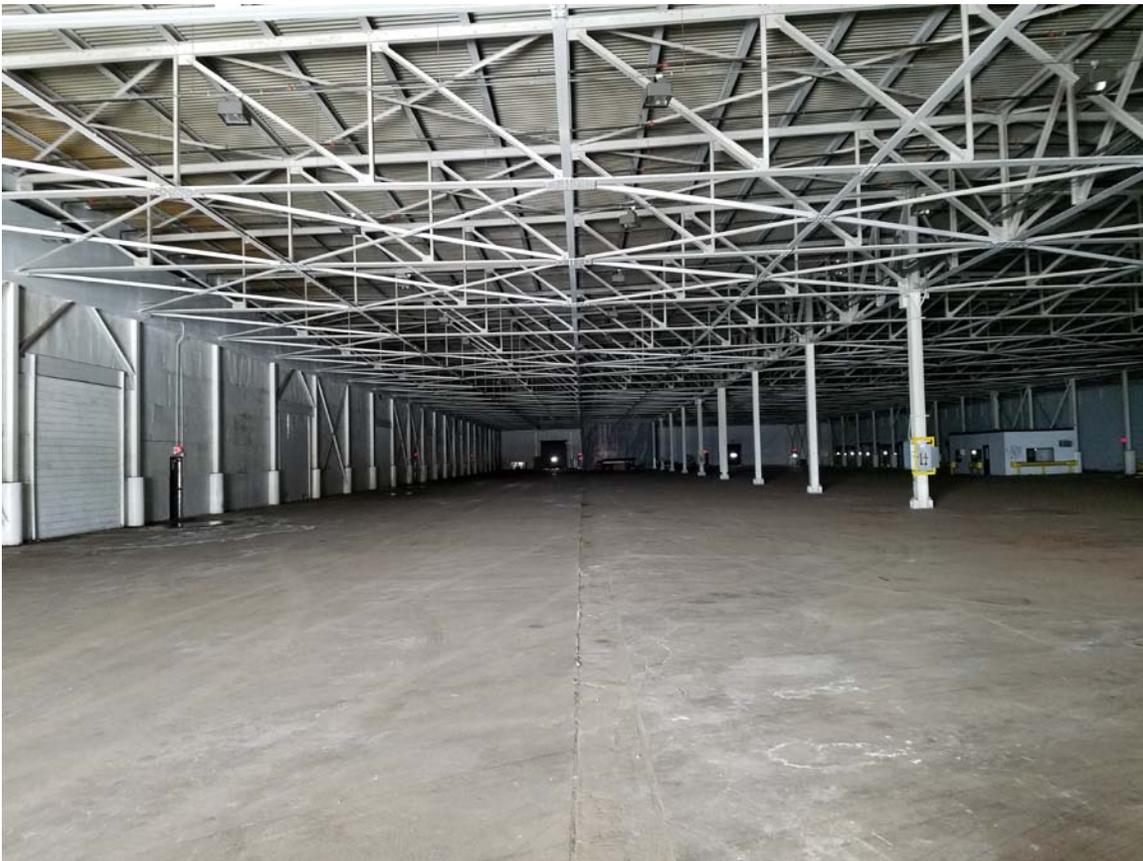
Figure E-069. Terminal B Highbay Lighting

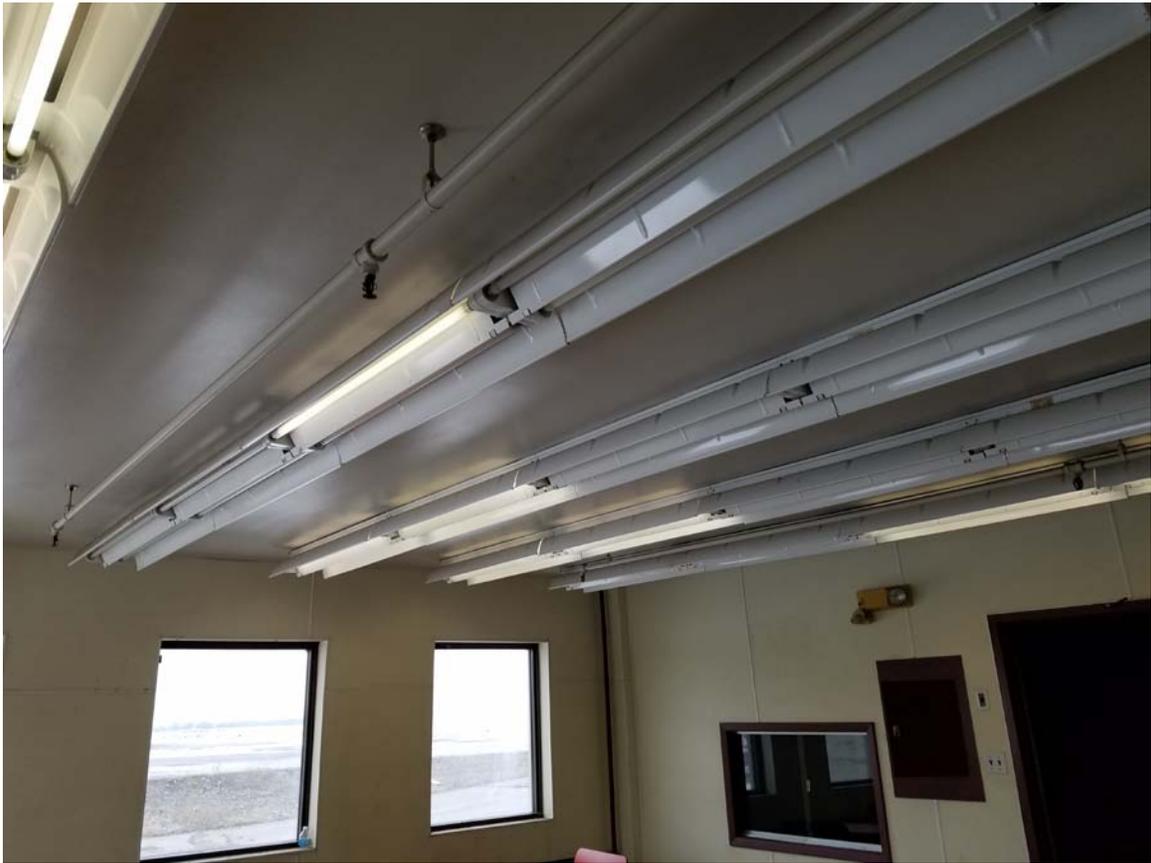
Figure E-070. Terminal B Breakroom Lighting

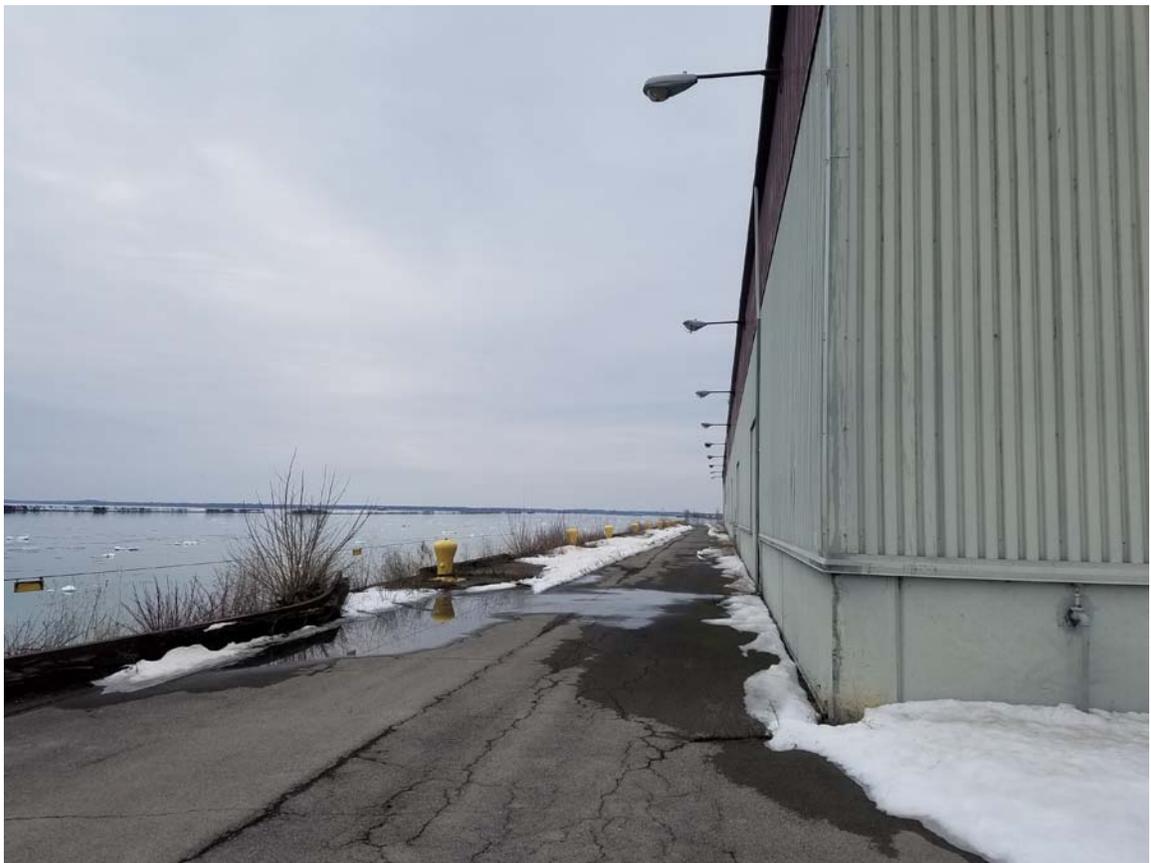
Figure E-071. Terminal B Exterior Lighting West Side

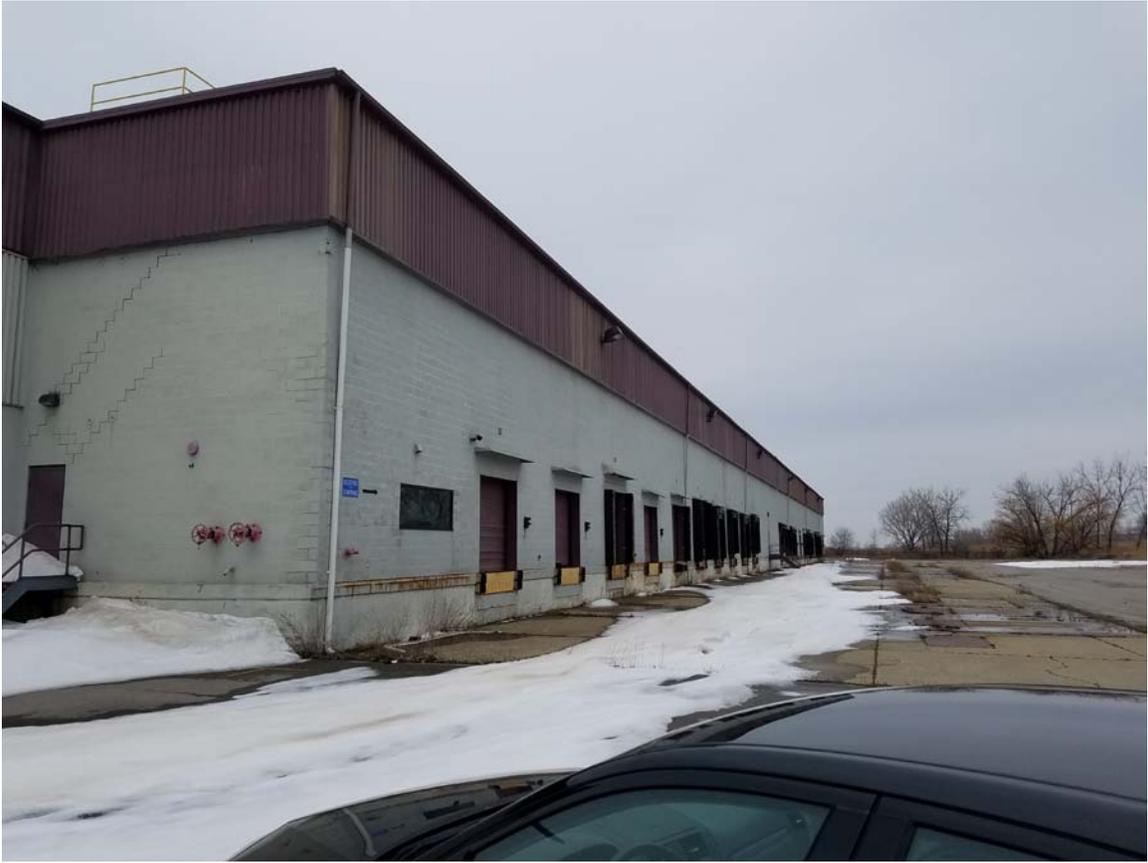
Figure E-072. Terminal B Exterior Lighting East Side

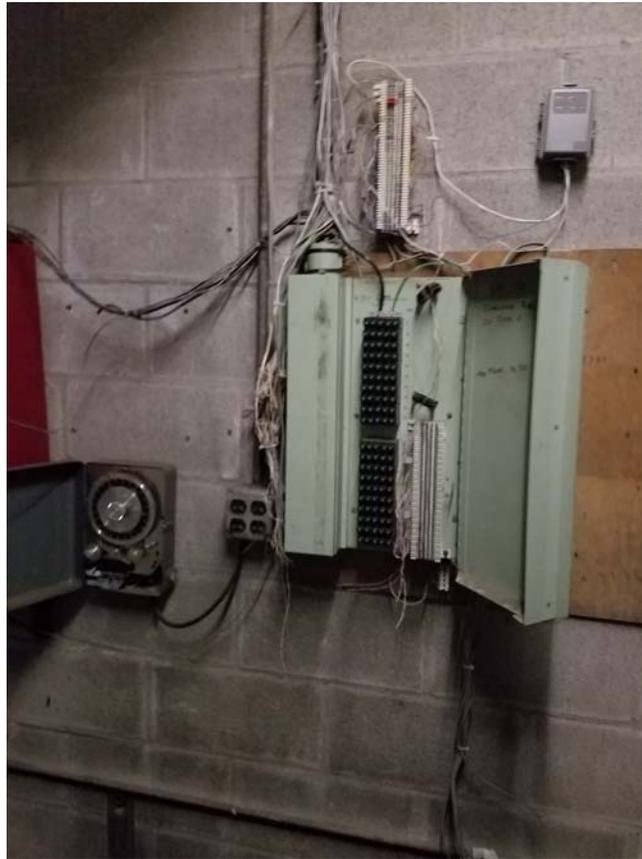
Figure E-073. Terminal B Phone Demarcation Point

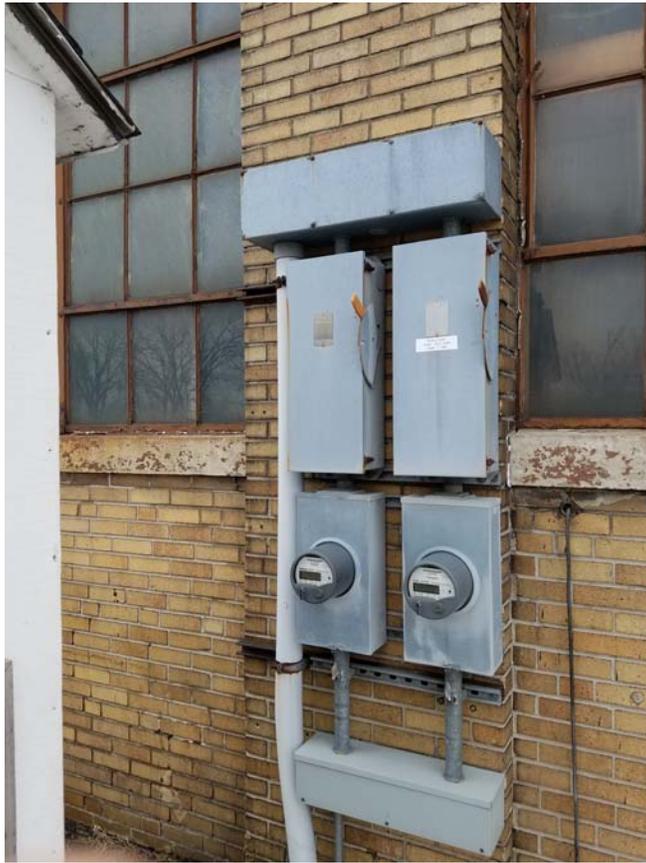
Figure E-074. Filbin Building Service Entrance

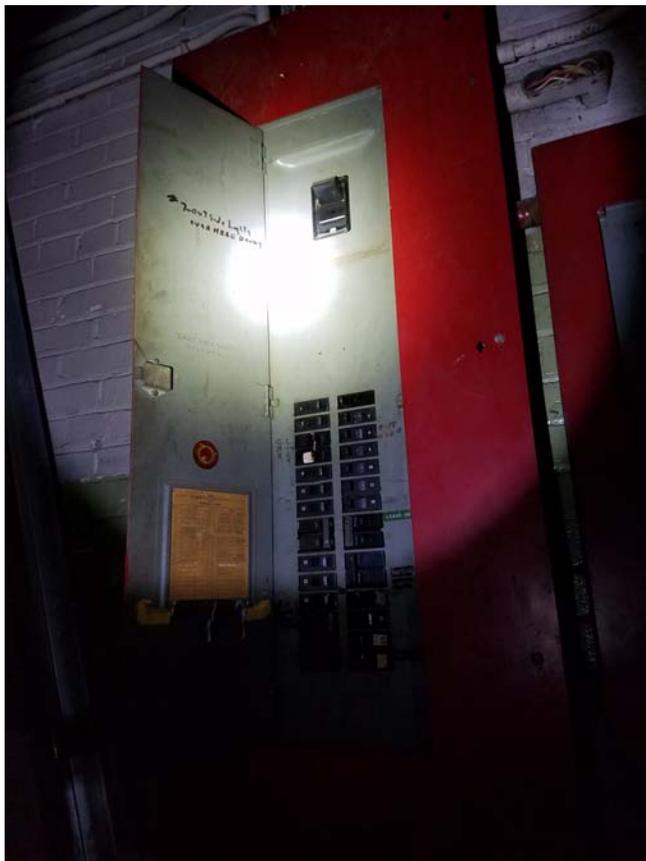
Figure E-075. Filbin Building Electrical Panels

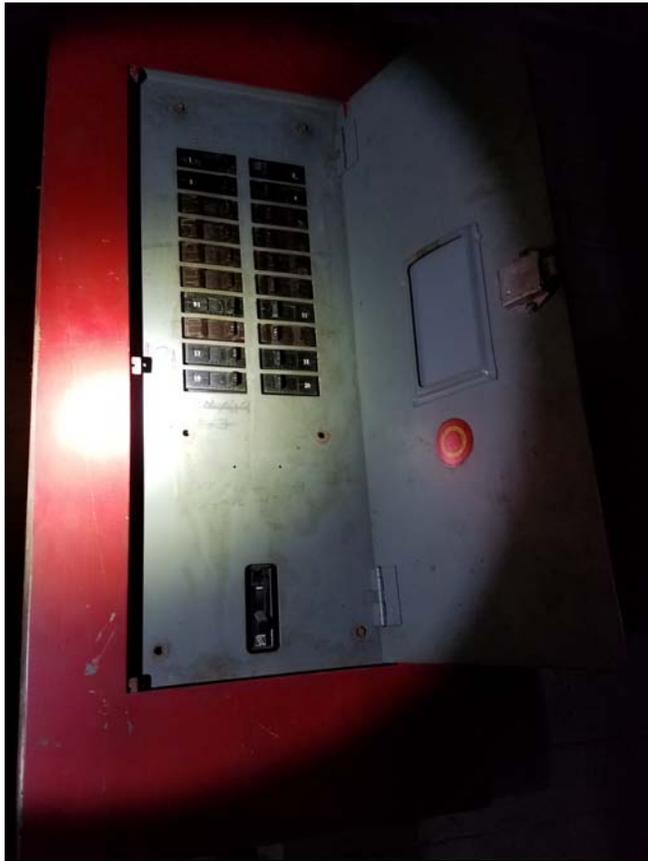
Figure E-076. Filbin Building Electrical Panels

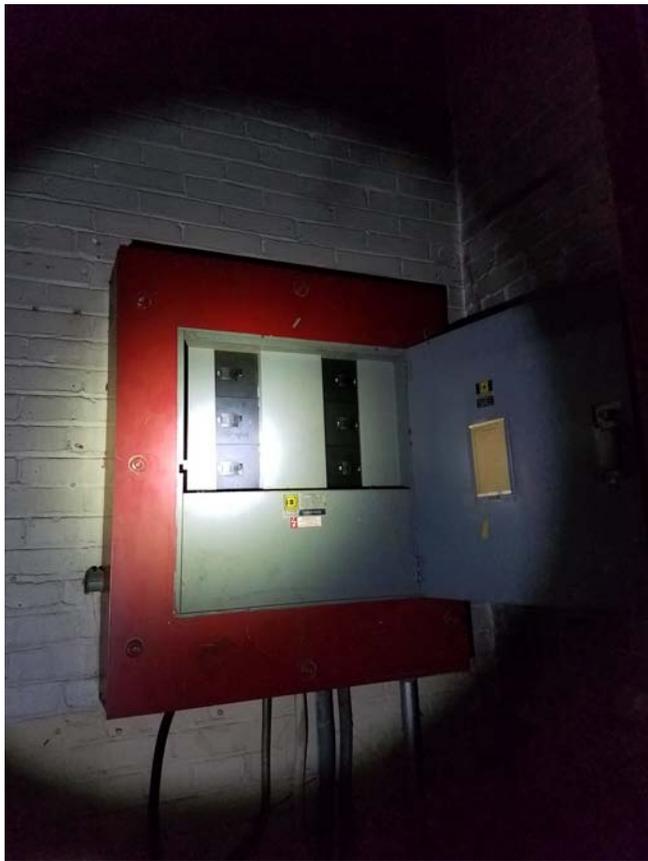
Figure E-077. Filbin Building Electrical Panels

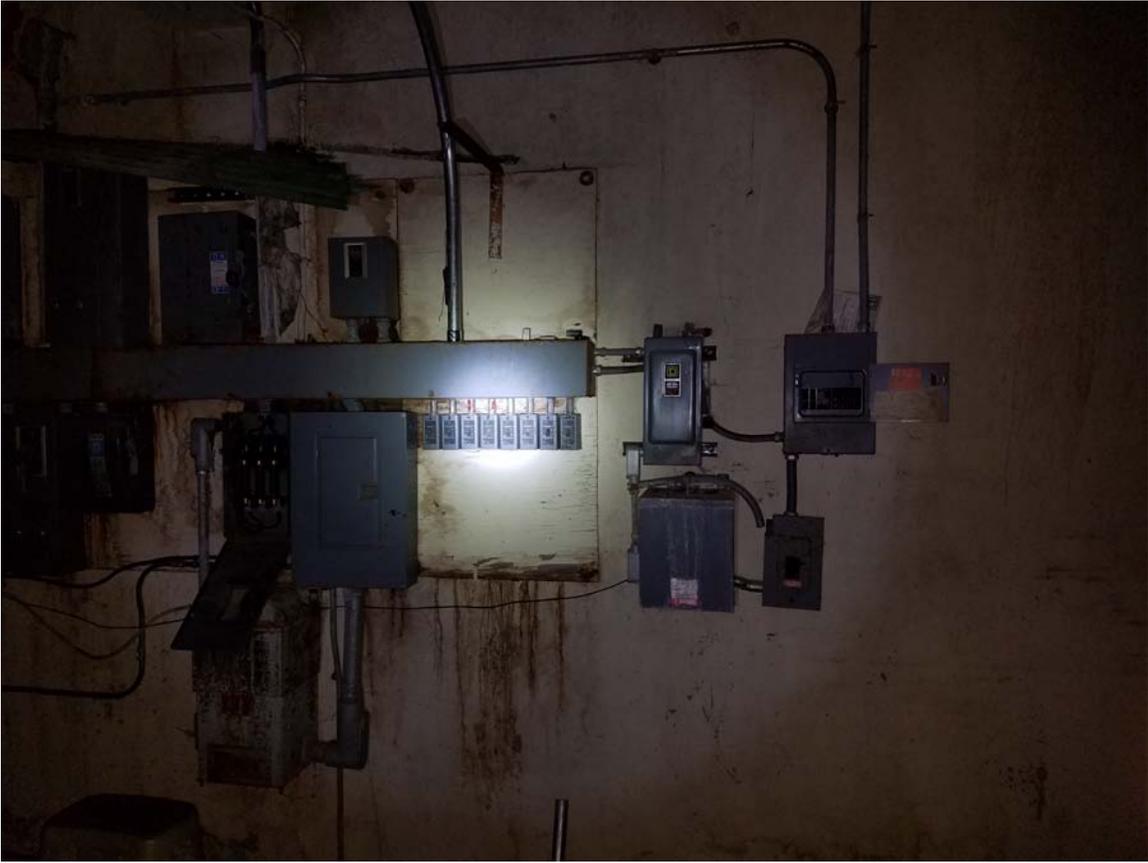
Figure E-078. Filbin Building Electrical Panels, Located in Basement

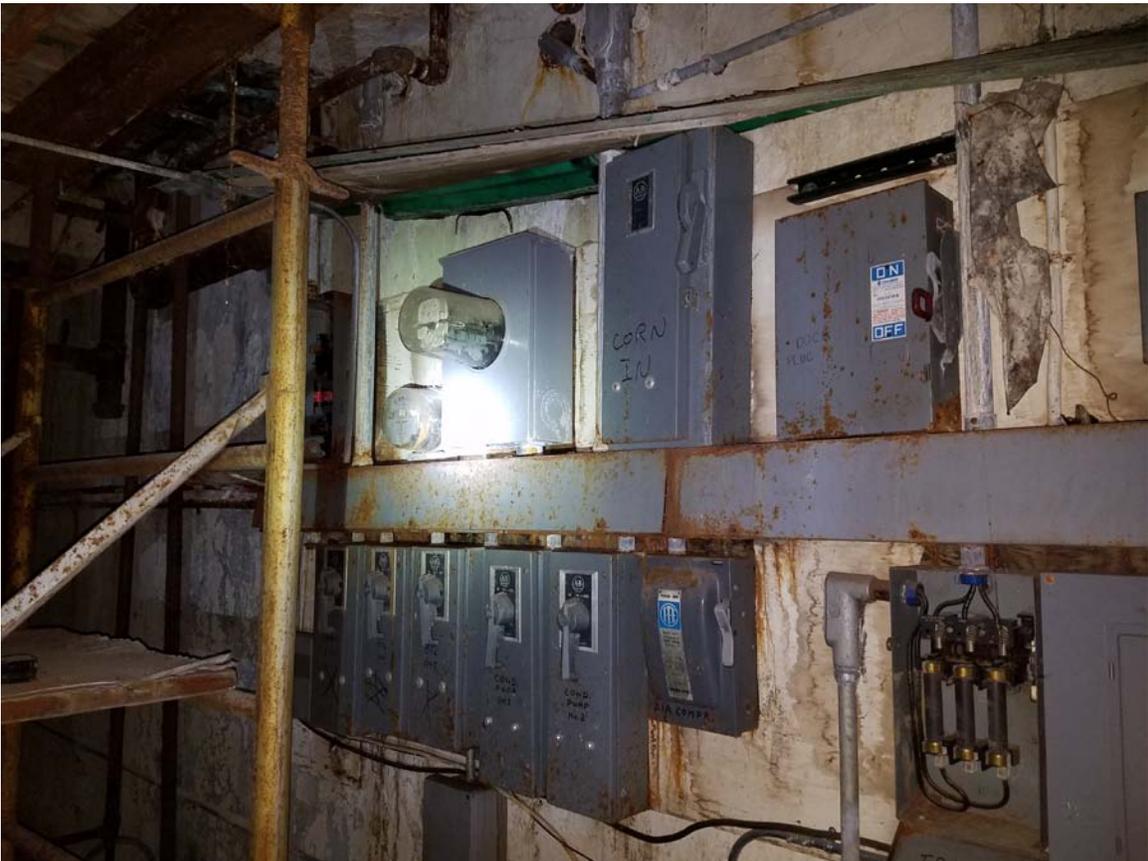
Figure E-079. Filbin Building Electrical Panels, Located in Basement

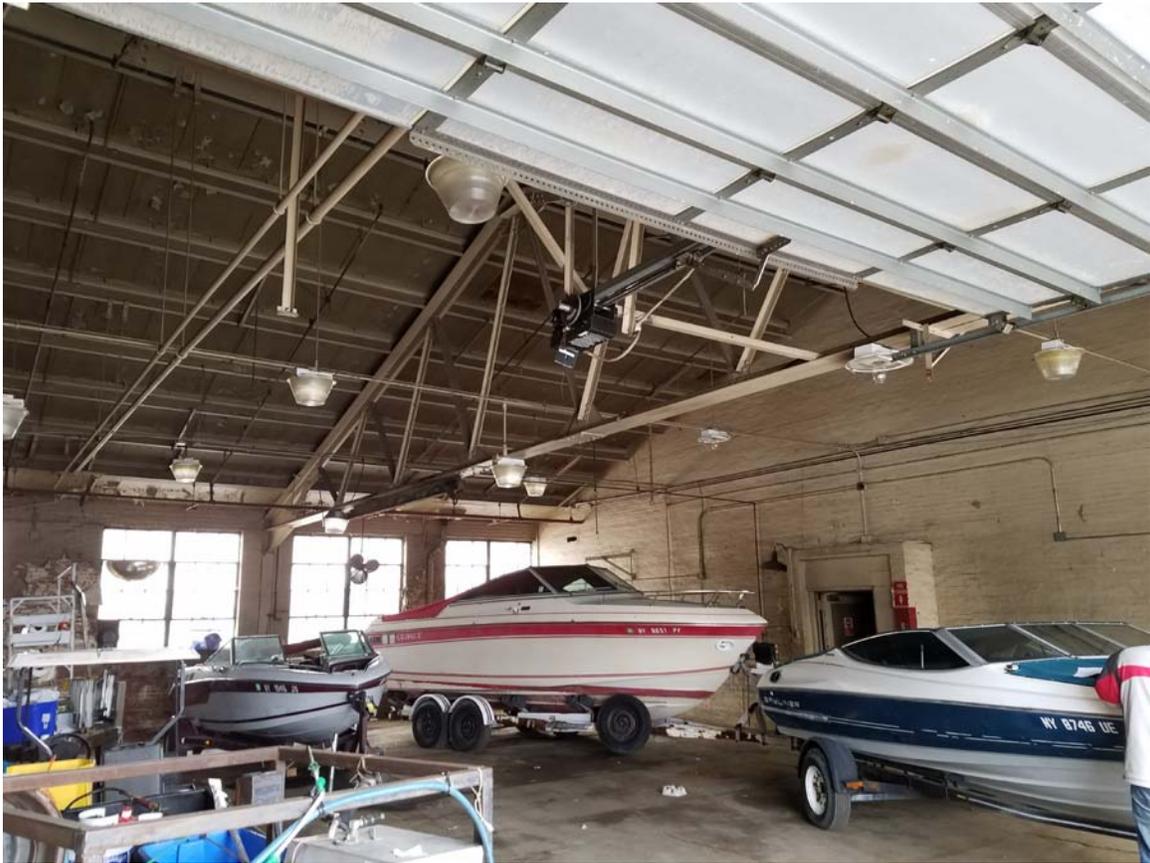
Figure E-080. Filbin Building Garage Area Lighting

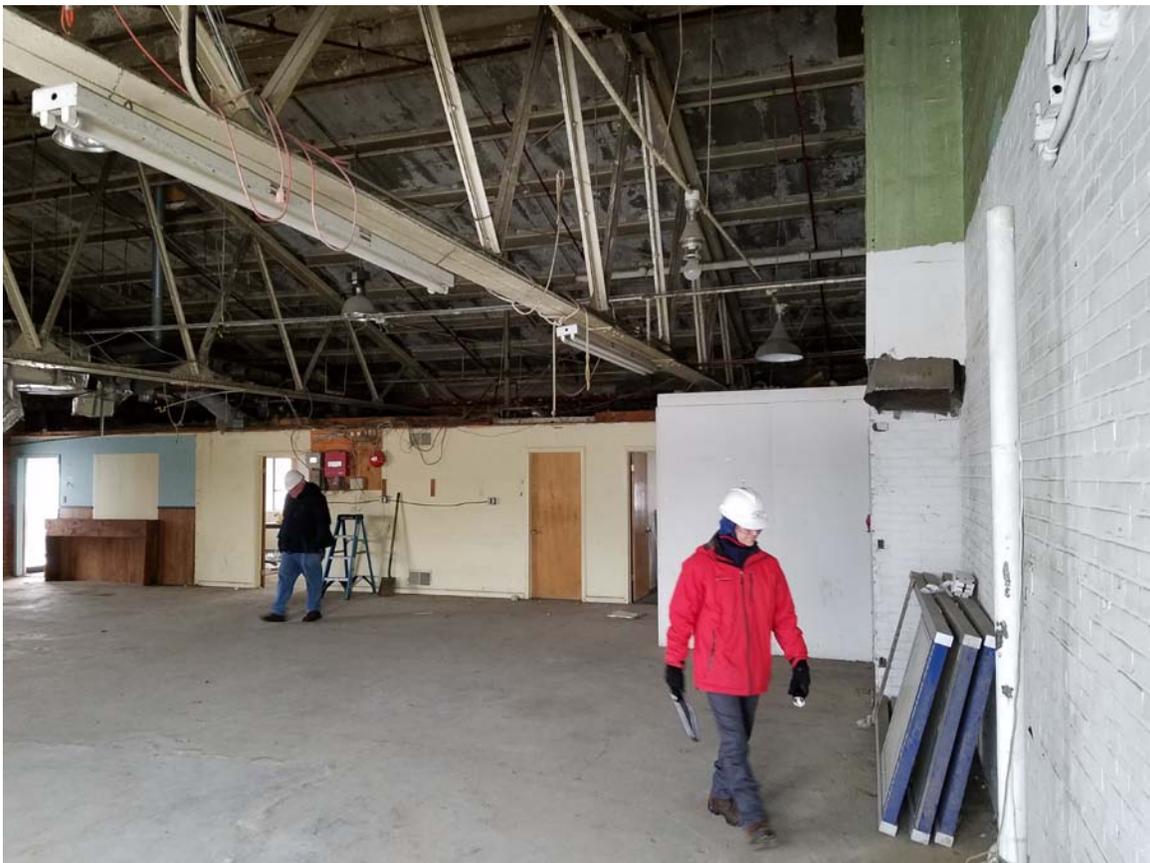
Figure E-081. Filbin Building Office Area Lighting – Notice Multiple Generations of Lighting Present

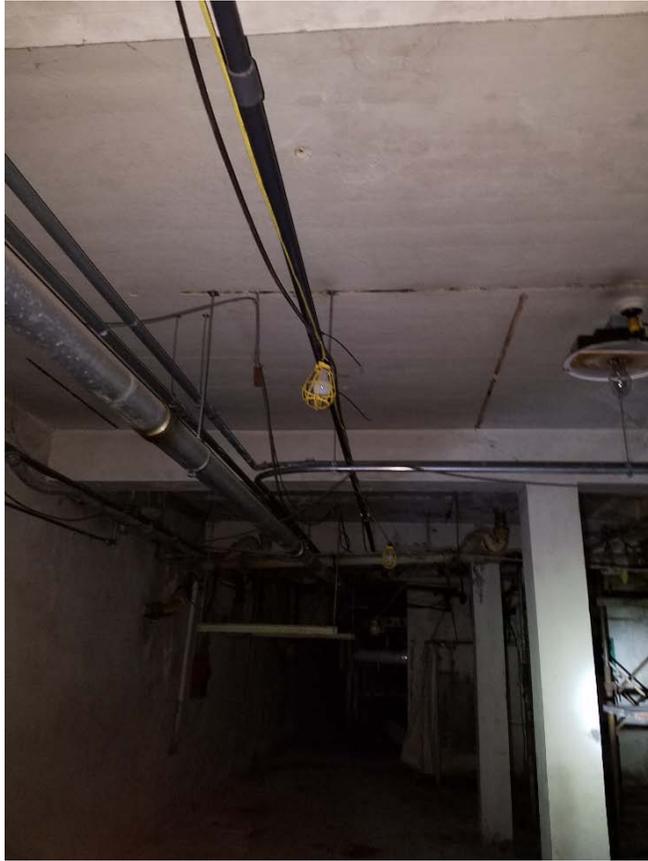
Figure E-082. Non-functional Tunnel and Basement Lighting

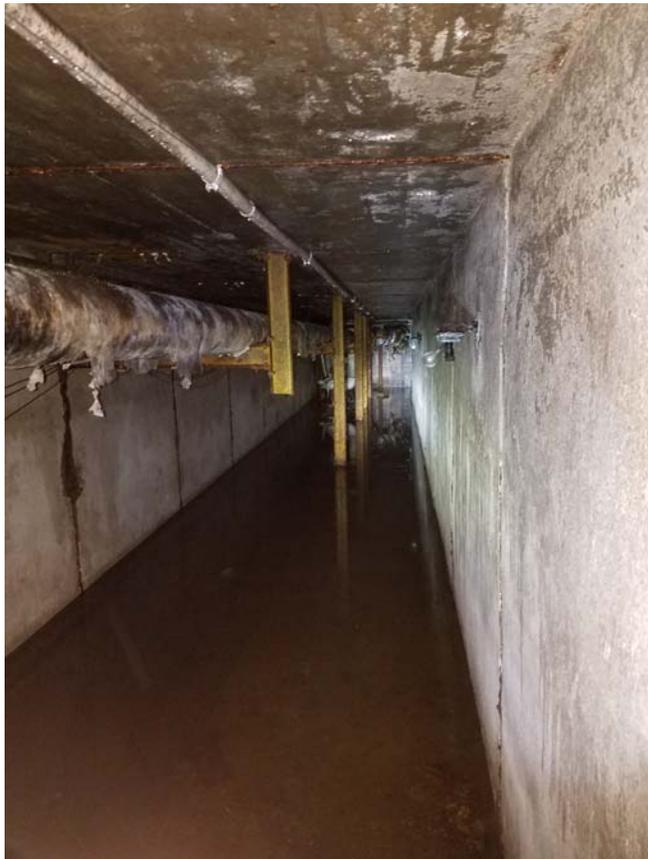
Figure E-083. Non-functional Tunnel and Lighting in Flooded Tunnel

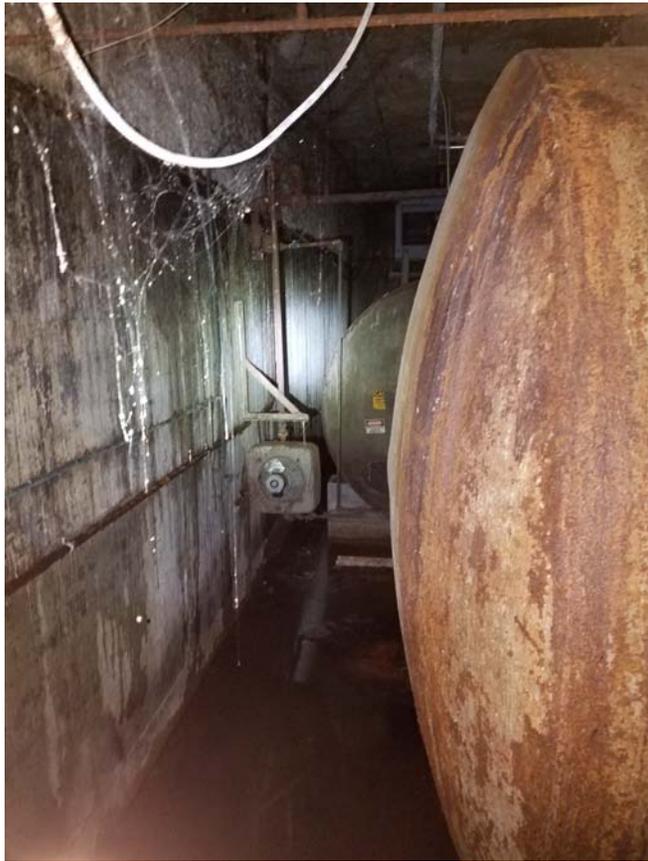
Figure E-084. Standing Water in Oil Tank Room

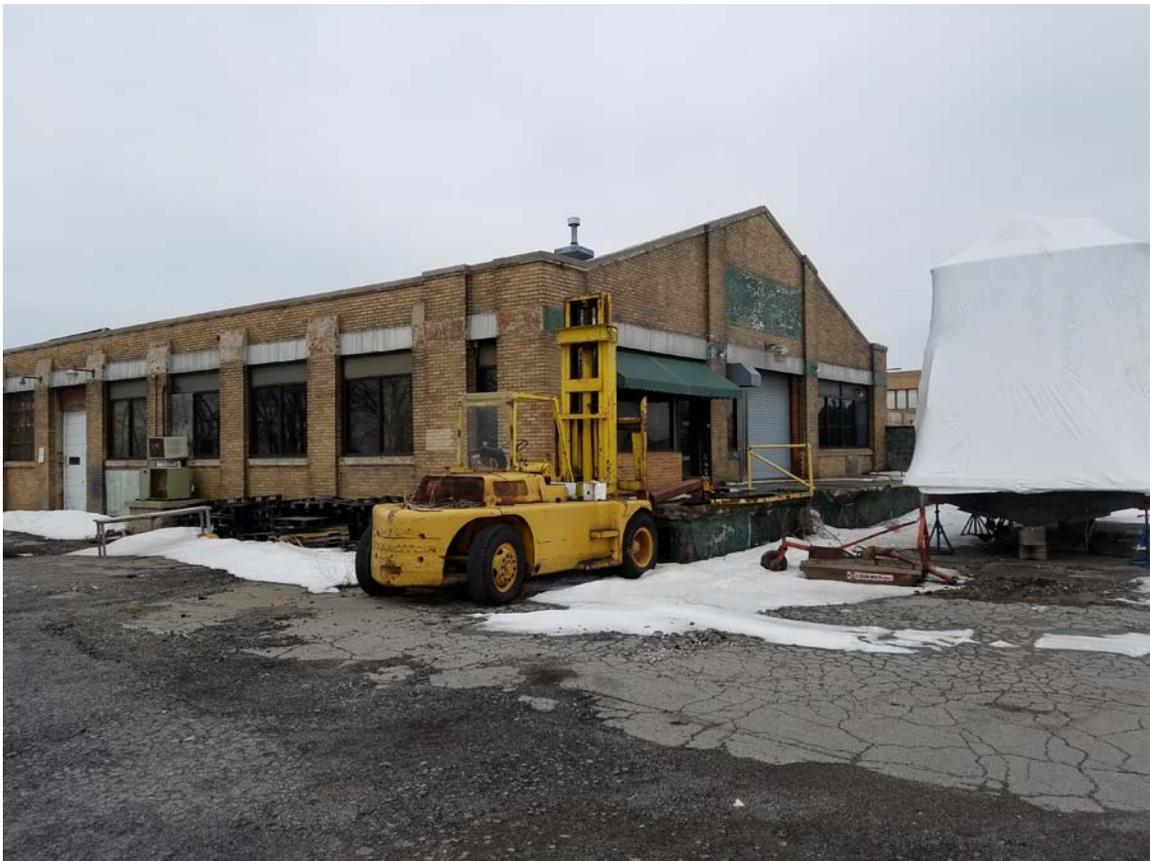
Figure E-085. Filbin Building Exterior, South East Corner

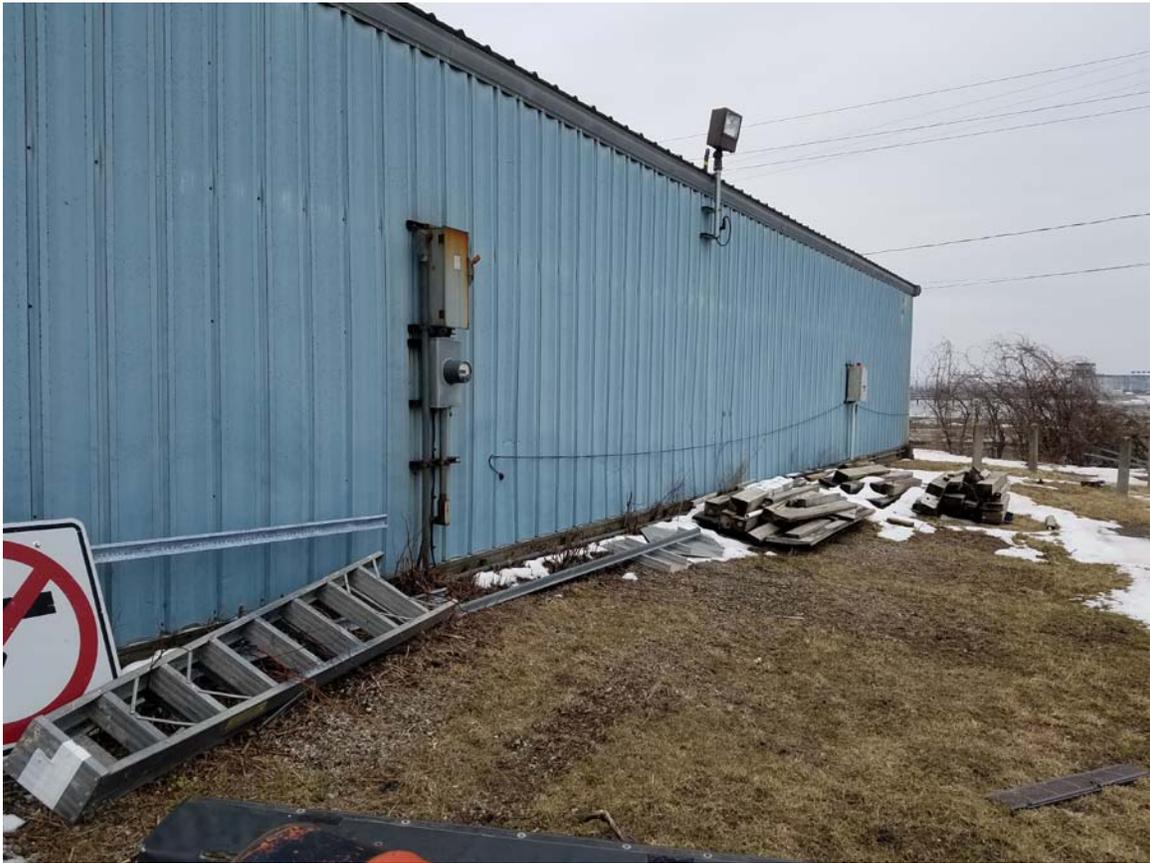
Figure E-086. Maintenance Building Service Entrance

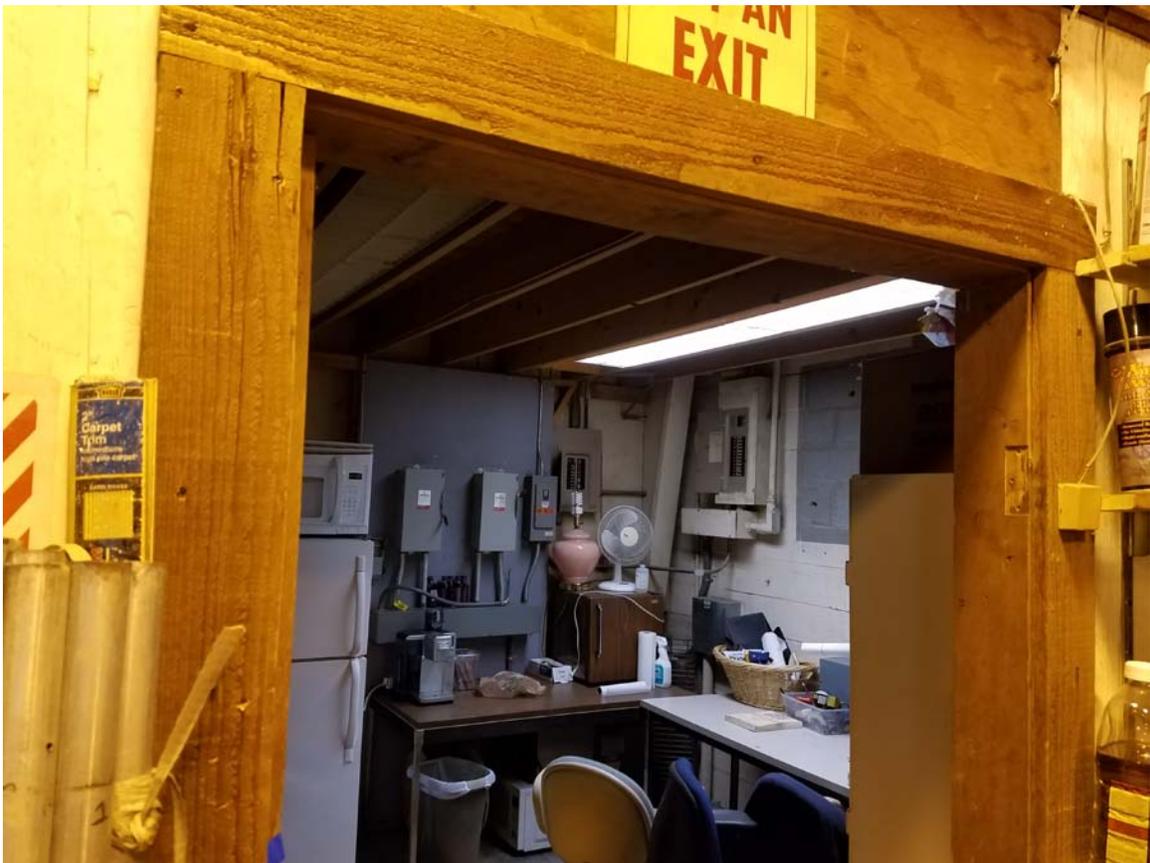
Figure E-087. Maintenance Building Electrical Panels

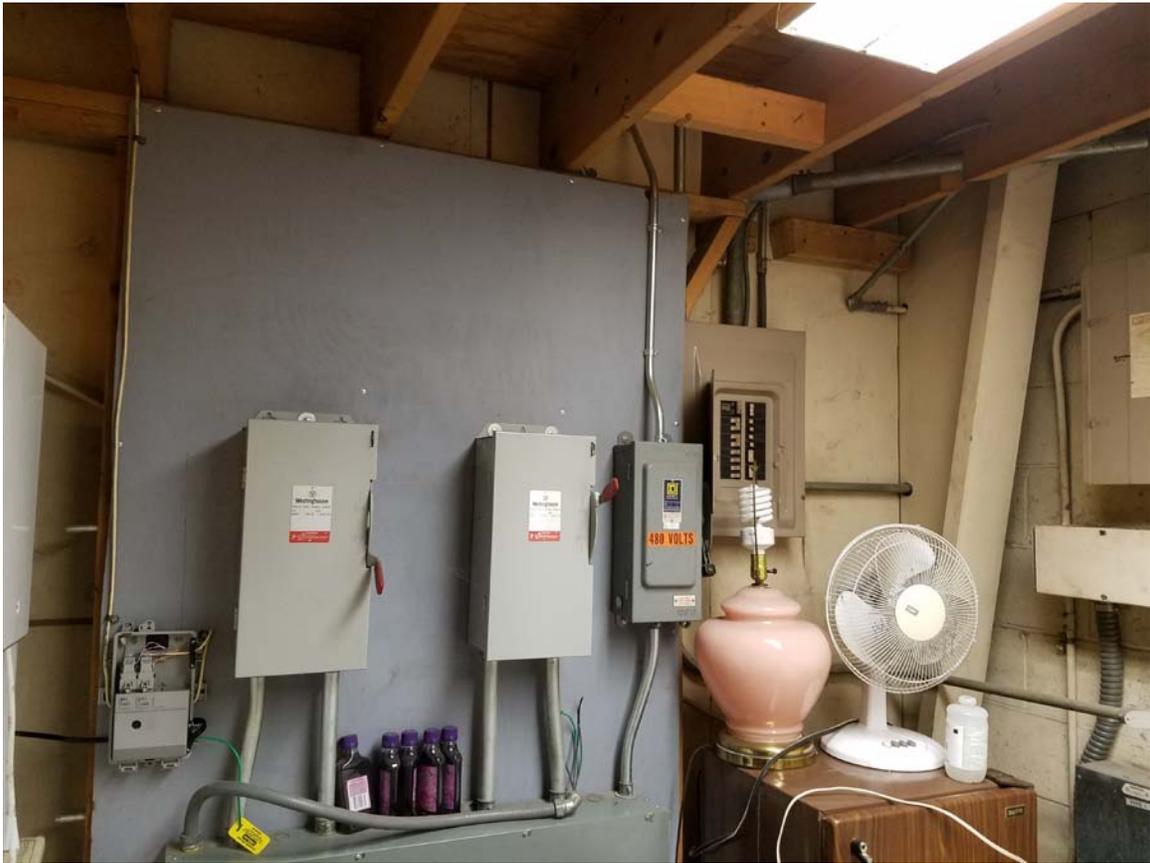
Figure E-088. Maintenance Building Electrical Panels and Telephone Demarcation Point

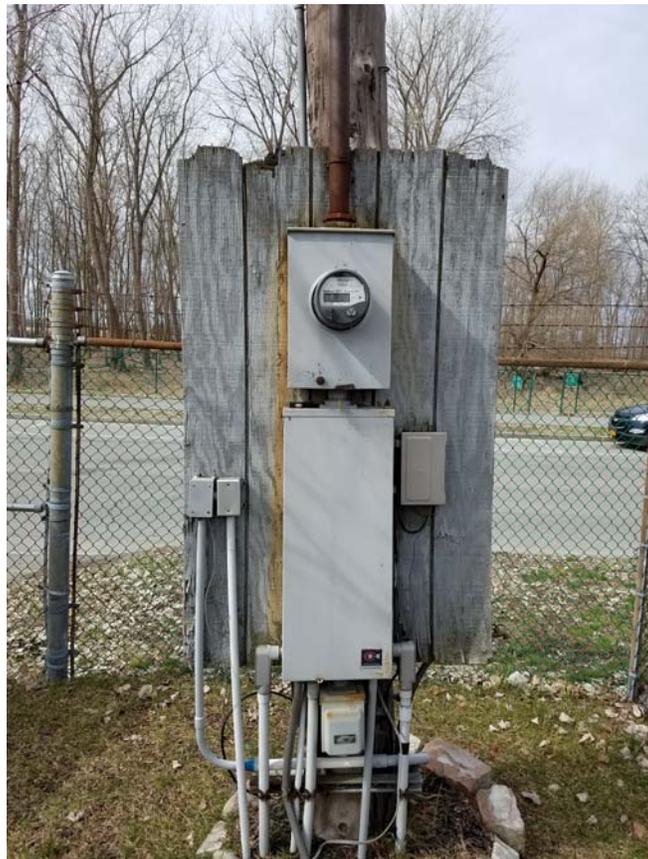
Figure E-089. First Buffalo River Marina Site Power Service Entrance

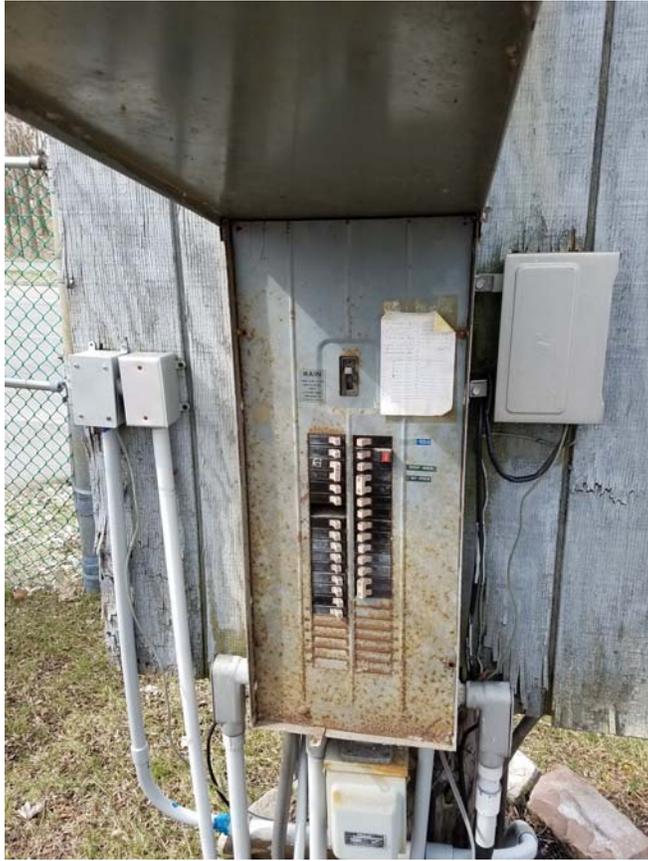
Figure E-090. First Buffalo River Marina Site Power Panel

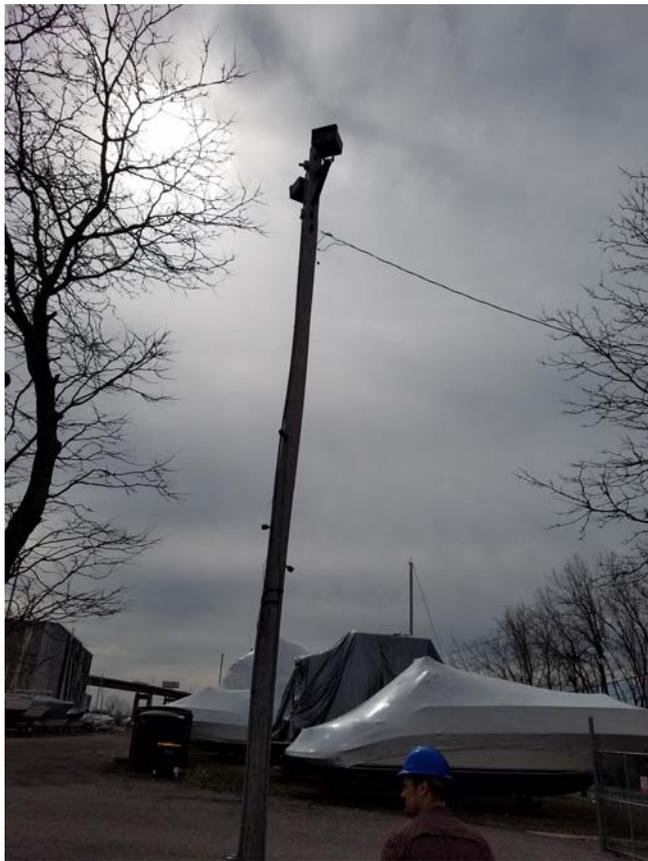
Figure E-091. First Buffalo River Marina Typical Site Lighting
