MEP/FP SYSTEM INVENTORY AND ASSESSMENT – FINAL REPORT

Project Title:	Buffalo Outer Harbor Access & Activation Civic Improvements
----------------	--

REP-17055-001, REV. 2

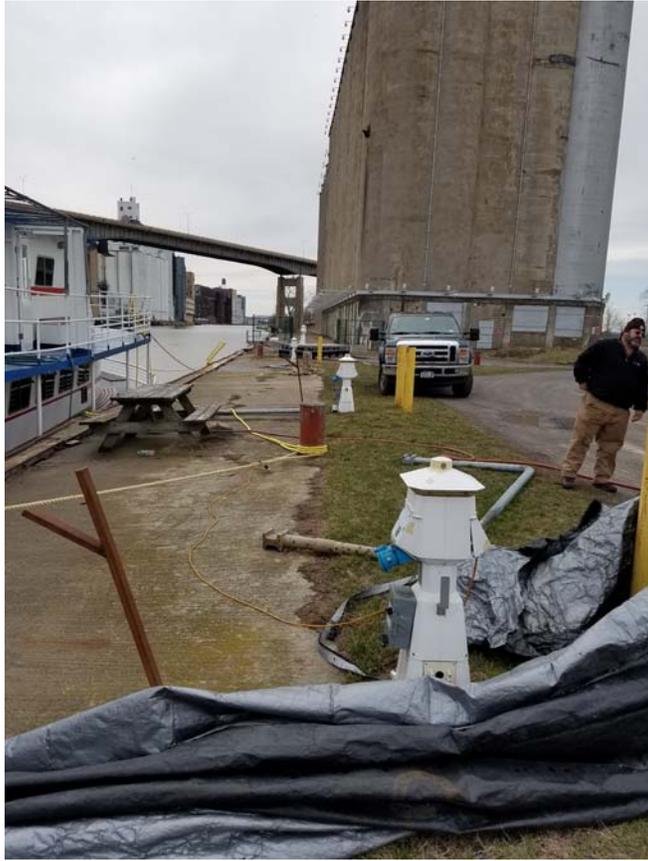
Figure E-092. First Buffalo River Marina Typical Shore Power Connection

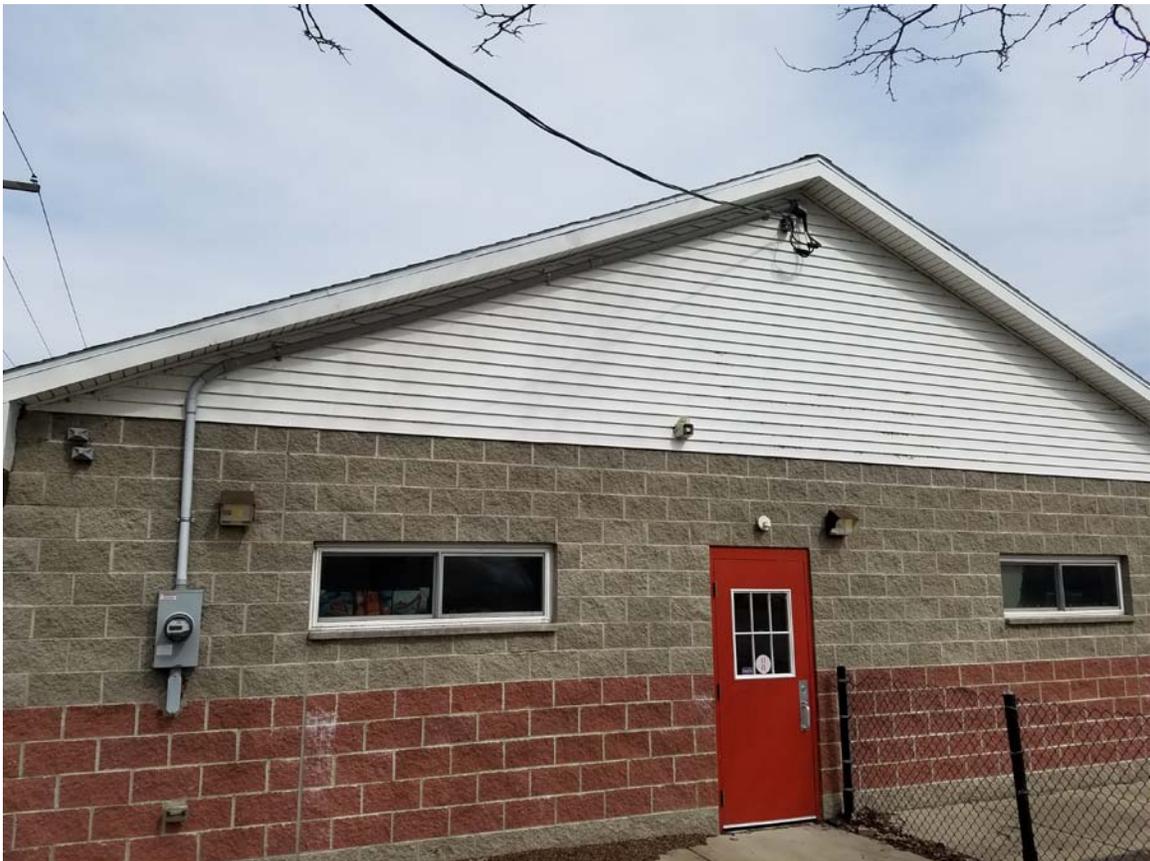
Figure E-093. First Buffalo River Marina Office and Restrooms Service Entrance

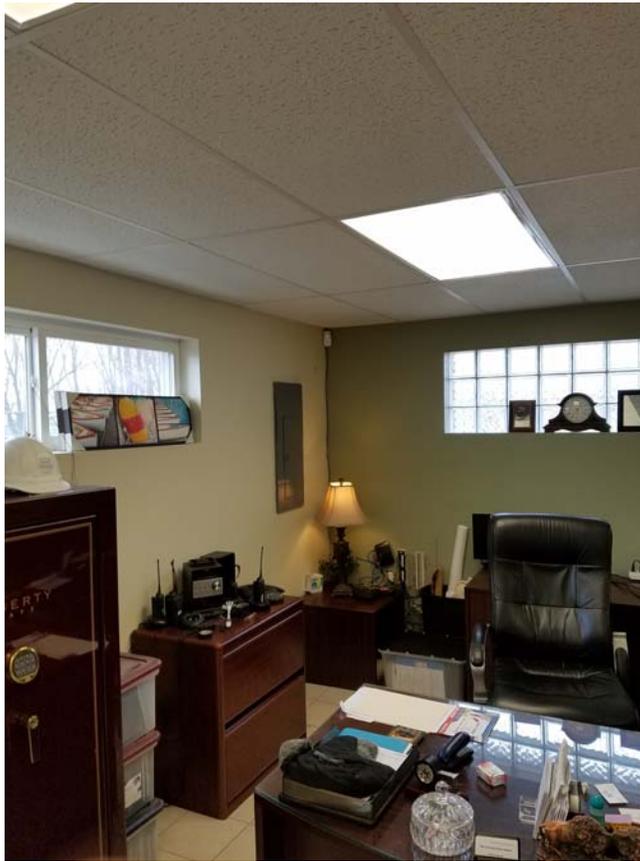
Figure E-094. First Buffalo River Marina Office and Restrooms Panelboard

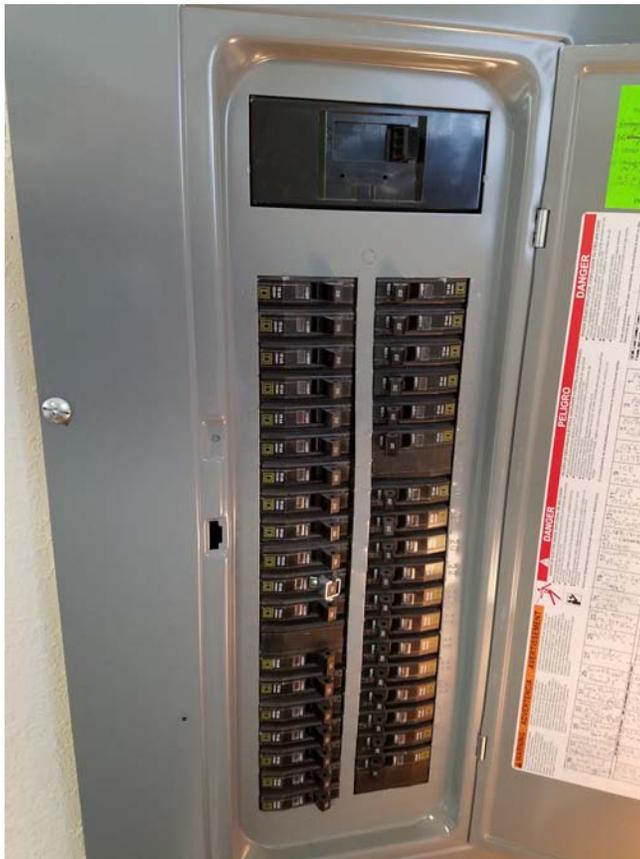
Figure E-095. First Buffalo River Marina Office and Restrooms Panelboard Closeup

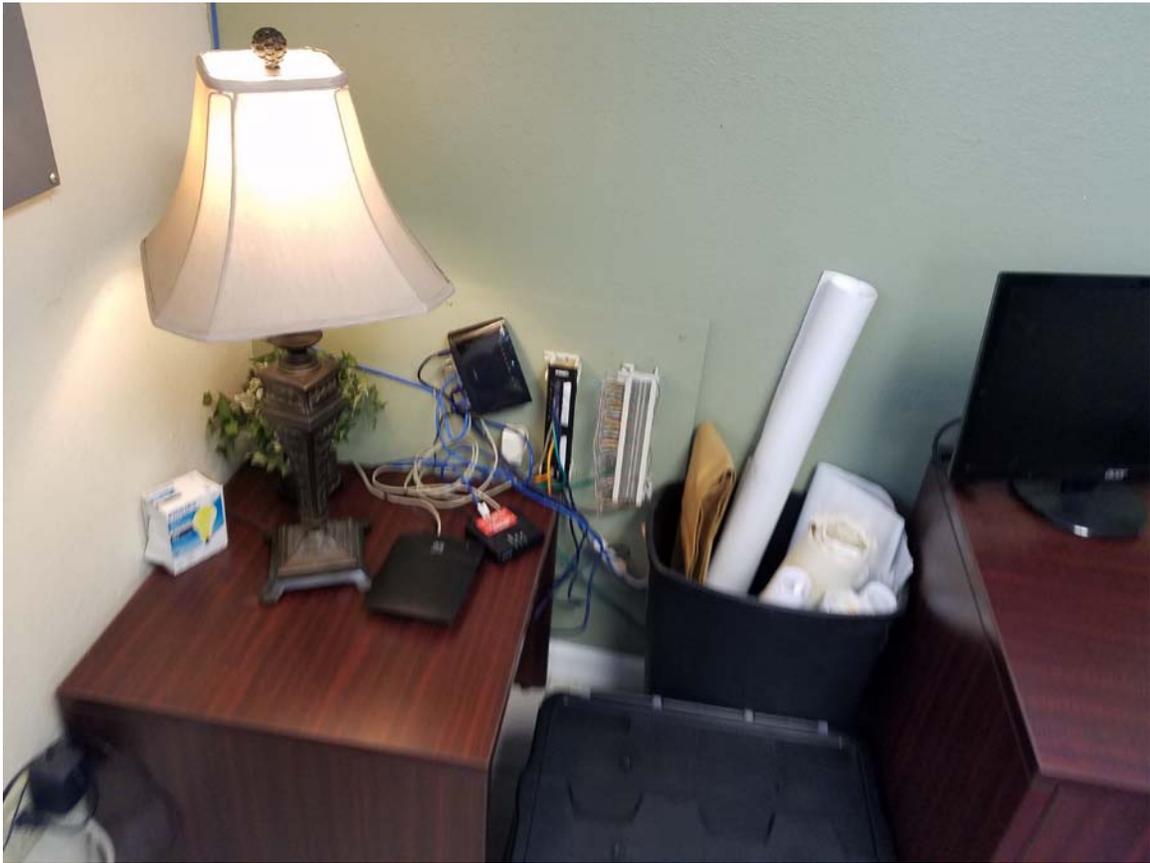
Figure E-096. First Buffalo River Marina Office and Restrooms Phone and Internet Connections

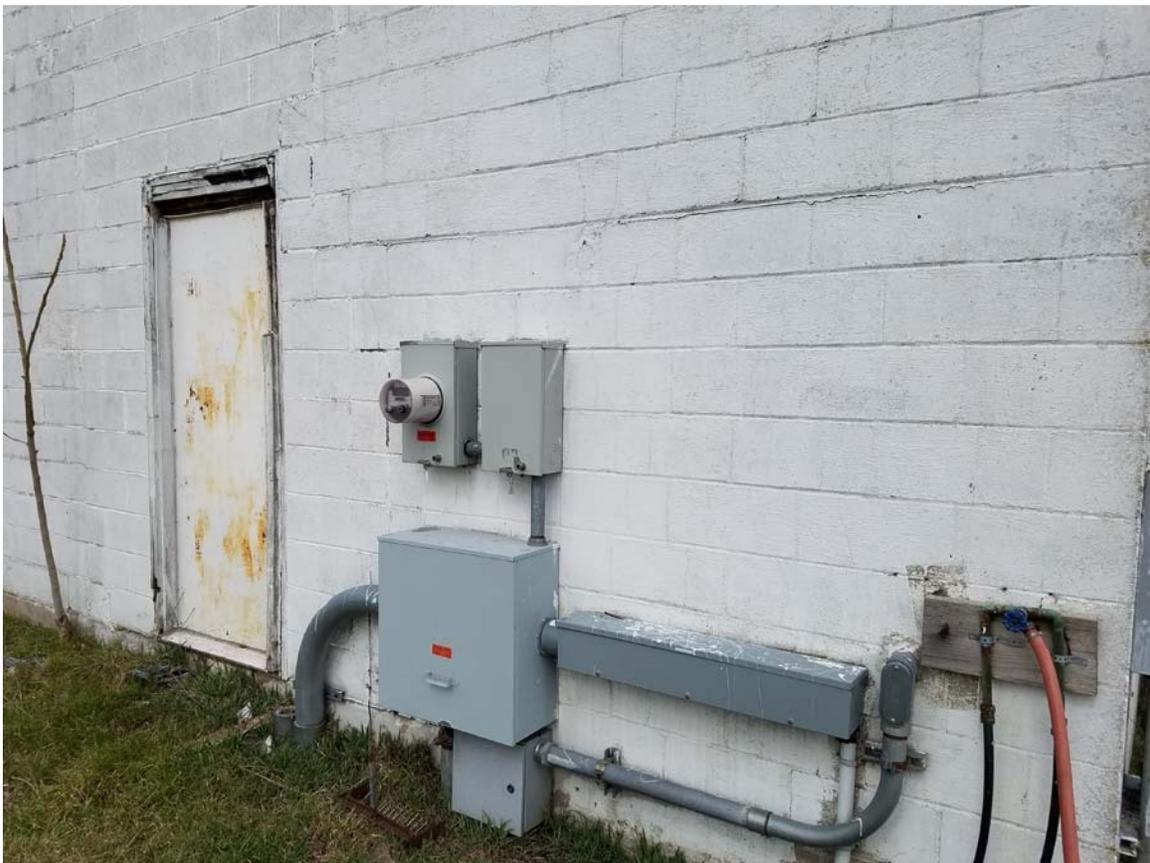
Figure E-097. First Buffalo River Marina Maintenance Building Service Entrance

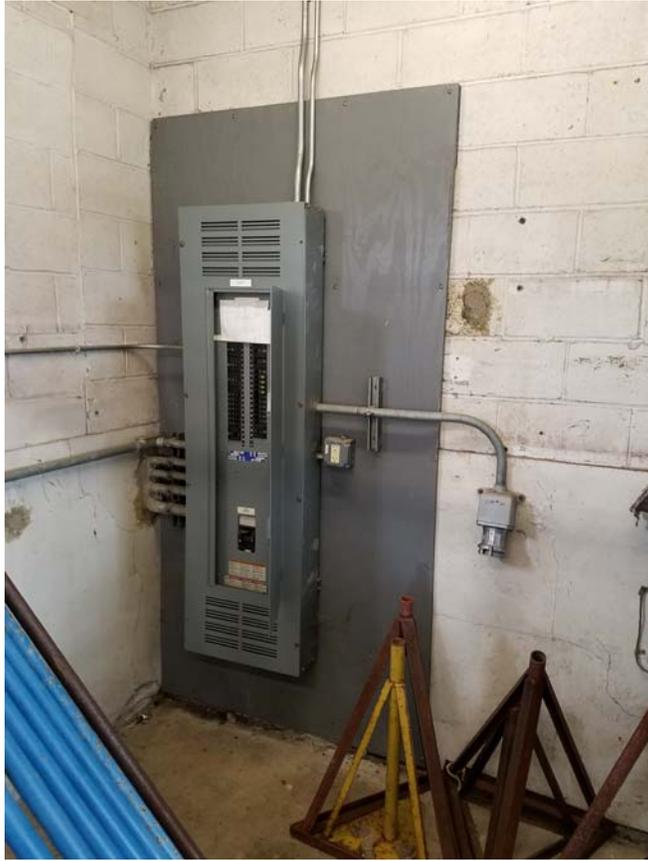
Figure E-098. First Buffalo River Marina Maintenance Building Panelboard

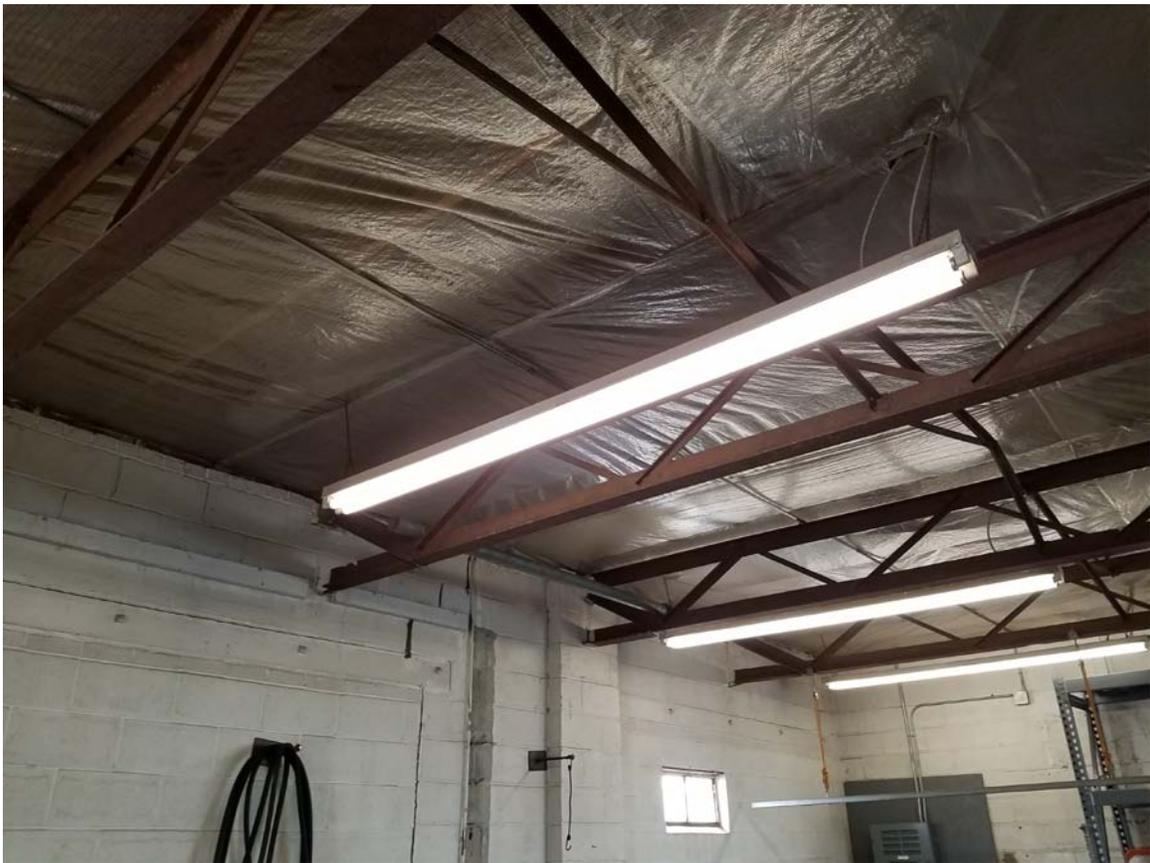
Figure E-099. First Buffalo River Marina Maintenance Building Lighting

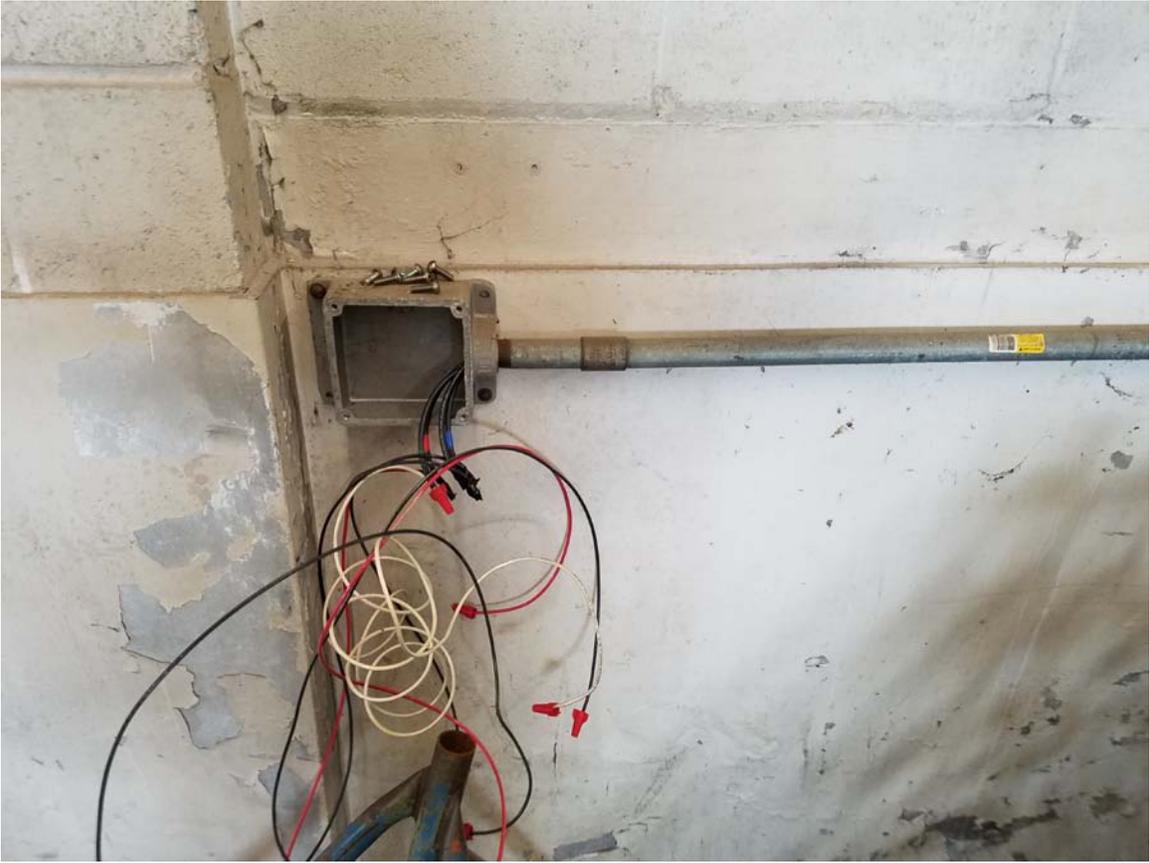
Figure E-100. First Buffalo River Marina Maintenance Building Exposed Wiring
